Re: *Algonquin Gas Transmission, LLC*
E-1 System Regulator Installation Project, Docket No. CP24-21-000
Report No. 2

**E-1 System Regulation
WEEKLY REPORT #2**

Project:	E-1 System Regulation Installation
FERC Docket Number:	CP24-21-000
Report Number:	2
Reporting Period:	July 19 through July 24, 2024

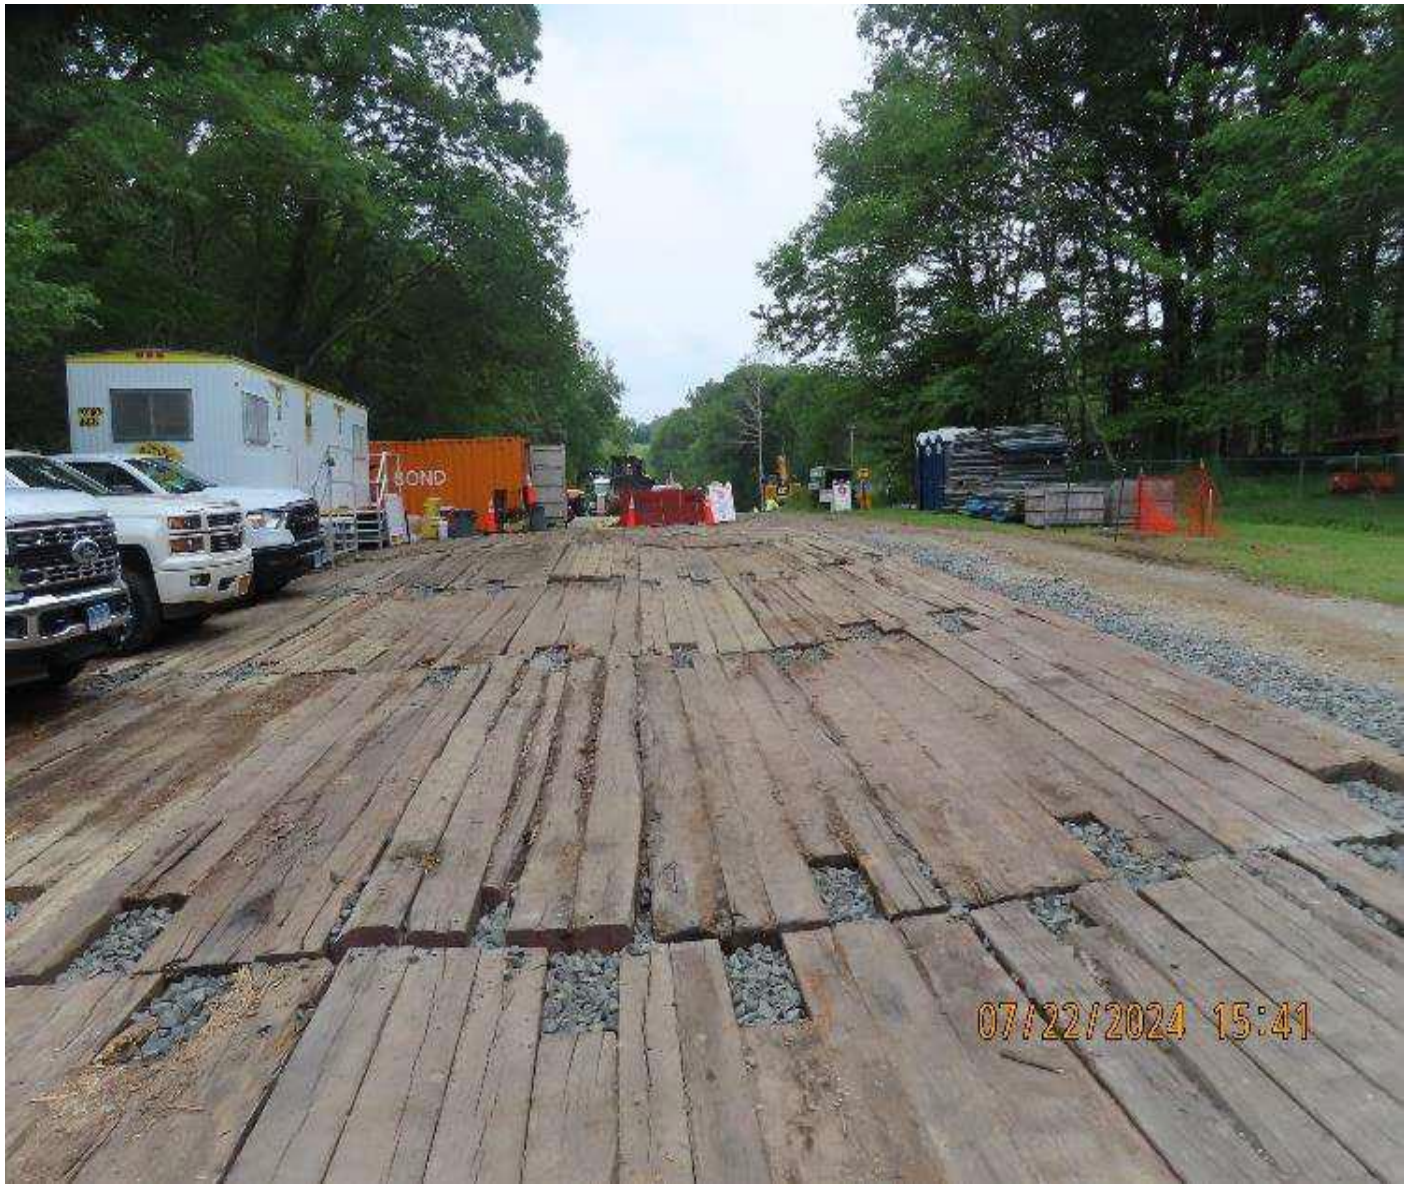
Photo 1. View (looking northeast) of matted staging area for job trailers and vehicle parking.

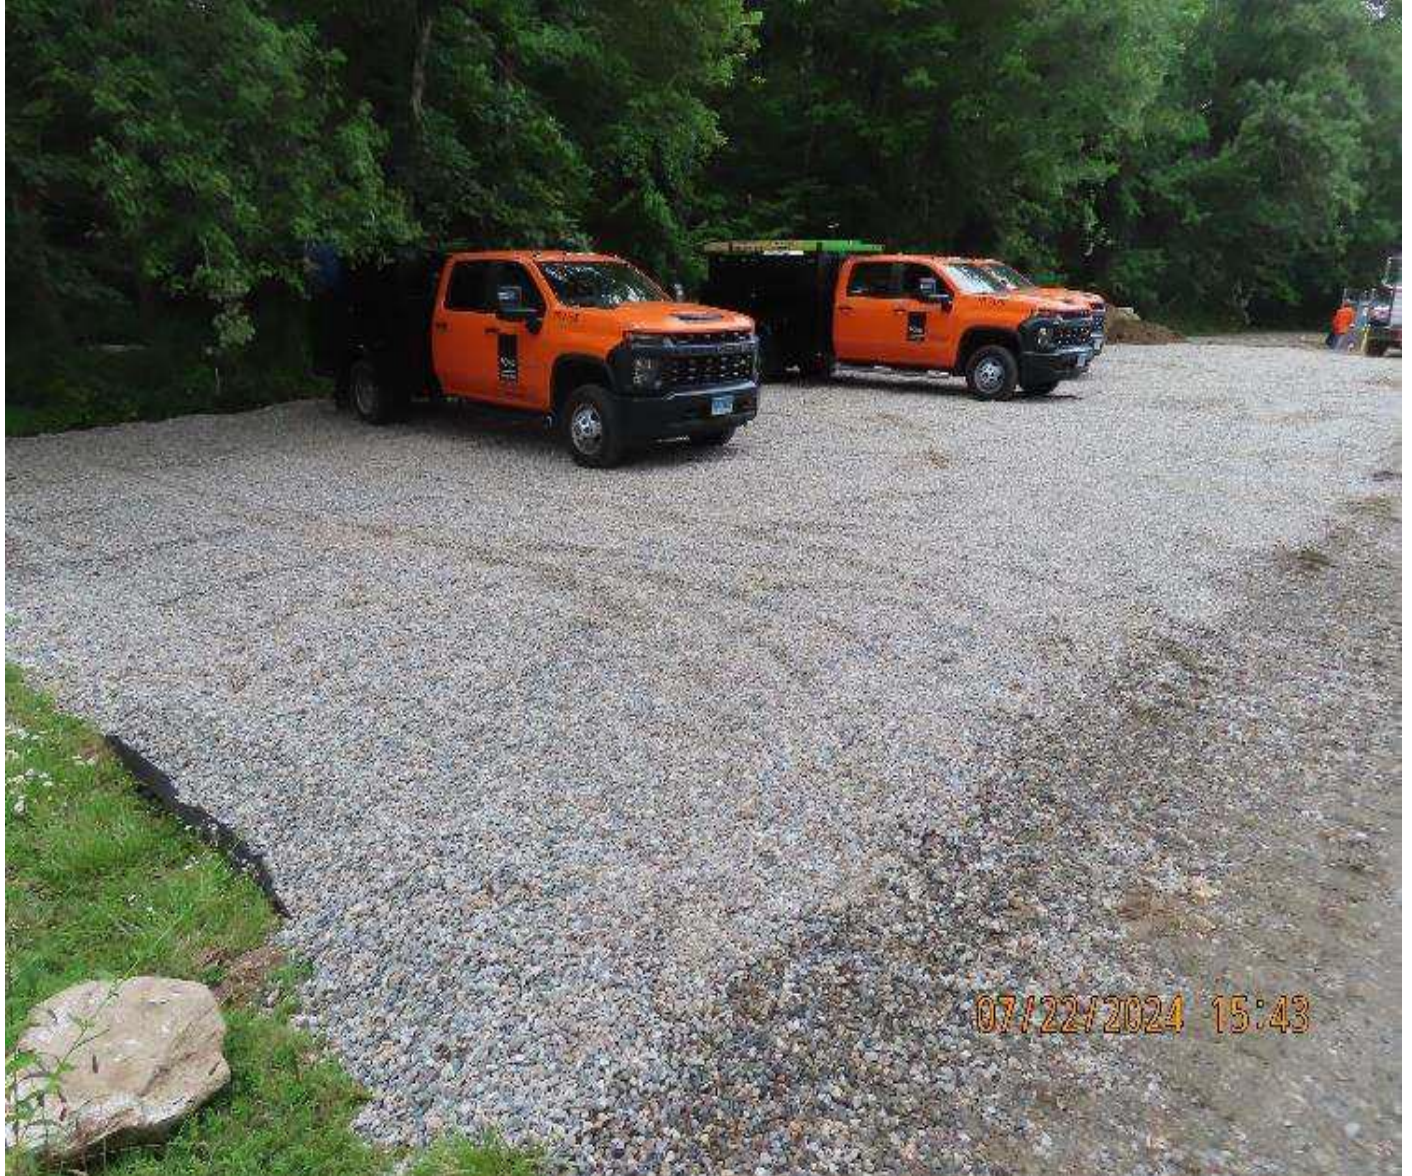
Photo 2. View (looking northeast) of stone placed over geotextile fabric to establish area for welding and fabrication.

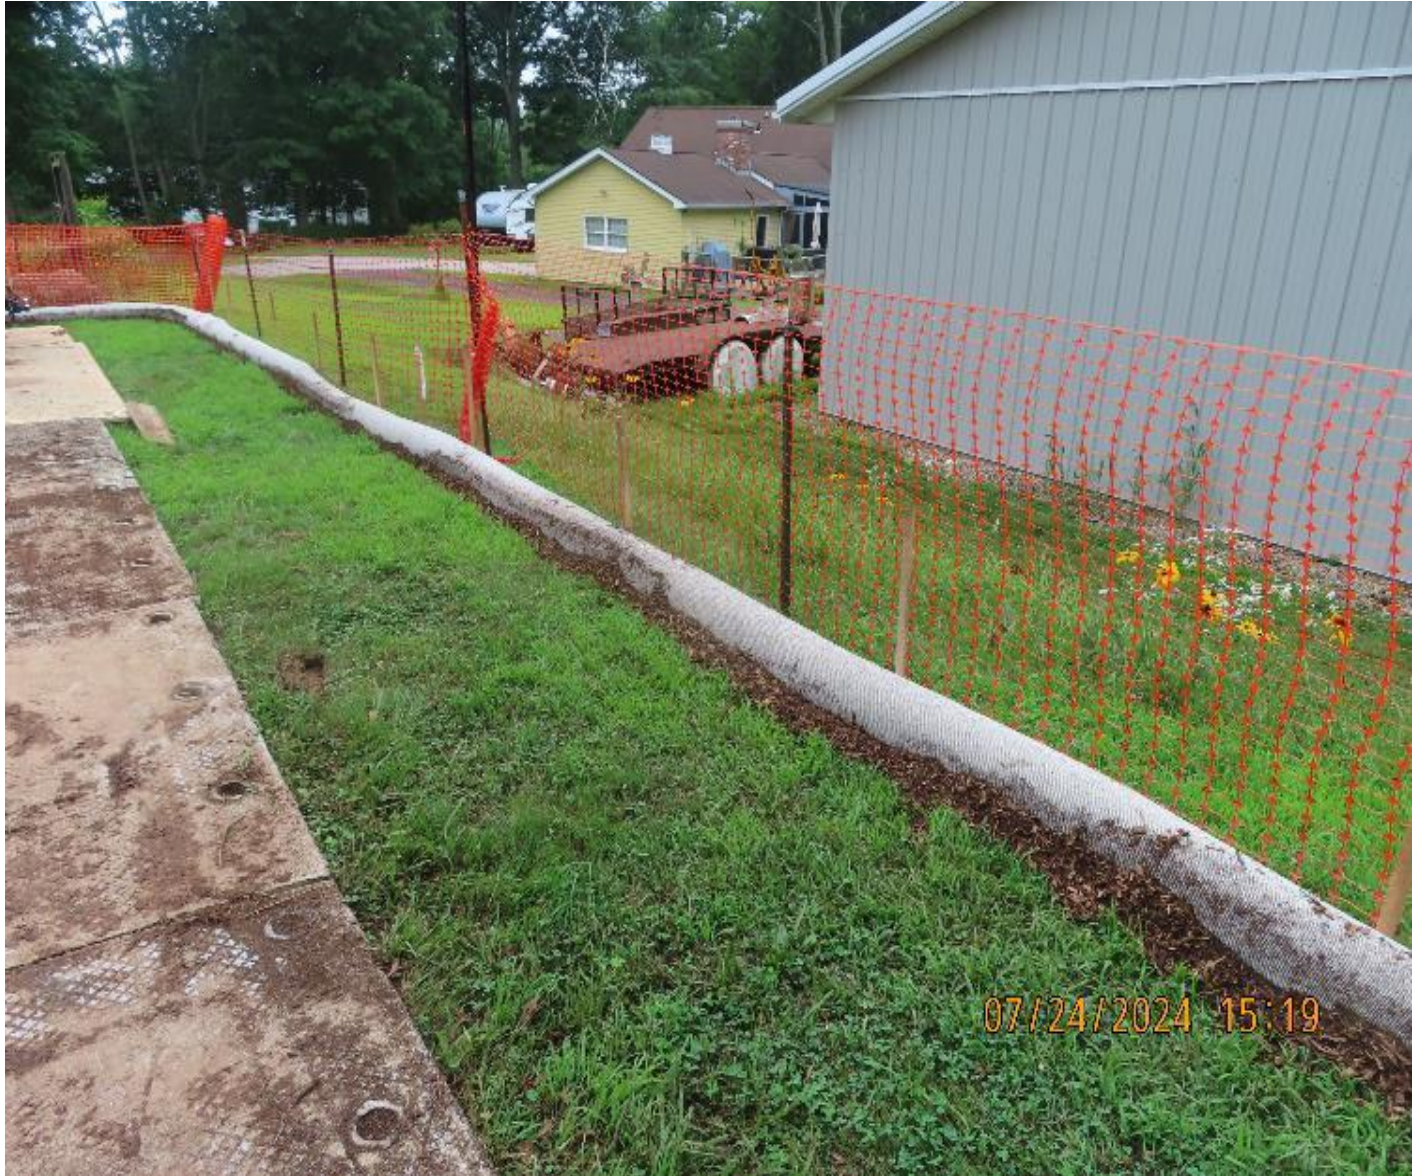
Photo 3. View (looking southwest) of filter sock and security fencing installed along both sides of the access road.

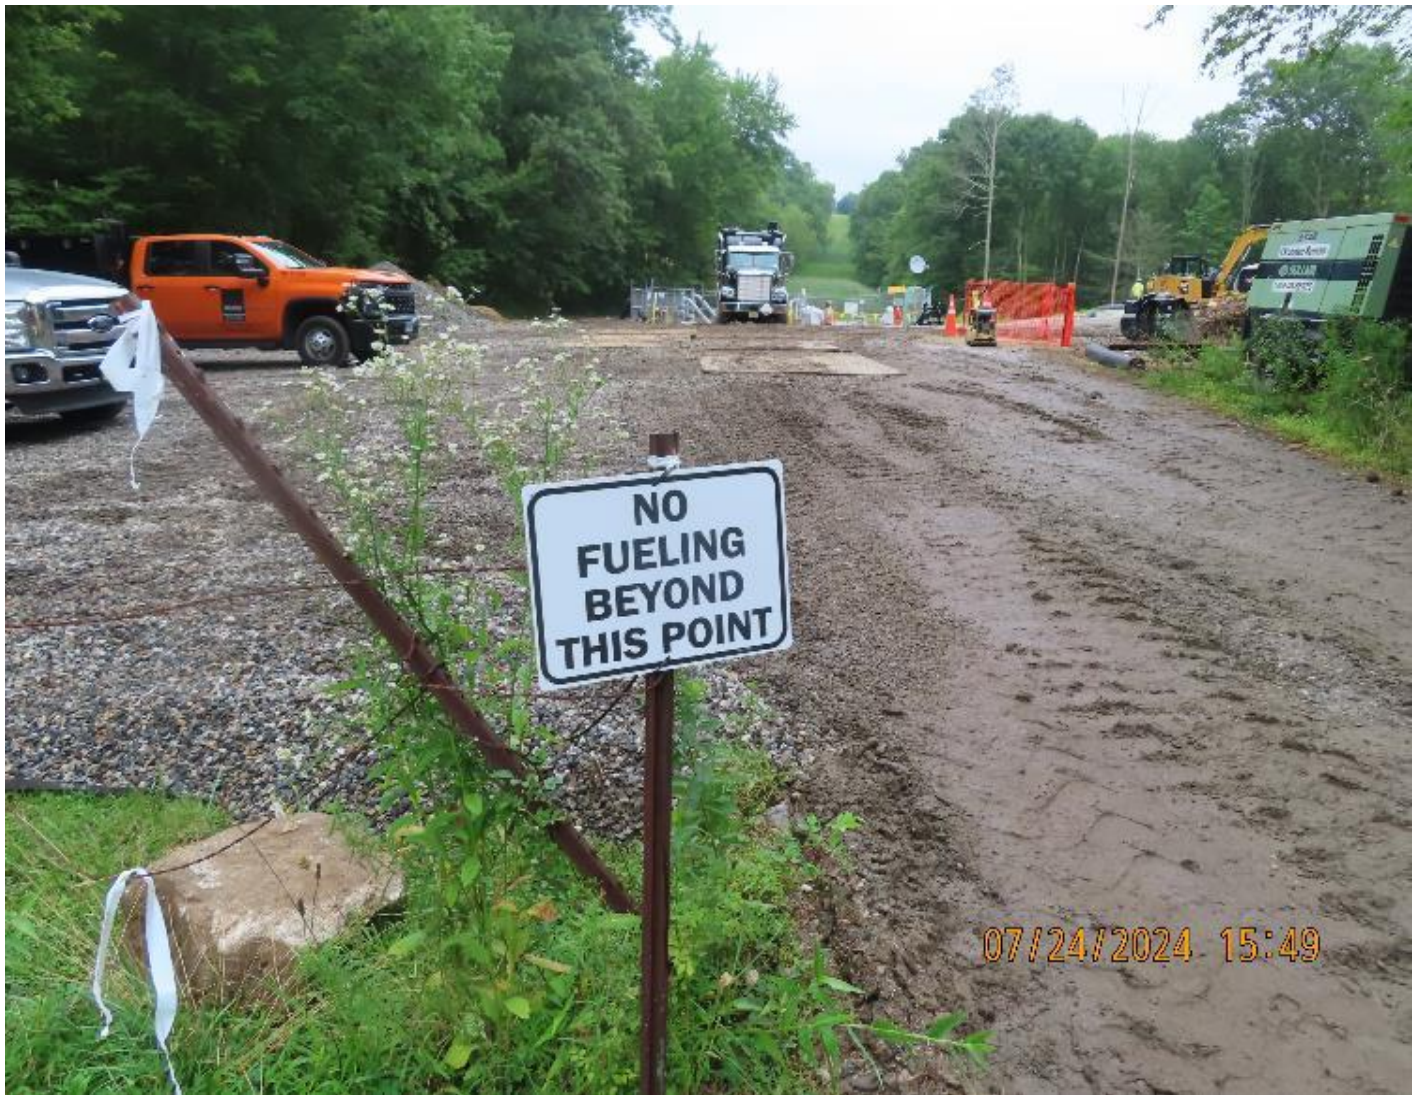
Photo 4. View (looking northeast) at refueling area.

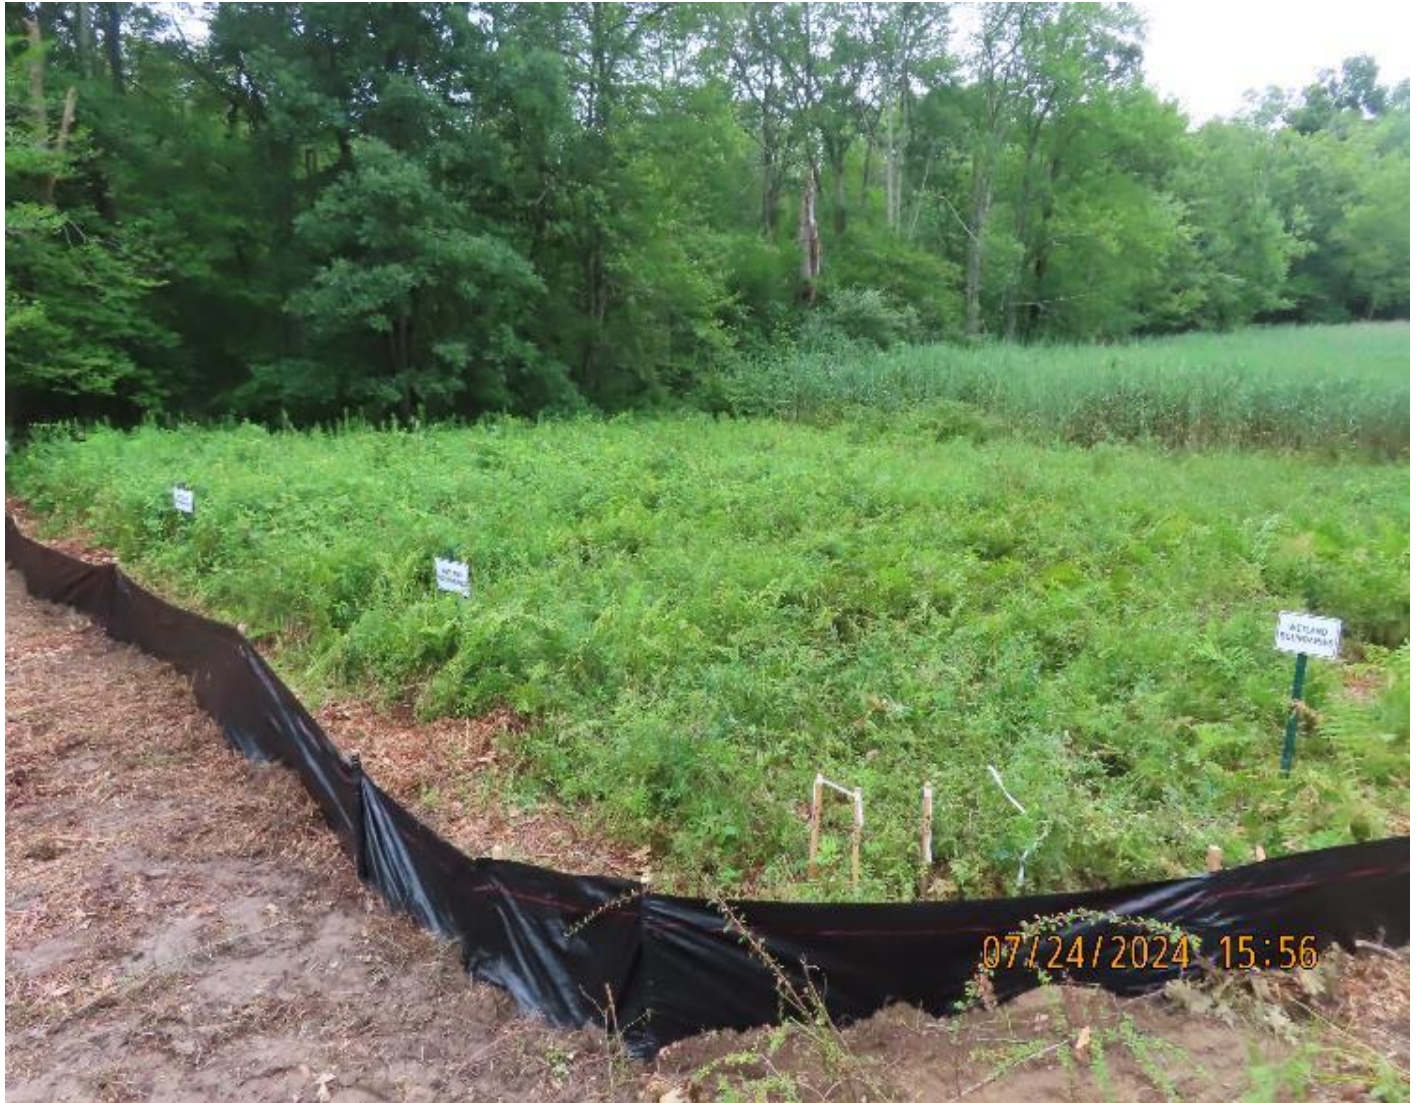
FERC submitted a question for Report Number 1 regarding Photograph 7. The reviewer asked why no Erosion Control Devices (ECDs) or wetland signage was in-place and requested a date stamped photograph of the same area in the next report after the ECDs and signage was installed.

Photo 5. View (looking north) at silt fence, wetland protection signage, and vegetative buffer for wetland W-CZ-01.

The ECDs and signage had not been installed yet because the activities being completed were limited to mowing and felling of trees with no associated ground disturbance. Photographs 5 and 6 of this report show the same area after the ECDs and wetland protection signs were installed.

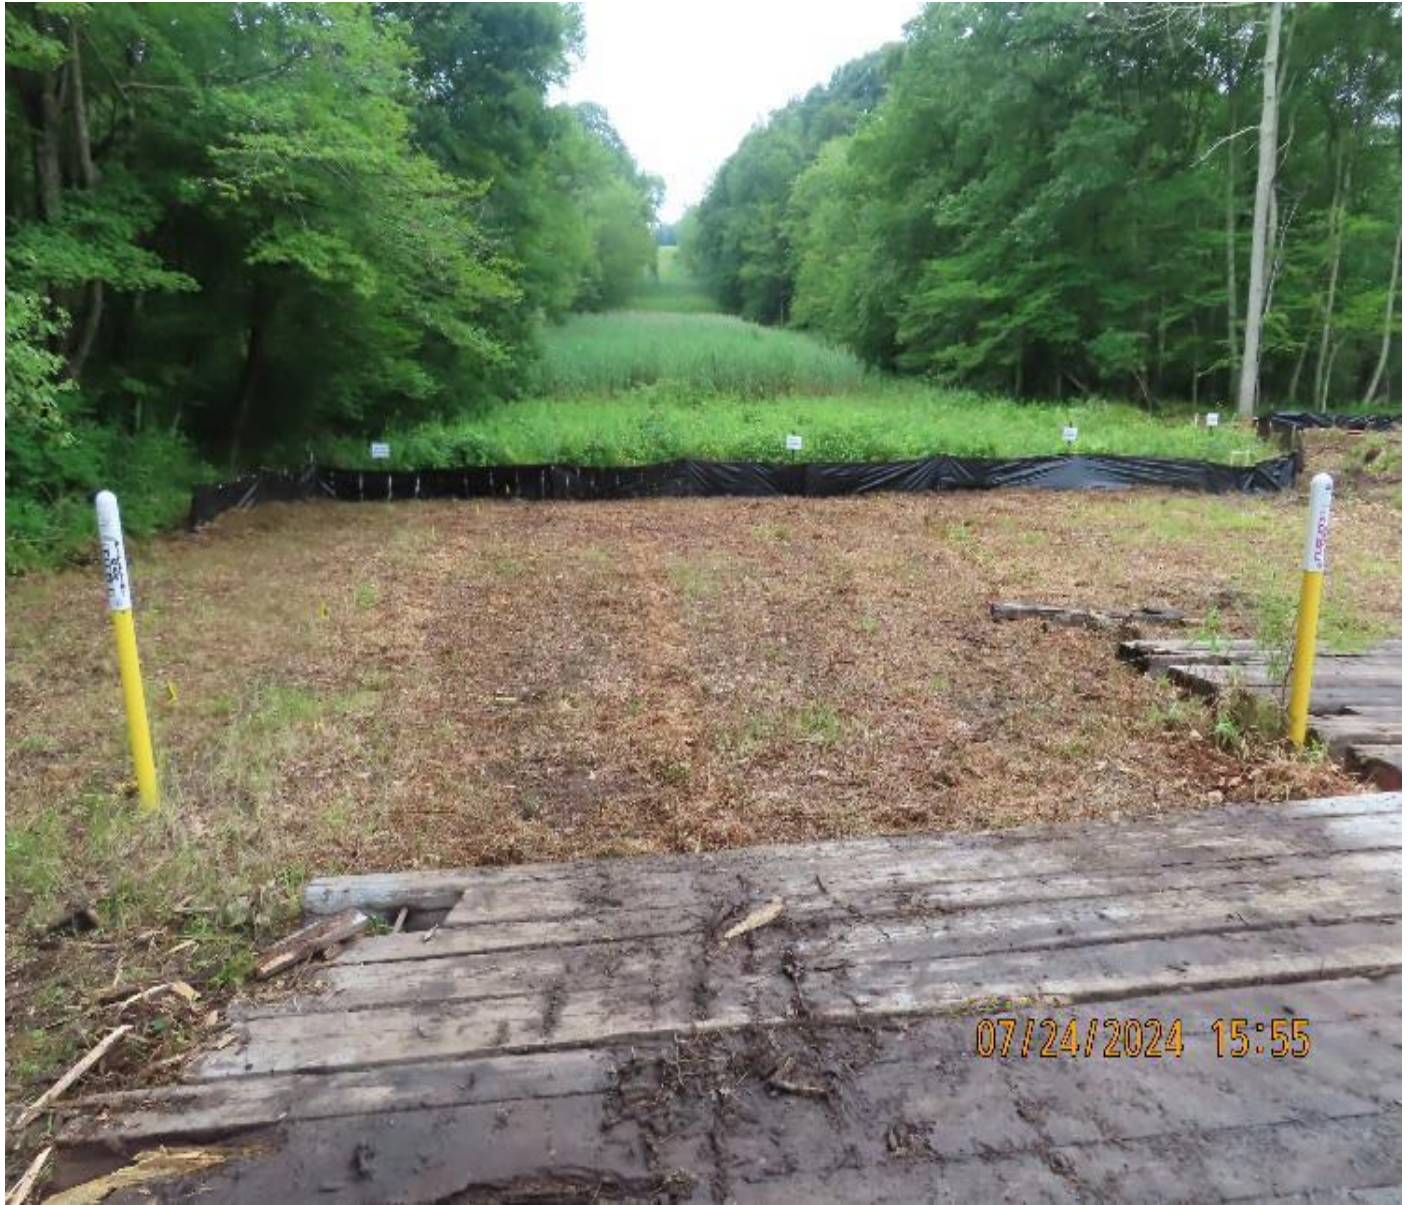
Photo 6. View (looking northeast) of silt fence, wetland signage, and vegetative buffer along northeast site boundary. Mowing has occurred in this area but no ground disturbance.

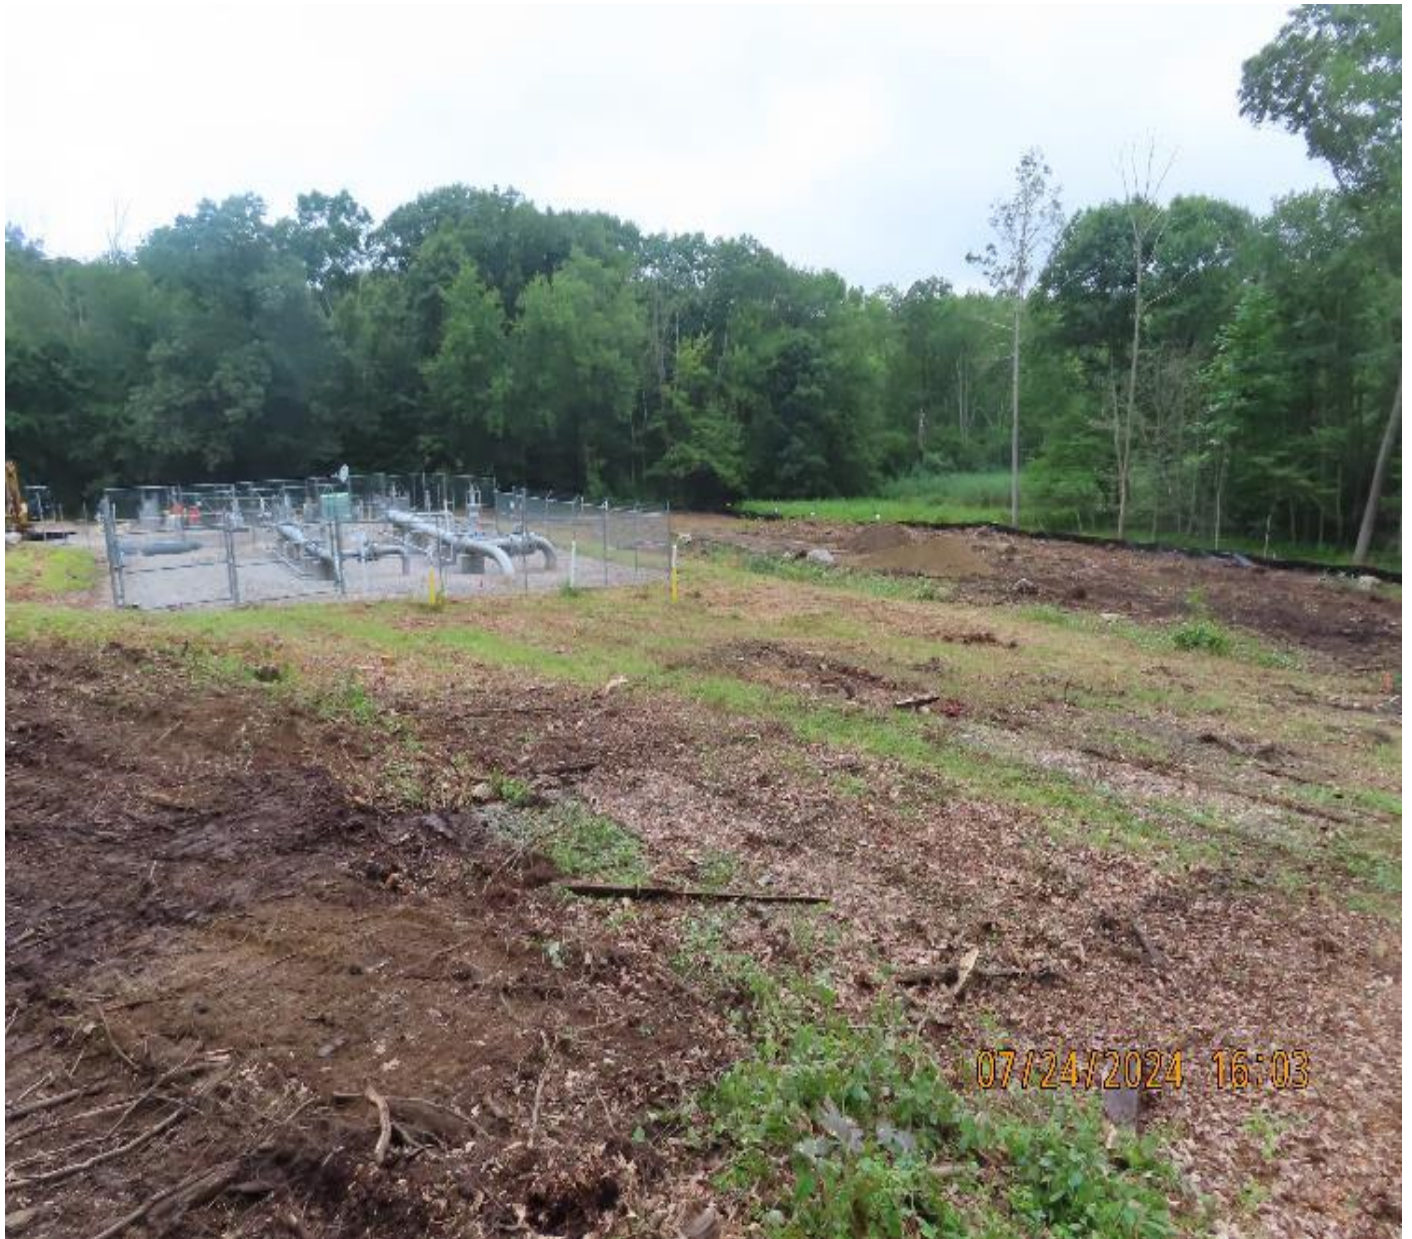
Photo 7. View (looking north) of mowed and cleared workspace near the E-System launcher yard.

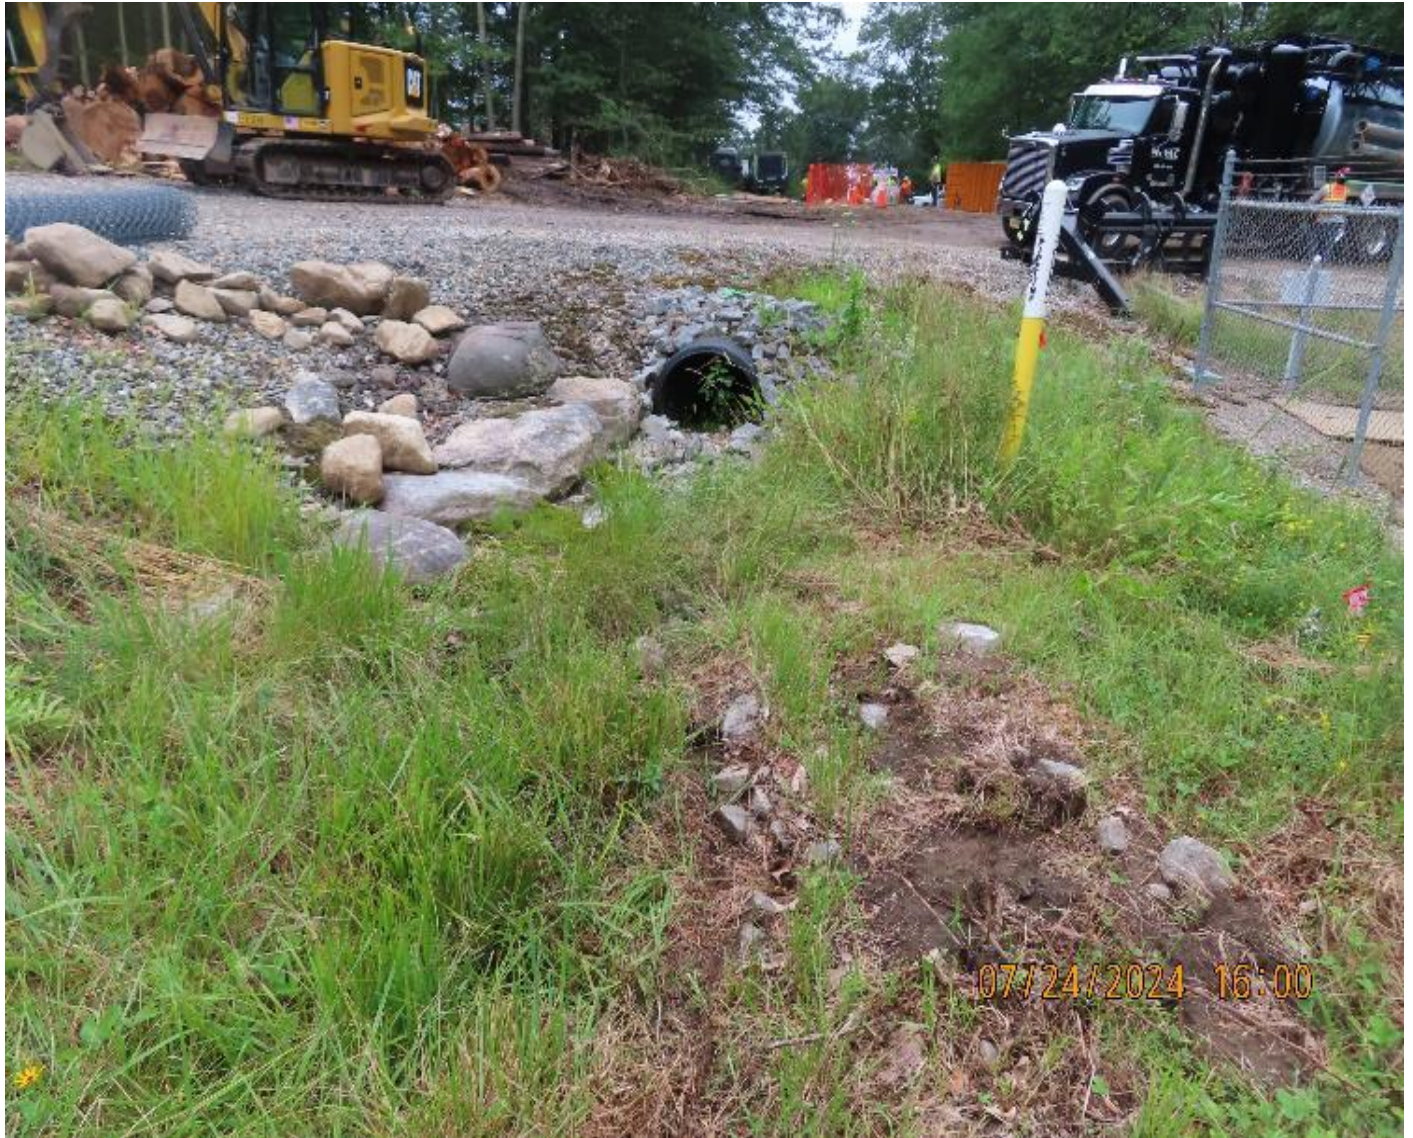
Photo 8. View (looking southeast) of drainage culvert and swale by valve pen. The culvert will be extended as ground disturbance approaches this area, which is upslope of current excavation work.

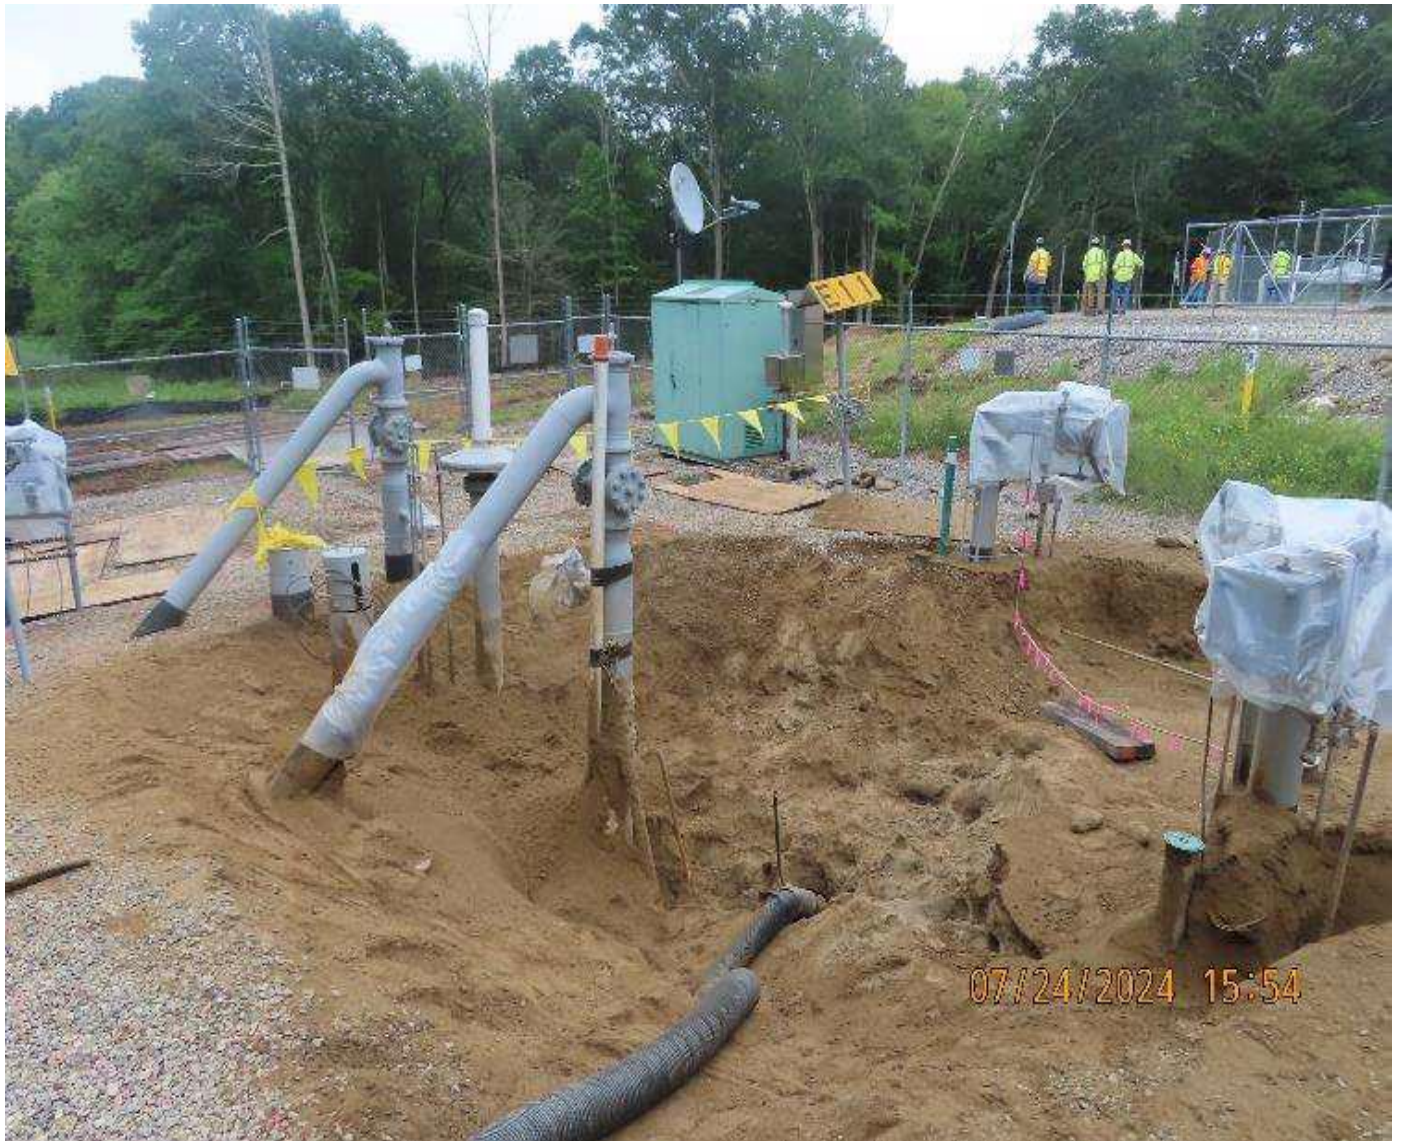
Photo 8. View (looking east) of buried pipe exposure work in the 30-inch valve pen area.
