Re: *Algonquin Gas Transmission, LLC*
E-1 System Regulator Installation Project, Docket No. CP24-21-000
Report No. 7

**E-1 System Regulation
WEEKLY REPORT #7**

Project:	E-1 System Regulation
FERC Docket Number:	CP24-21-000
Report Number:	7
Reporting Period:	August 22 through August 28, 2024

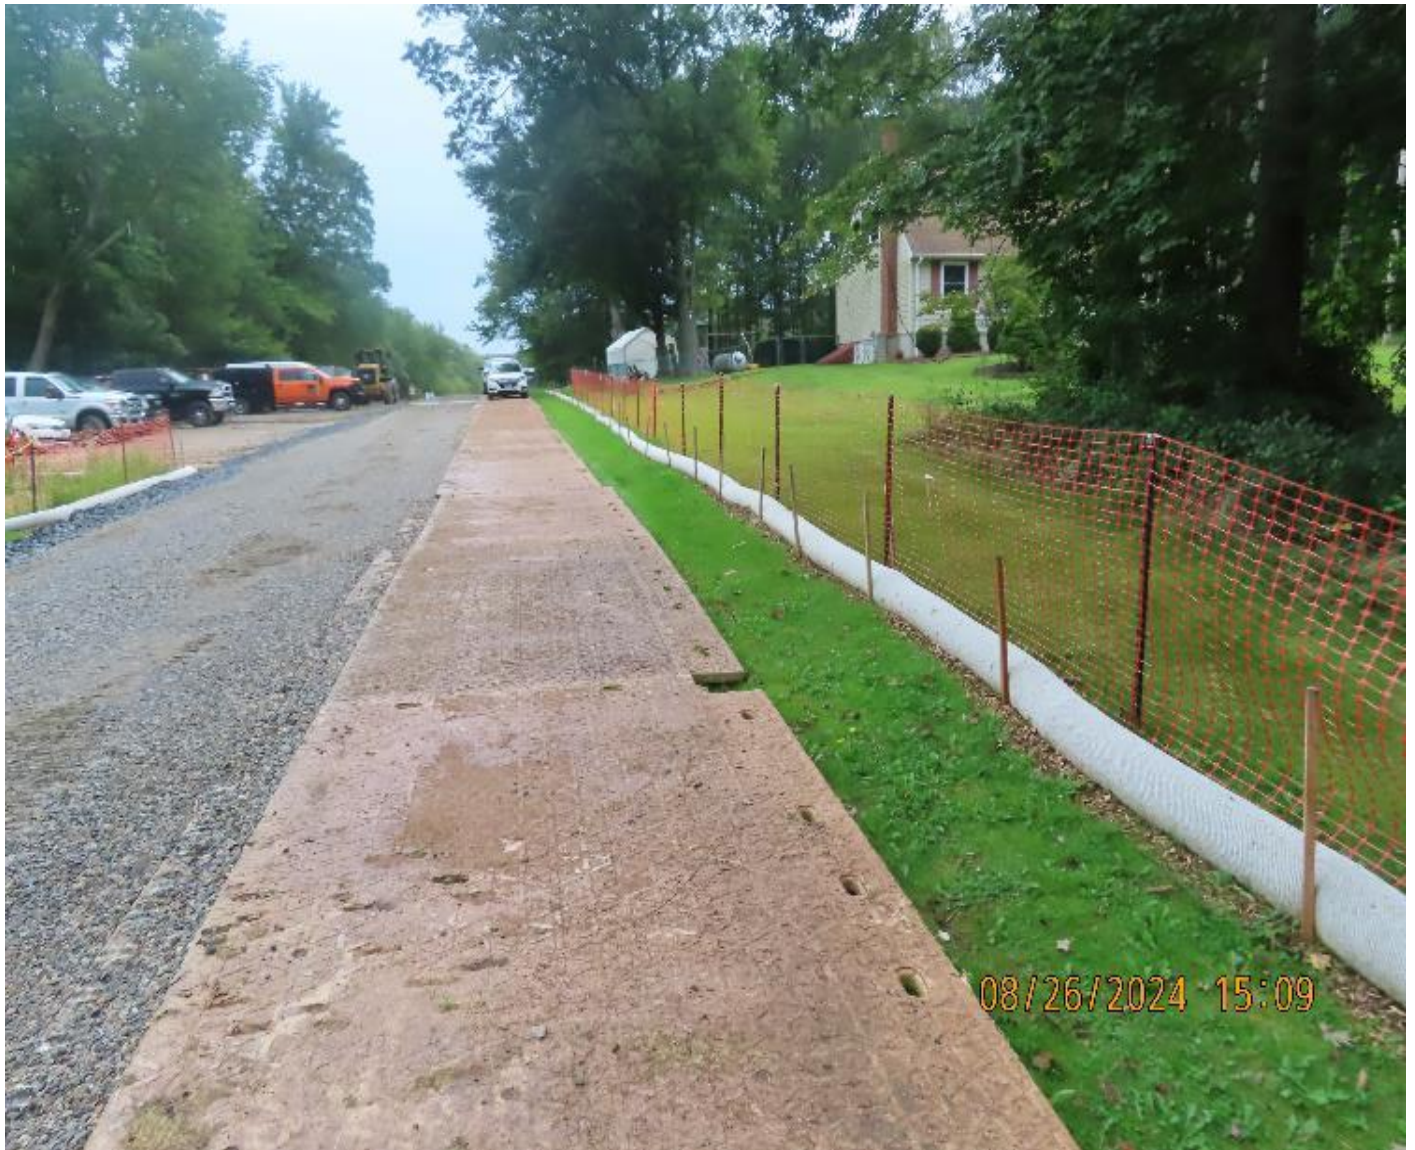
Photo 1: View (looking northeast) along access road with perimeter SESC and security fencing.

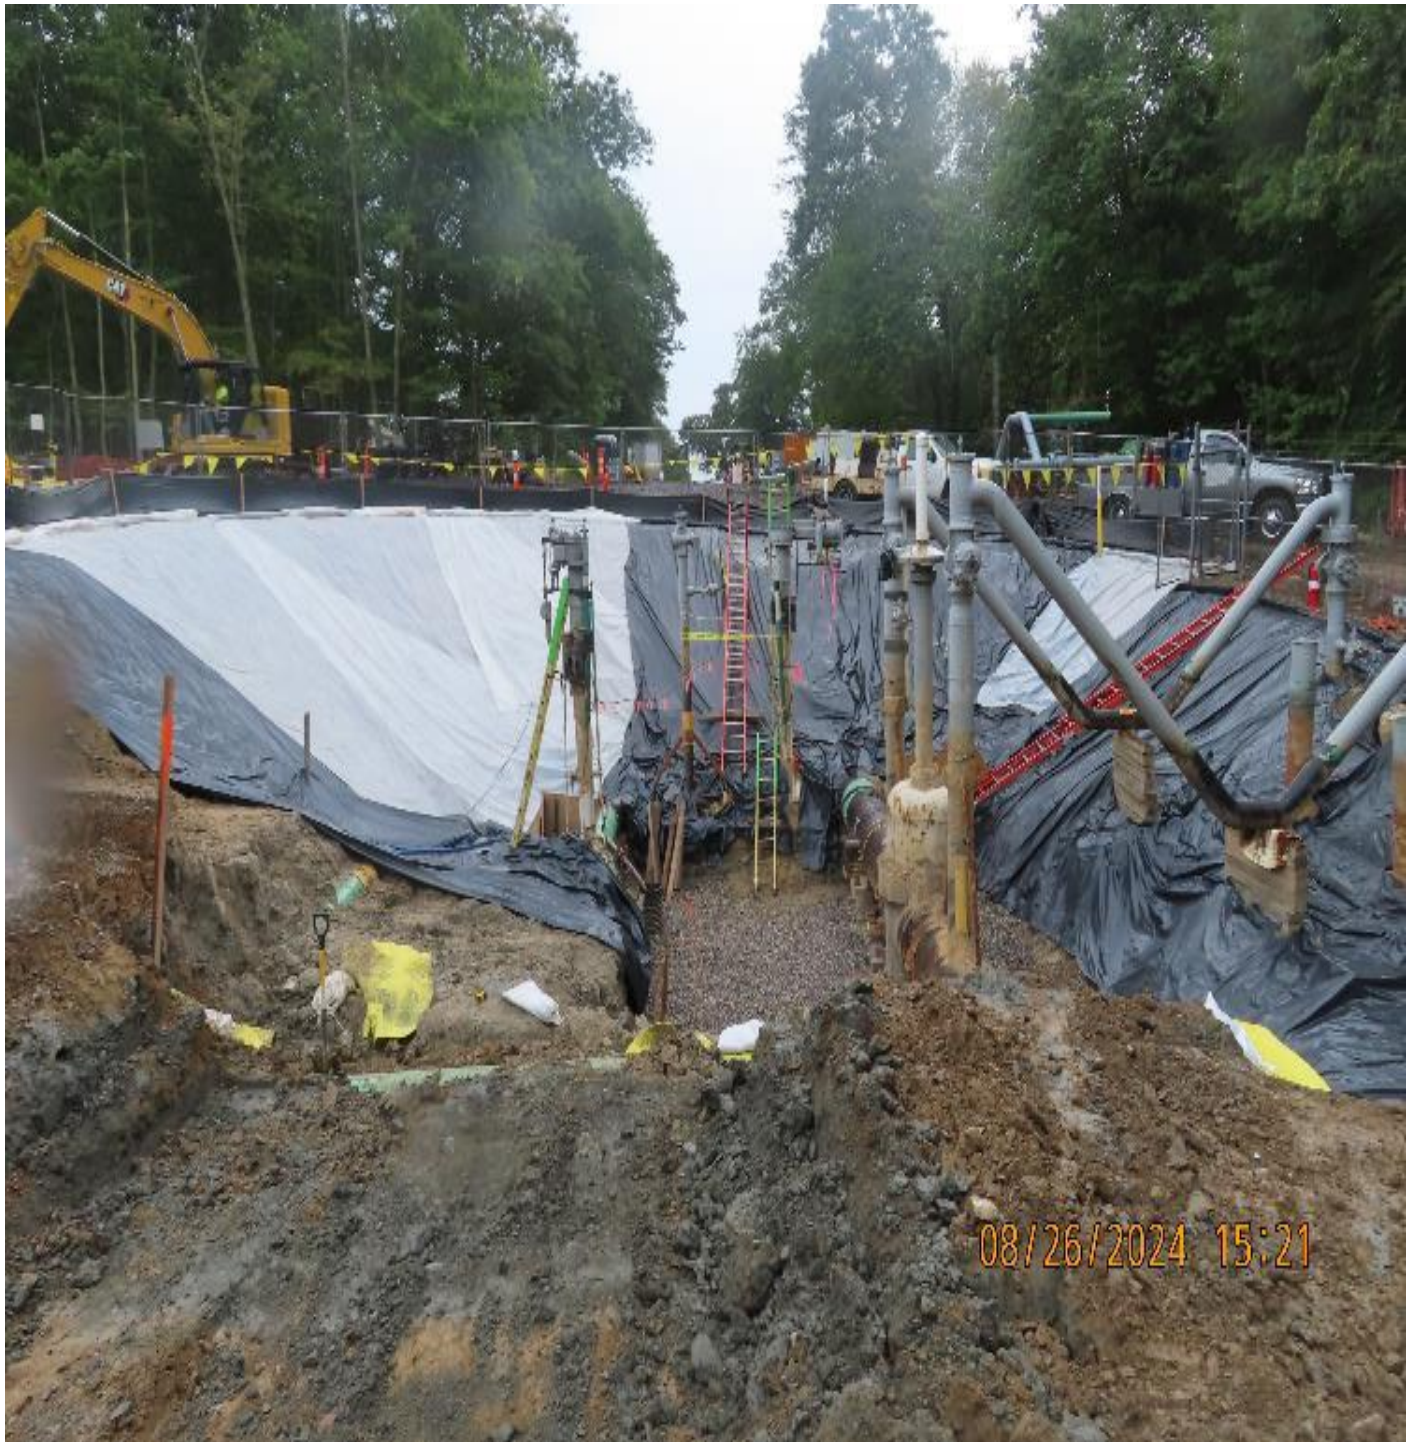
Photo 2: View (looking southwest) at excavated areas in the valve yard.

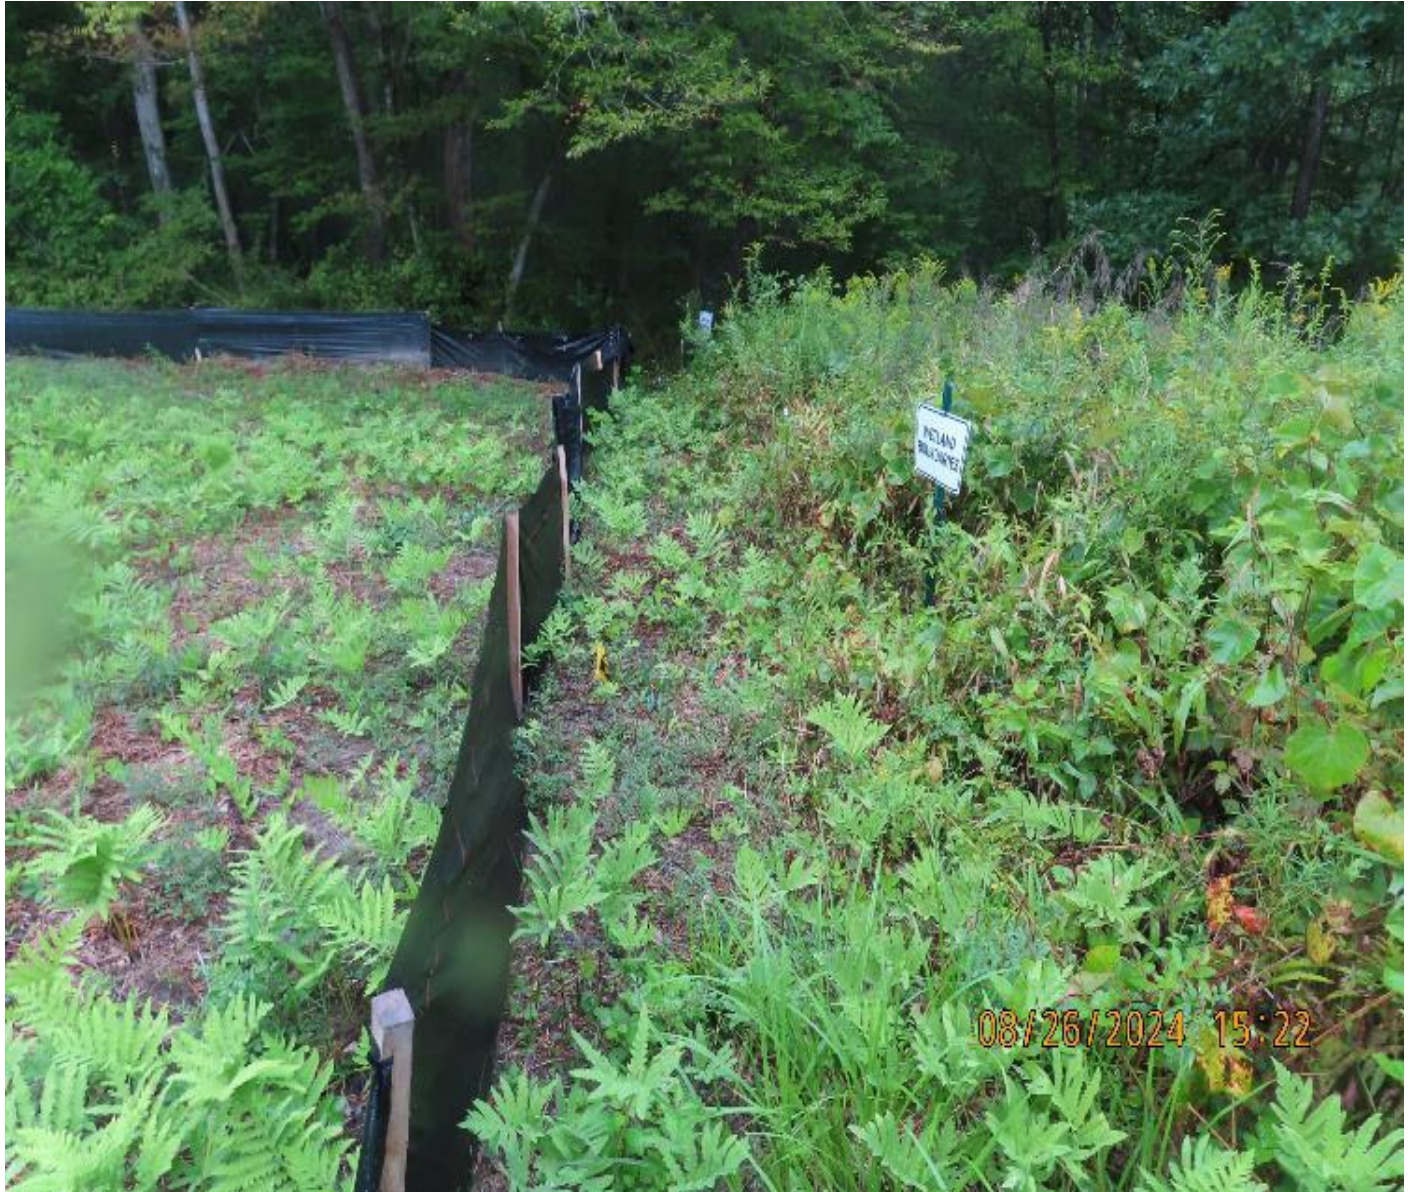
Photo 3: View (looking northwest) of perimeter SESCOs, vegetative buffer, and signage protecting wetland area.

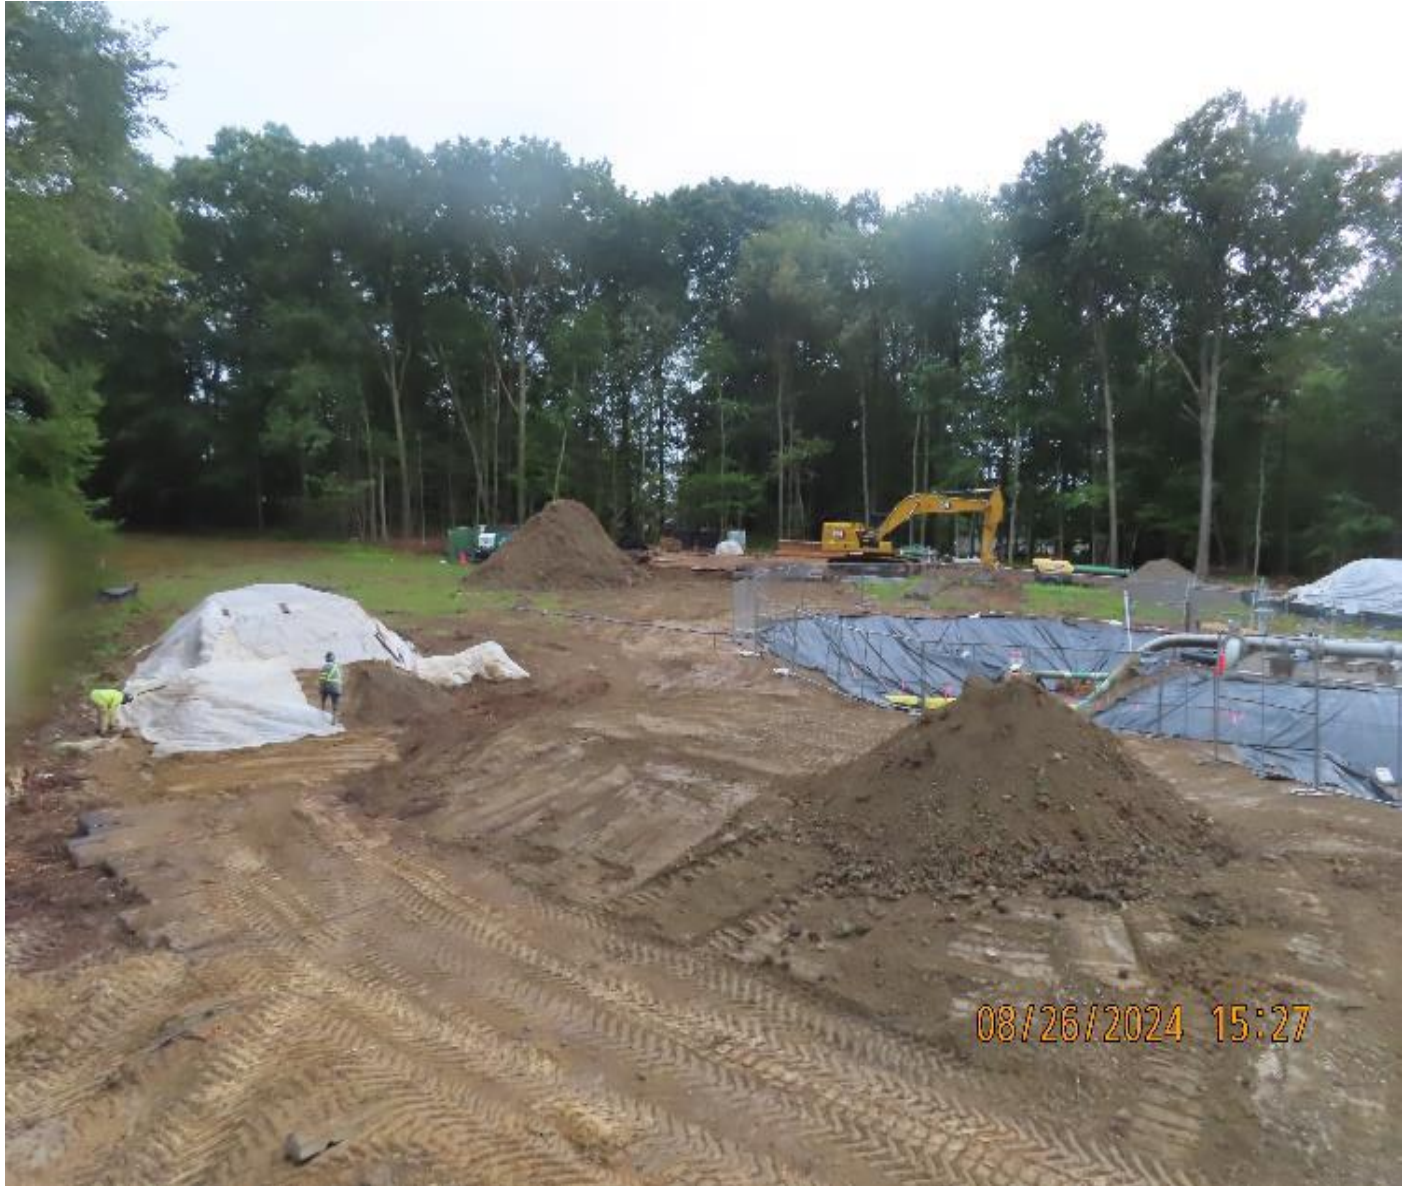
Photo 4: View (looking south) of southeastern portion of site showing stockpiles being covered at the end of the workday.

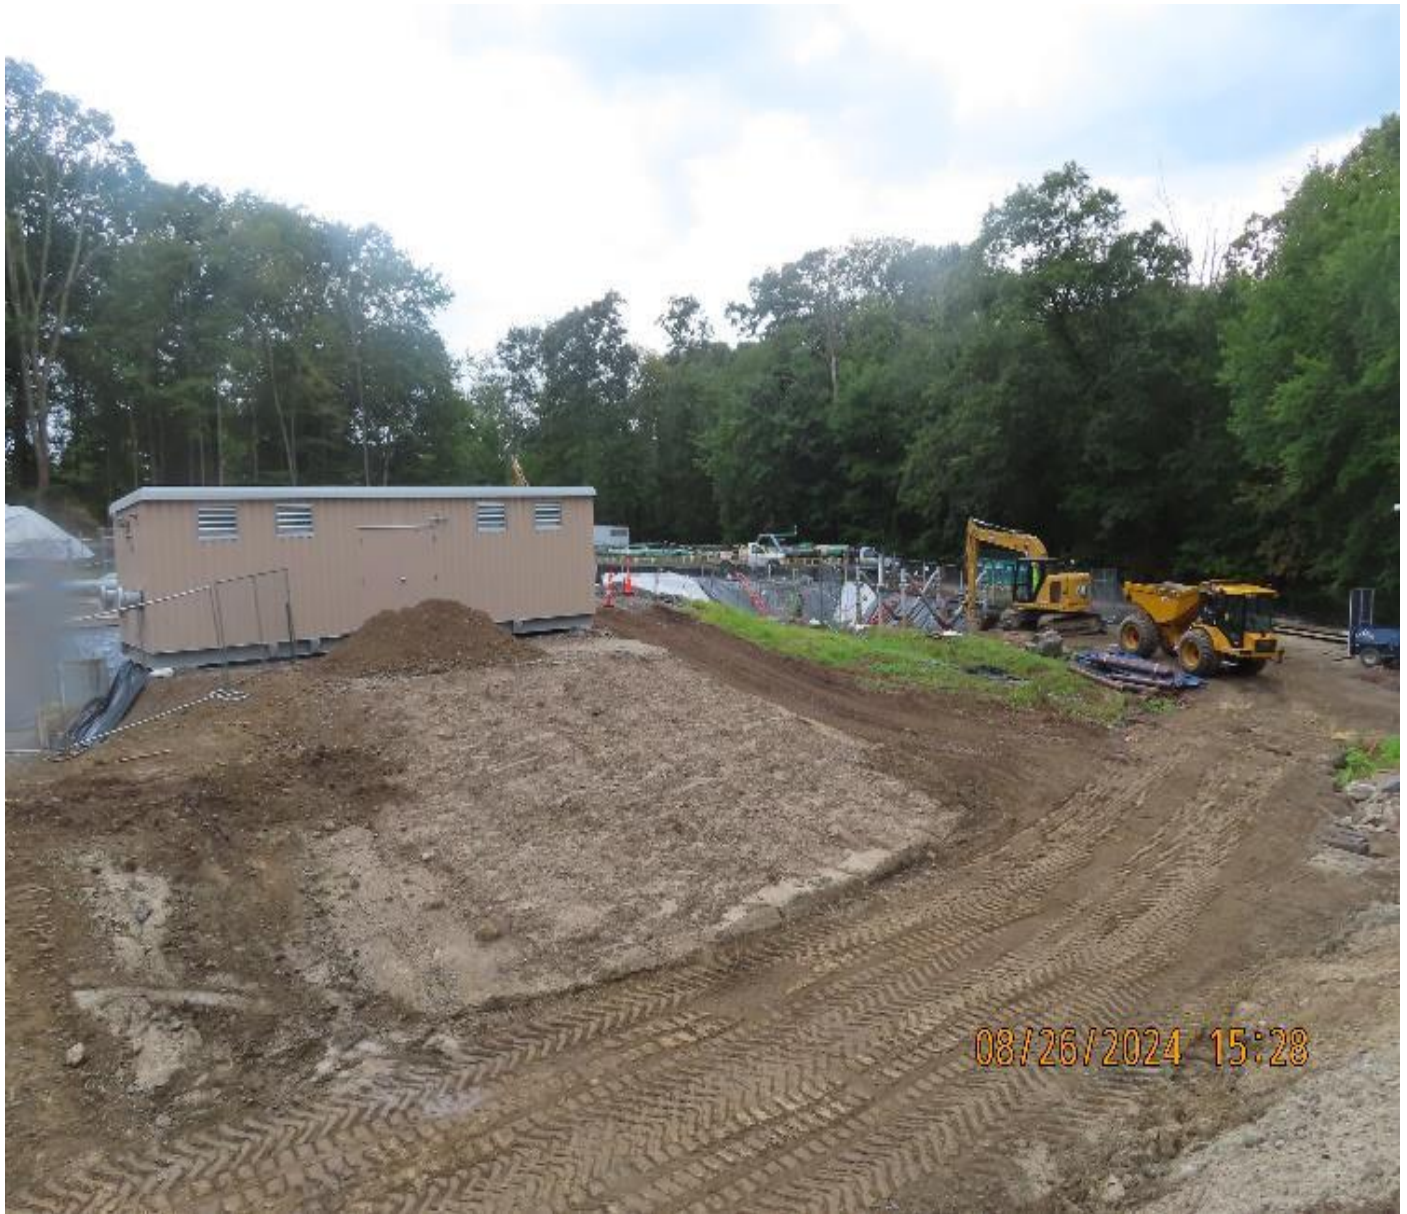
Photo 5: View (looking southwest) of new regular building after being set on foundations.

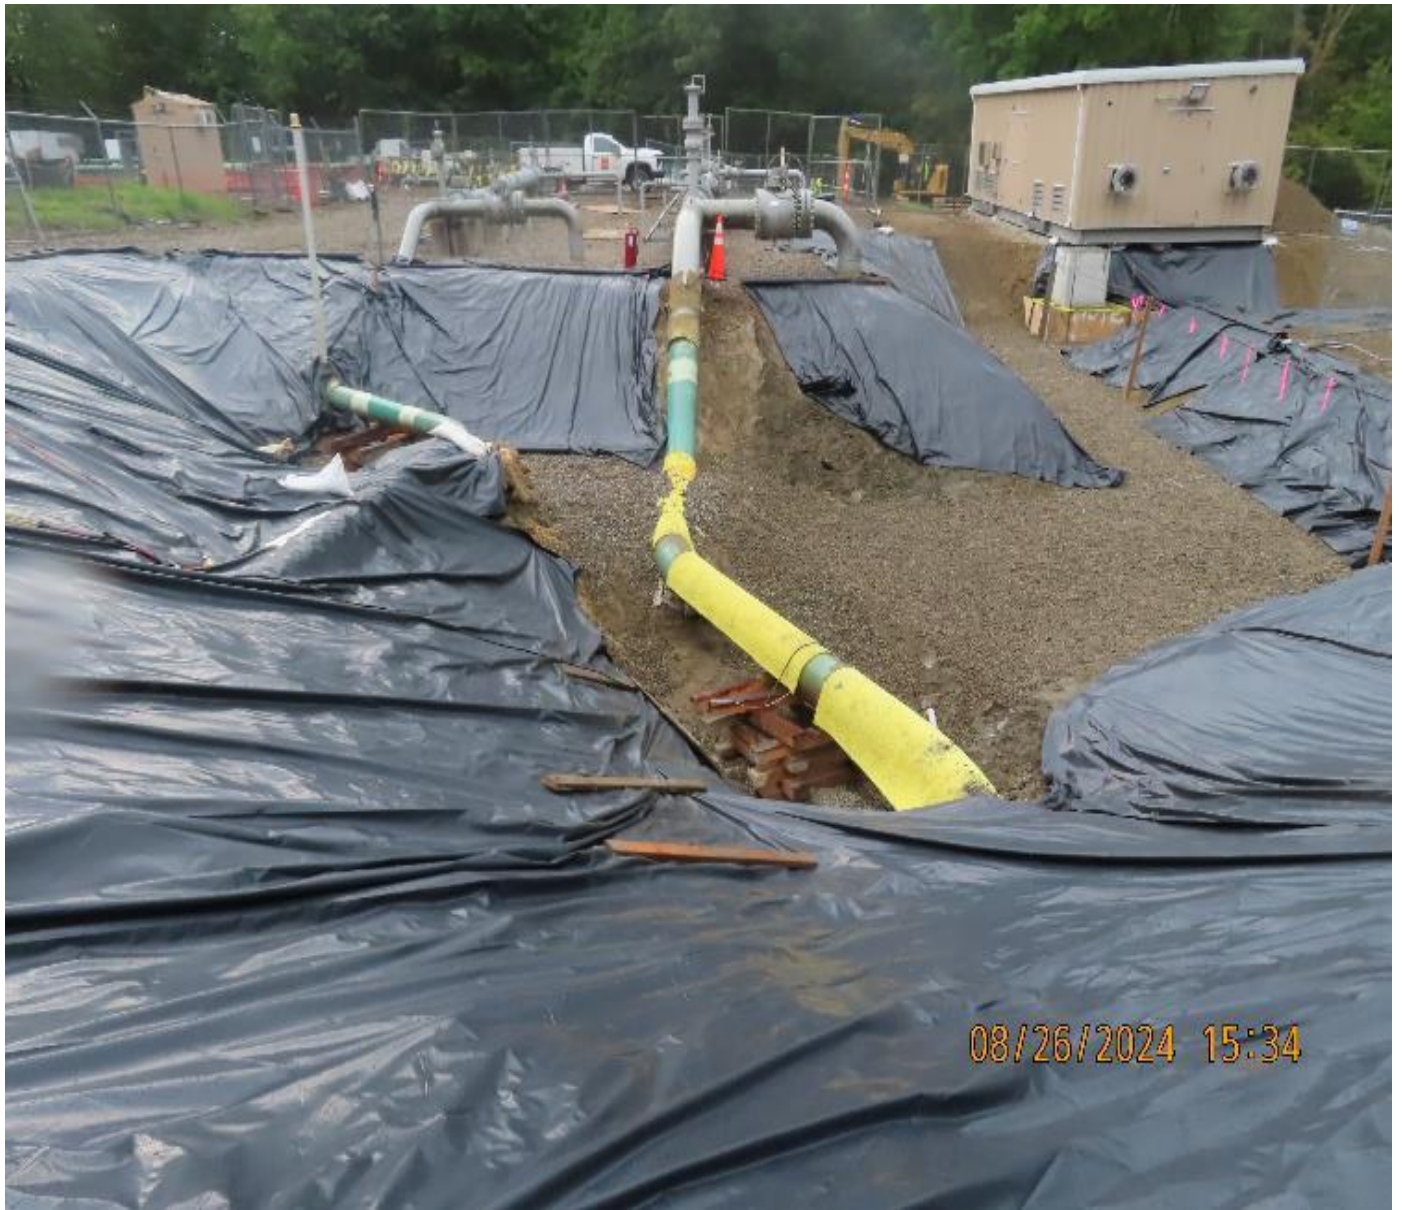
Photo 6: View (looking northwest) of stabilized excavation sidewalls for E-1 and E-1L work.

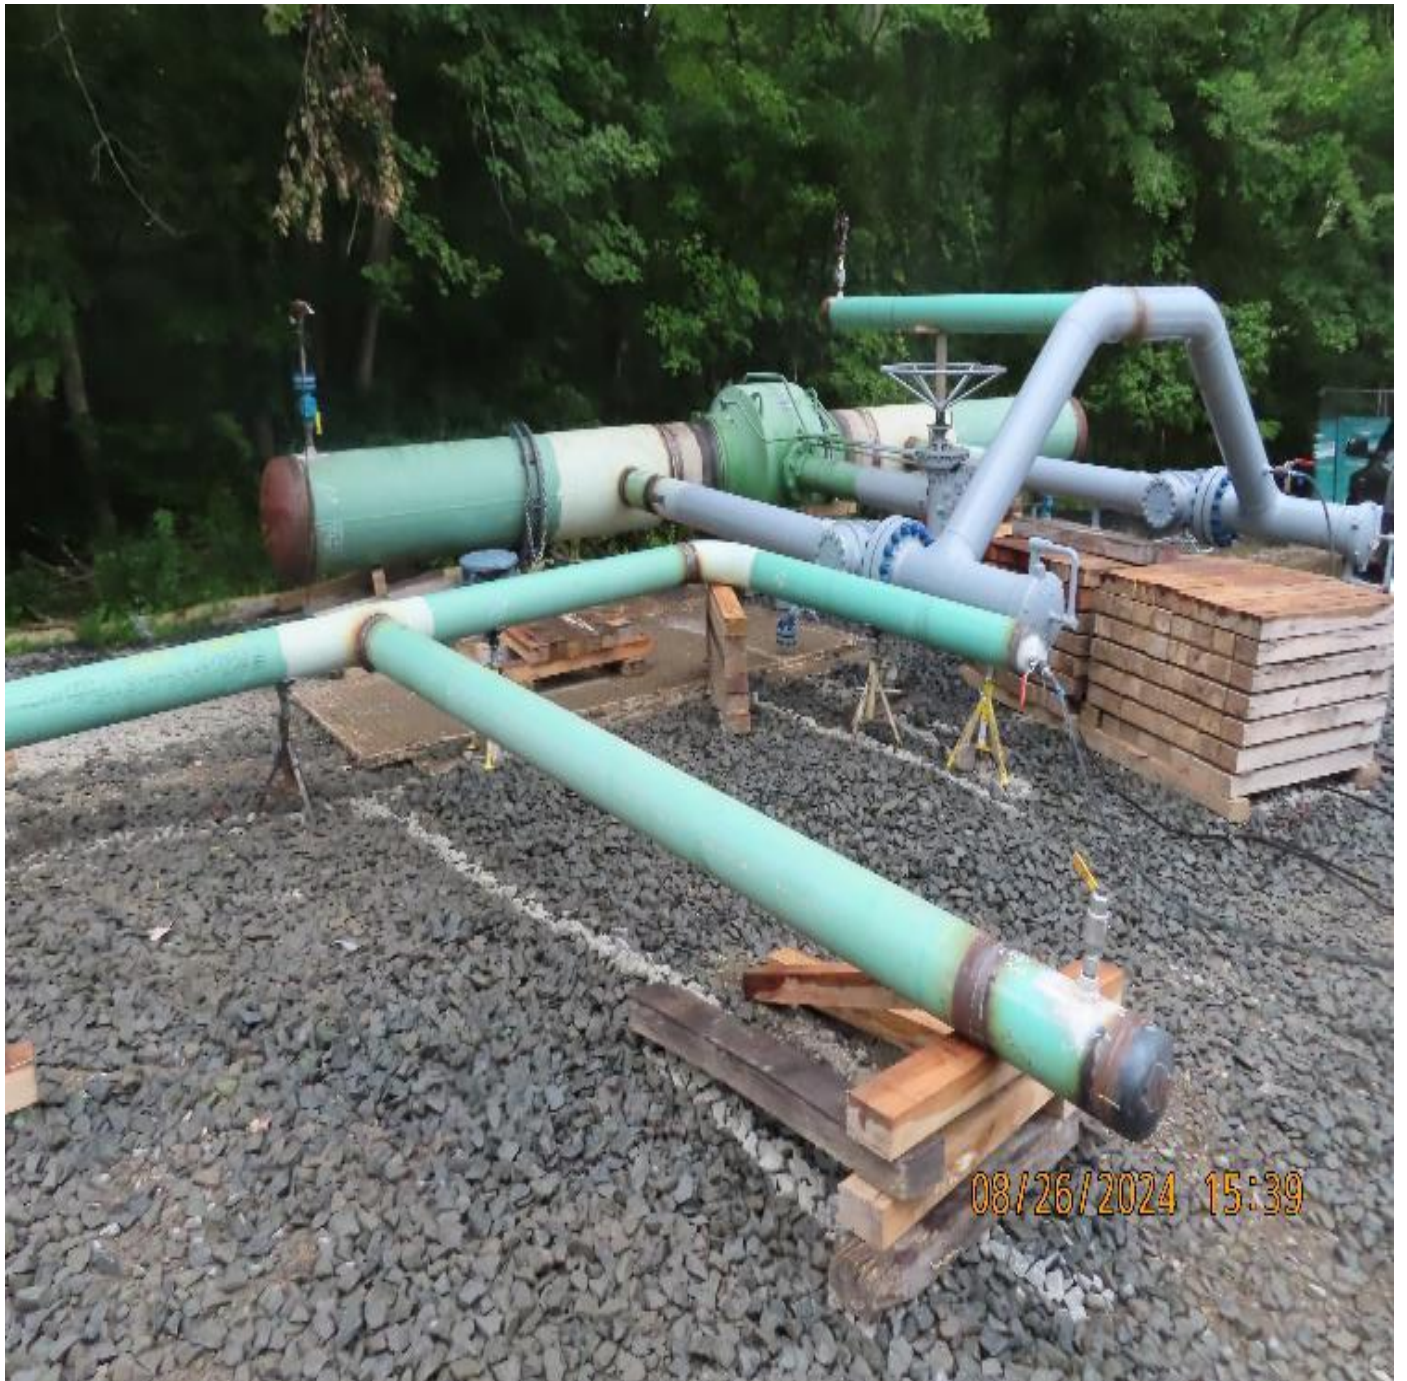
Photo 7: View (looking west) of new piping infrastructure ready for hydrostatic testing.
