Re: *Algonquin Gas Transmission, LLC*
E-1 System Regulator Installation Project, Docket No. CP24-21-000
Report No. 8

**E-1 System Regulation
WEEKLY REPORT #8**

Project:	E-1 System Regulation
FERC Docket Number:	CP24-21-000
Report Number:	8
Reporting Period:	August 29 through September 4, 2024

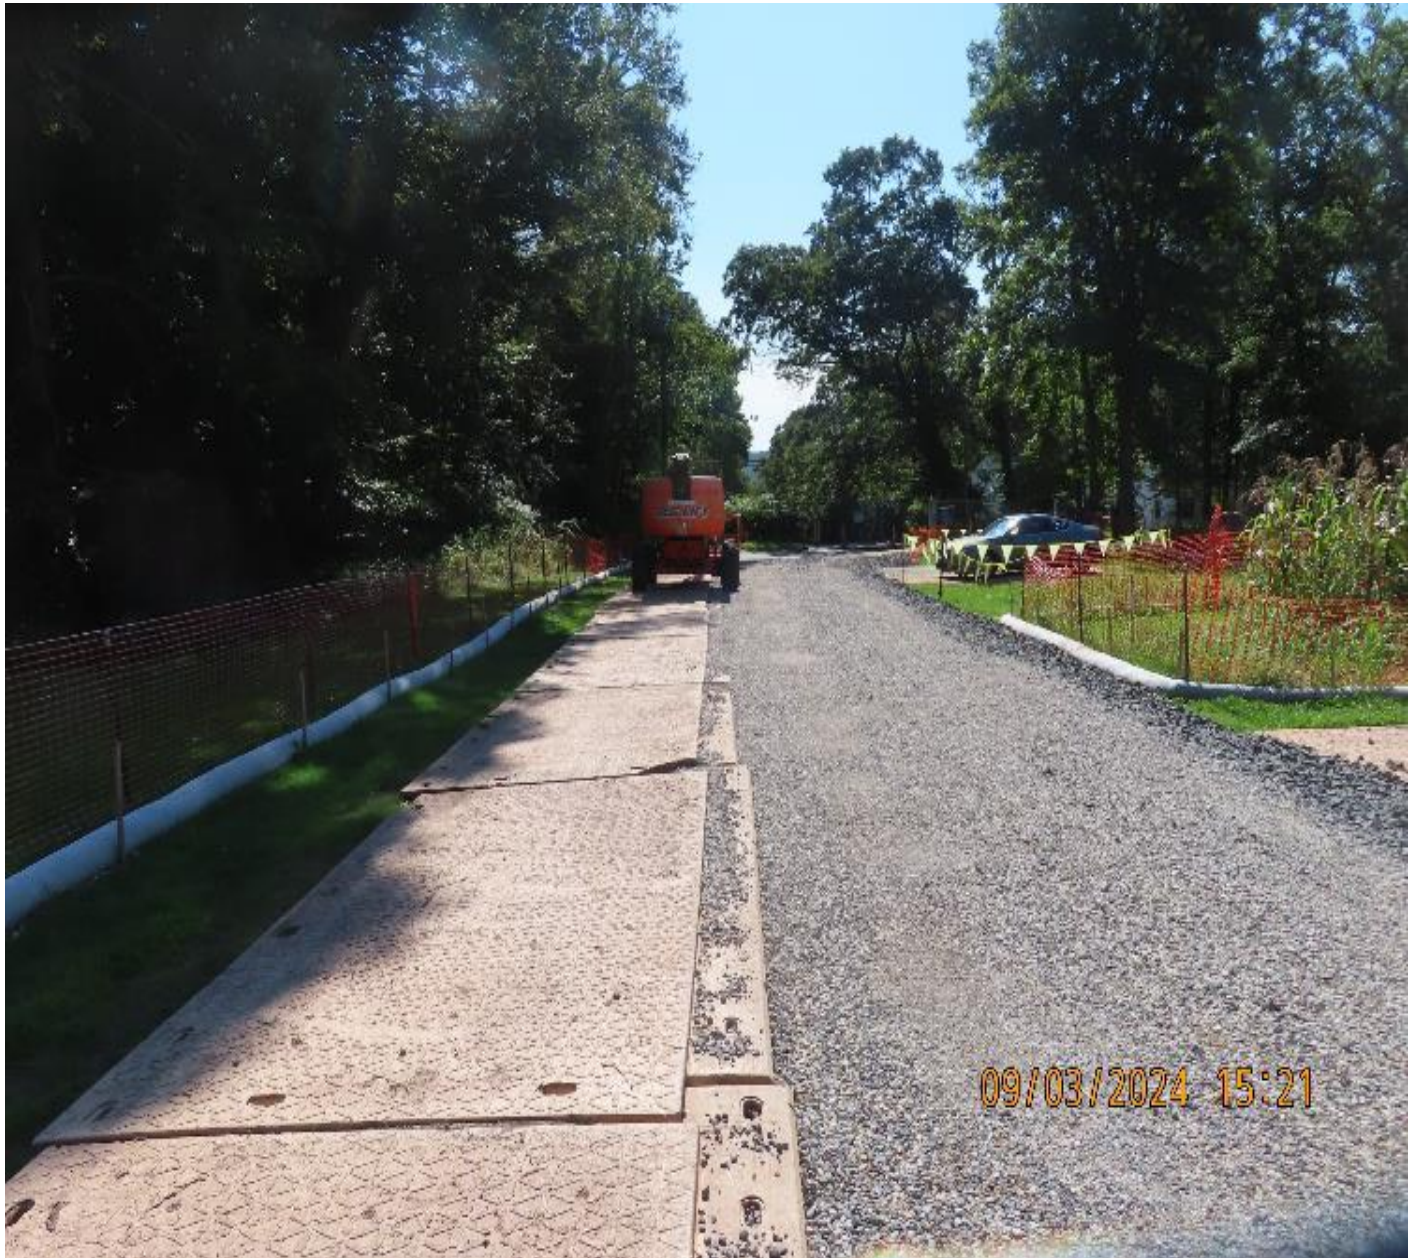
Photo 1: View (looking southwest) of access off Hop River Road.

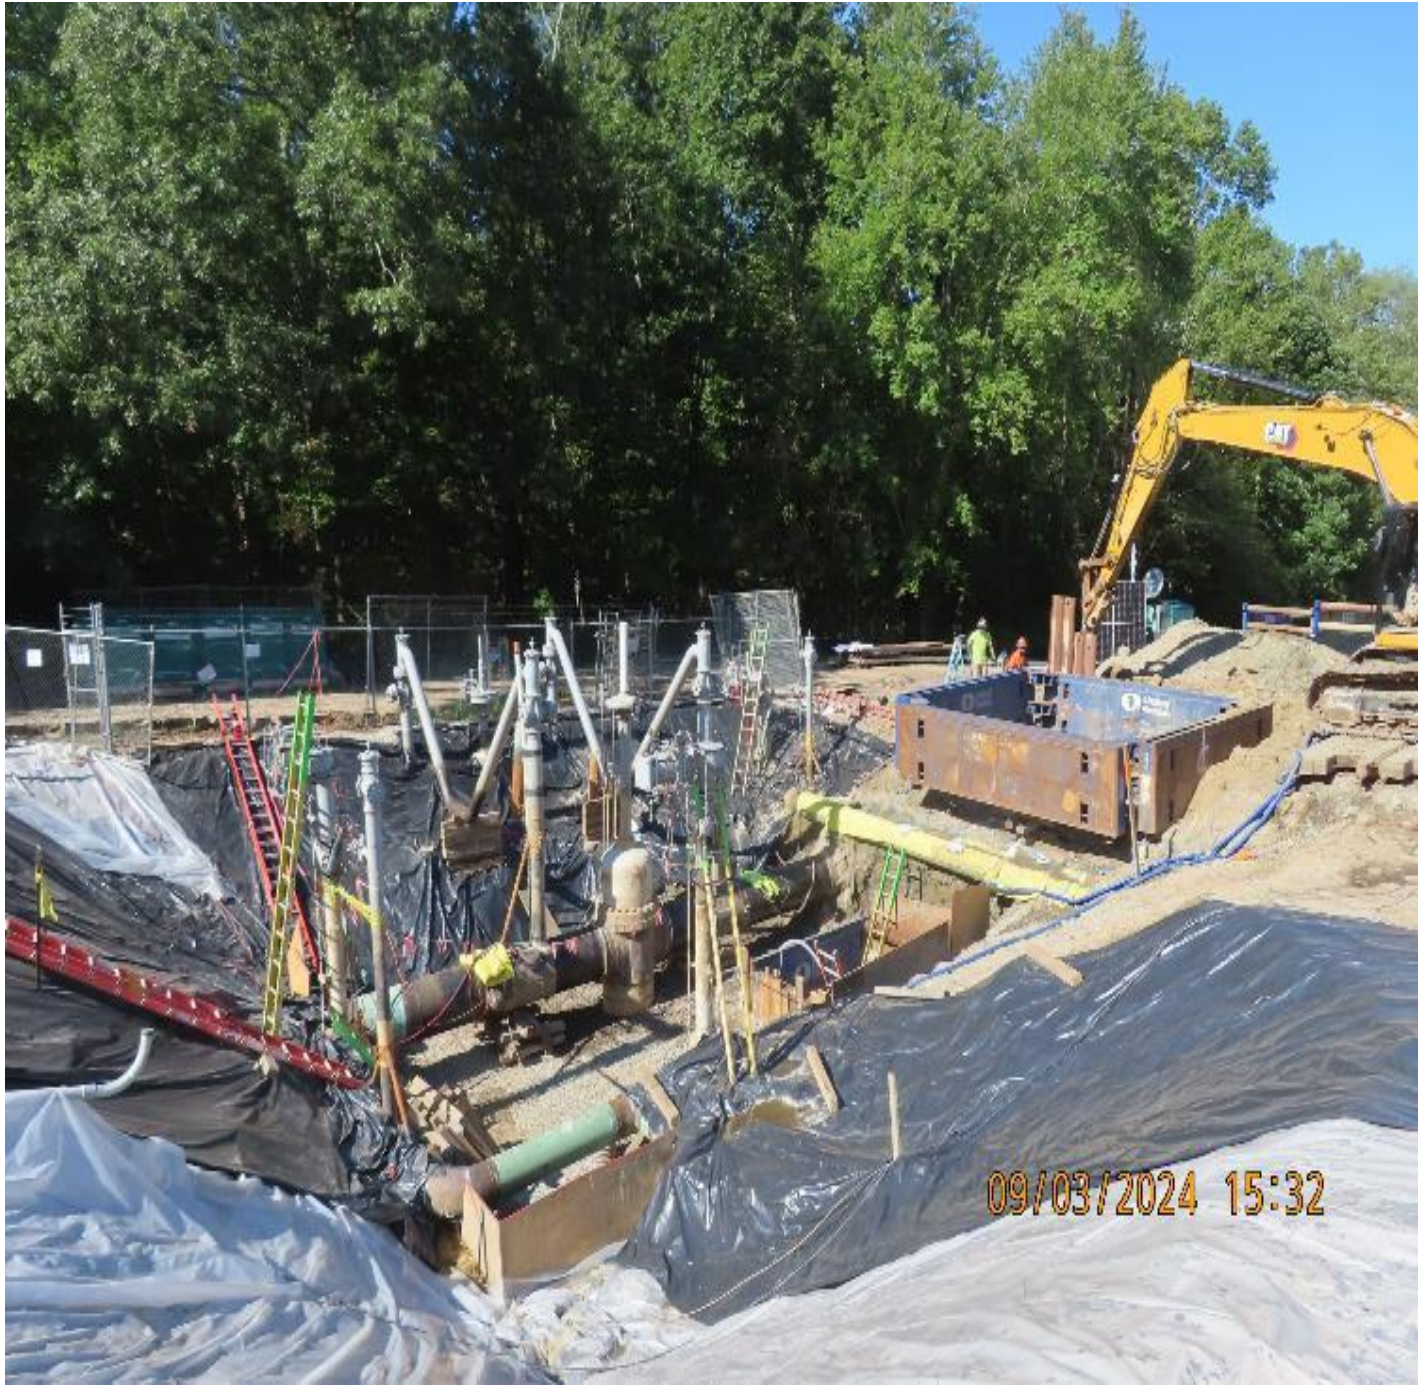
Photo 2: View (looking northwest) of excavation and sheet pile installation work taking place in the Valve Yard.

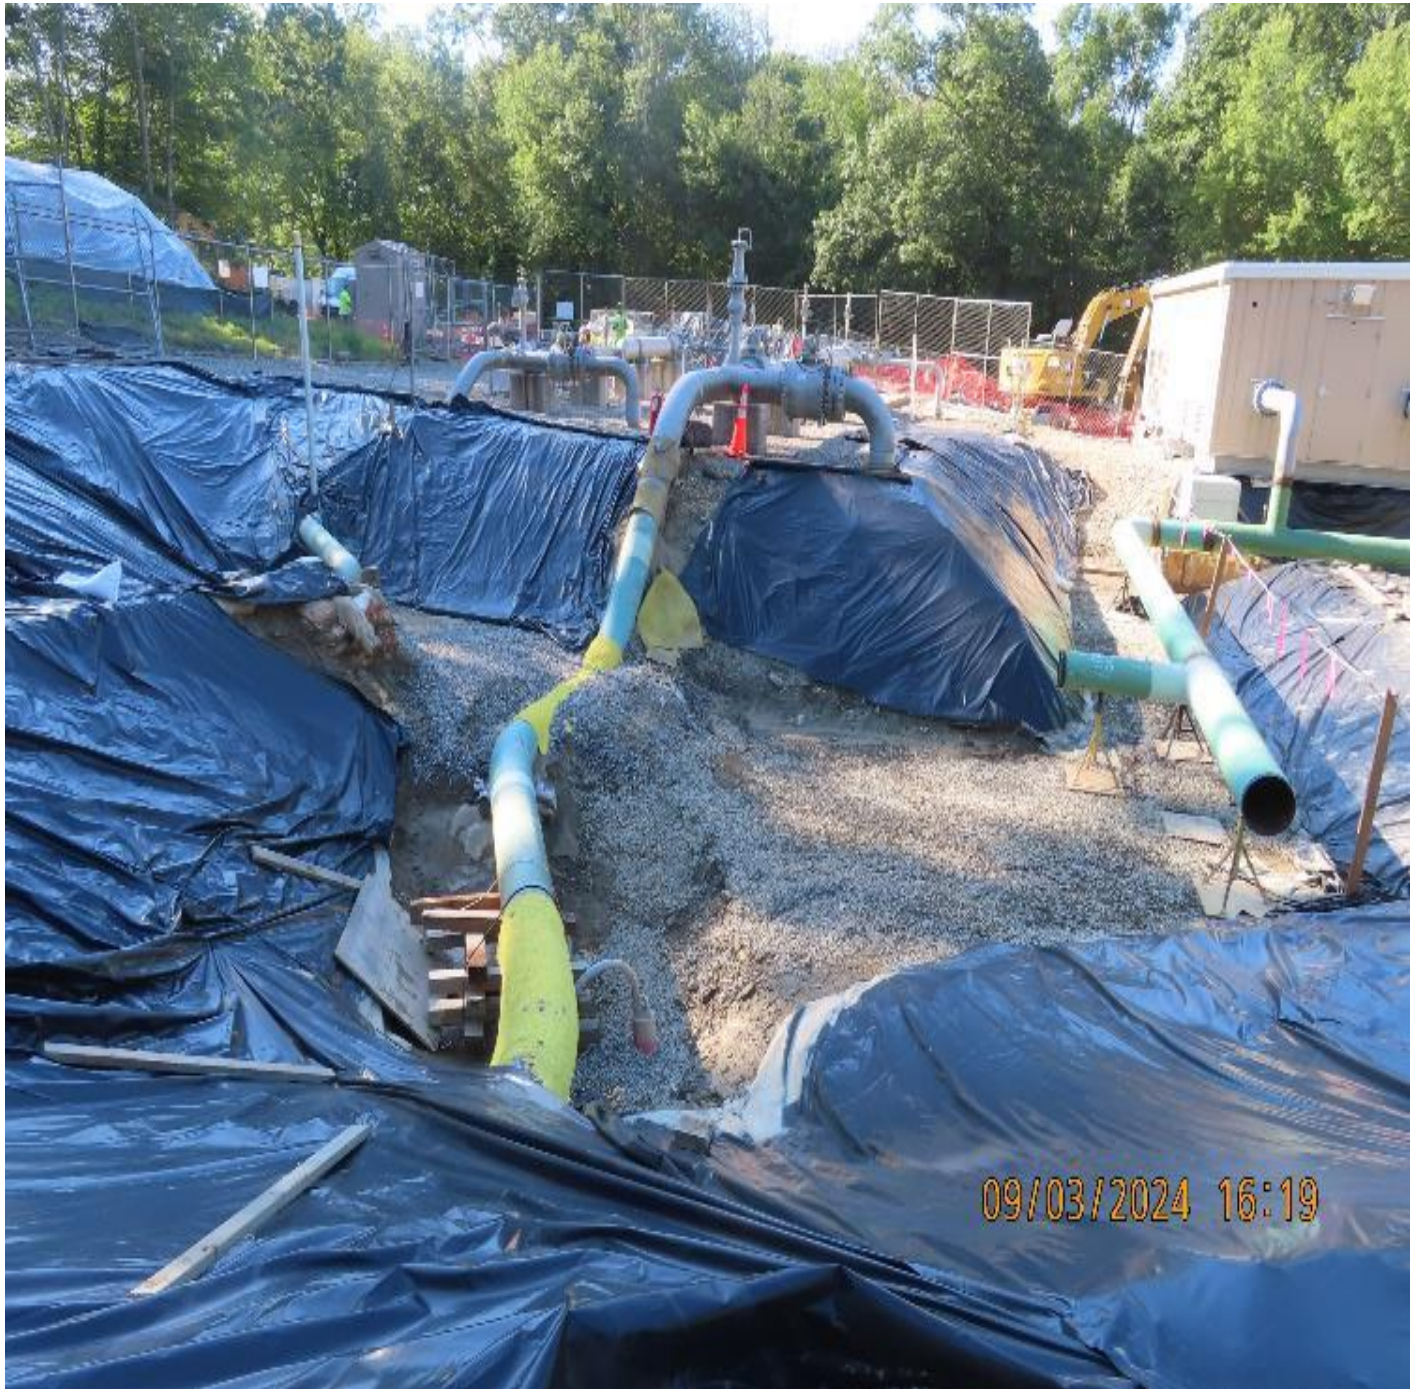
Photo 3: View (looking northwest) of excavation for E-System piping tie-ins.

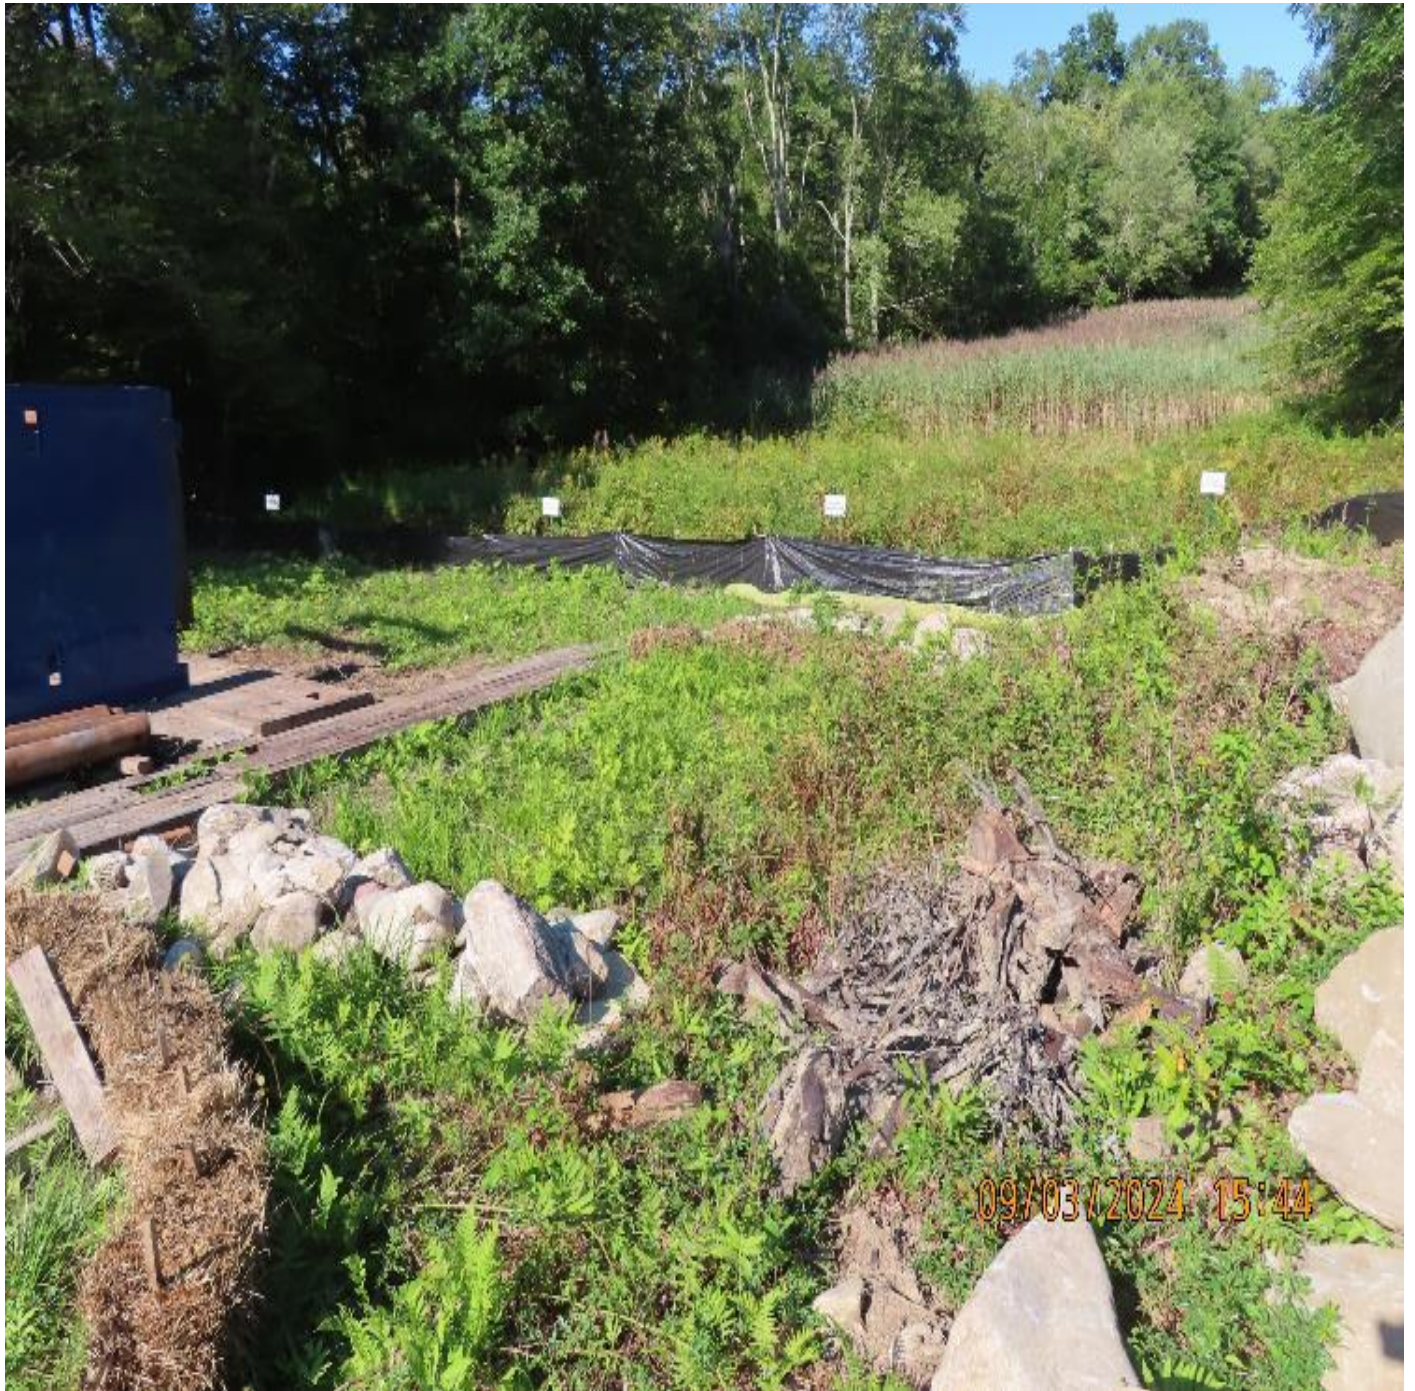
Photo 4: View (looking northeast) of excavation dewatering discharge flow path with rock check-dams.

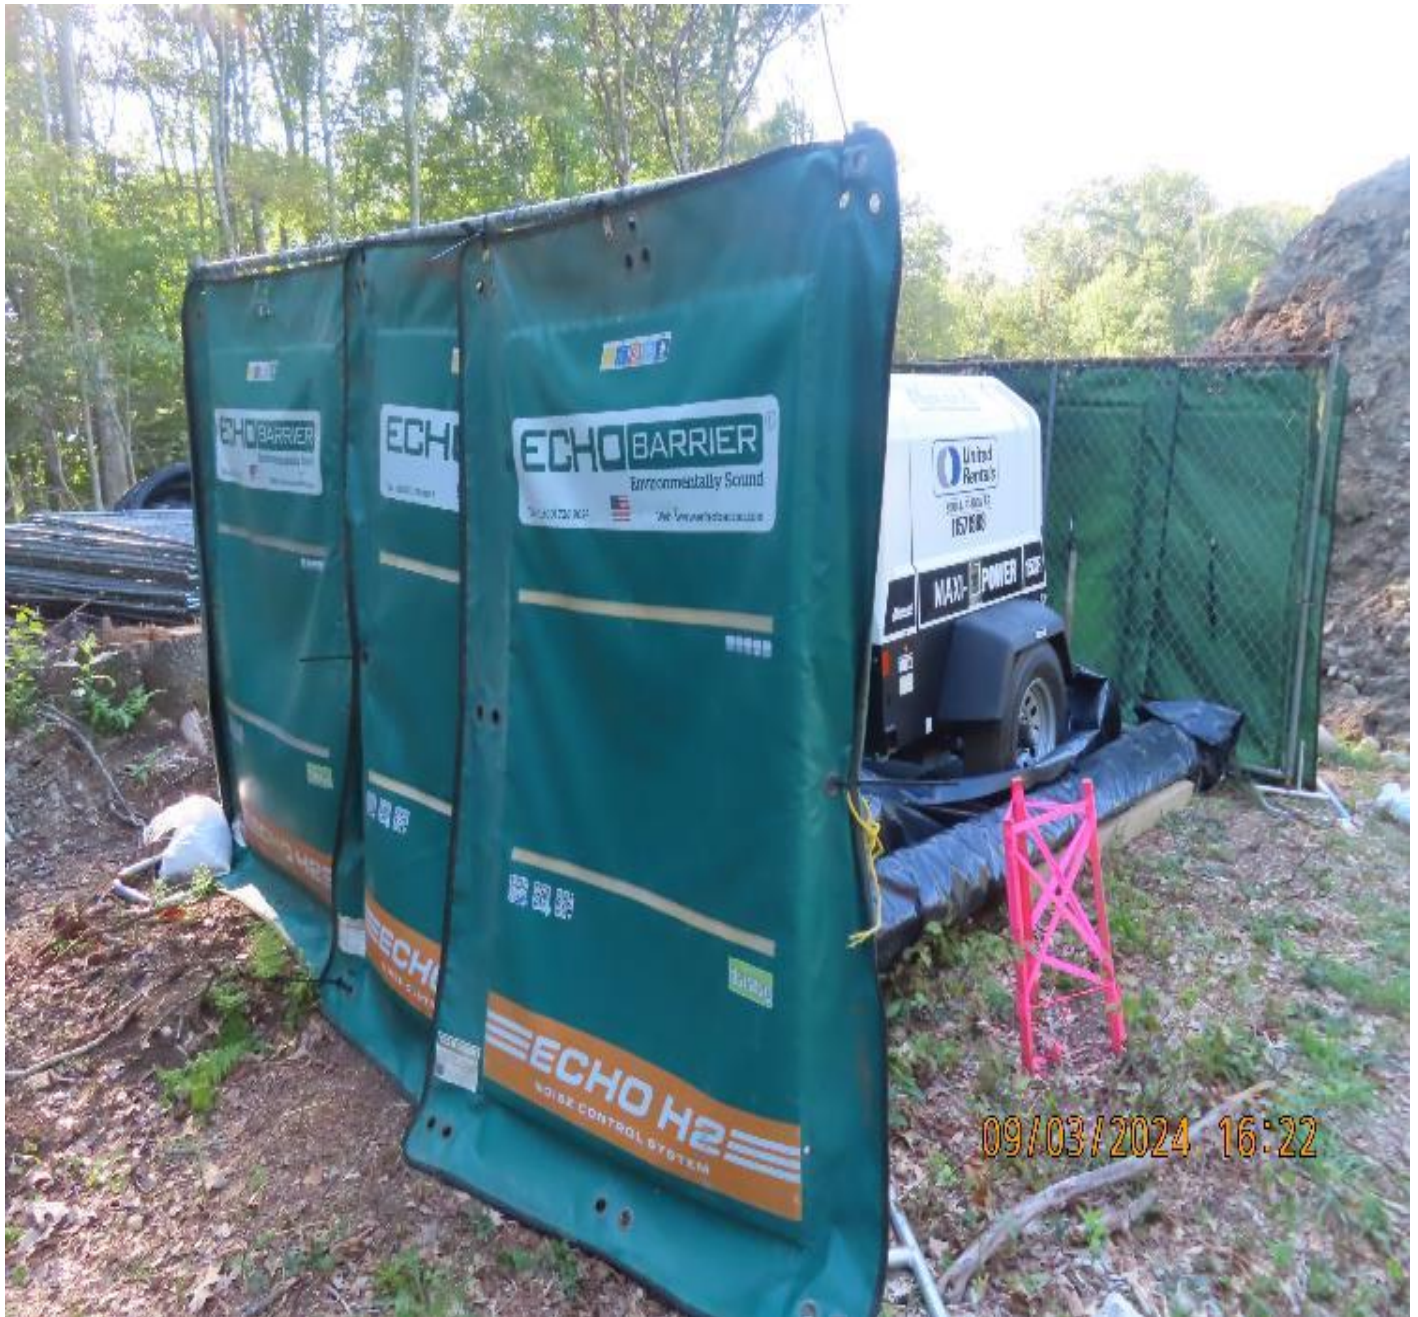
Photo 5: View (looking west) of portable generator with secondary containment and noise mitigation acoustic padding.

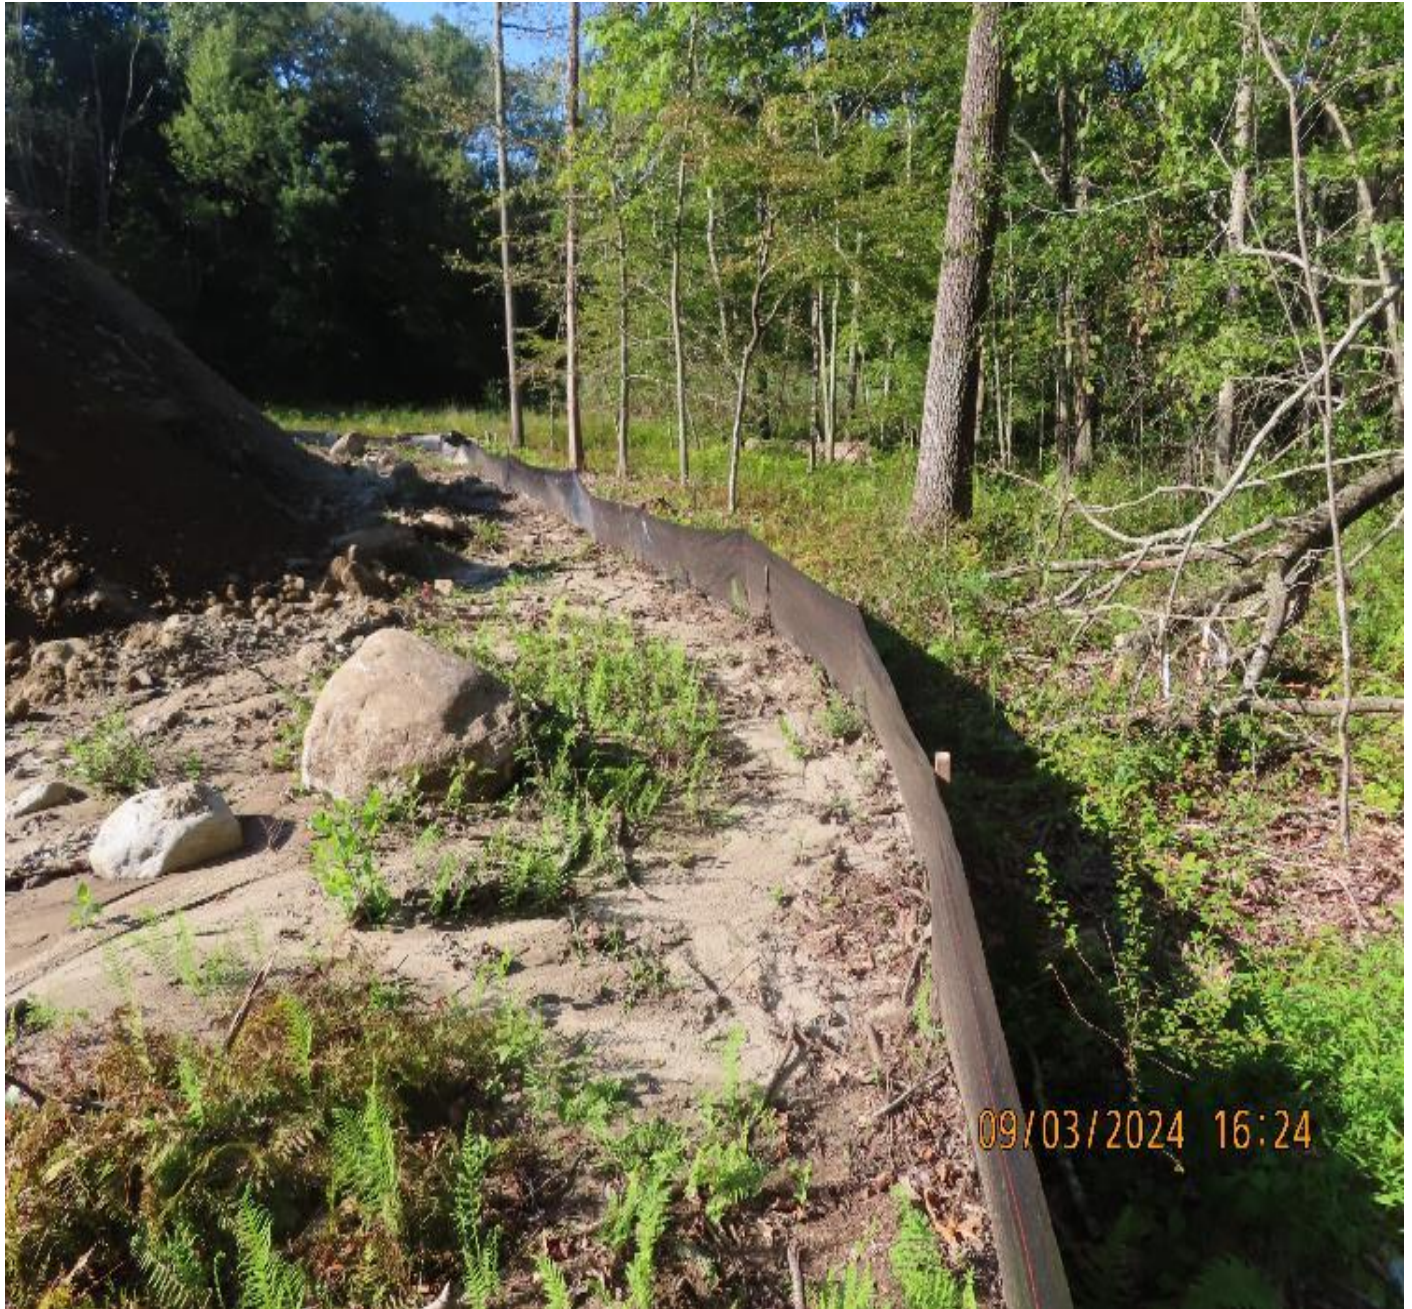
Photo 6: View (looking northwest) at silt fence in good condition after heavy rain event. Minor sediment accumulations with no migration beyond the silt fence was observed.

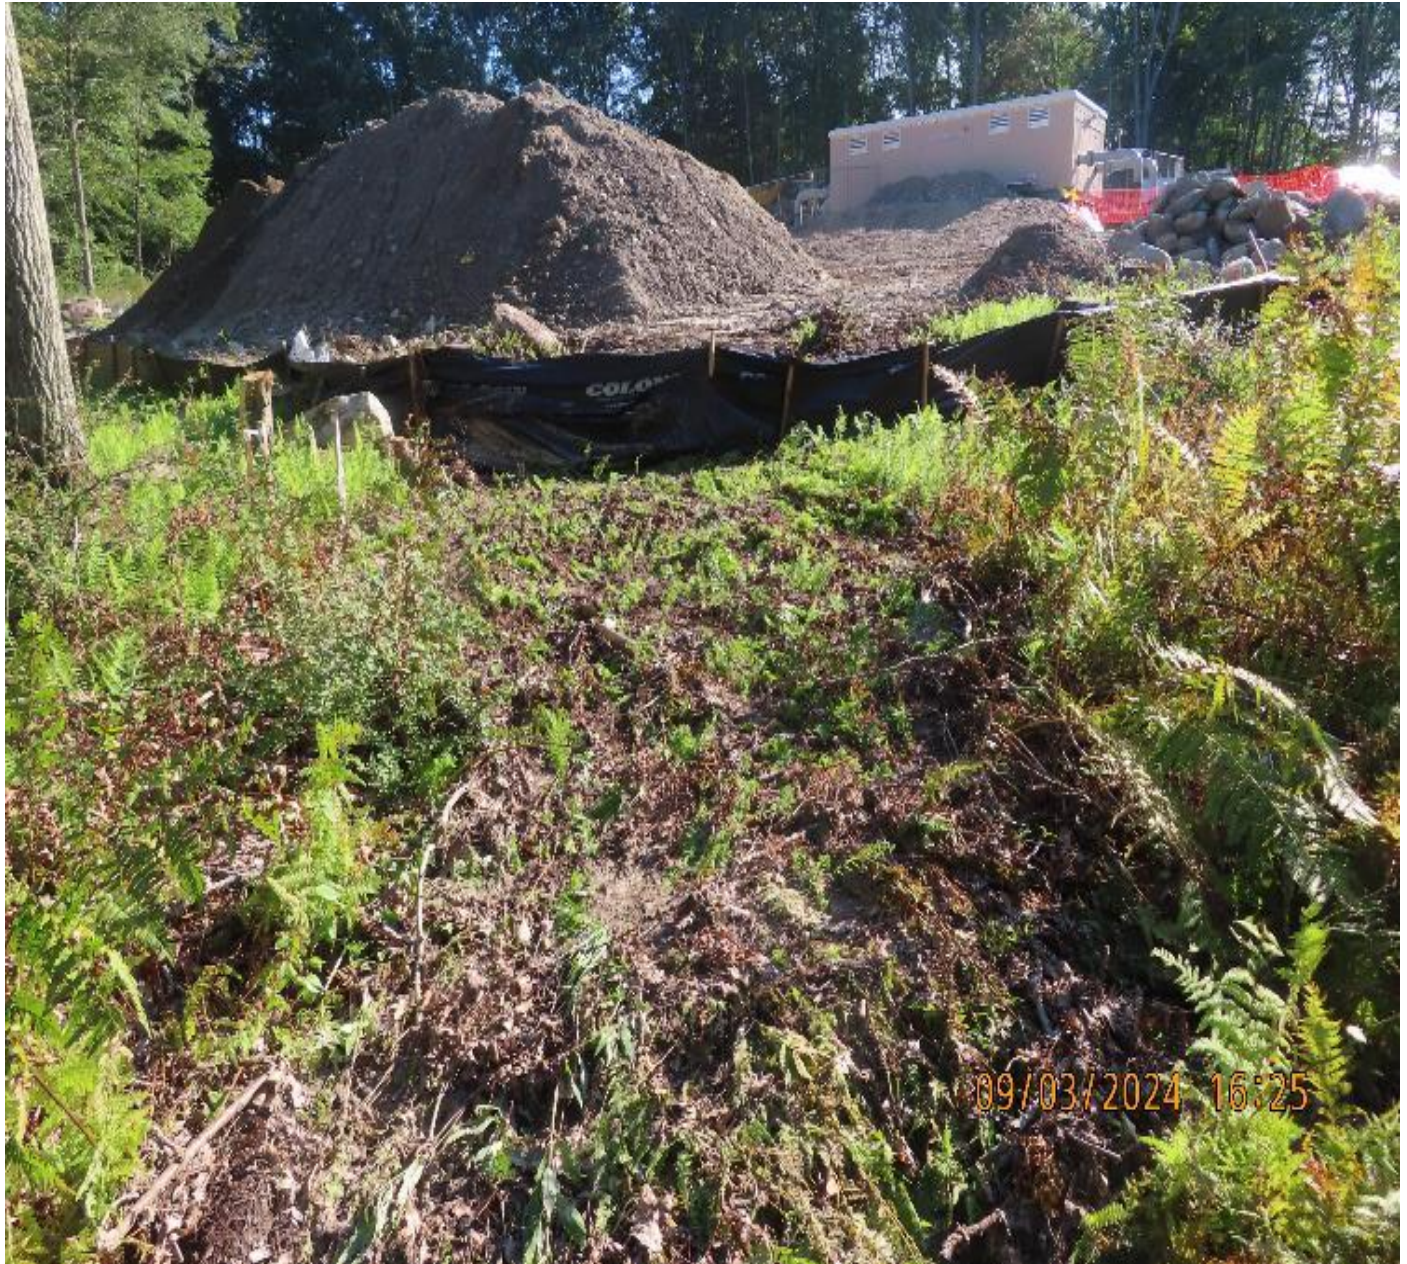
Photo 7: View (looking south) of flattened vegetation from stormwater flow that occurred during recent heavy rain event. Minor damage to silt fencing was repaired.

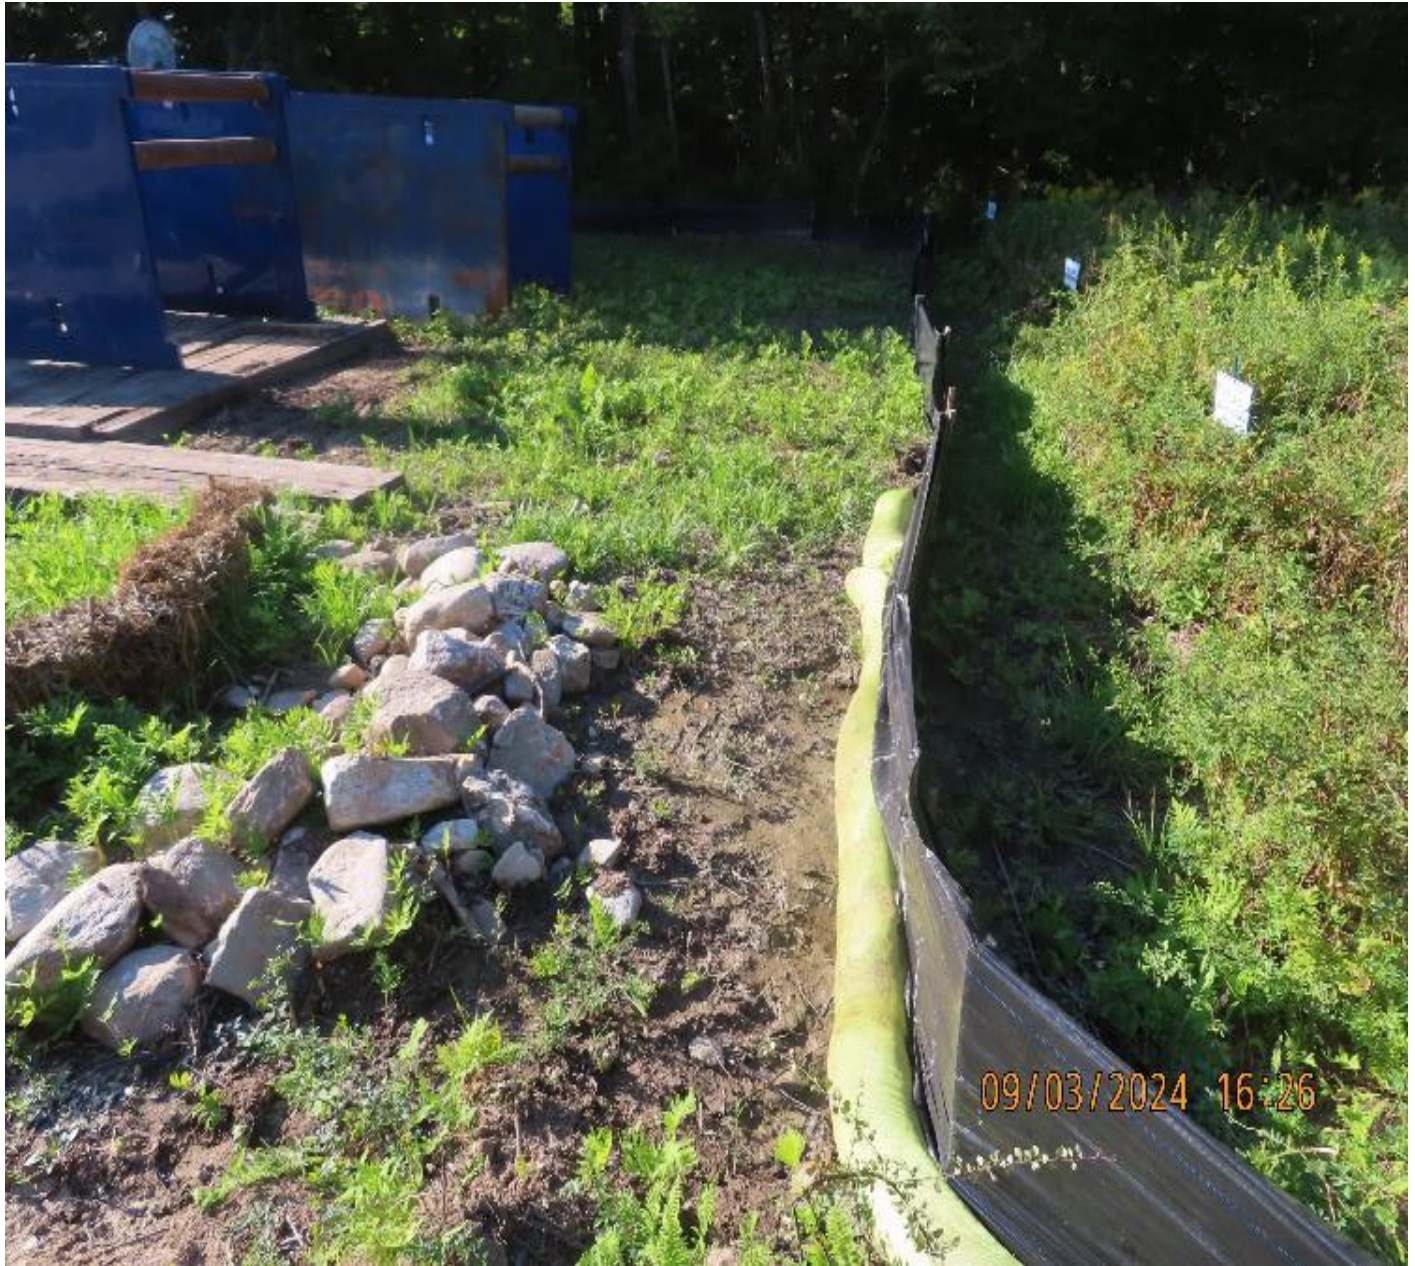
Photo 8: View (looking northwest) of silt fence protecting wetland W-CZ-01 in good condition after heavy rain event.
