Re: *Algonquin Gas Transmission, LLC*  
E-1 System Regulator Installation Project, Docket No. CP24-21-000  
Report No. 9

**E-1 System Regulation  
WEEKLY REPORT #9**

Project:	E-1 System Regulation
FERC Docket Number:	CP24-21-000
Report Number:	9
Reporting Period:	September 5 through September 11, 2024

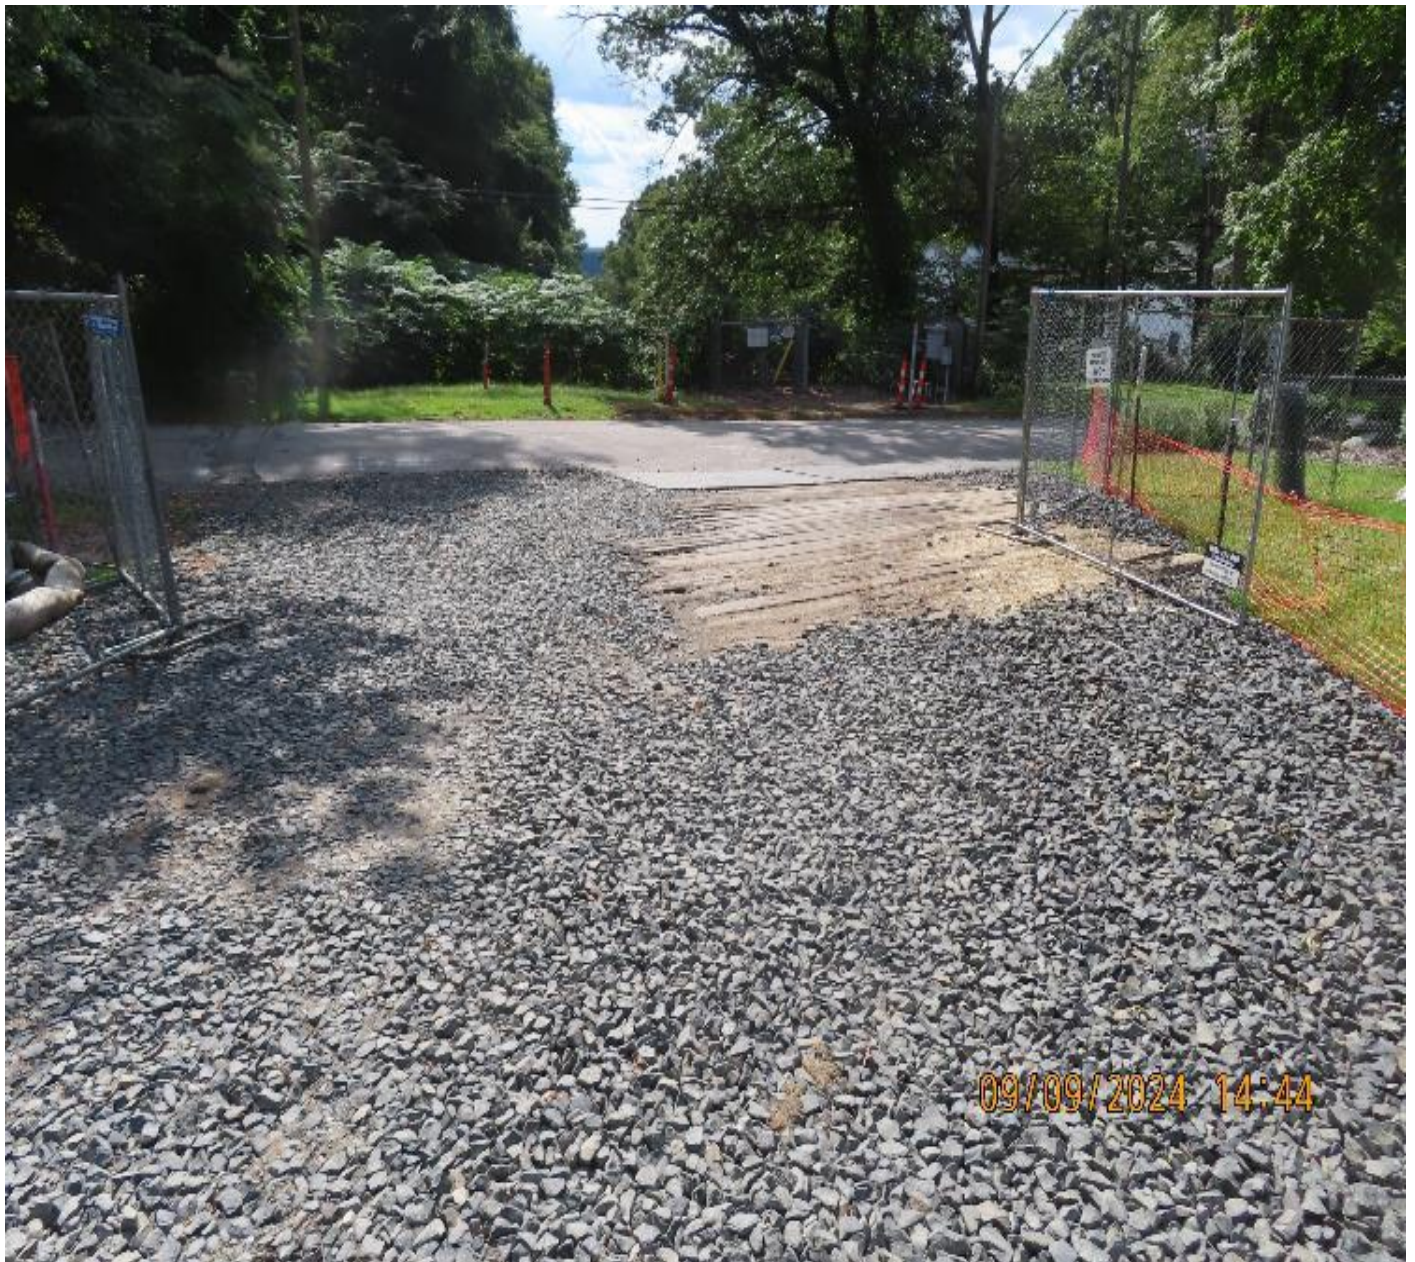
**Photo 1:** View (looking southwest) of site entrance from Hop River Road.

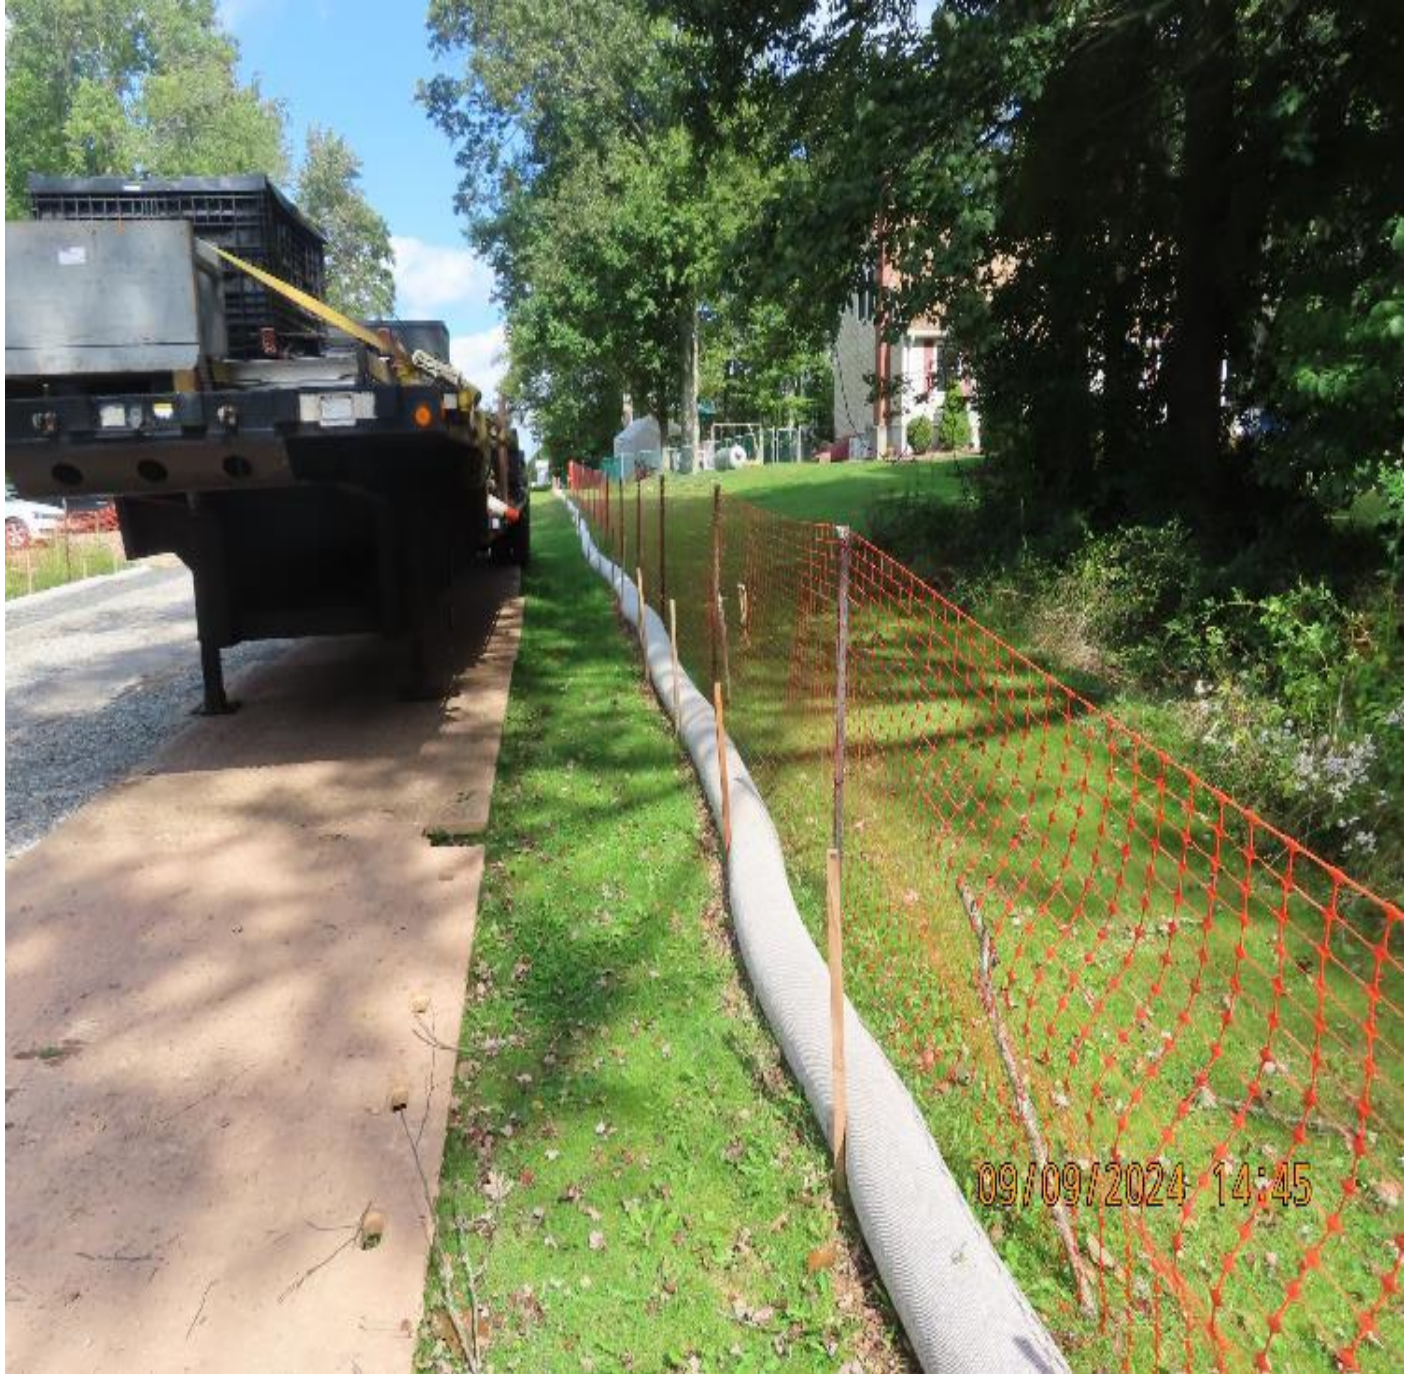
**Photo 2:** View (looking northeast) of compost filter sock and security fencing along workspace boundary in residential area.

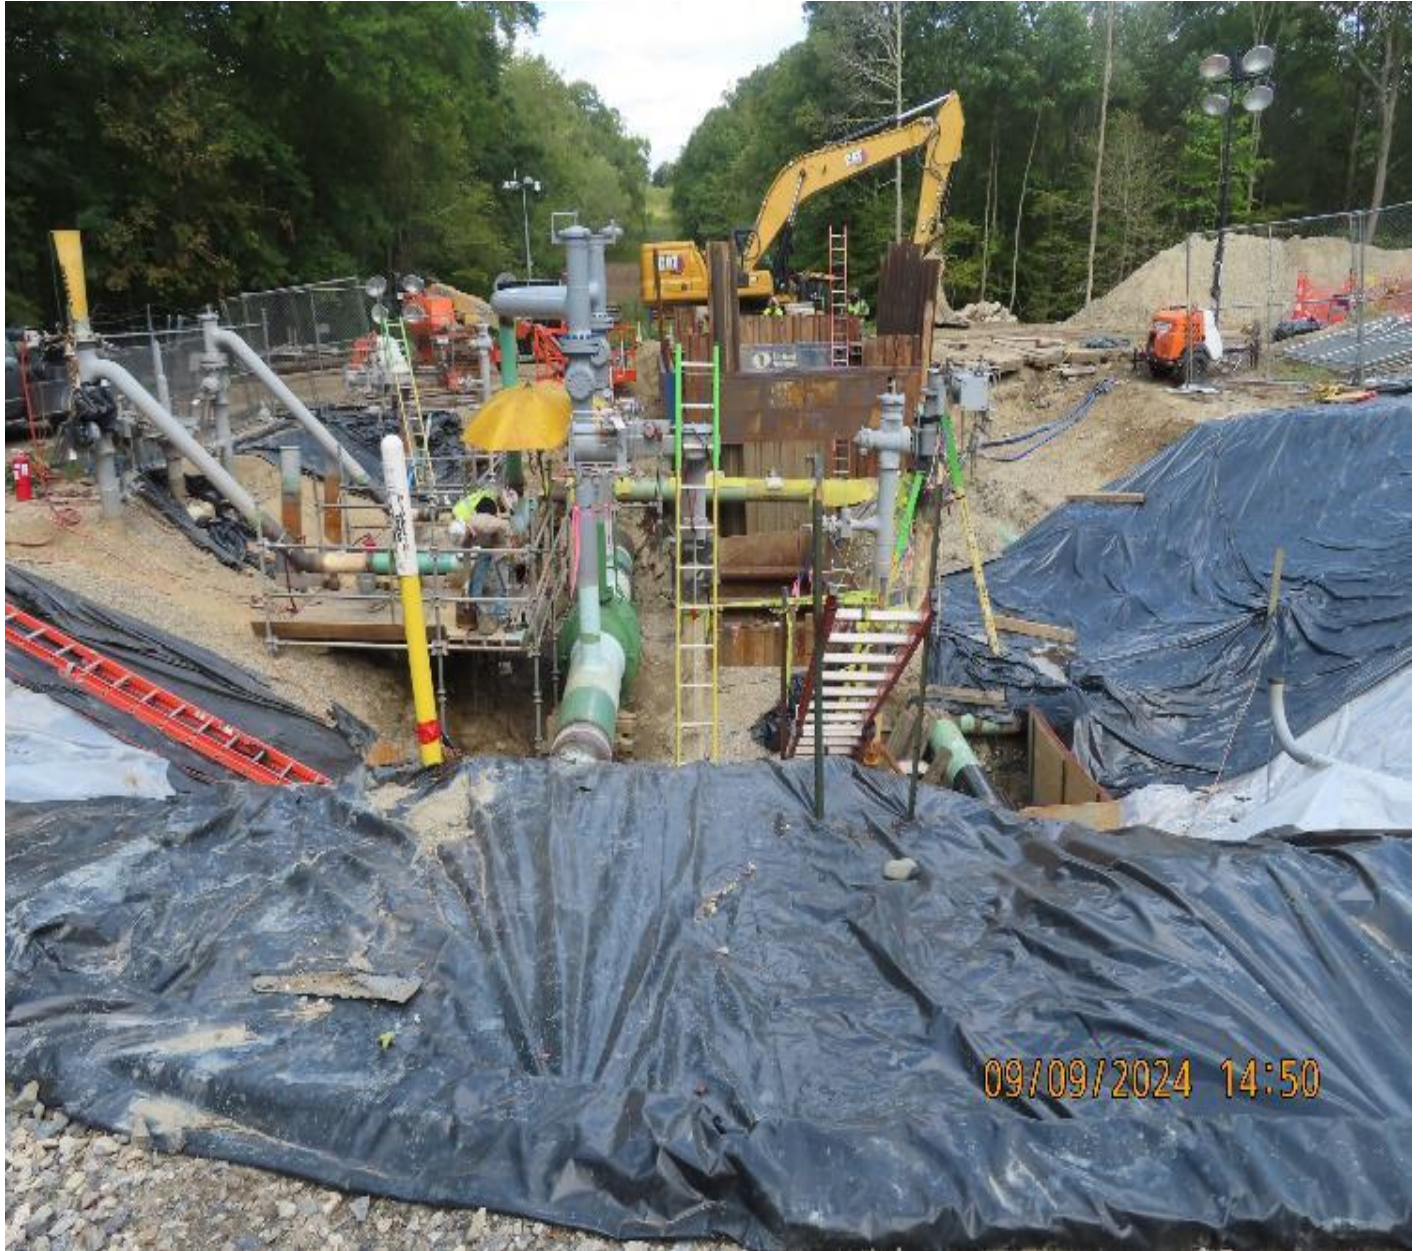
**Photo 3:** View (looking northeast) of ongoing excavation and mechanical work in valve yard.

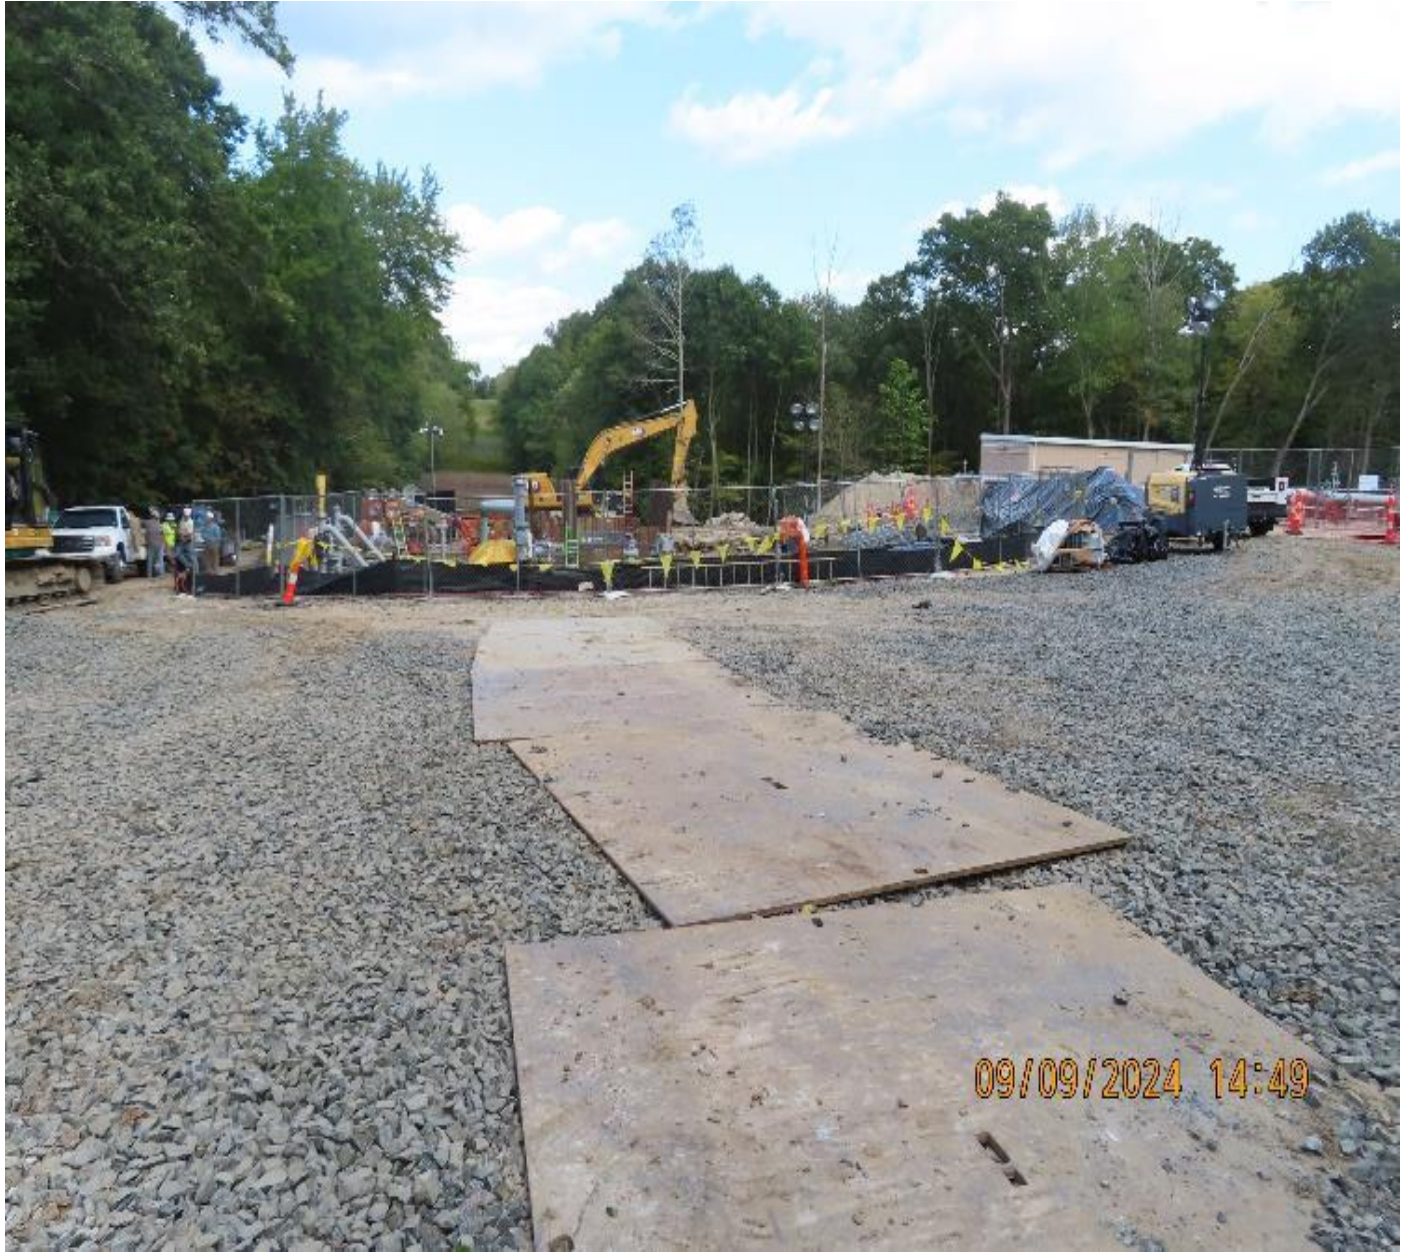
**Photo 4:** View (looking northeast) of area stabilized with rock and metal sheeting for lift crane setup.

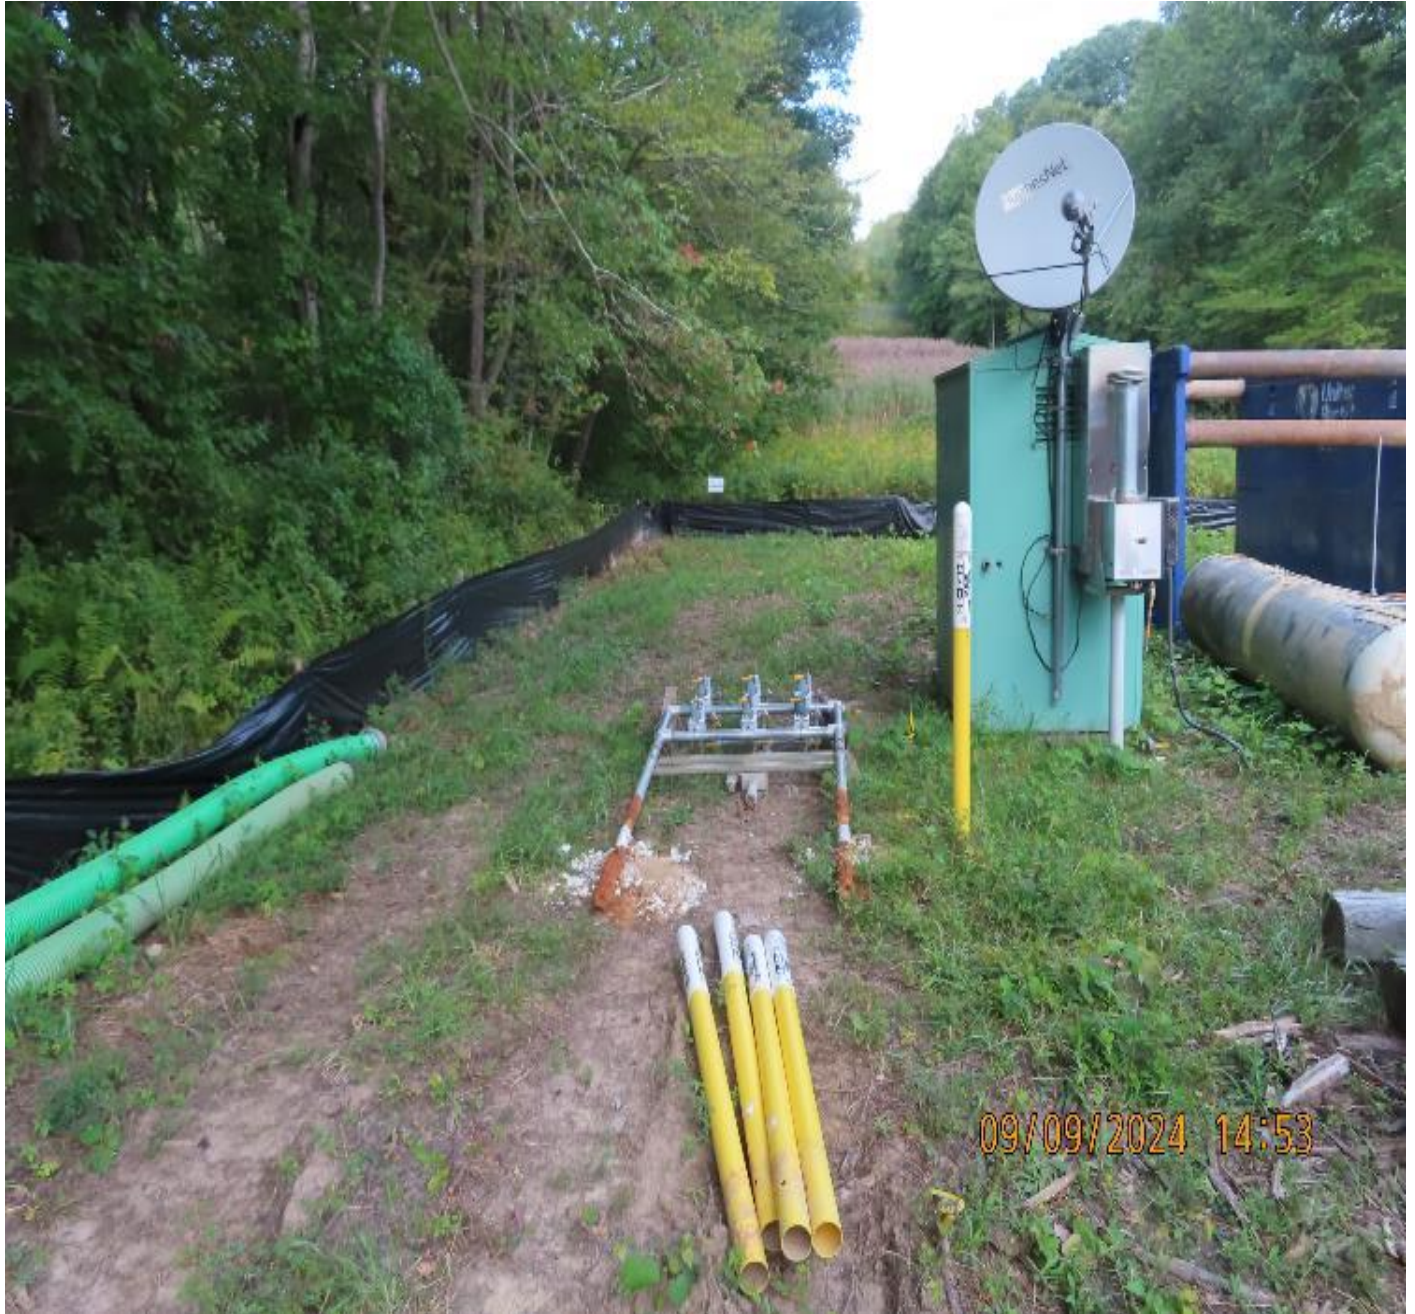
**Photo 5:** View (looking northeast) of new satellite dish near northwest corner of worksite.

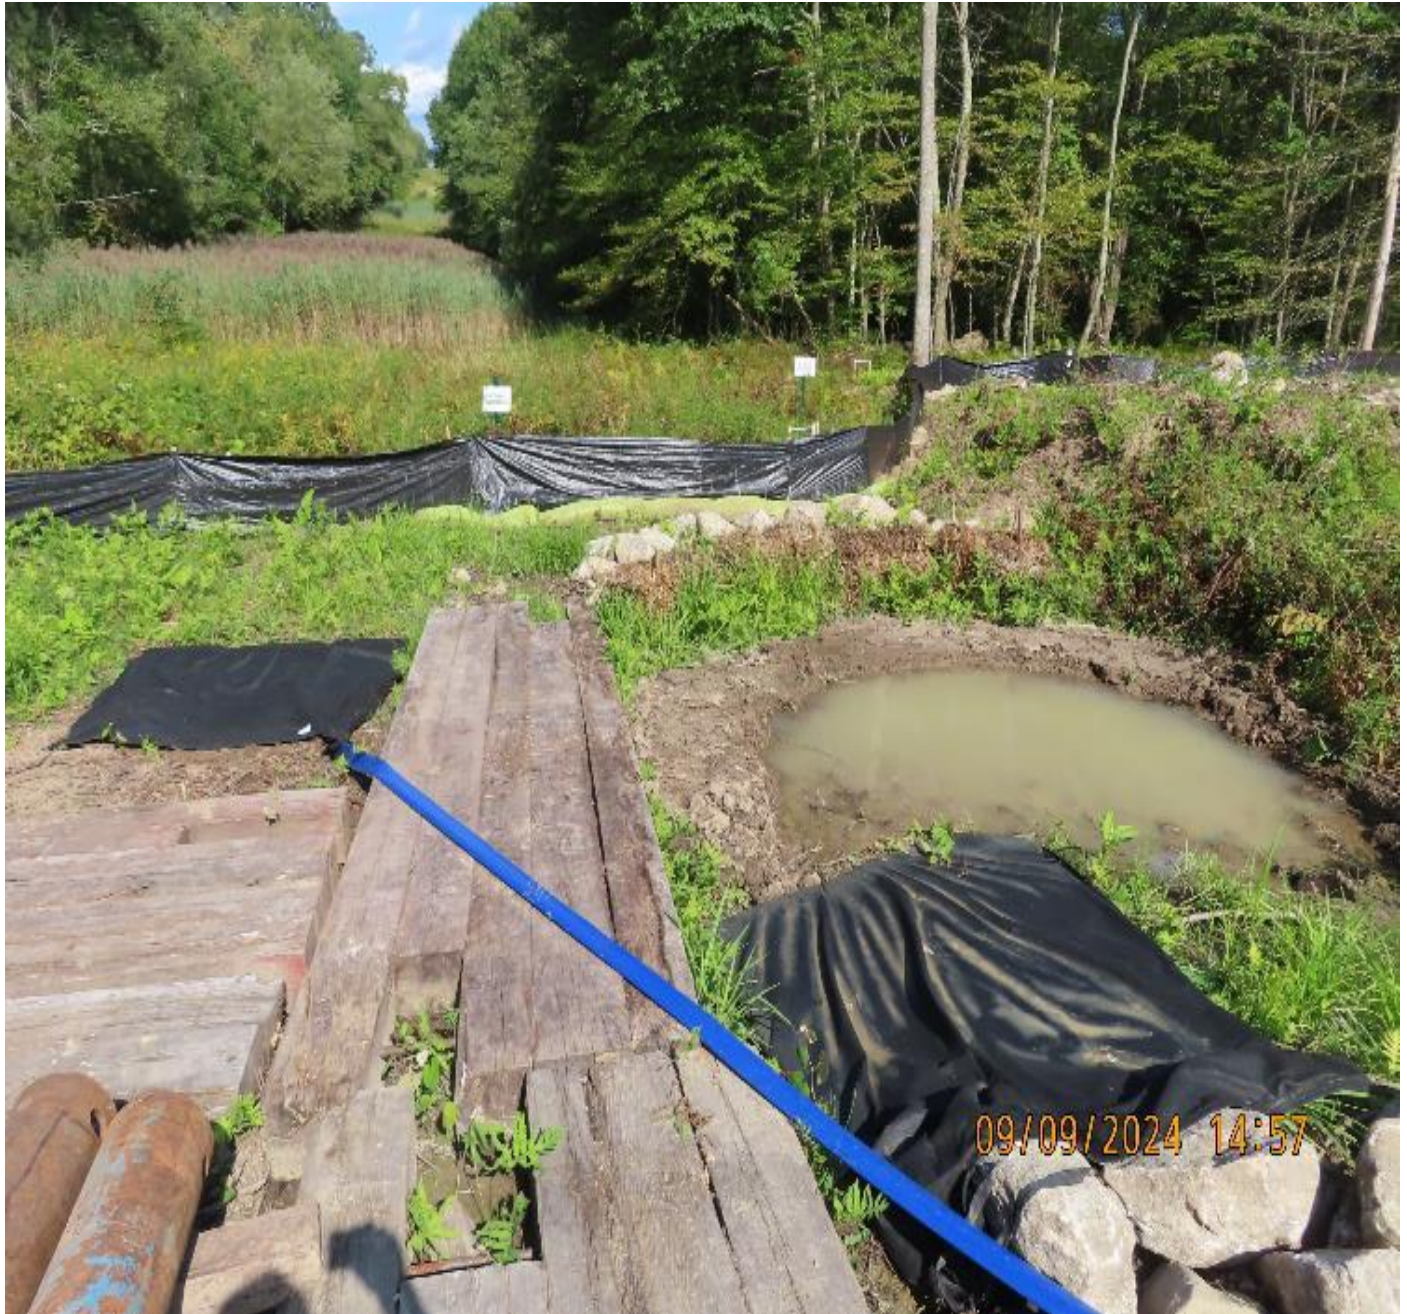
**Photo 6:** View (looking northeast) of filter bag for excavation dewatering discharges with shallow sump pit excavated nearby to increase retention for ground infiltration.

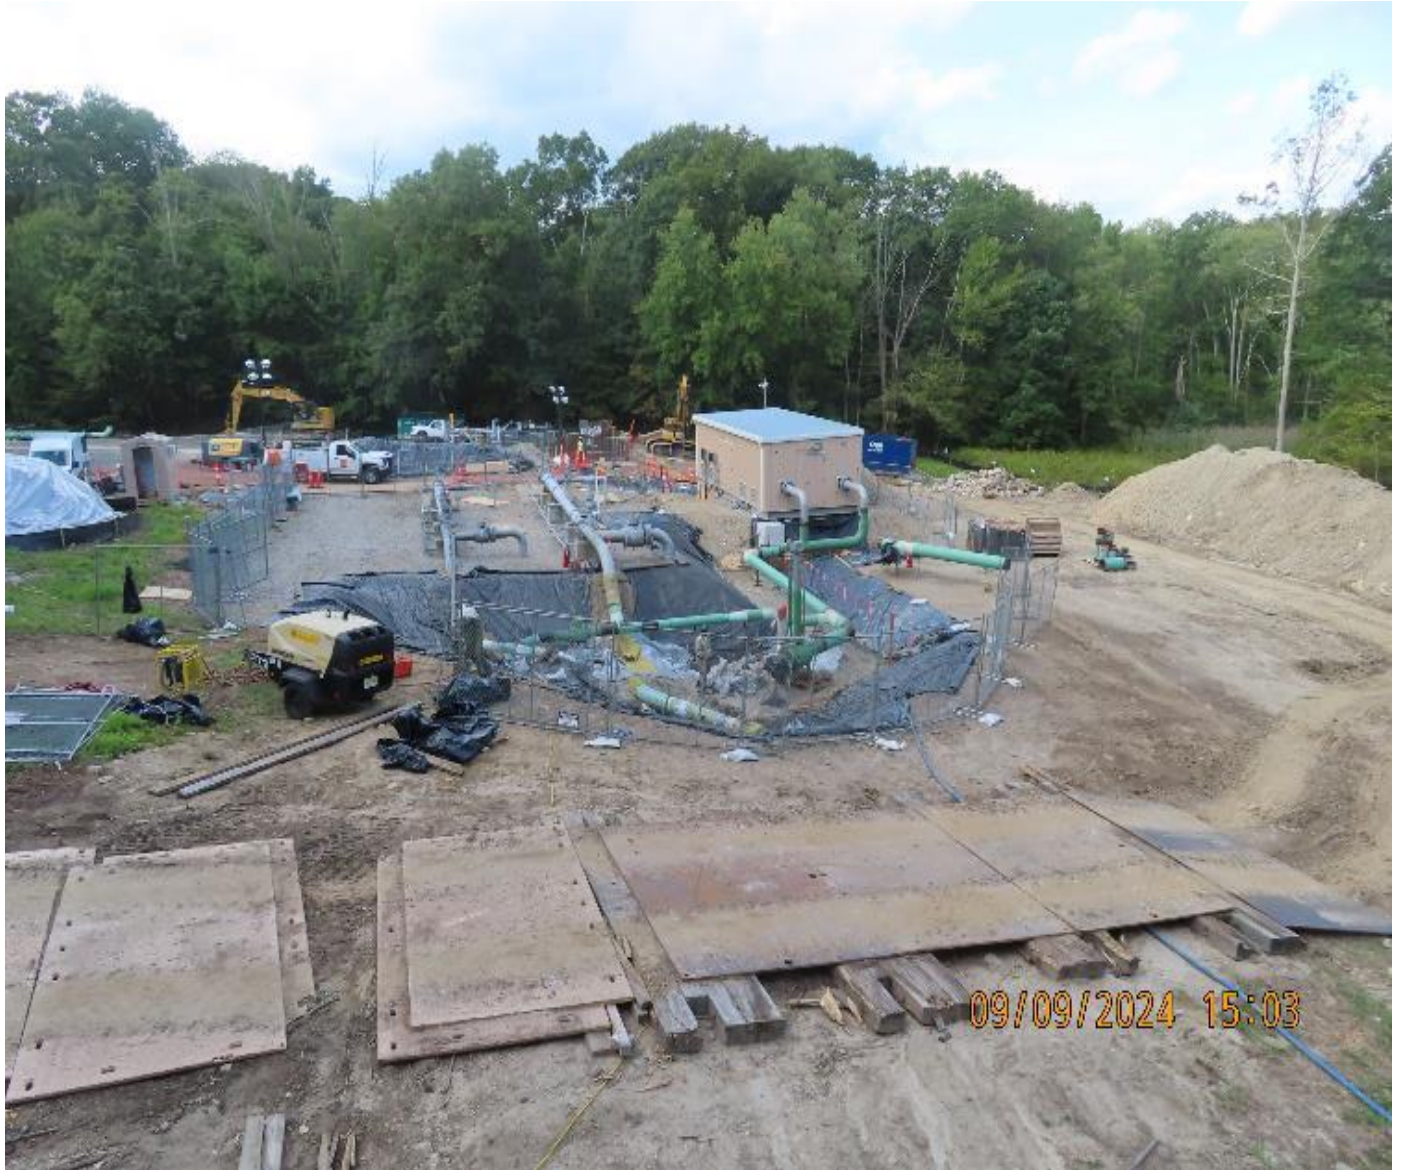
**Photo 7:** View (looking northwest) of construction work in valve yard.
