Re: Algonquin Gas Transmission, LLC

E-1 System Regulator Installation Project, Docket No. CP24-21-000

Report No. 12

E-1 System Regulation WEEKLY REPORT #12

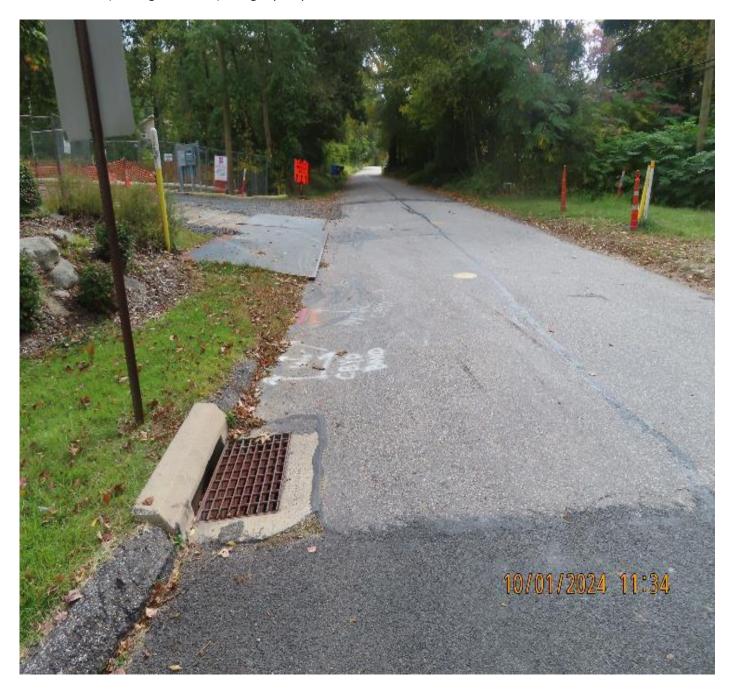
Photo 1: View (looking northeast) along Hip Hop Road at site entrance.

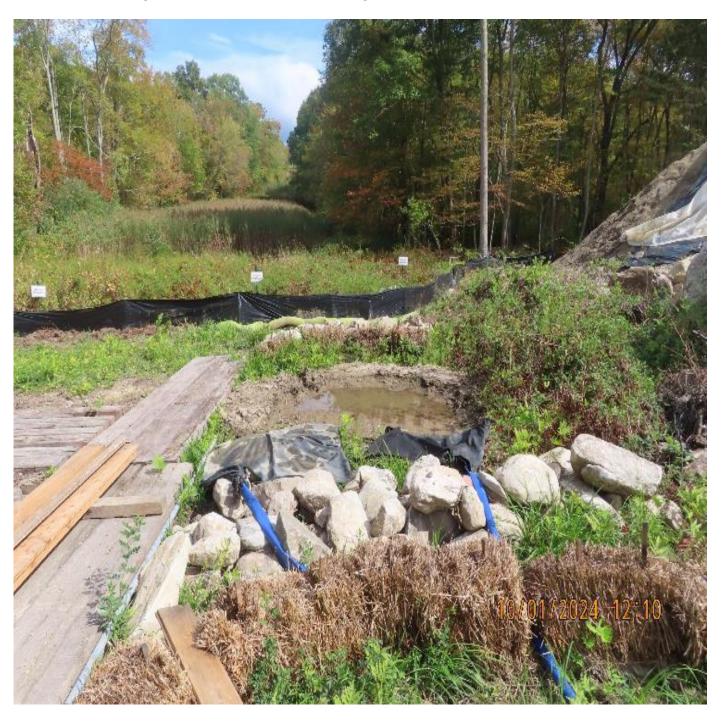
Photo 2: View (looking northeast) at excavation dewatering controls.

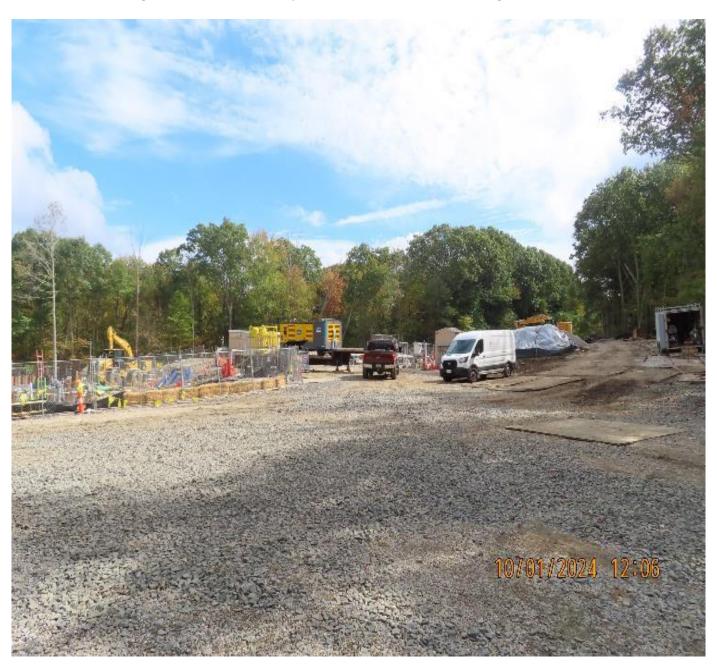
Photo 3: View (looking east) at southern workspace stabilized with stone surfacing.

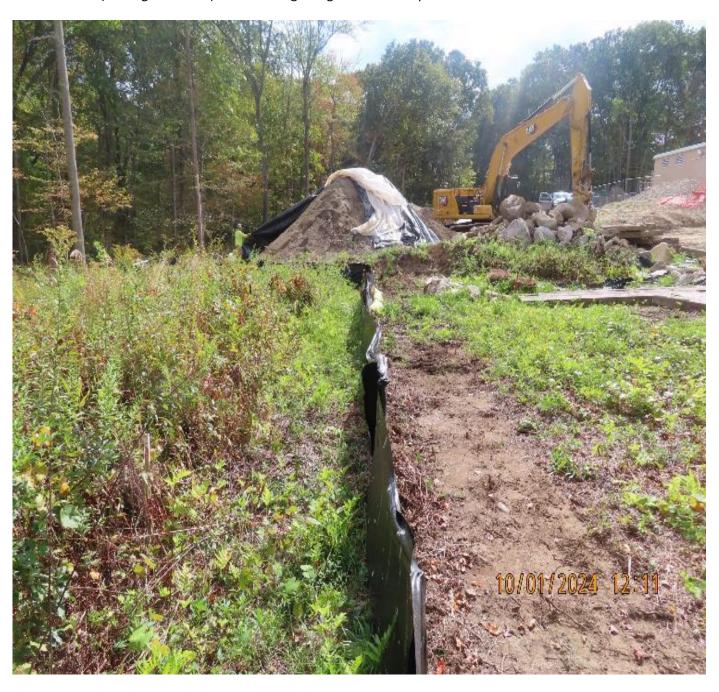
Photo 4: View (looking southeast) at silt fencing along northern site perimeter.

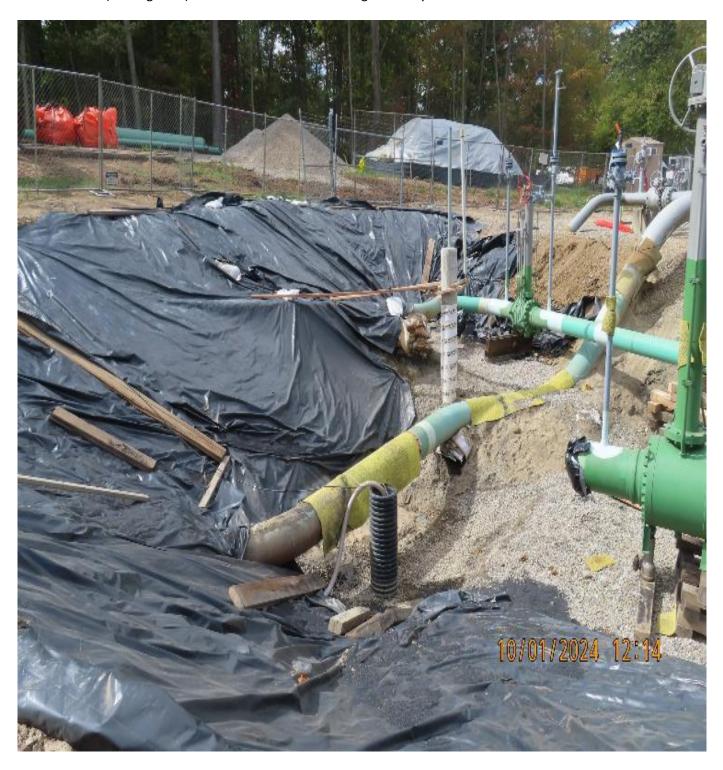
Photo 5: View (looking west) at mechanical work occurring in valve yard.

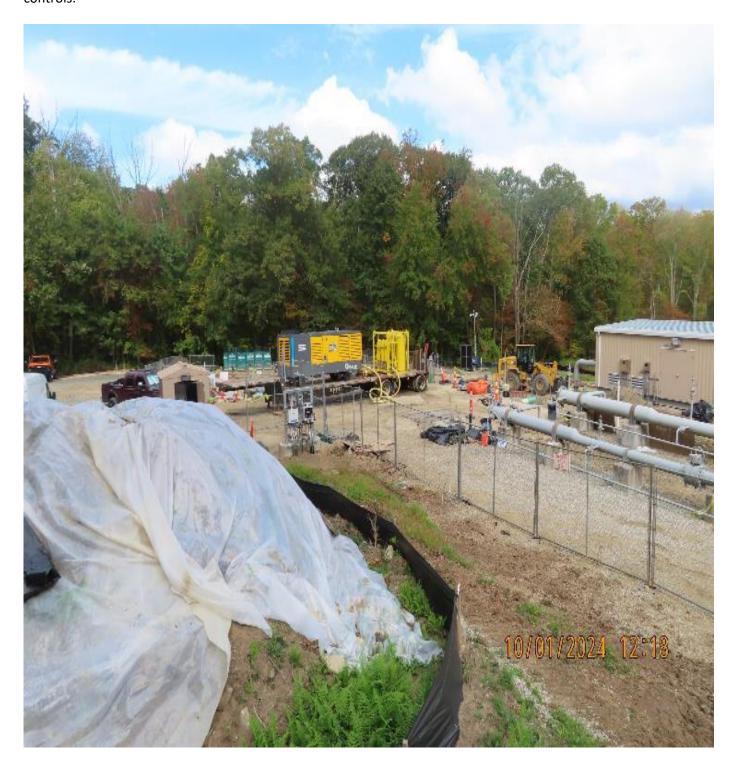
Photo 6: View (looking northwest) at segregated stockpile of topsoil with covering and perimeter erosion controls.

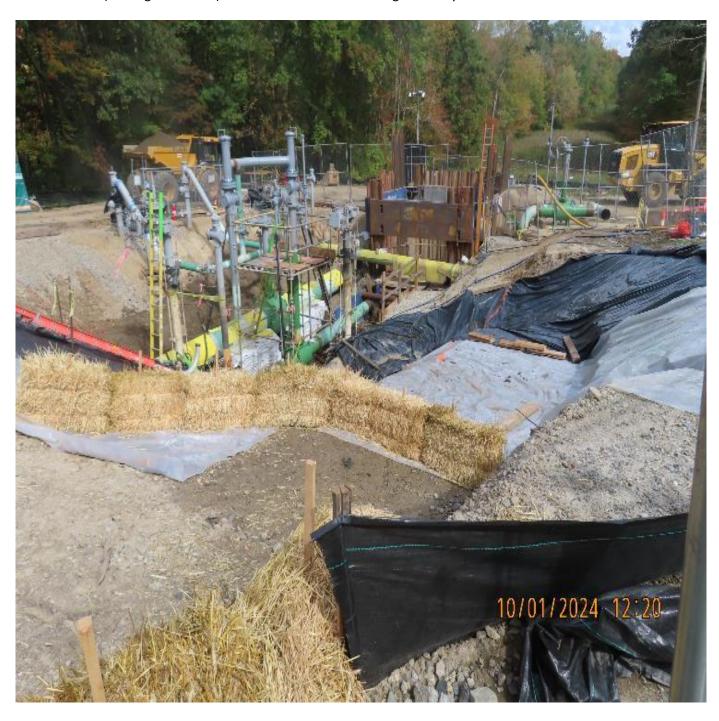
Photo 7: View (looking northwest) at mechanical work occurring in valve yard.

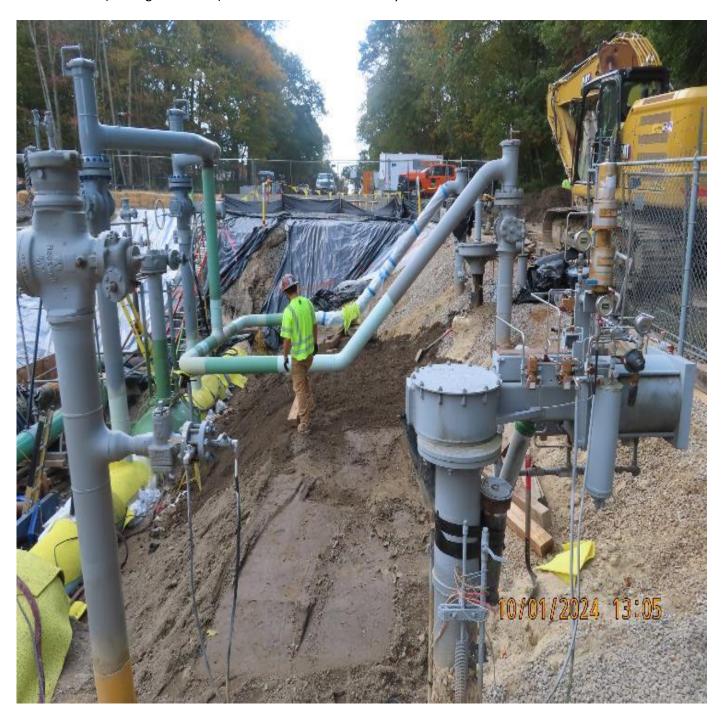
Photo 8: View (looking southwest) at mechanical work in valve yard.
