Re: *Algonquin Gas Transmission, LLC*
E-1 System Regulator Installation Project, Docket No. CP24-21-000
Report No. 14

**E-1 System Regulation
WEEKLY REPORT #14**

Project:	E-1 System Regulation
FERC Docket Number:	CP24-21-000
Report Number:	14
Reporting Period:	October 9 through October 15, 2024

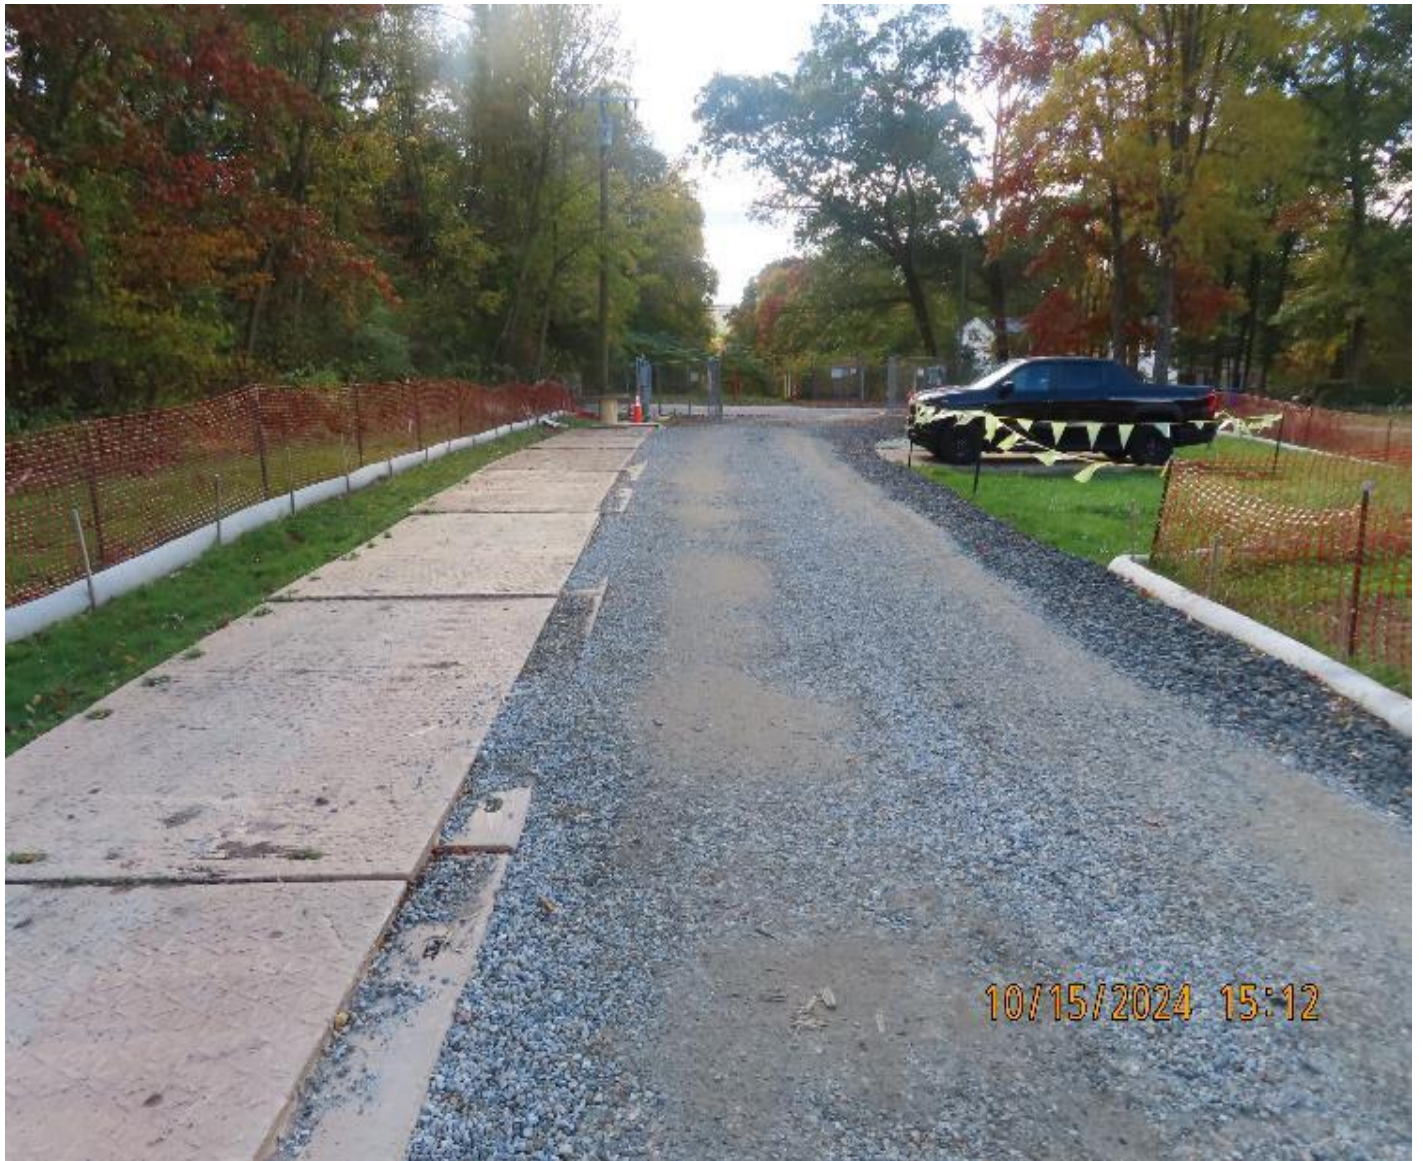
Photo 1: View (looking southwest) of access road from Hop River Road.

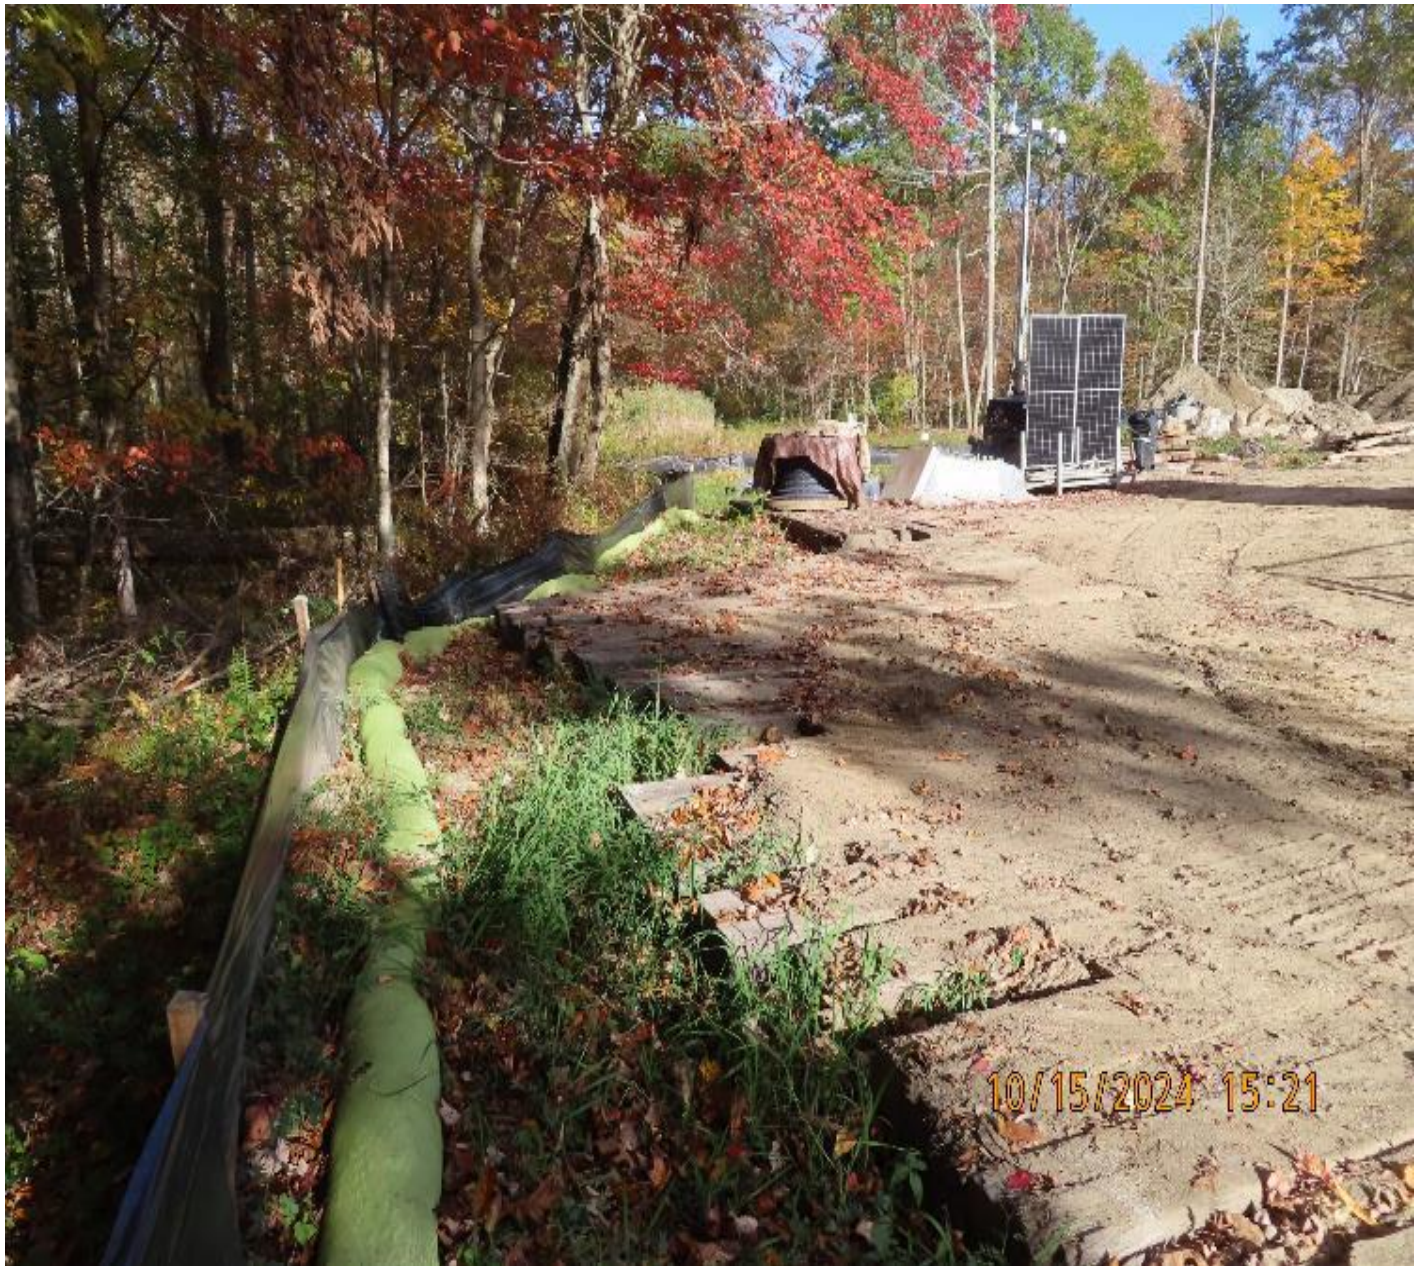
Photo 2: View (looking northeast) of silt fence and filter sock along perimeter of western workspace.

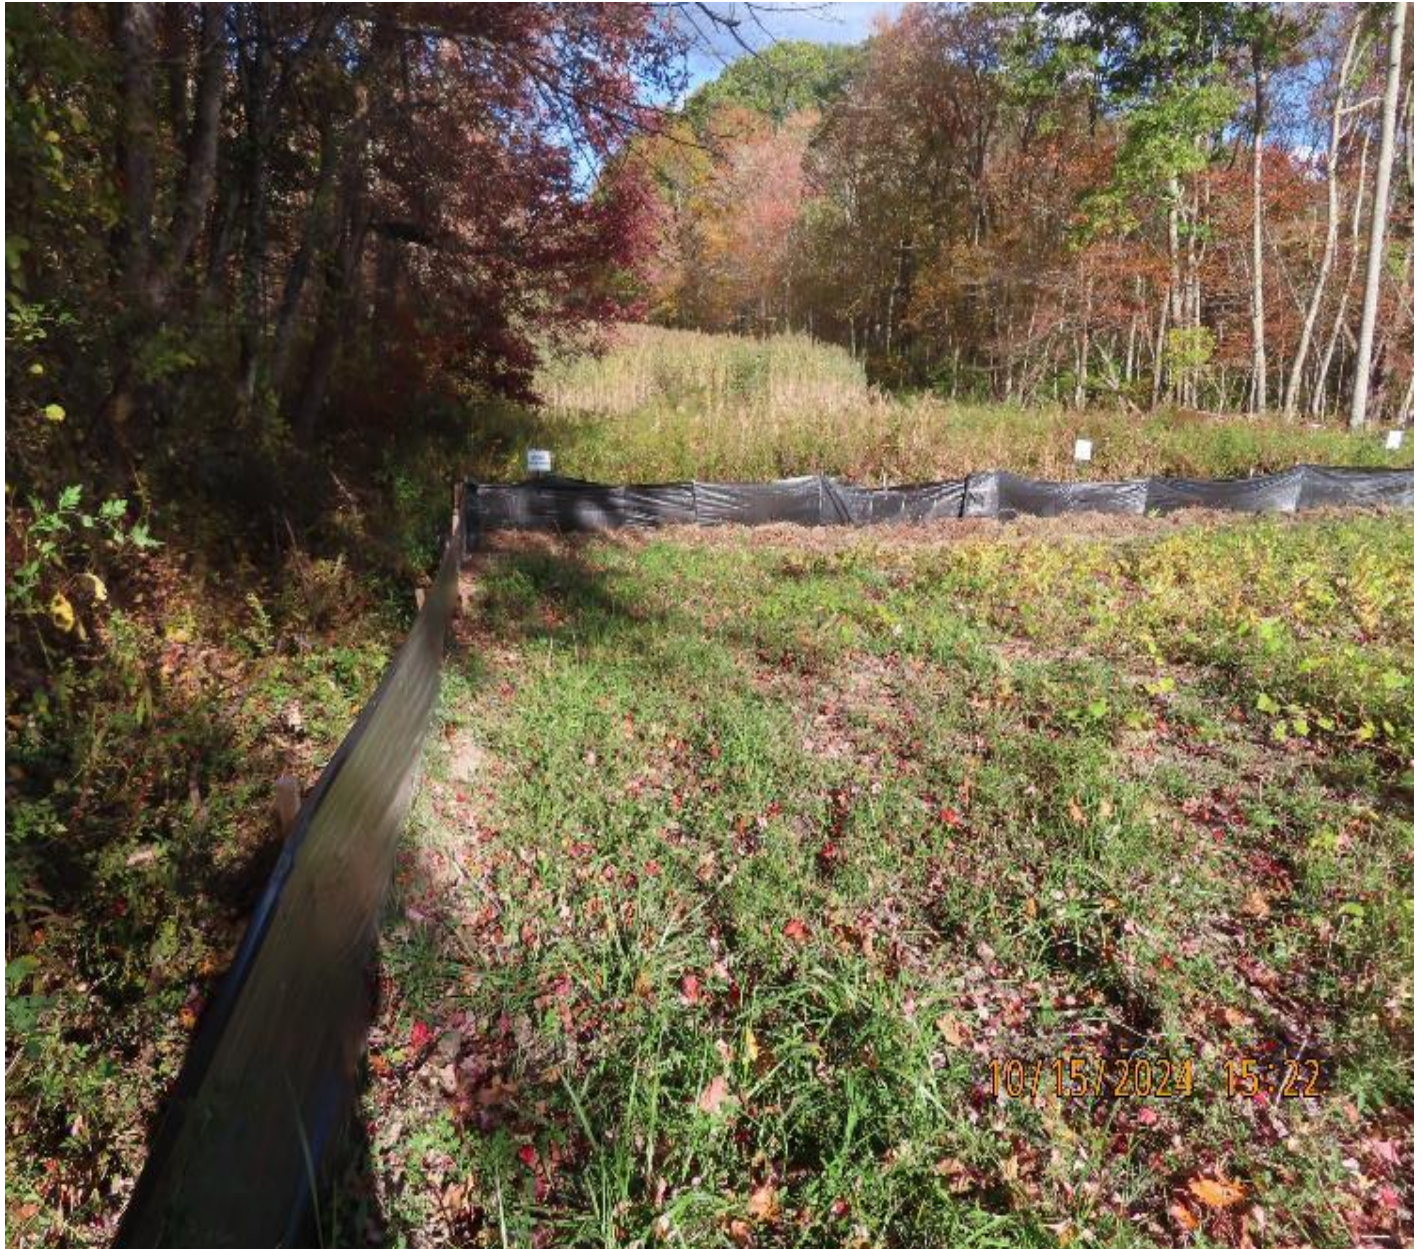
Photo 3: View (looking northwest) of silt fencing and vegetative buffer near wetland at southwest corner of site.

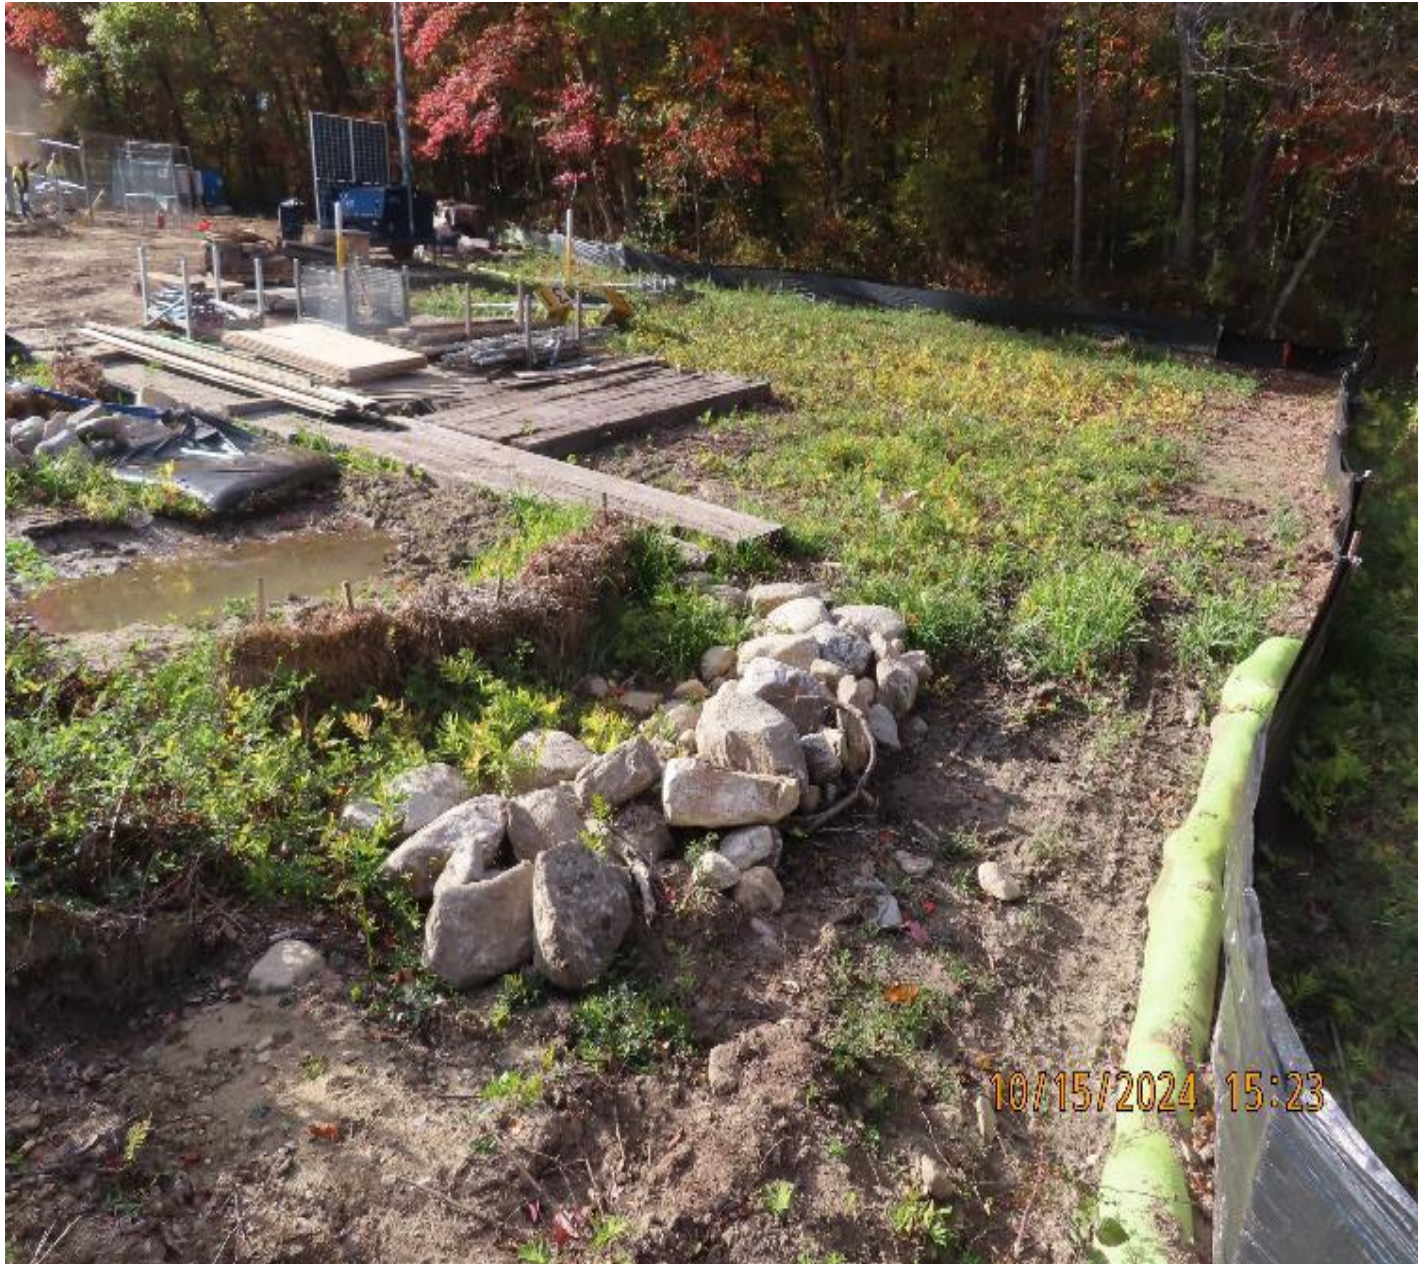
Photo 4: View (looking northwest) of excavation dewatering controls and down-gradient perimeter controls at northwest corner of site, near wetland W-CZ-01.

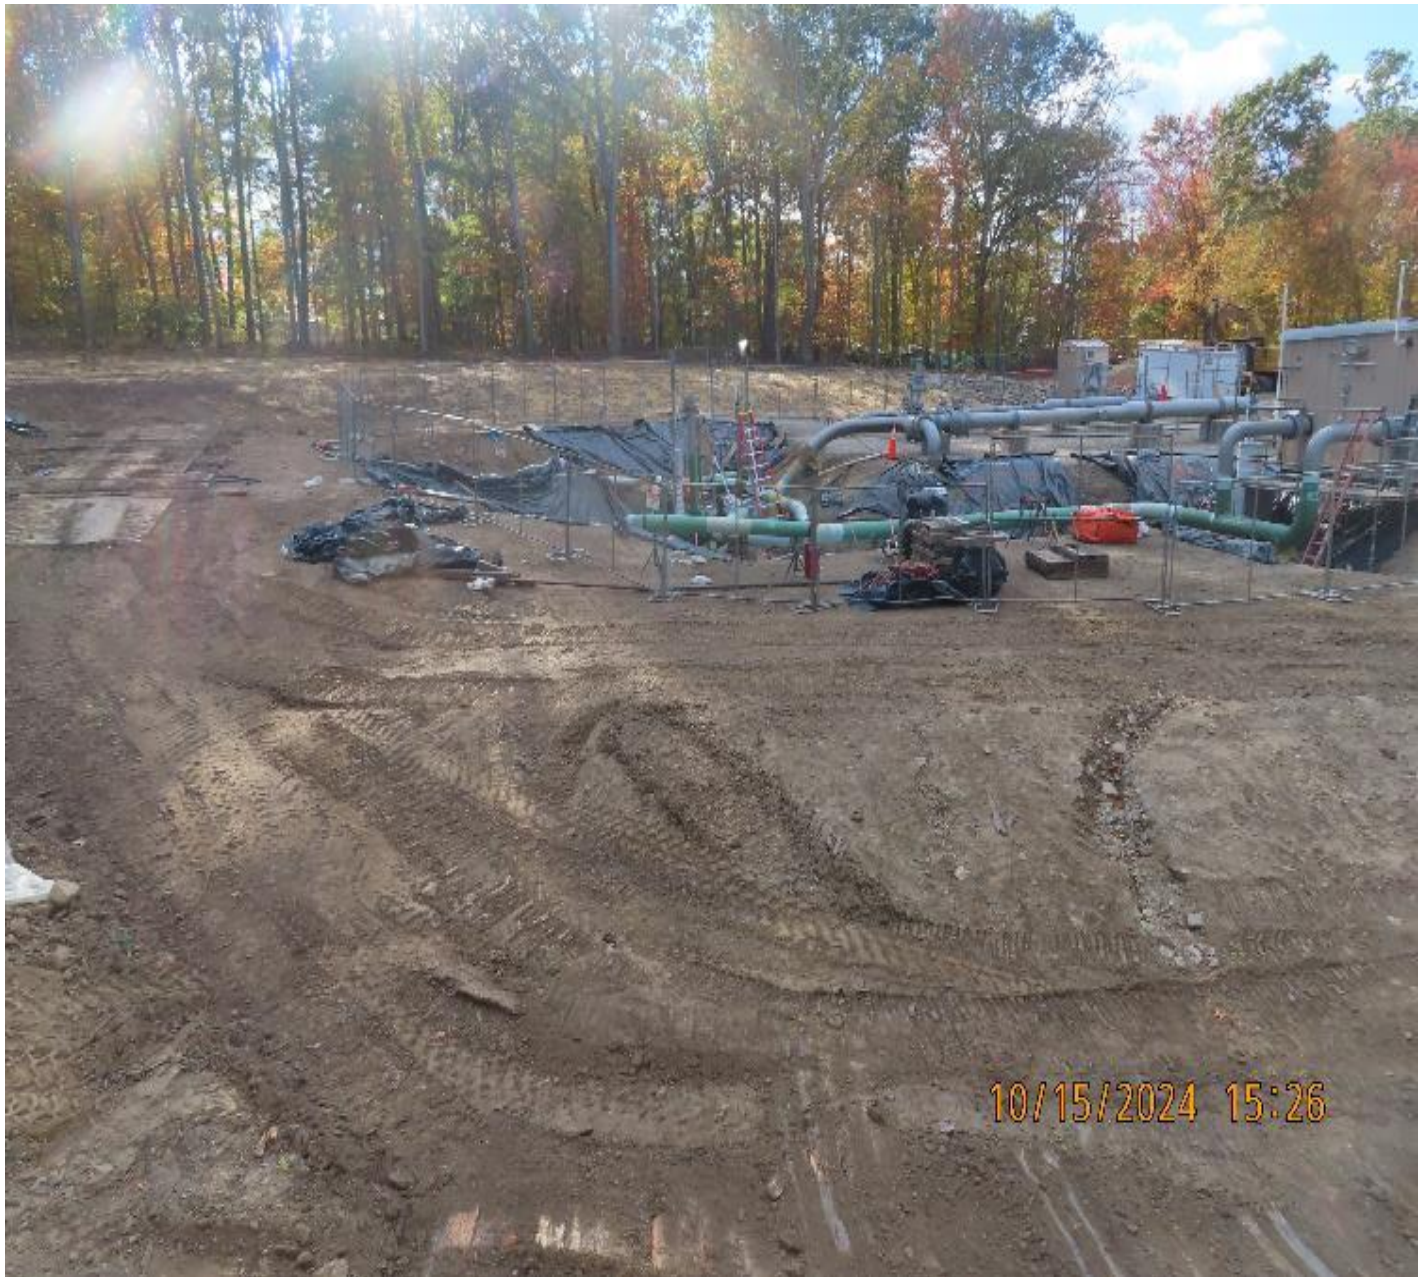
Photo 5: View (looking southwest) of E-System 30-inch tie-in excavation area after backfilling.

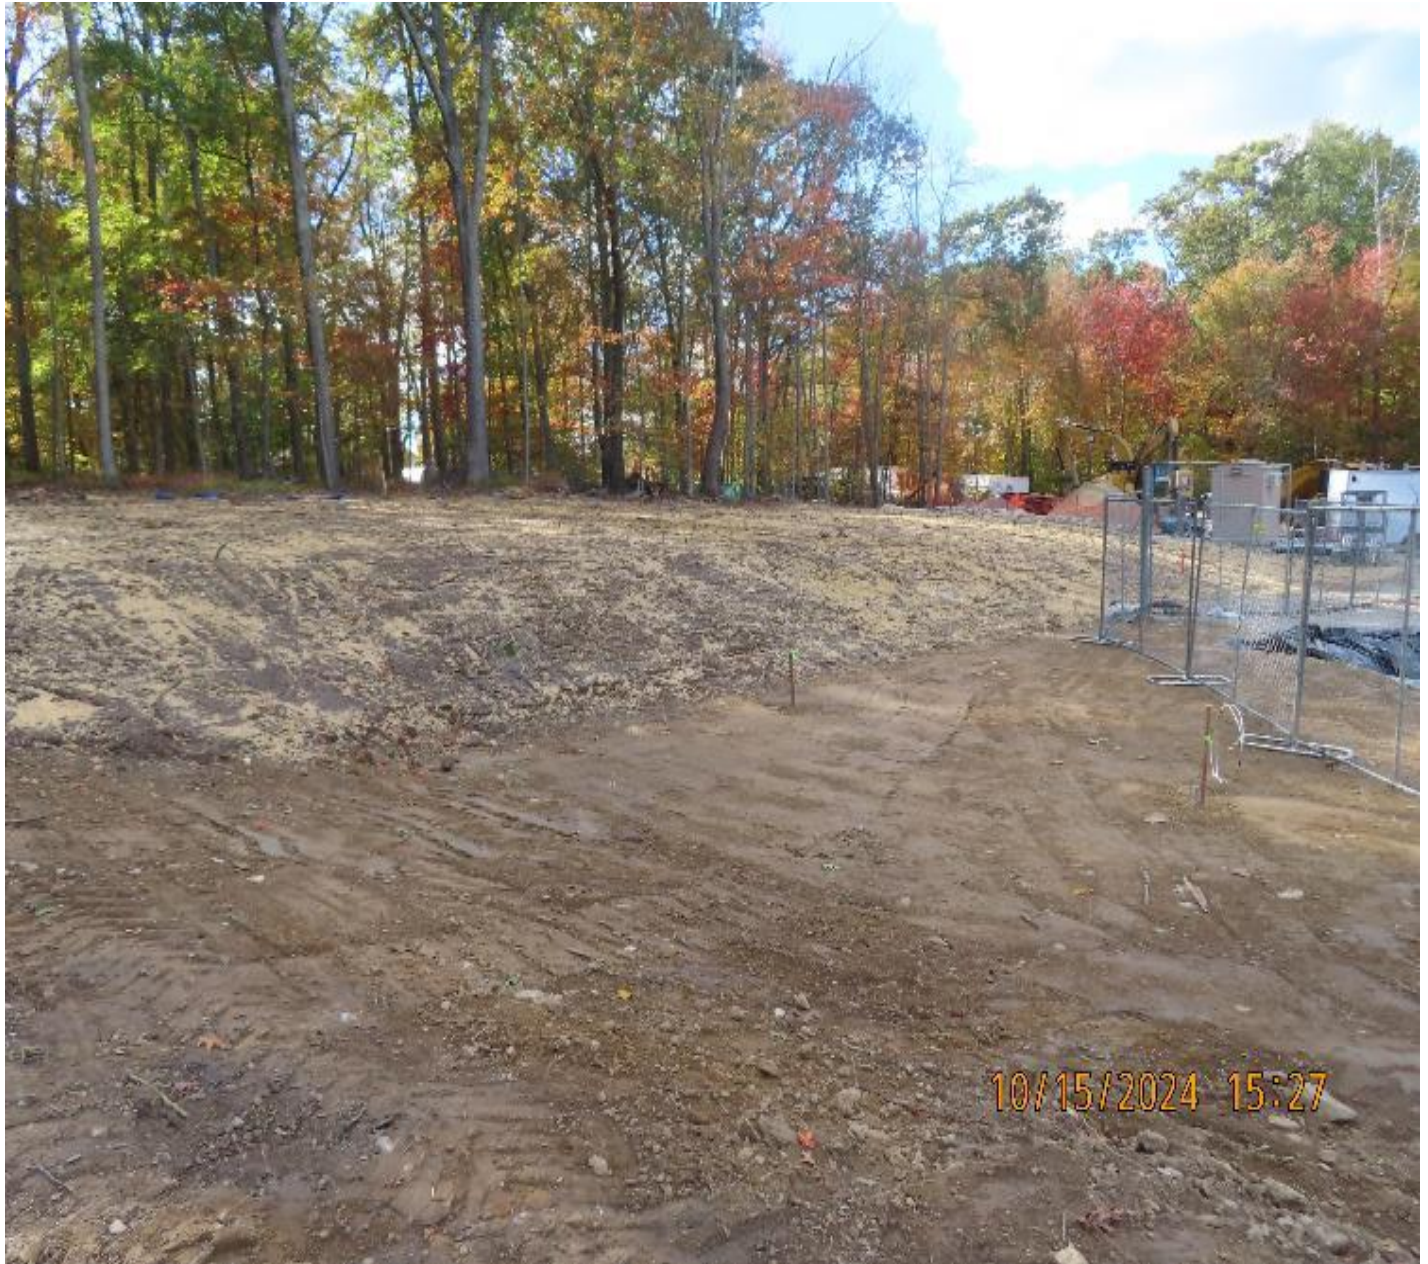
Photo 6: View (looking west) of southern portion of site where final grading and partial stabilization work has been completed.

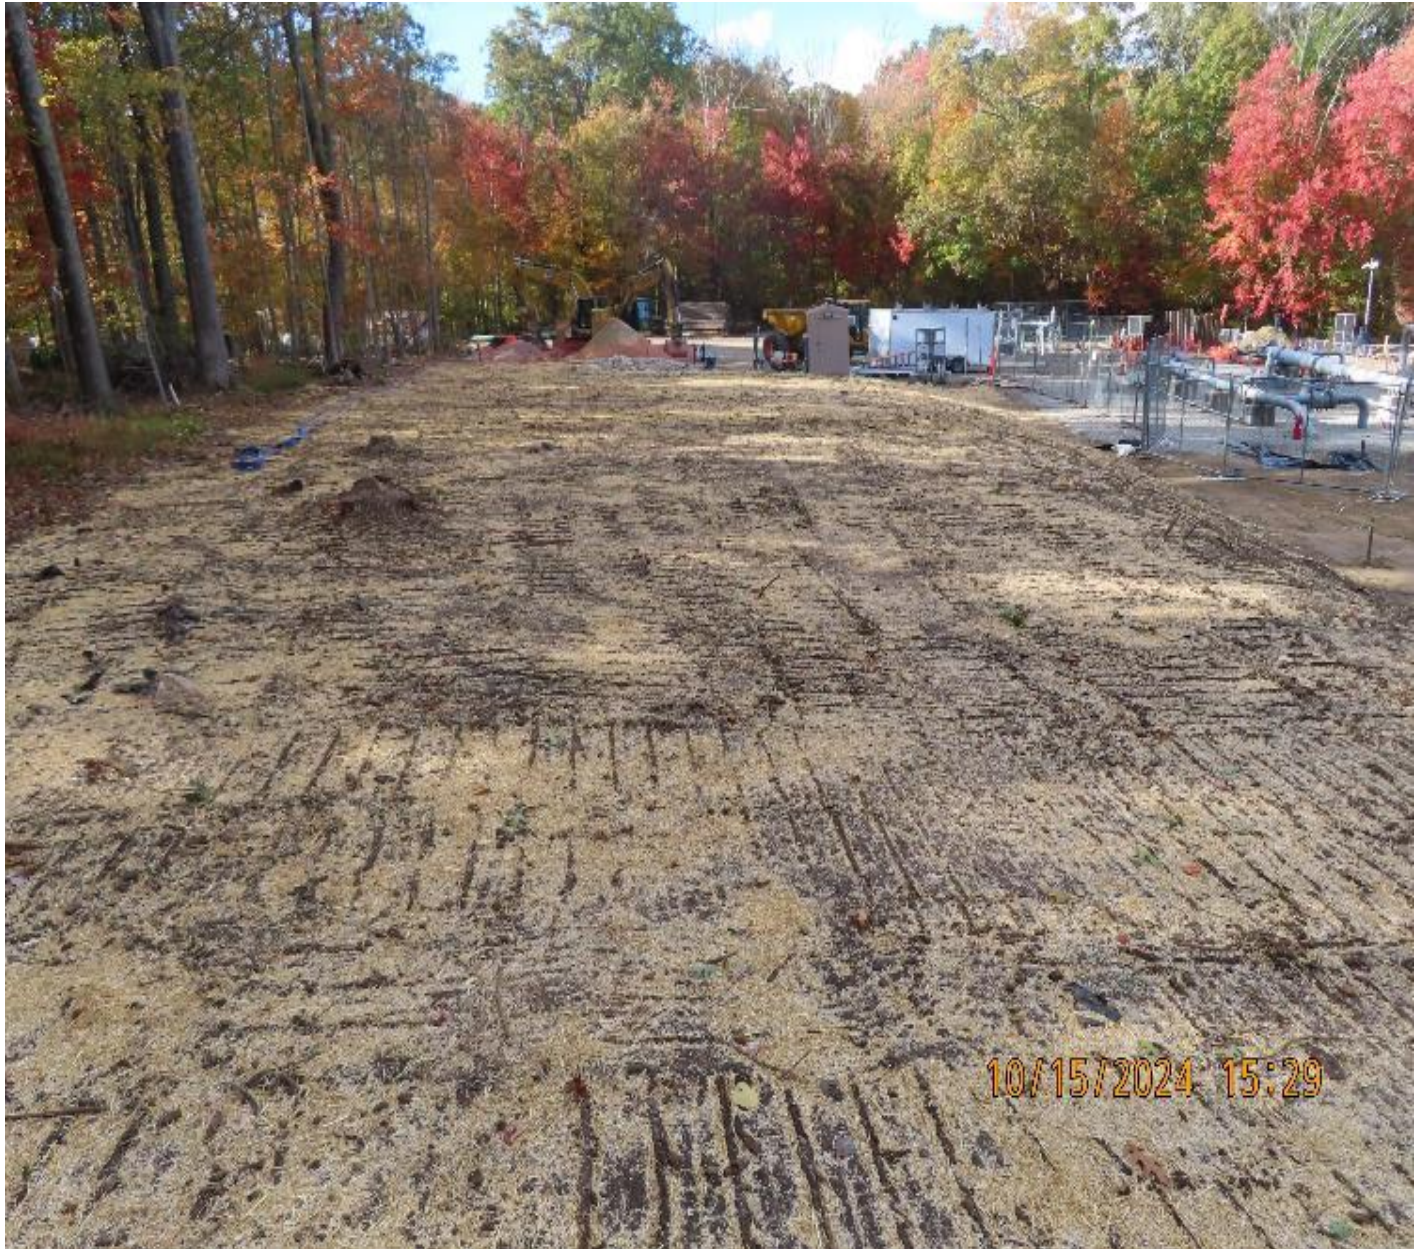
Photo 7: View (looking northwest) of area recently graded, seeded, and mulched. Additional mulch and application and crimping is planned for this area for further stabilization.

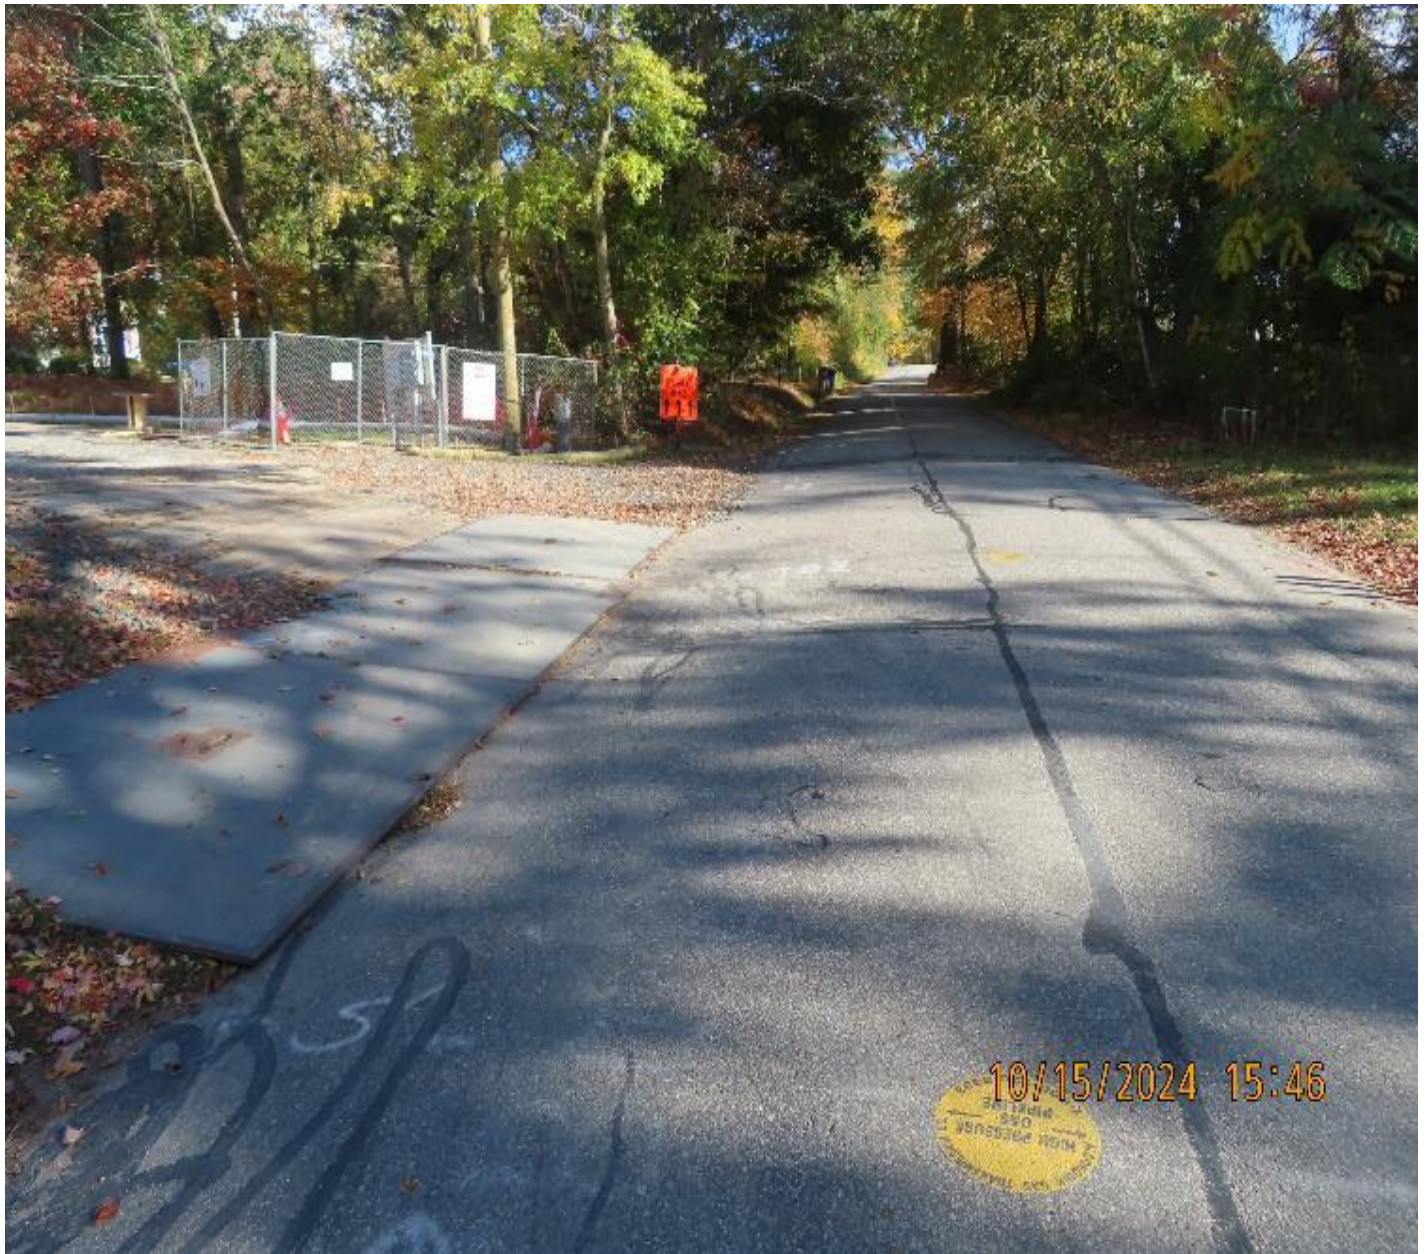
Photo 8: View (looking east) at site entrance from Hop River Road.
