Re: *Algonquin Gas Transmission, LLC*
E-1 System Regulator Installation Project, Docket No. CP24-21-000
Report No. 15

**E-1 System Regulation
WEEKLY REPORT #15**

Project:	E-1 System Regulation
FERC Docket Number:	CP24-21-000
Report Number:	15
Reporting Period:	October 16 through October 23, 2024

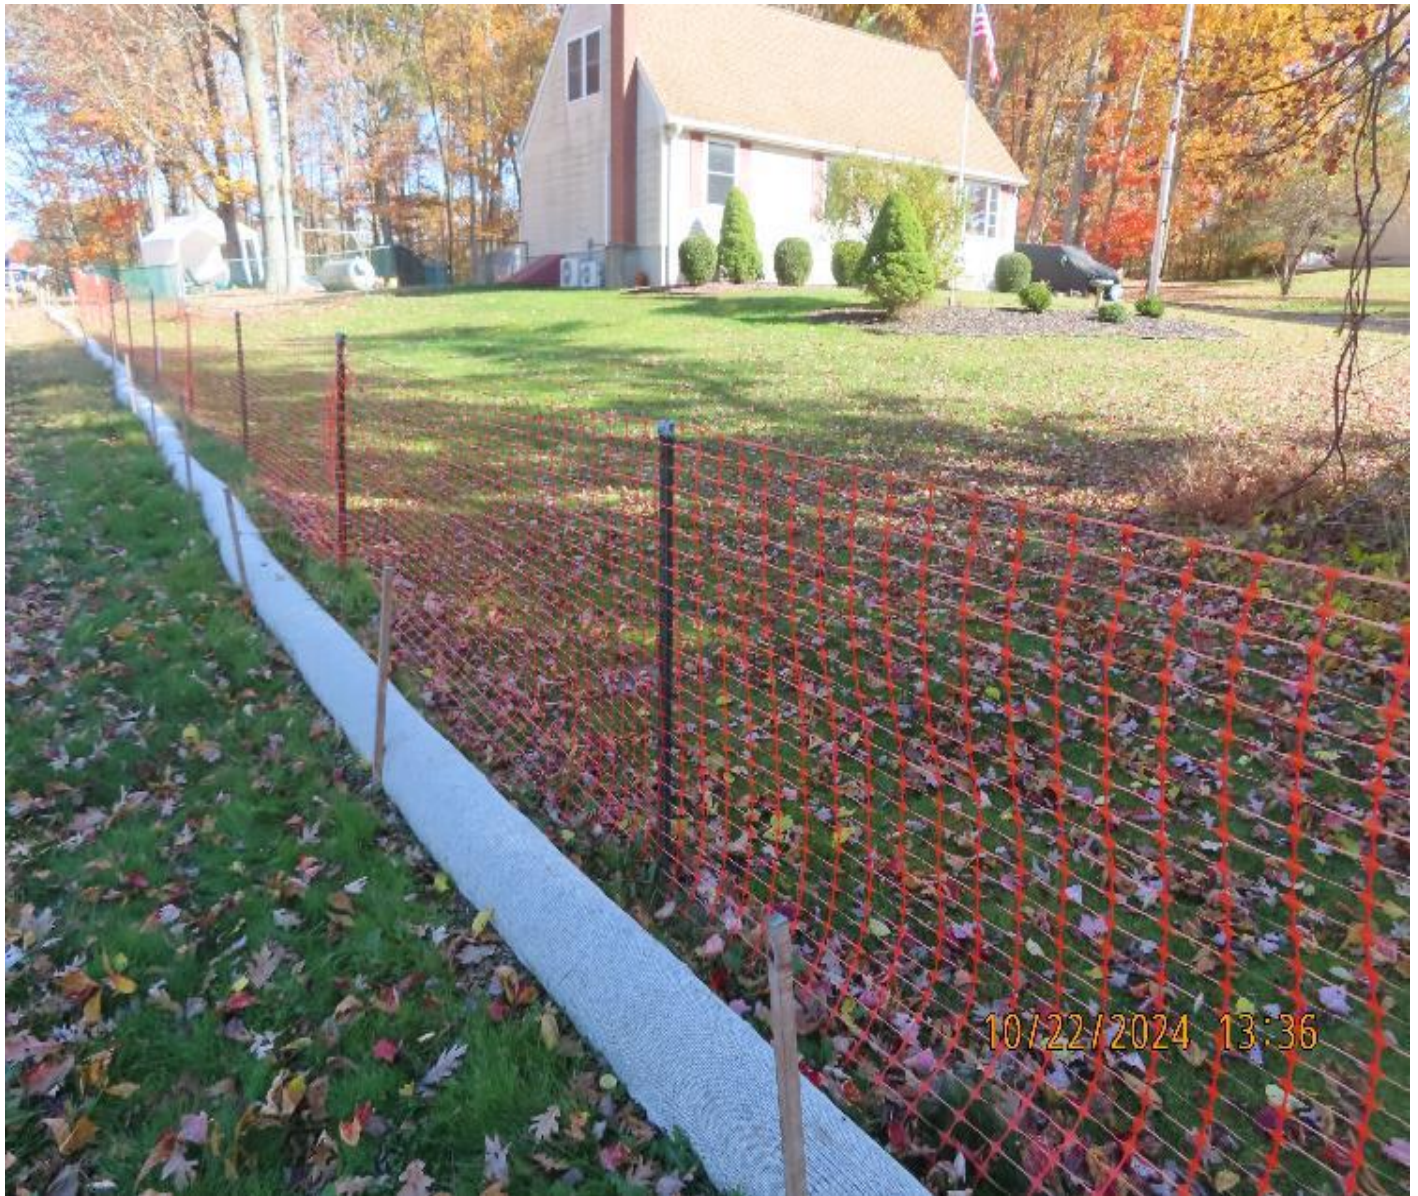
Photo 1: View (looking northeast) of perimeter ECDs and security fencing along the east side of site access.

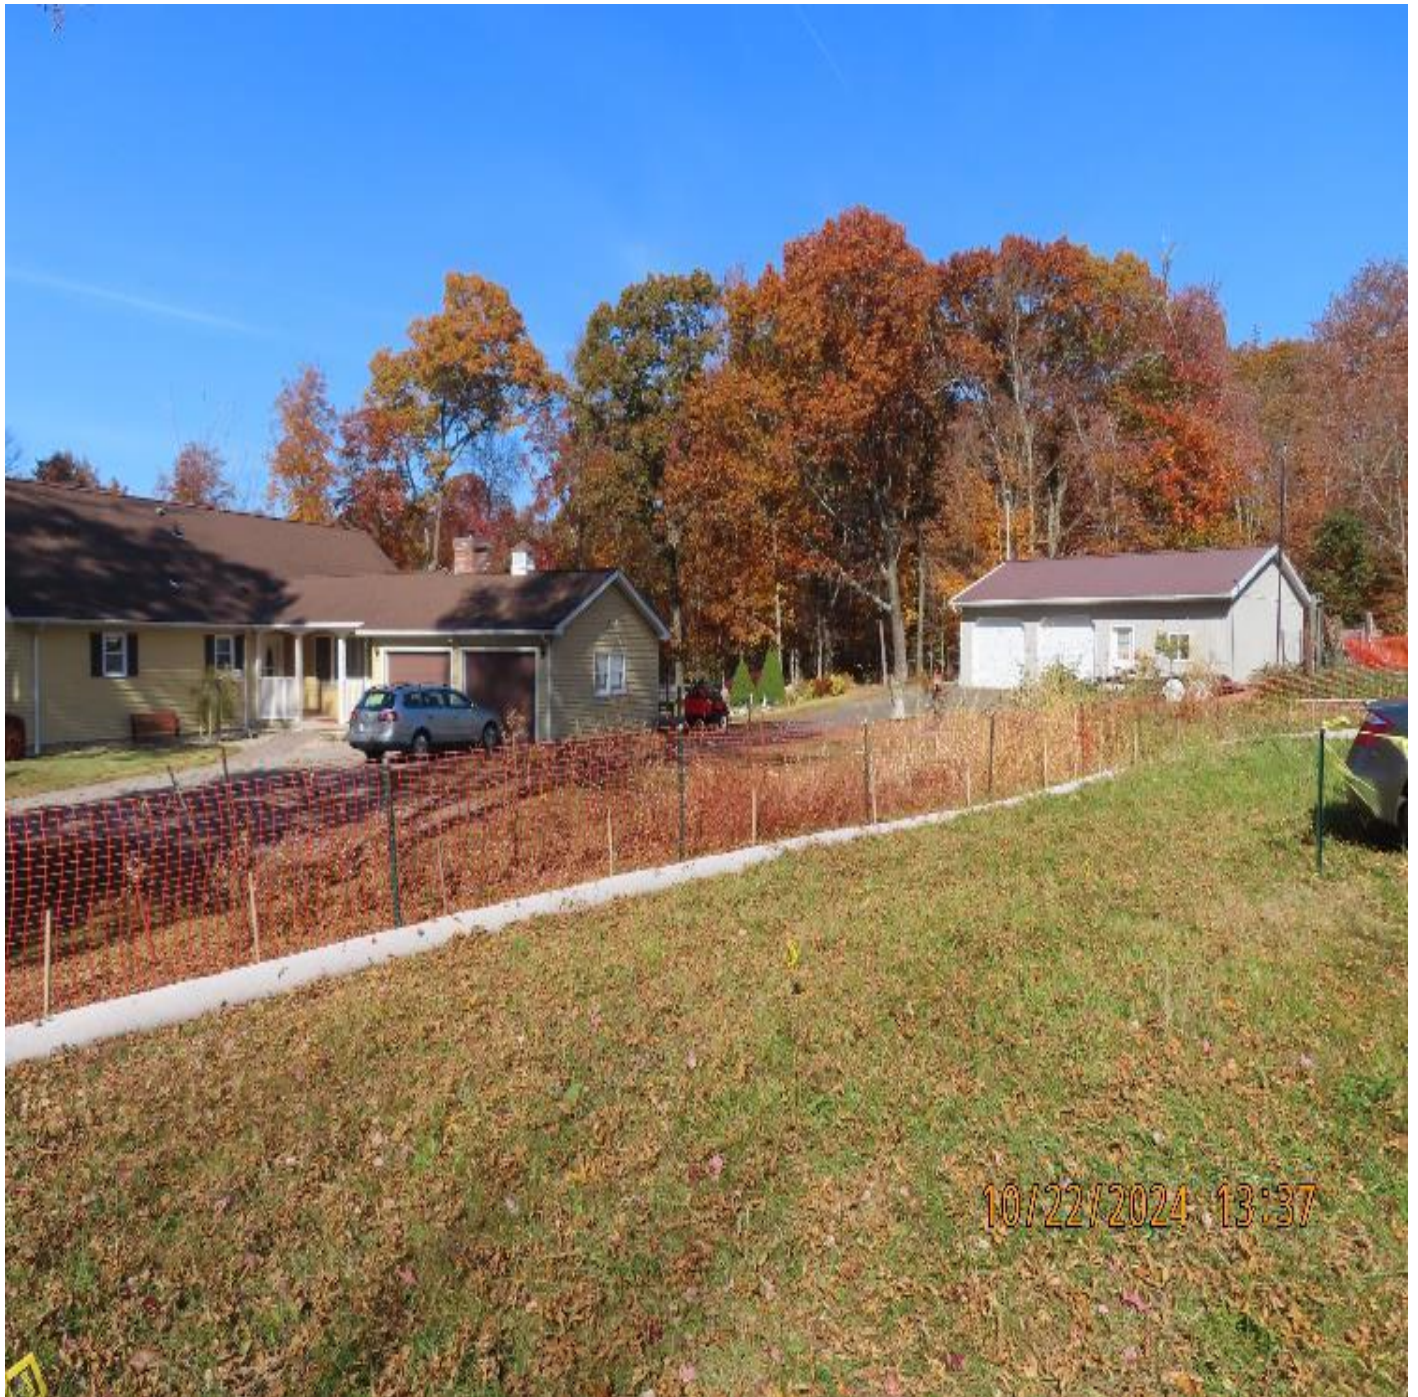
Photo 2: View (looking northwest) of perimeter ECDs and security fencing along west side of site access.

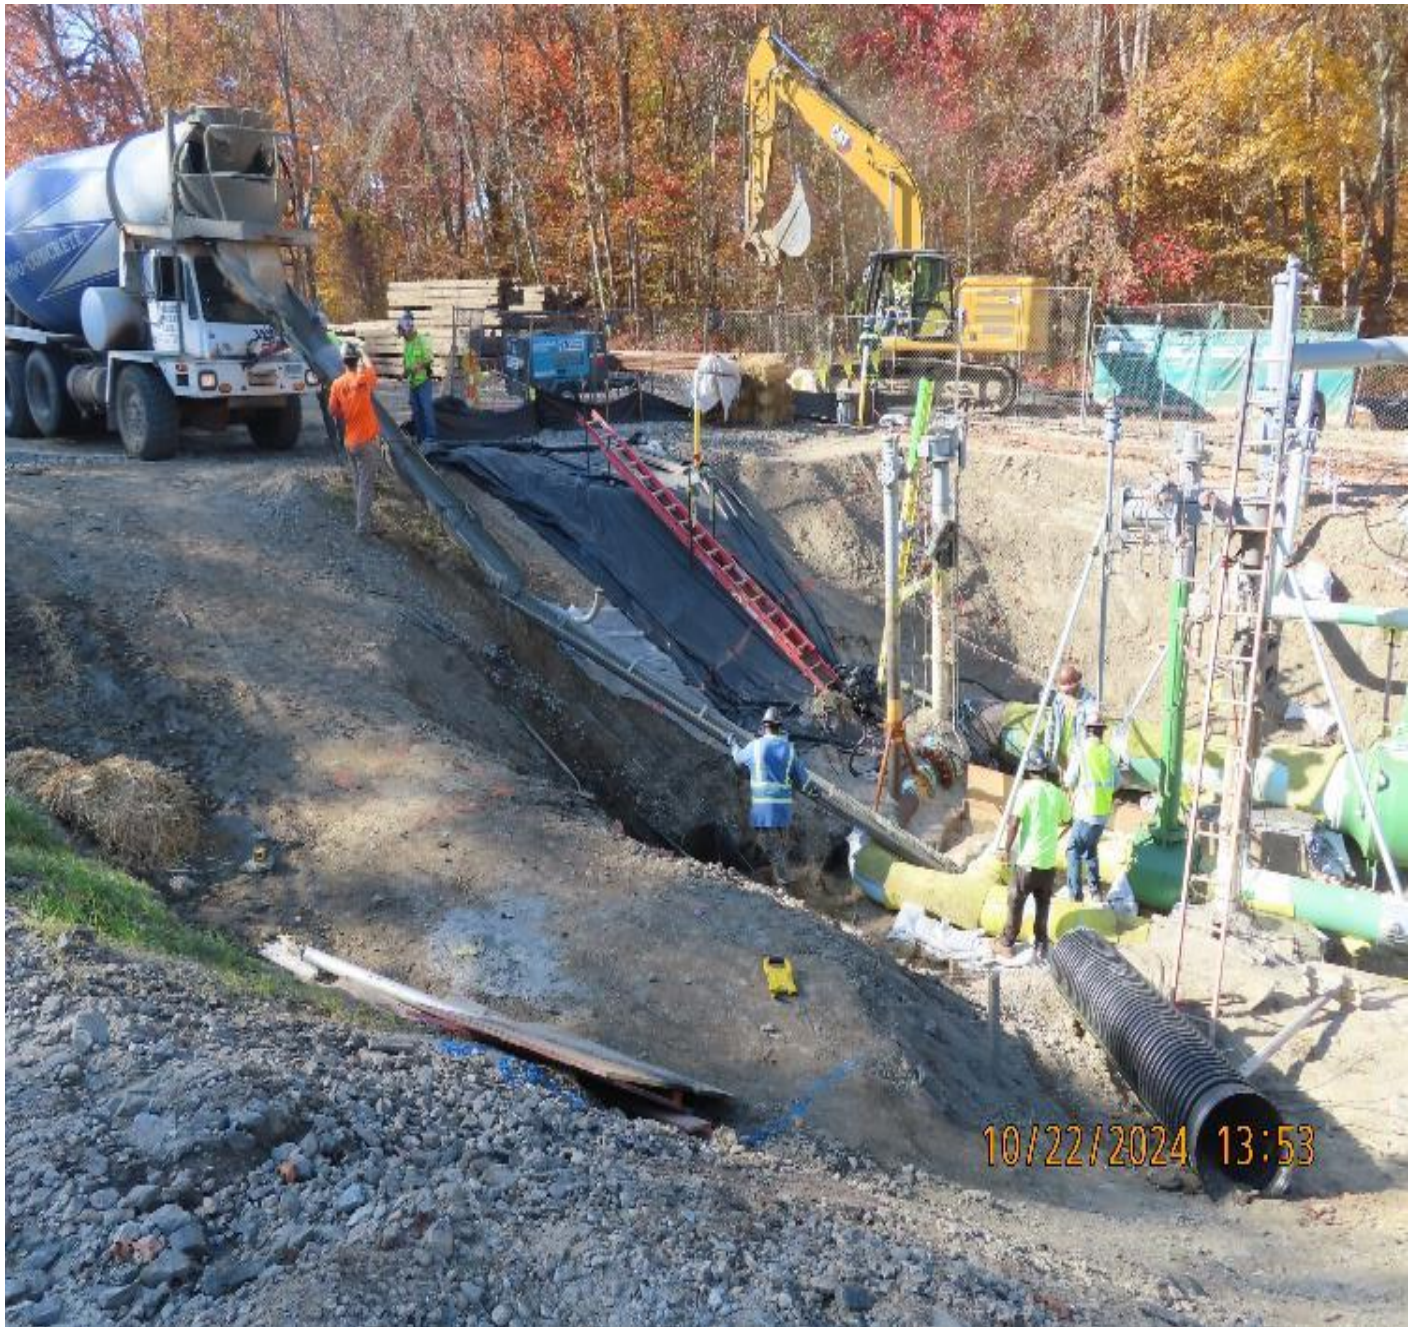
Photo 3: View (looking northwest) of concrete supports being installed in valve yard excavation.

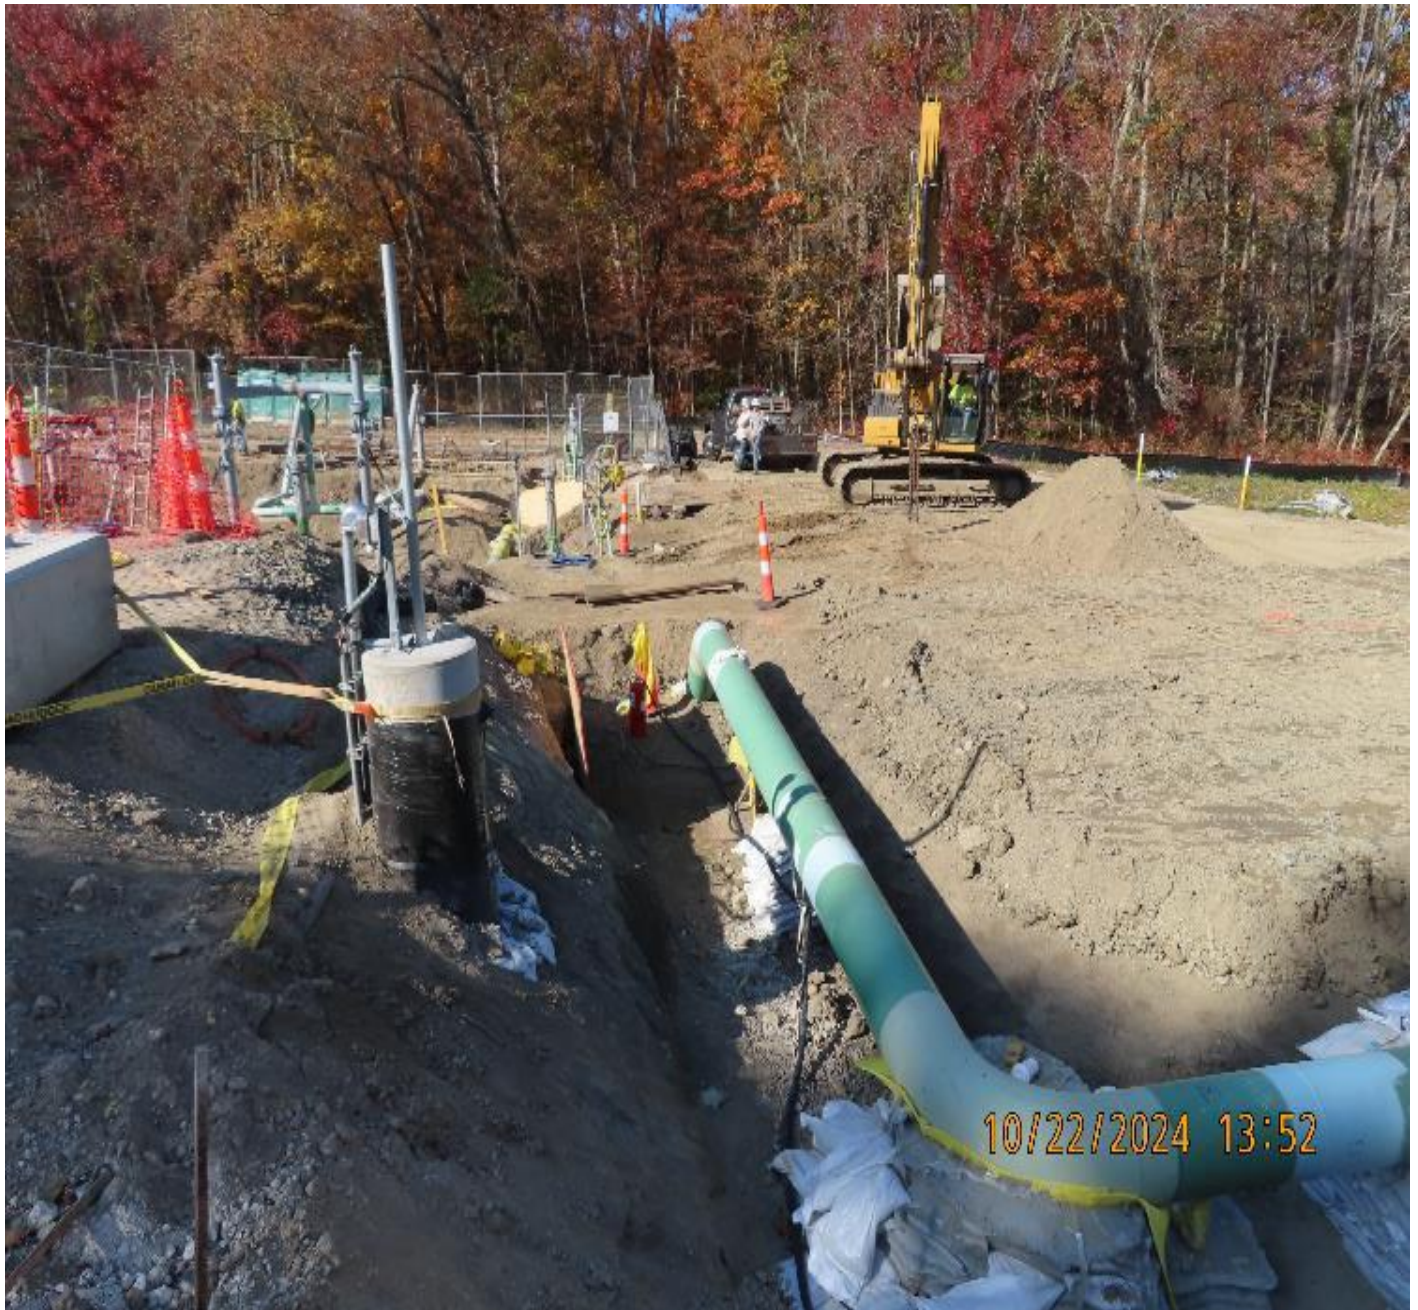
Photo 4: View (looking northwest) of backfill work along 16-inch inlet piping and tie-in point.

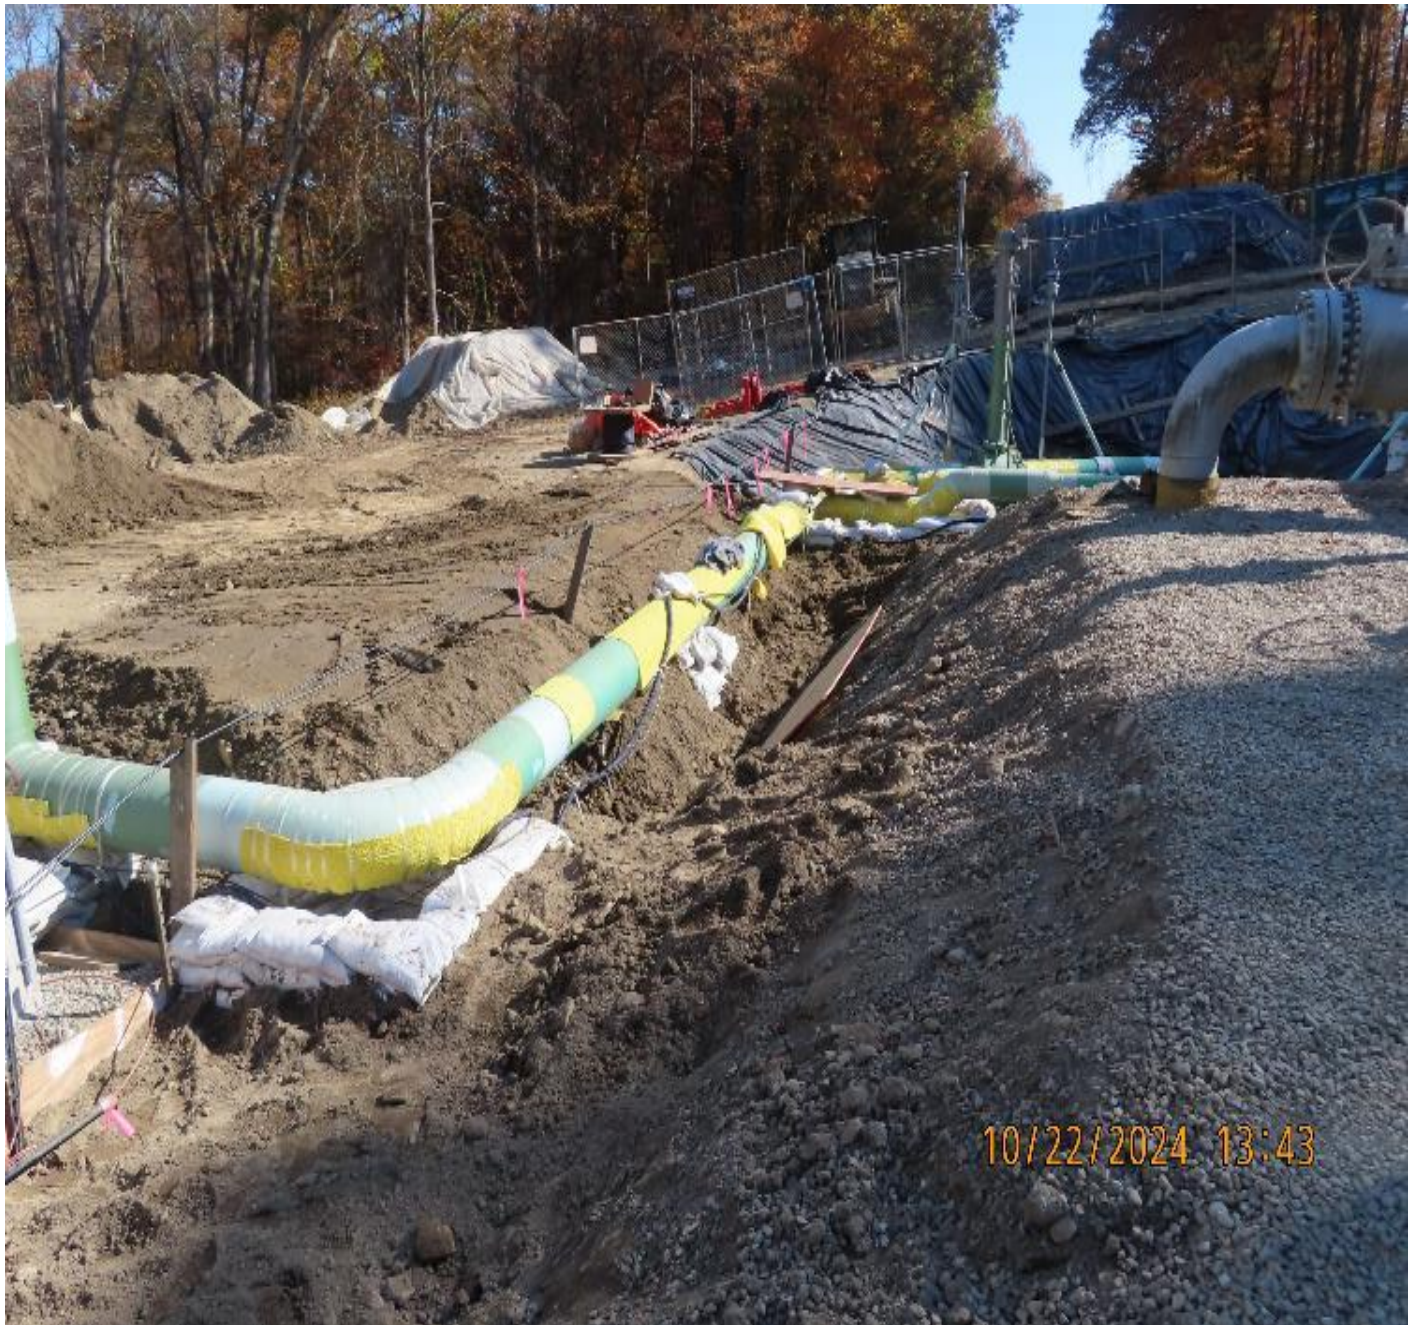
Photo 5: View (looking southeast) of partial backfilling completes along 16-inch outlet piping.

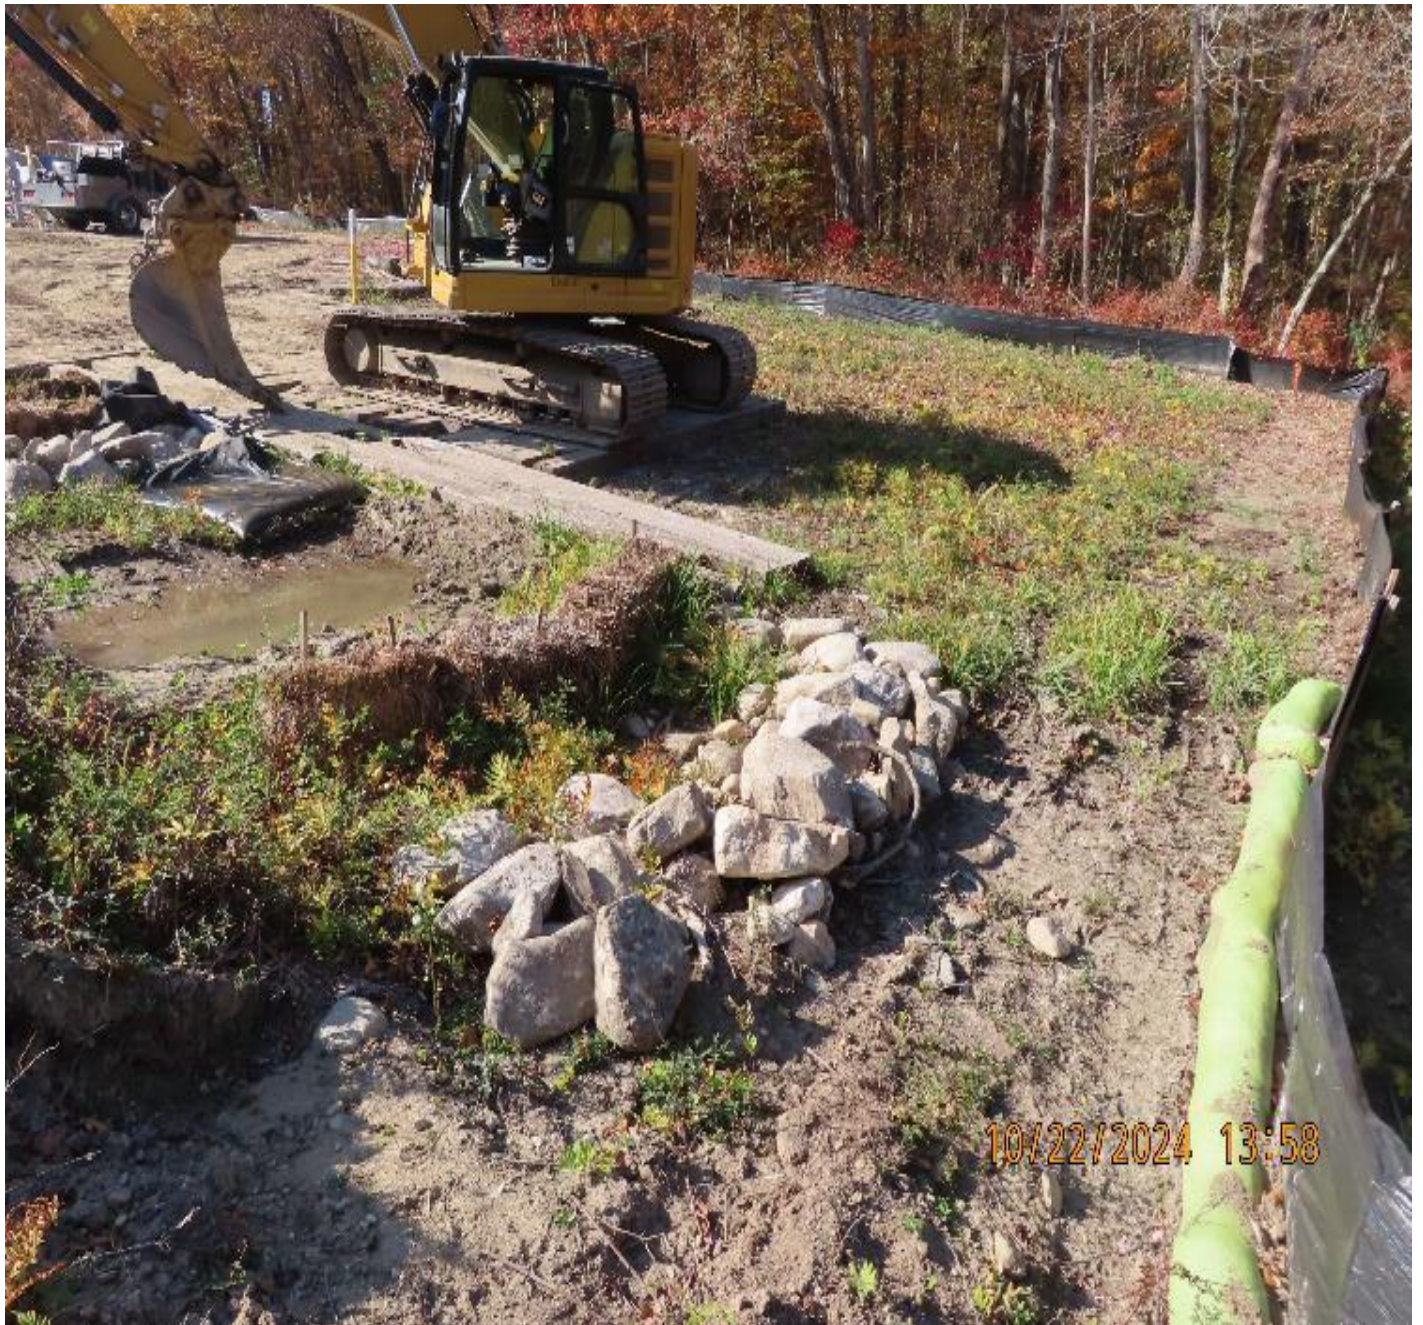
Photo 6: View (looking west) of excavation dewatering discharge area will full ground infiltration.

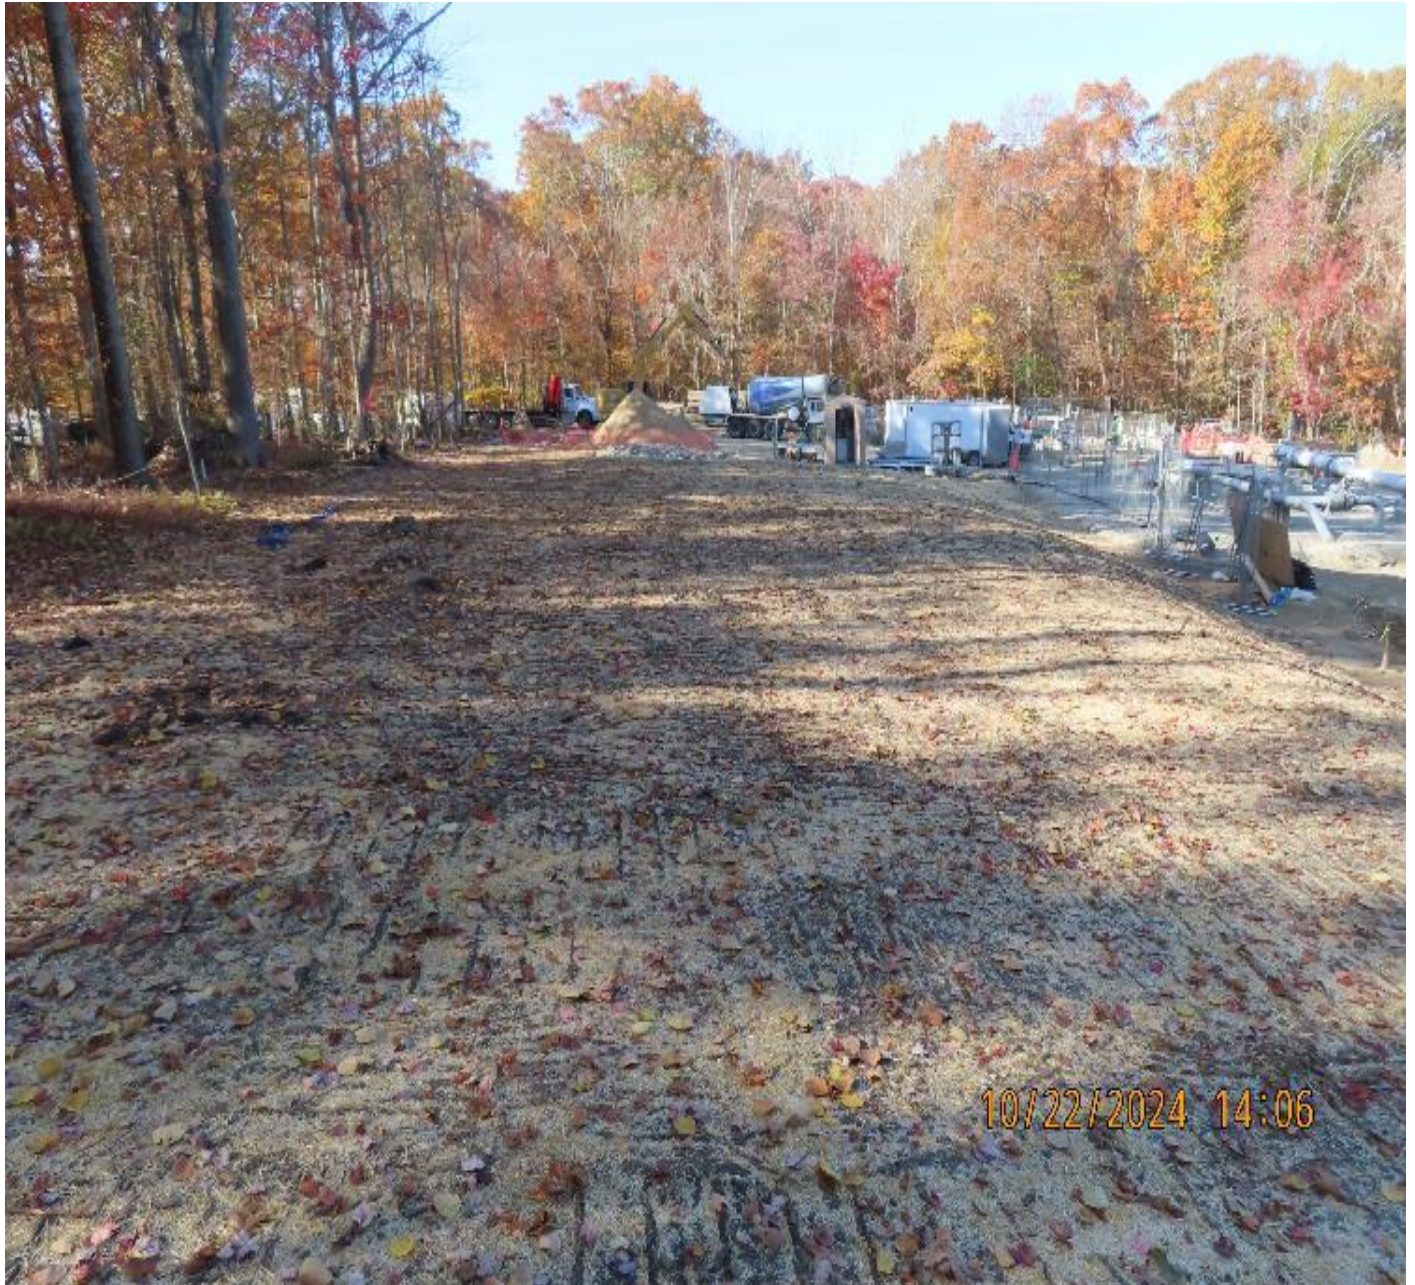
Photo 7: View (looking west) of stabilized soil conditions where construction is complete in southern portion of site.

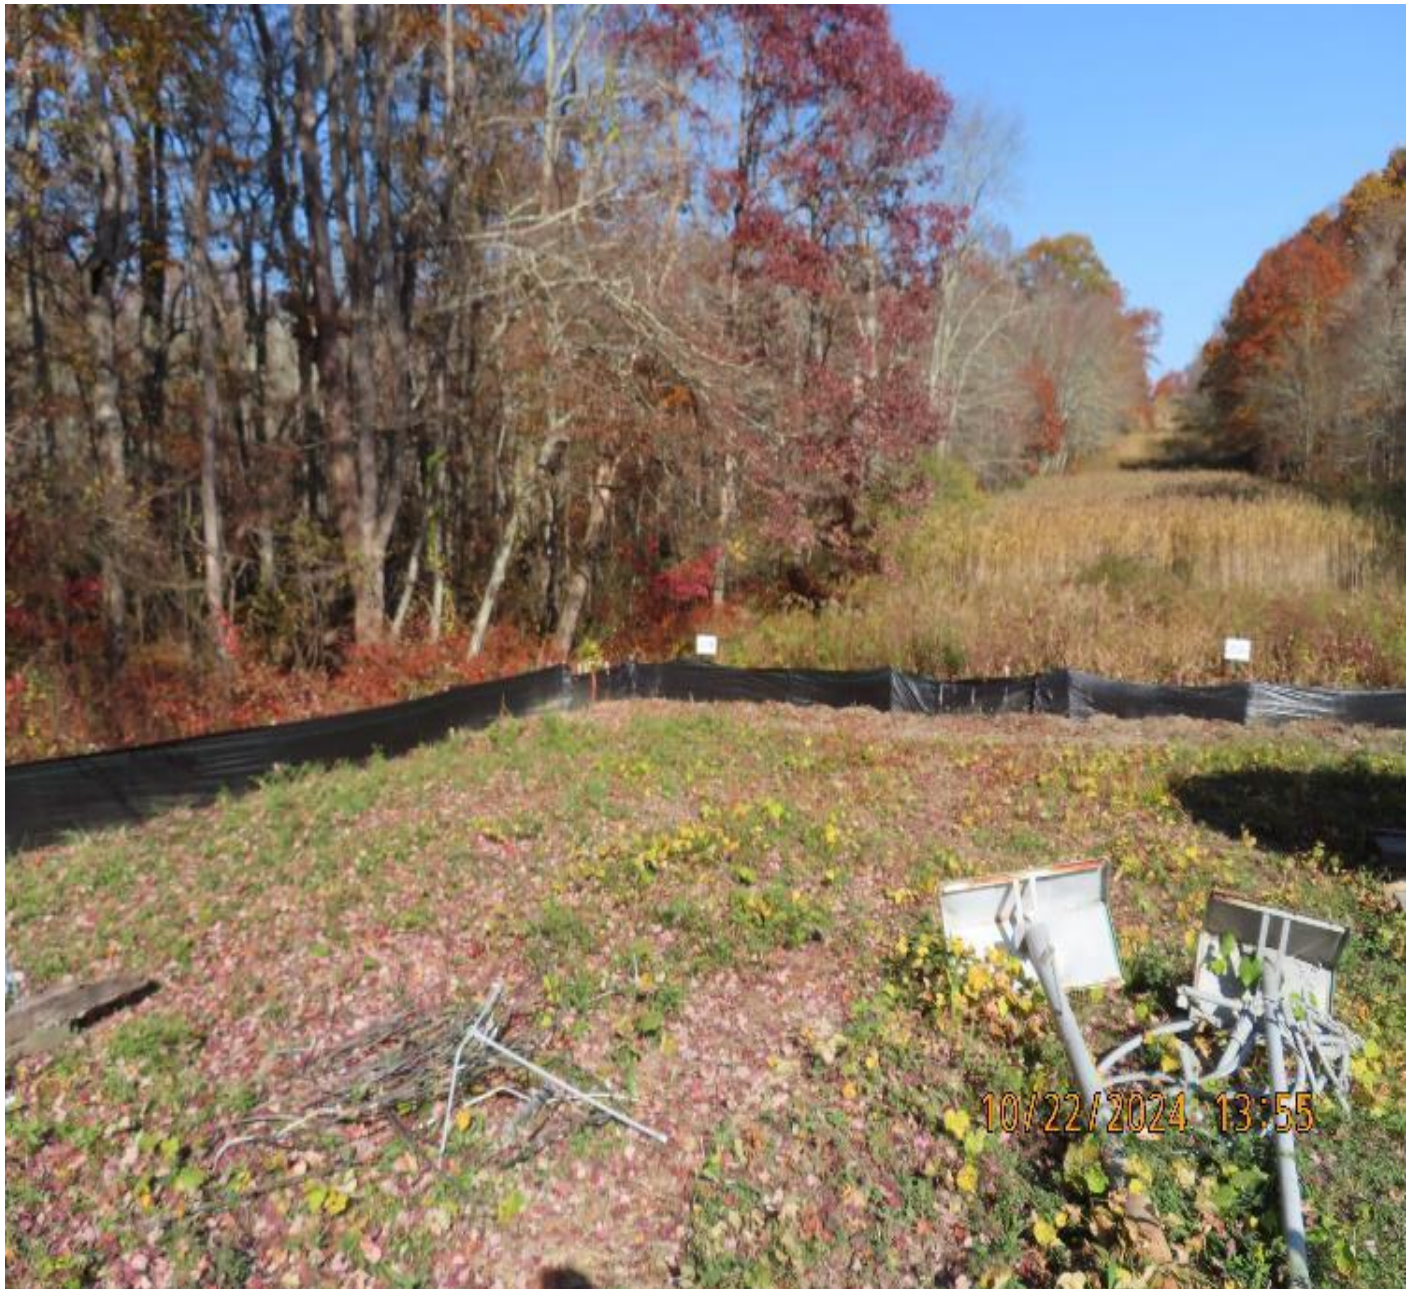
Photo 8: View (looking north) of perimeter ECDs and vegetative buffer protection for wetland W-CZ-01.
