Re: Algonquin Gas Transmission, LLC

E-1 System Regulator Installation Project, Docket No. CP24-21-000

Report No. 16

E-1 System Regulation WEEKLY REPORT #16

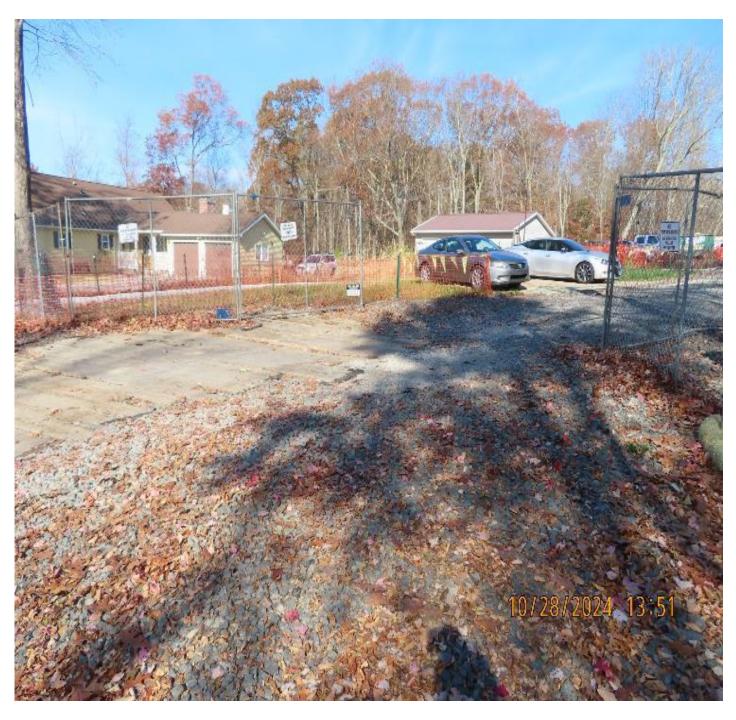
Photo 1: View (looking northwest) of work site entrance off Hop River Road.

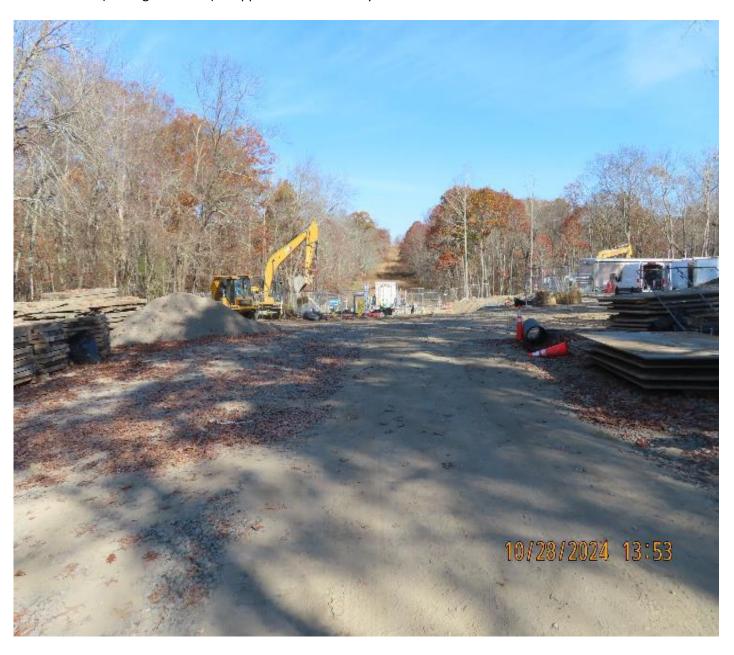
Photo 2: View (looking northeast) of approach to the valve yard work area.

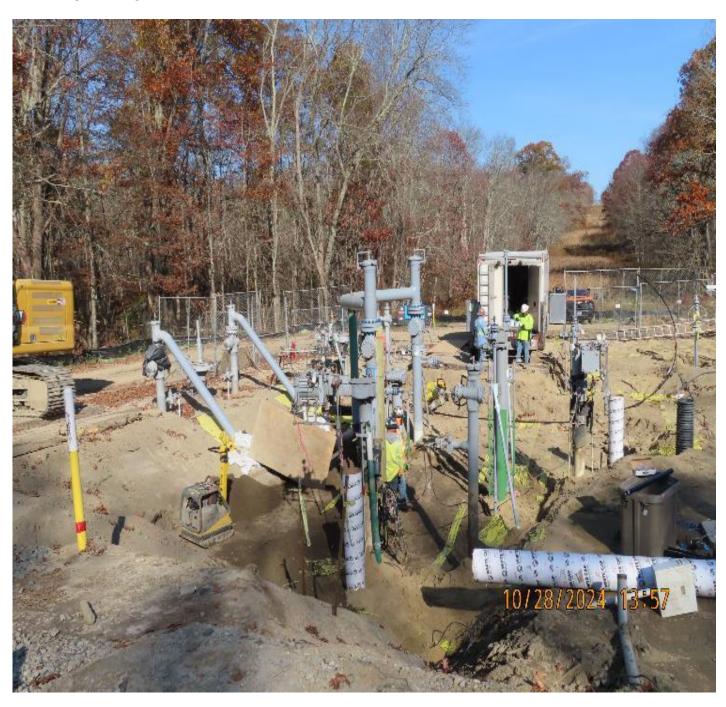
Photo 3: View (looking northeast) of valve yard after backfilling progressed to where excavation dewatering is no longer needed.

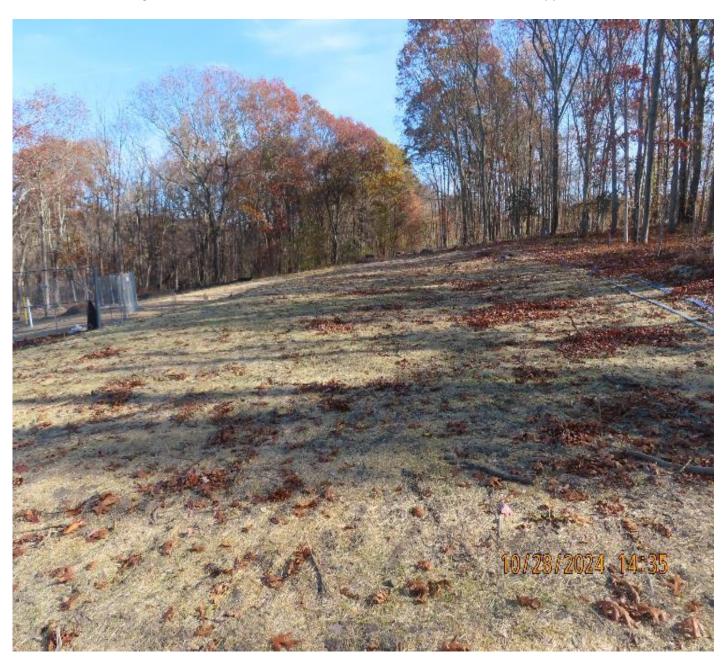
Photo 4: View (looking southeast) of south side of work site after seed and straw mulch application.

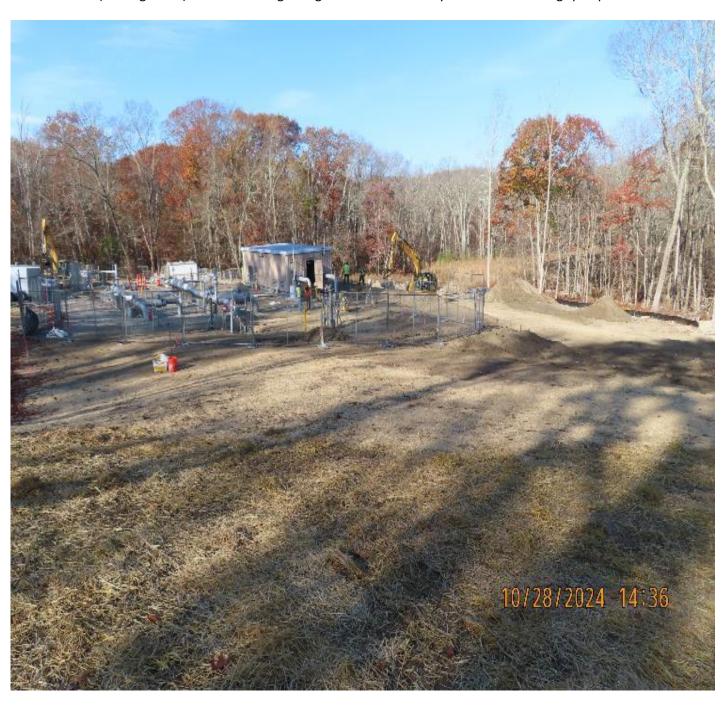
Photo 5: View (looking north) of backfill and grading work around valve yard and diminishing spoil piles.

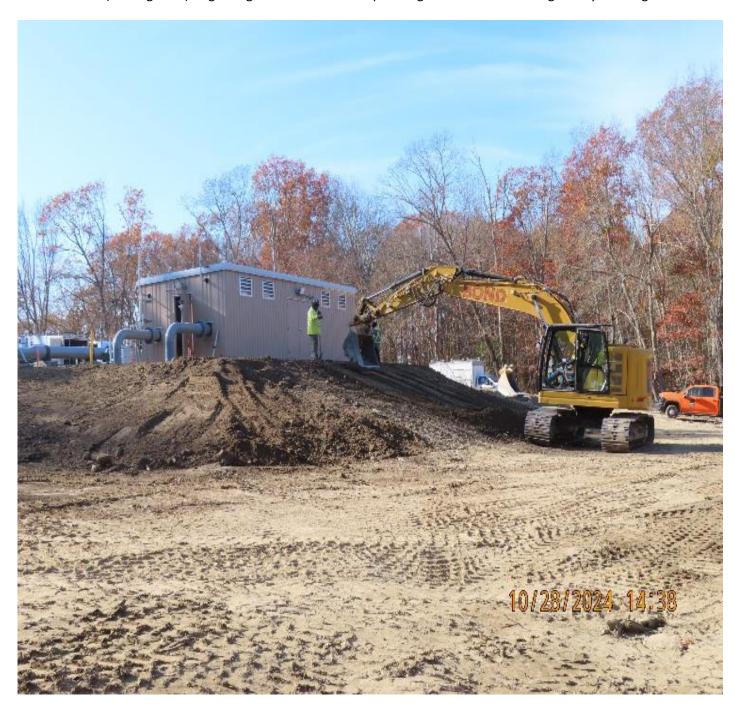
Photo 6: View (looking west) of grading work to contour slope along north side of new regulatory building.

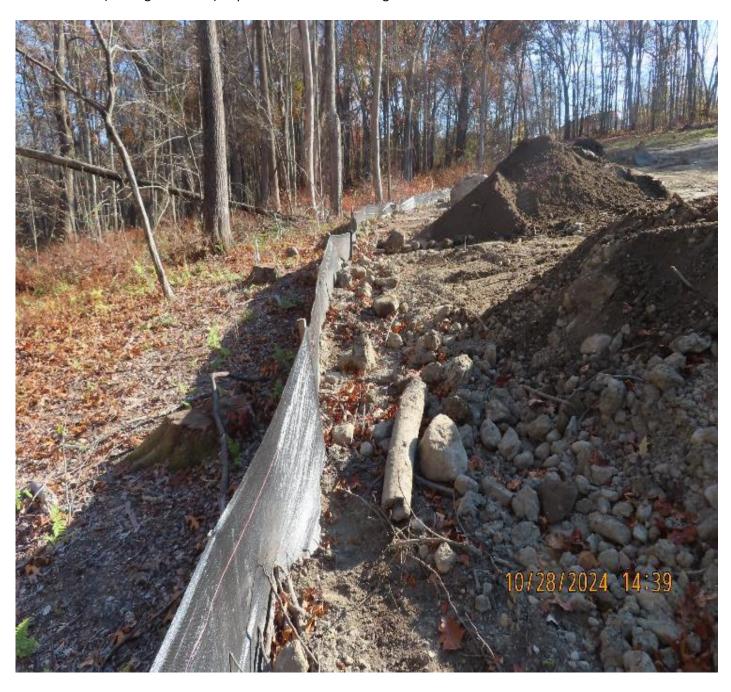
Photo 7: View (looking southeast) of perimeter silt fence along north side of work site.

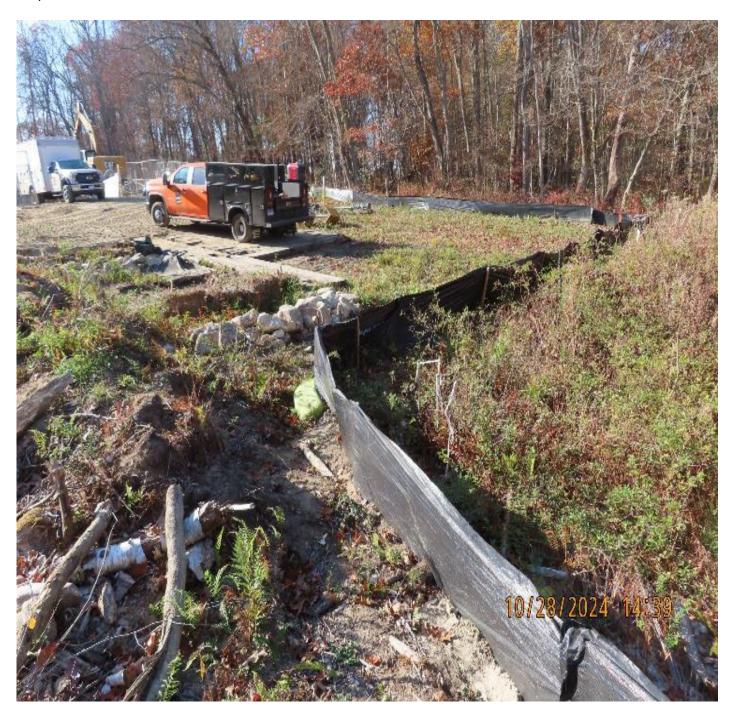
Photo 8: View (looking west) of perimeter silt fence protecting wetland W-CZ-01 (northeast corner of work site)
