Re: *Algonquin Gas Transmission, LLC*
E-1 System Regulator Installation Project, Docket No. CP24-21-000
Report No. 17

**E-1 System Regulation
WEEKLY REPORT #17**

Project:	E-1 System Regulation
FERC Docket Number:	CP24-21-000
Report Number:	17
Reporting Period:	October 31 through November 6, 2024

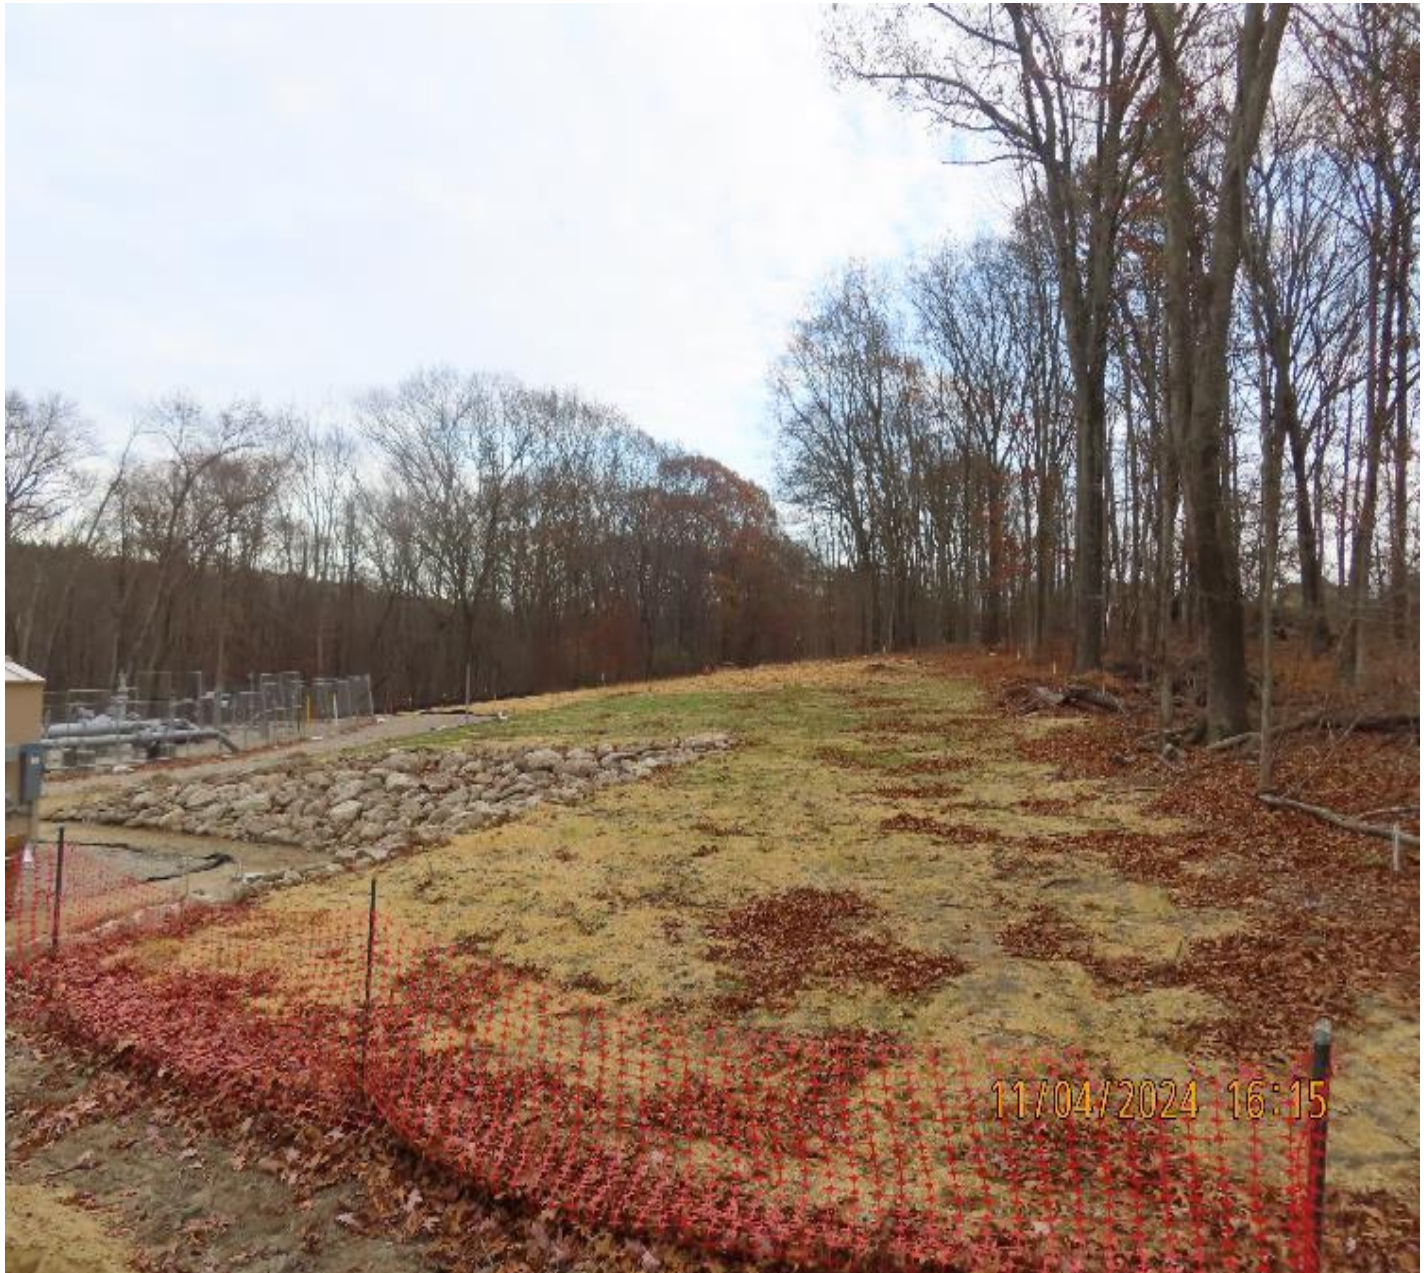
Photo 1: View (looking southeast) of stabilized conditions in south portion of the work site.

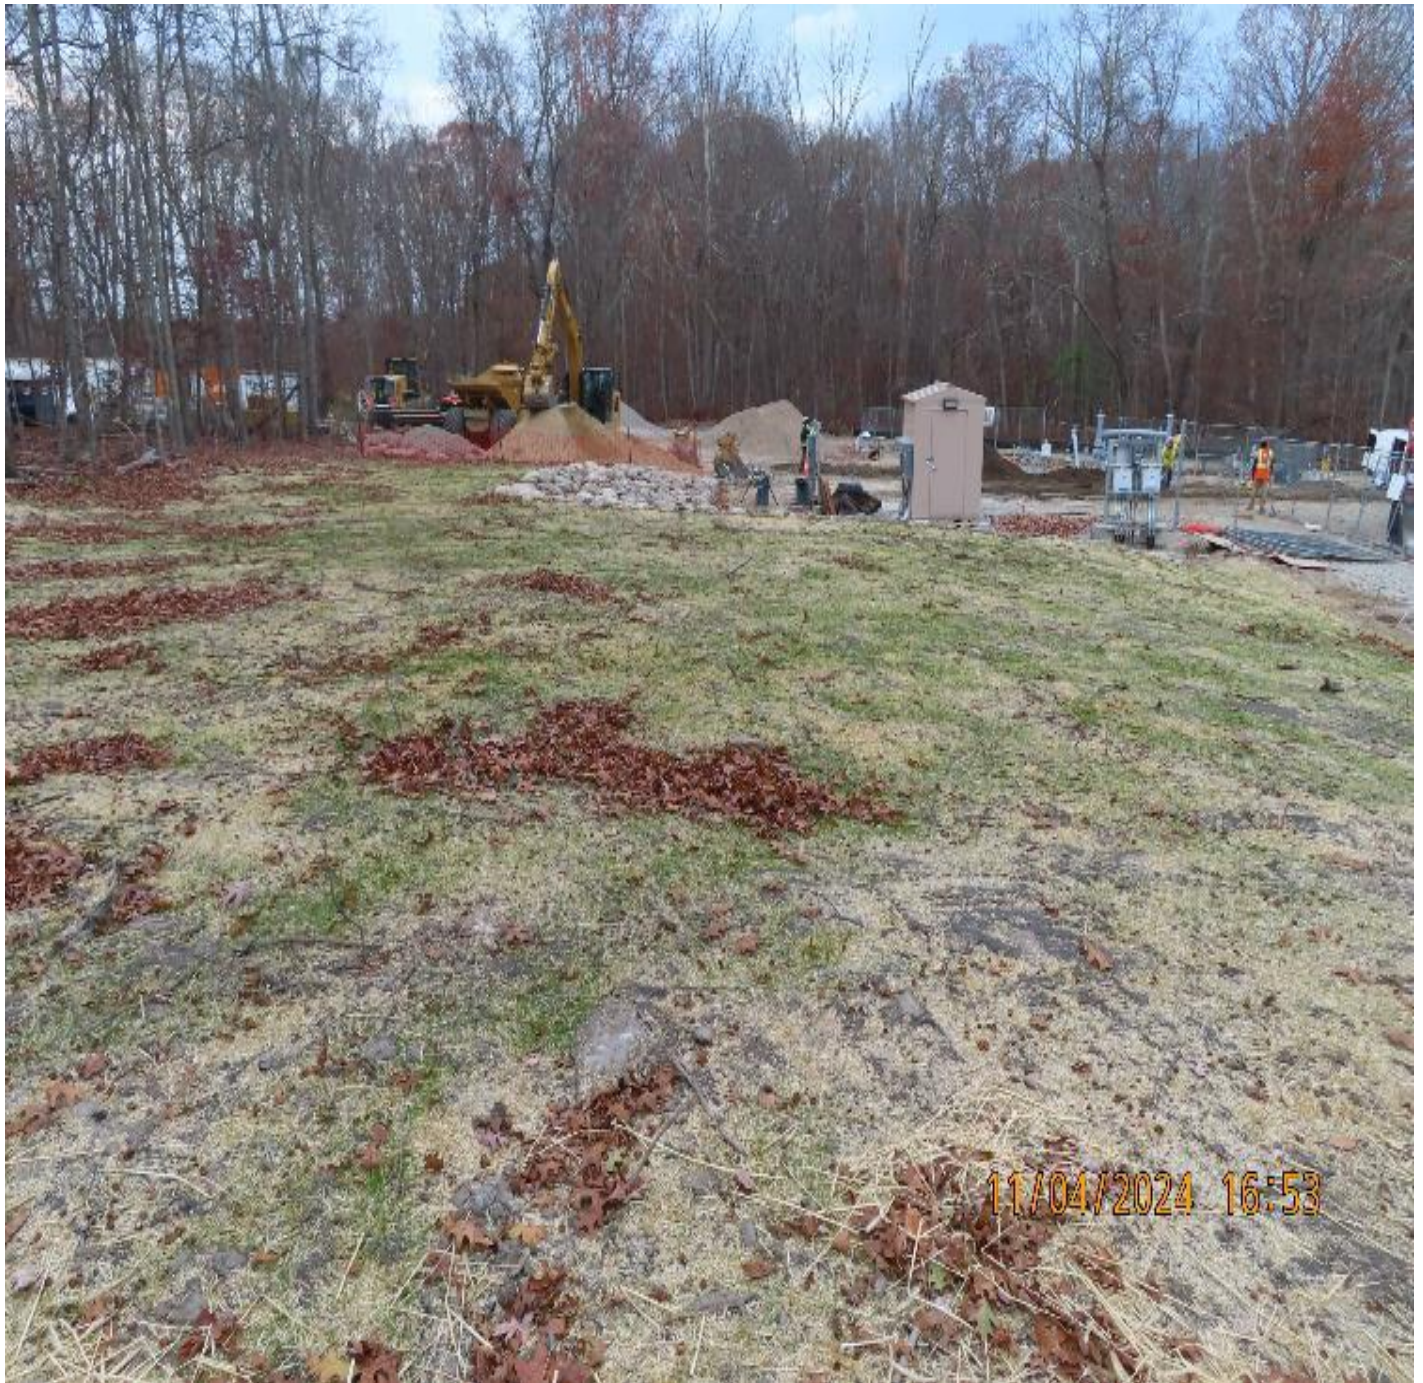
Photo 2: View (looking northwest) of grass germination progress in south portion of the work site.

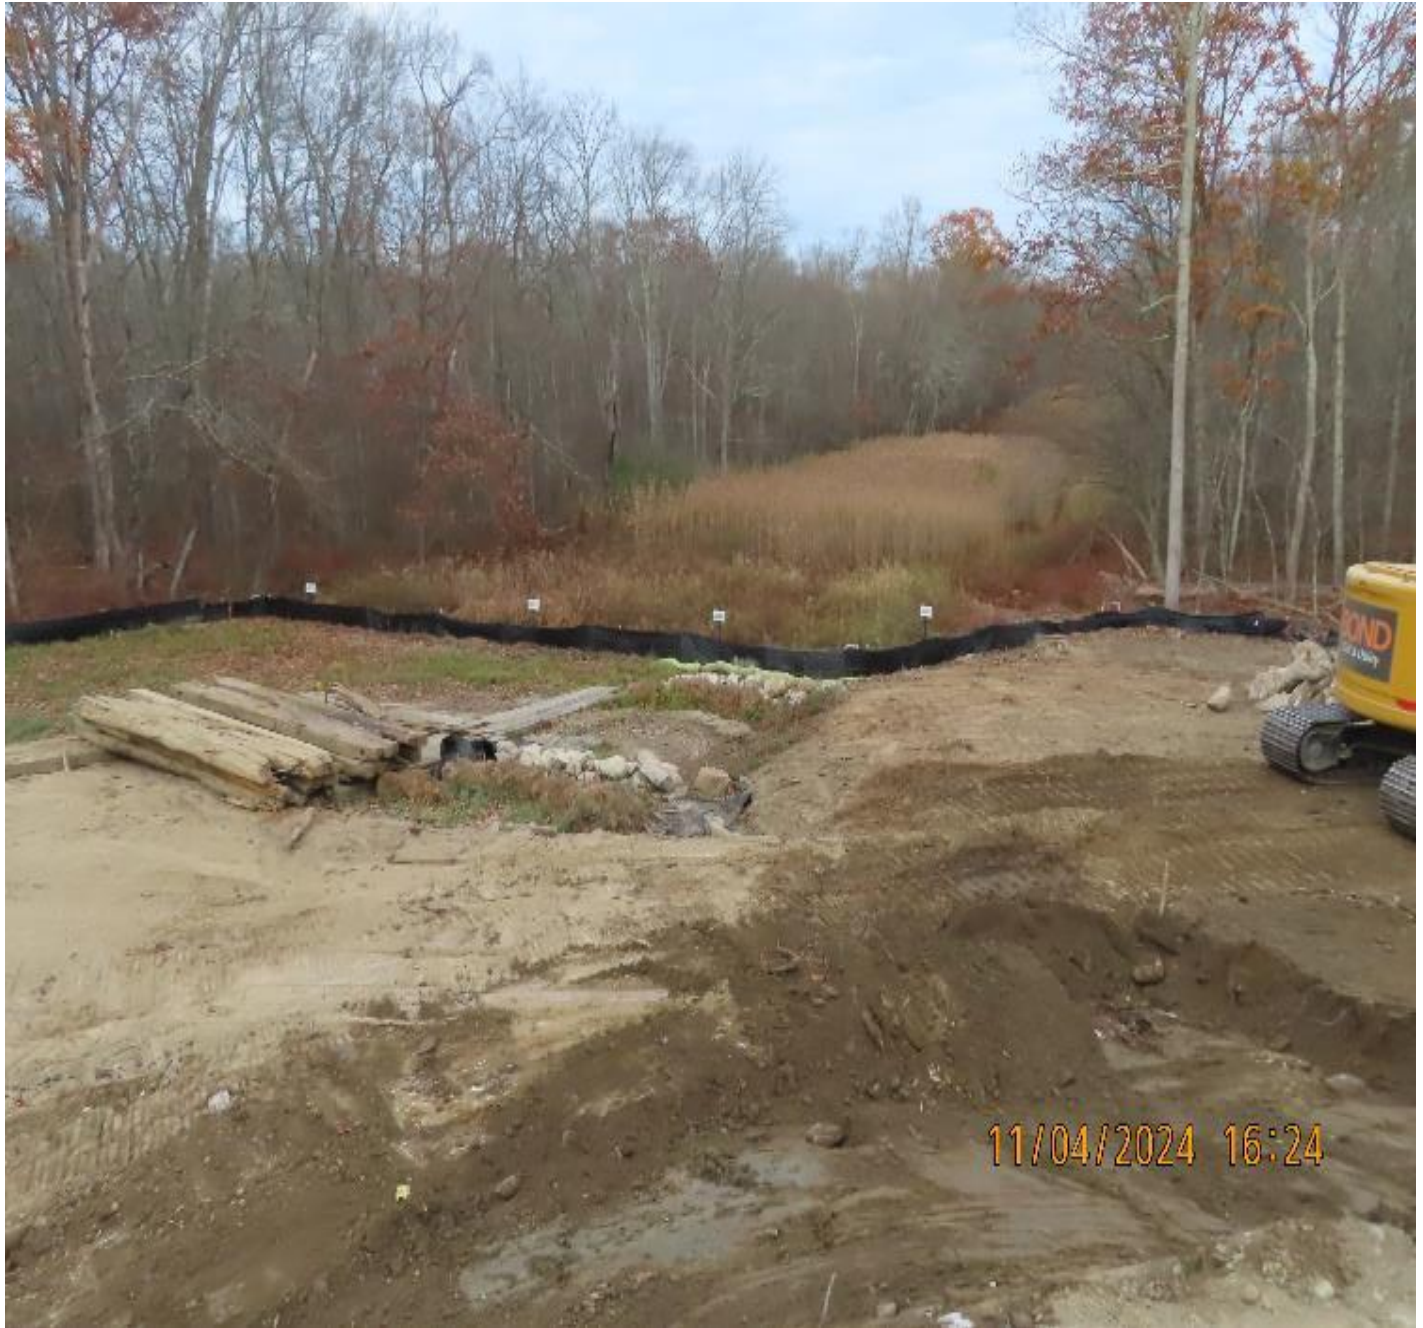
Photo 3: View (looking northeast) of clean-up work underway as mats are removed and final grading is completed near the north boundary of the work site.

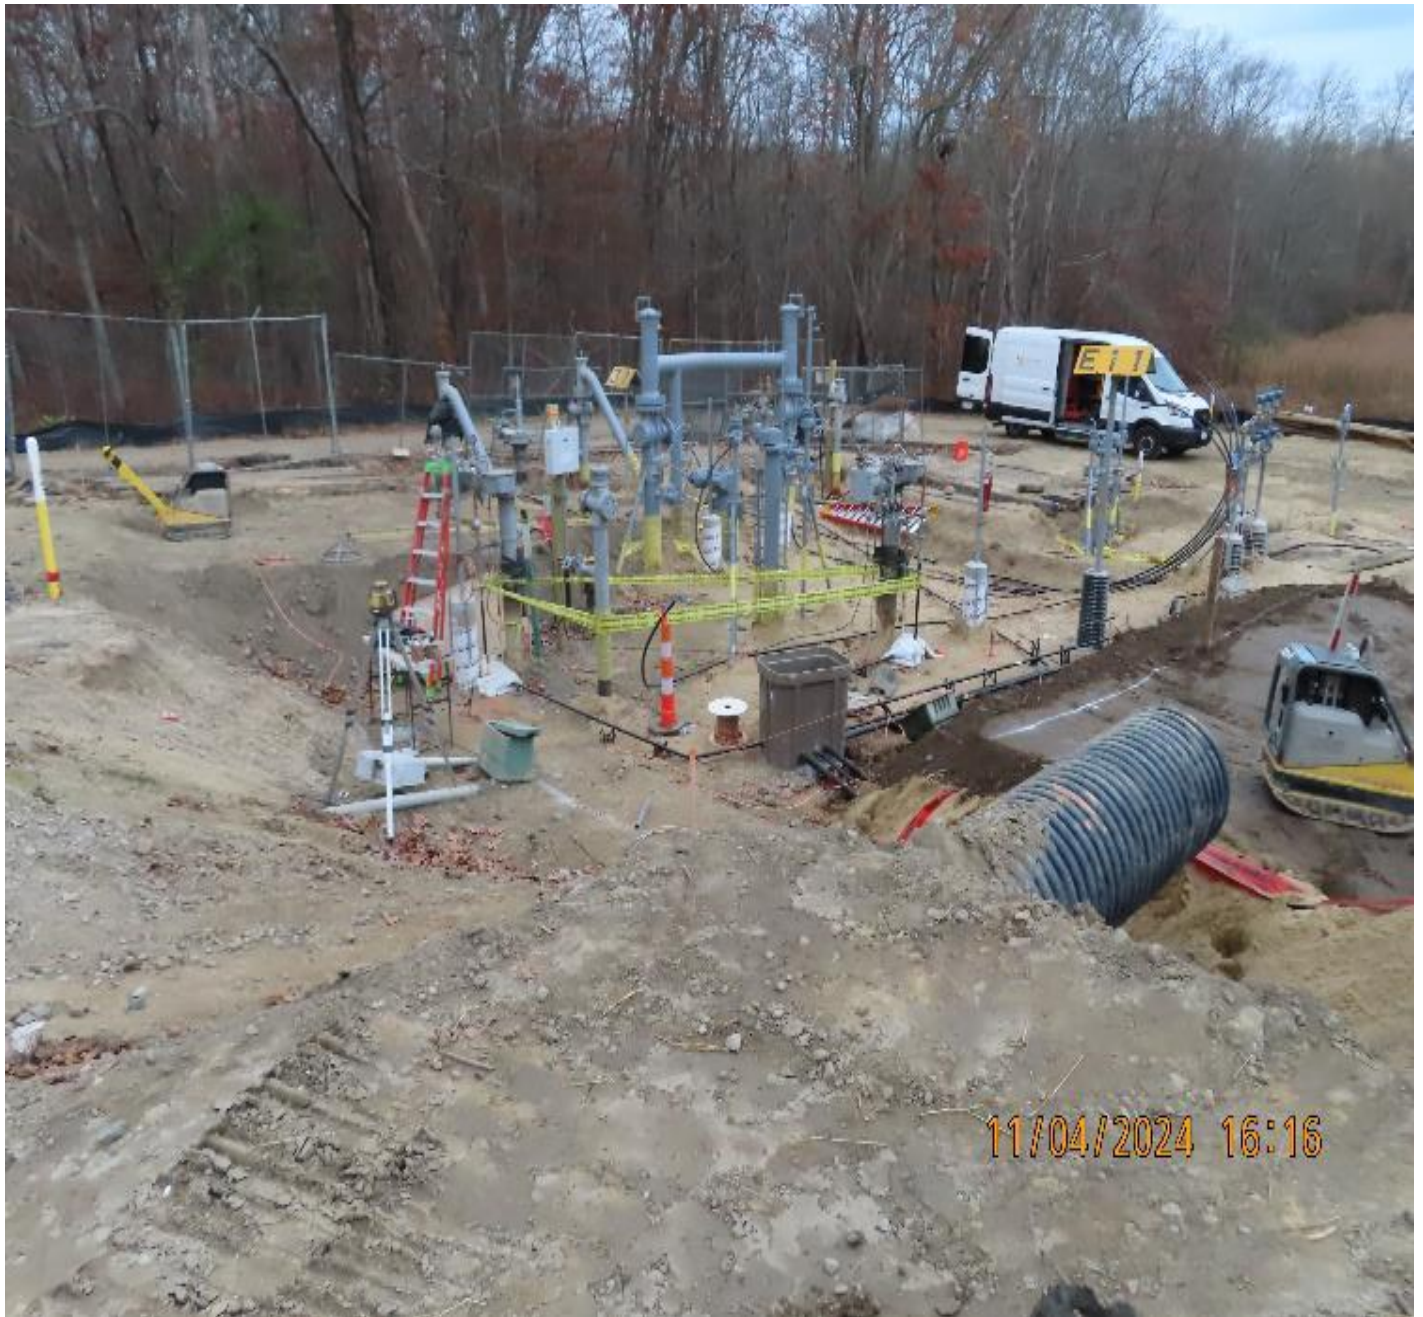
Photo 4: View (looking northwest) of backfilling and grading progress in the valve yard.

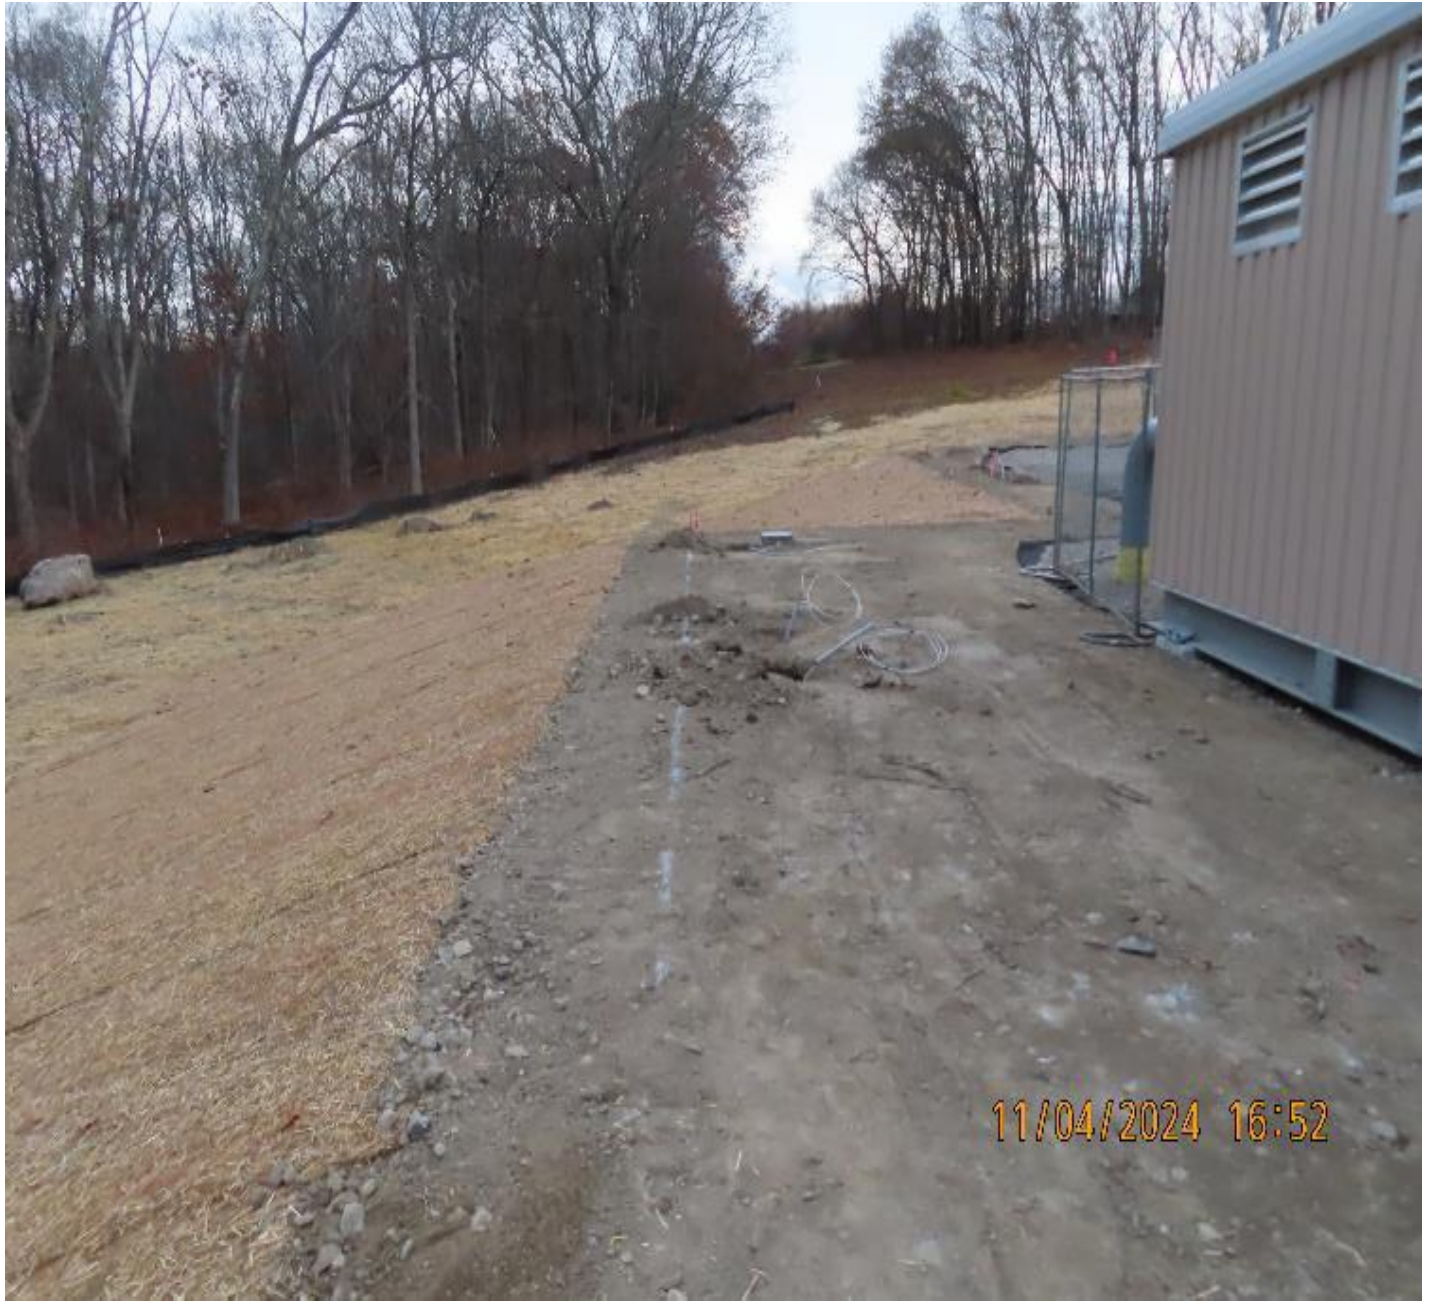
Photo 5: View (looking southeast) of sloped area restored with erosion control blanket north of the new regulator building.

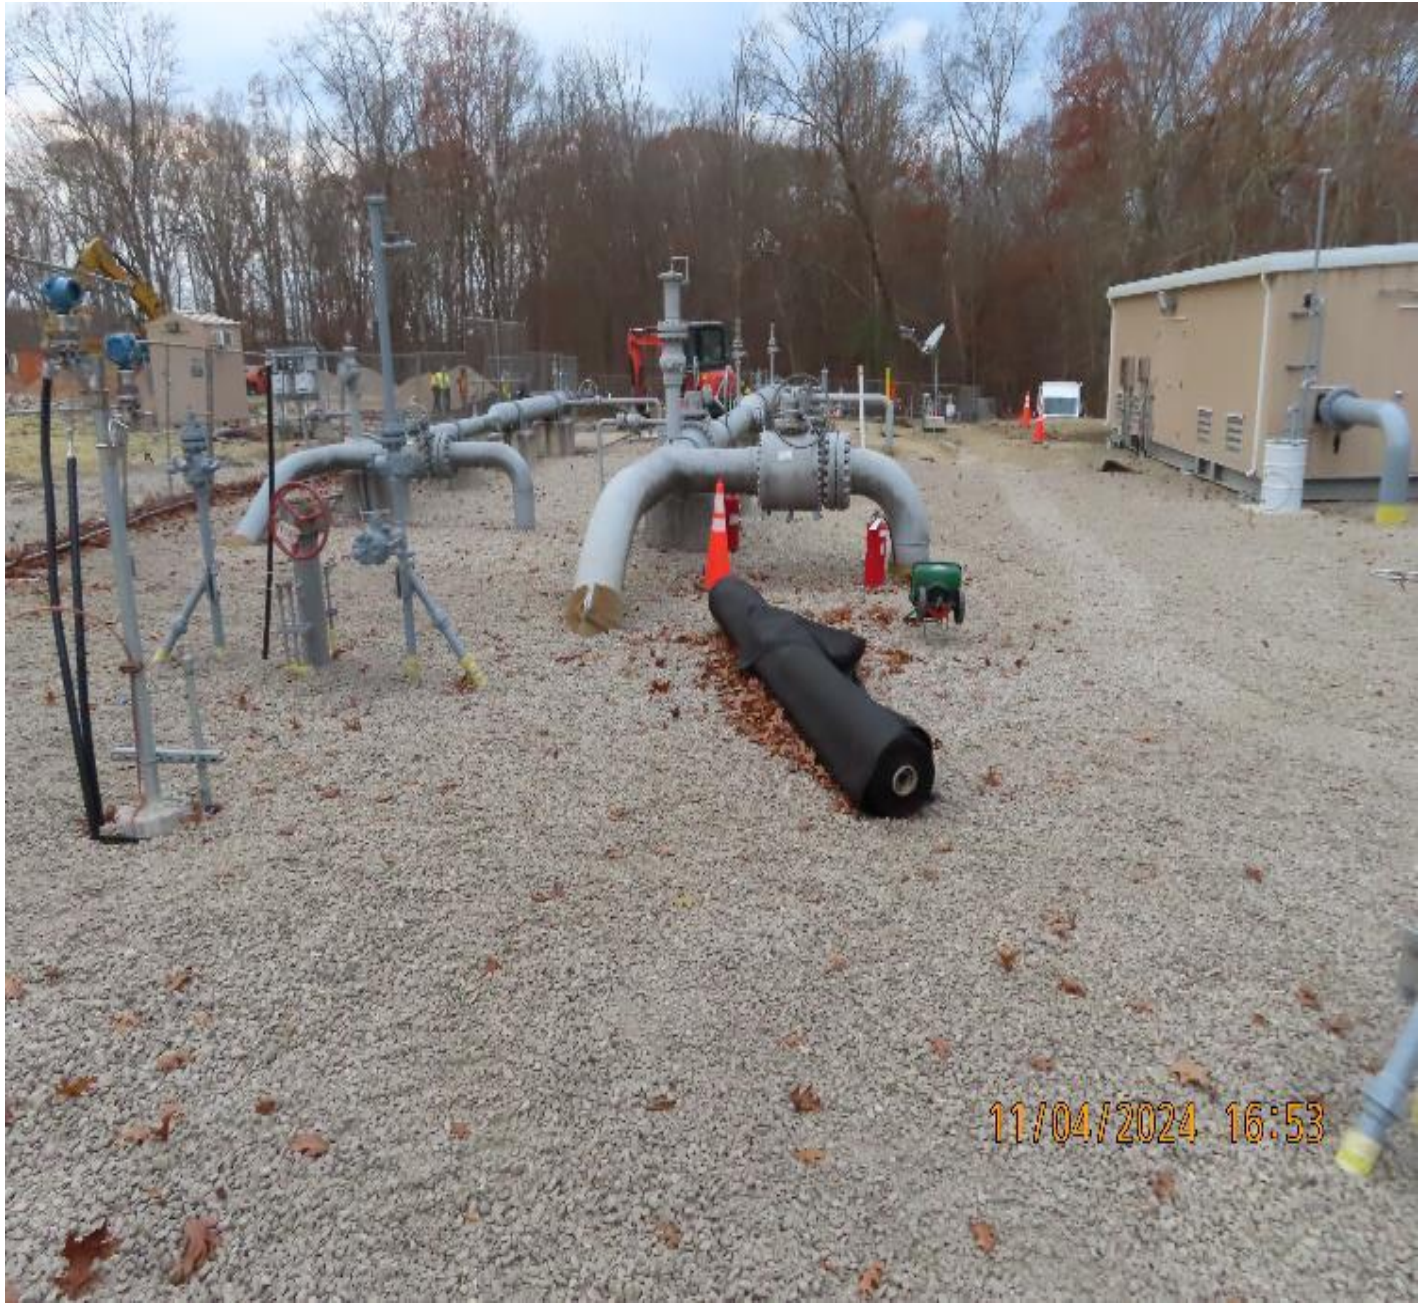
Photo 6: View (looking northwest) of former E-System tie-in excavations after backfilling, final grading, and surface gravel installation.

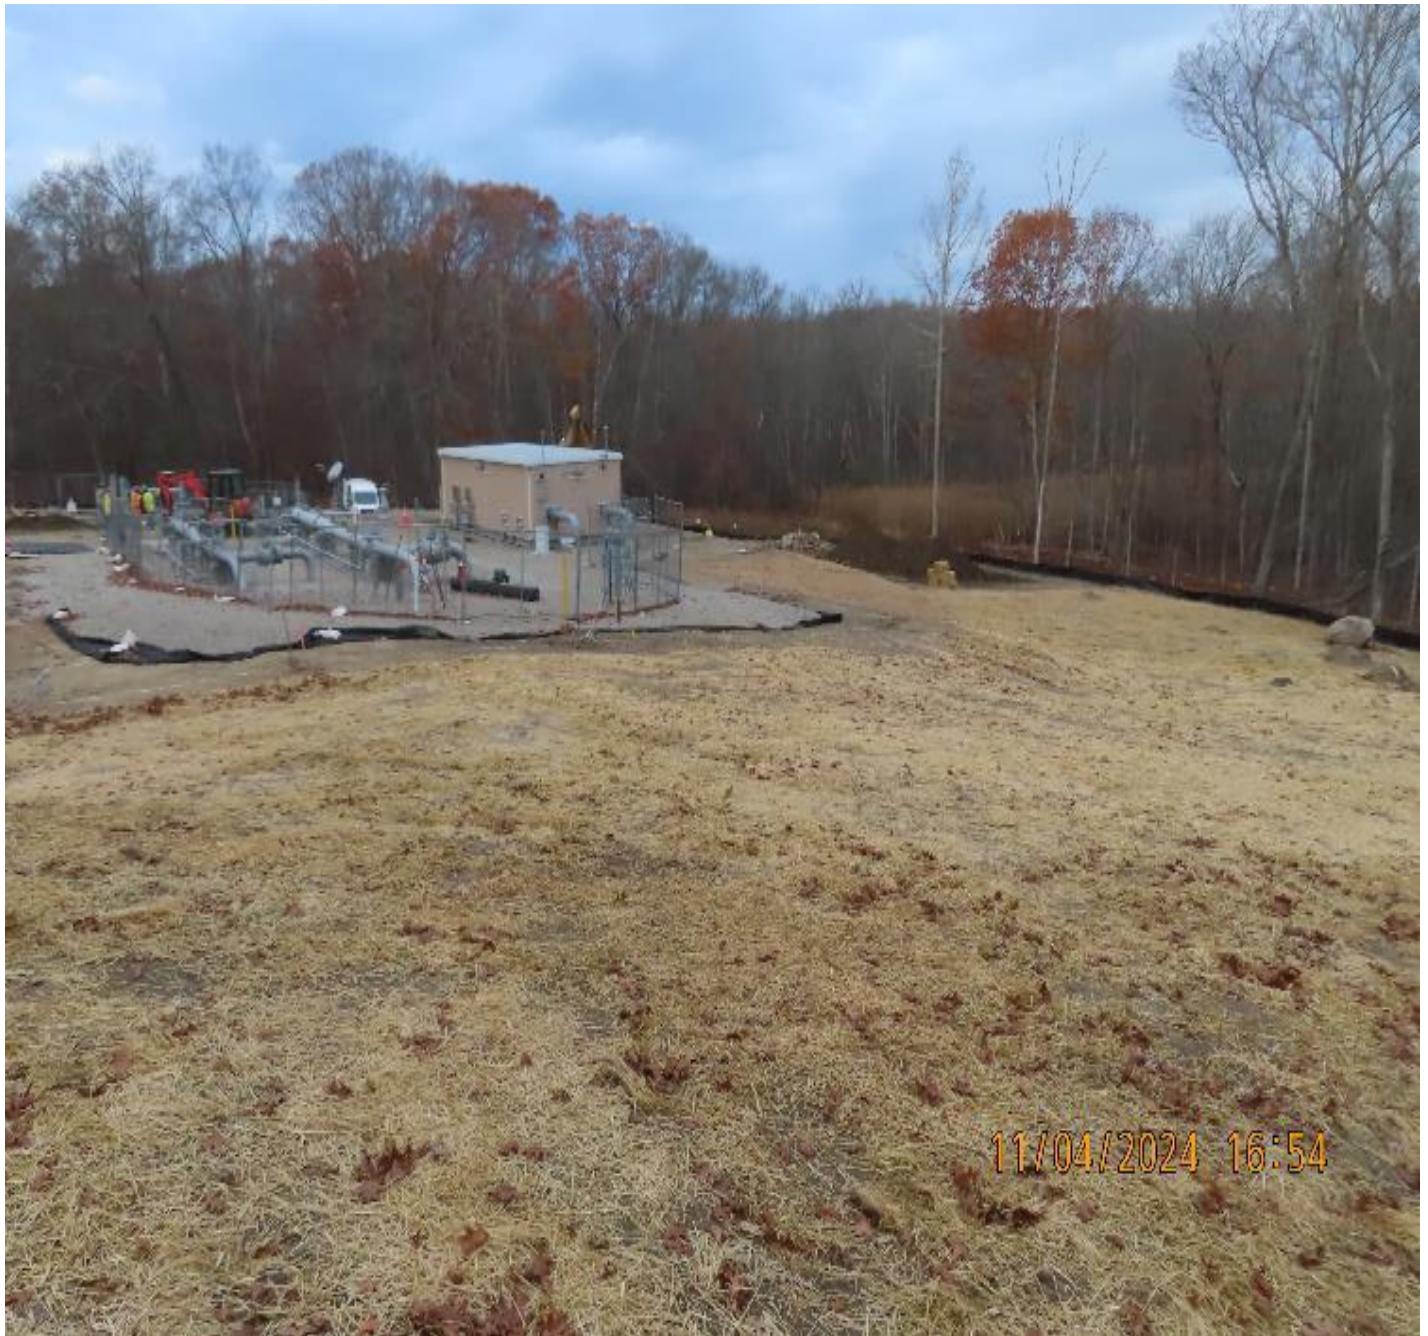
Photo 7: View (looking northwest) of stabilized areas east of the new regulator building.

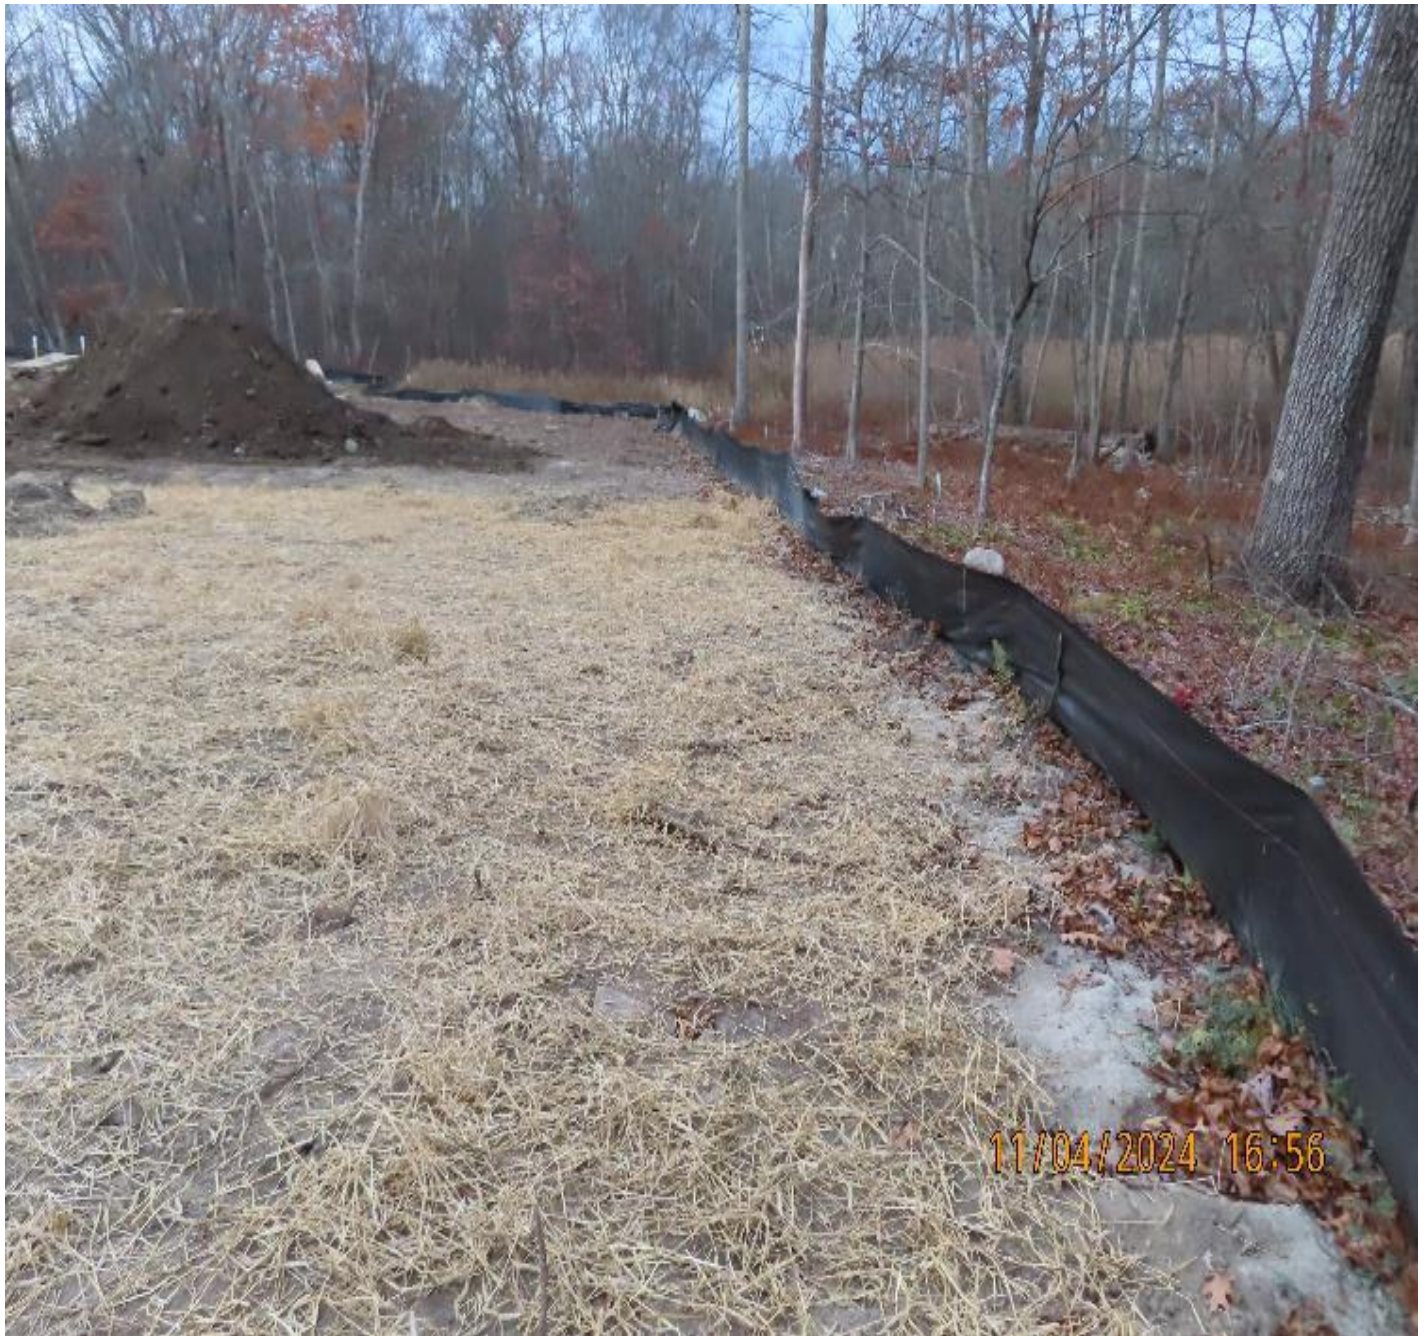
Photo 8: View (looking northwest) of perimeter silt fence downslope of northern portions of the work site.
