Re: Algonquin Gas Transmission, LLC

E-1 System Regulator Installation Project, Docket No. CP24-21-000

Report No. 18

# E-1 System Regulation WEEKLY REPORT #18

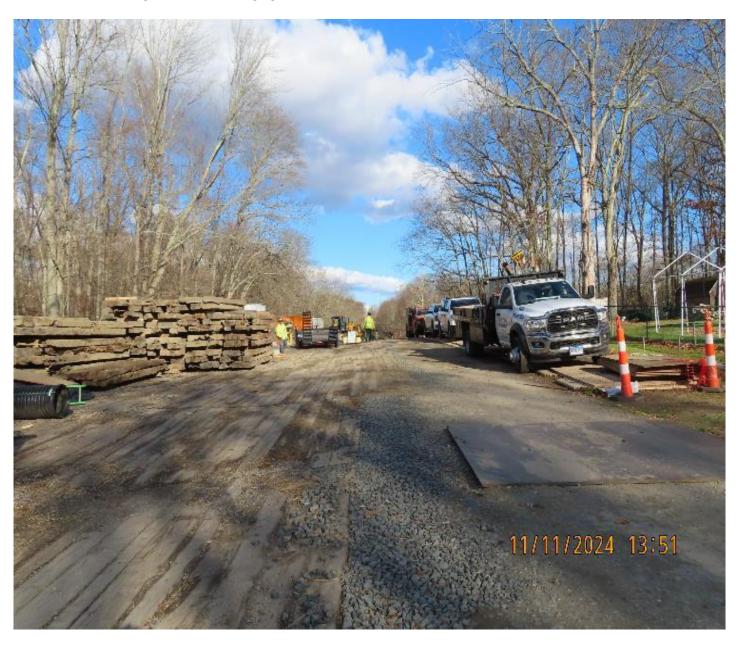
**Photo 1:** View (looking northeast) of staging area.

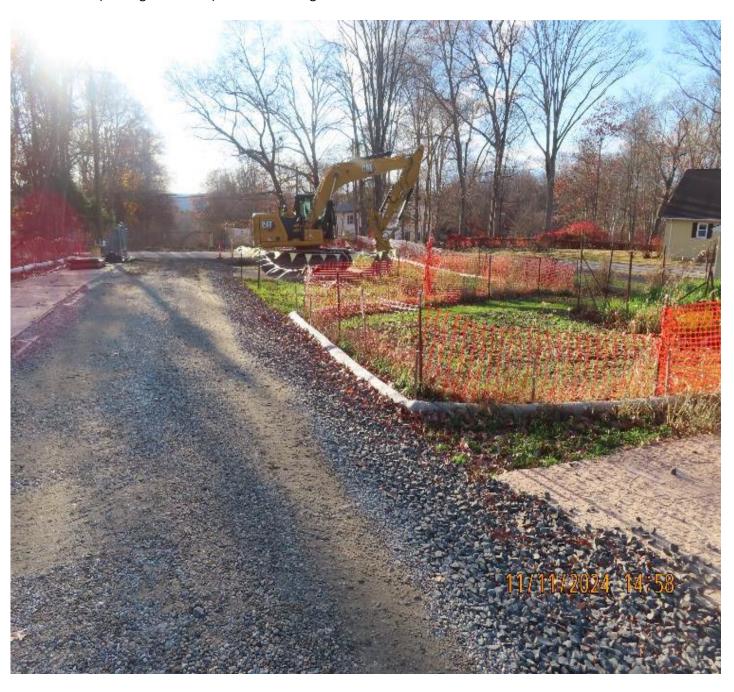
**Photo 2:** View (looking southwest) of access through residential area.

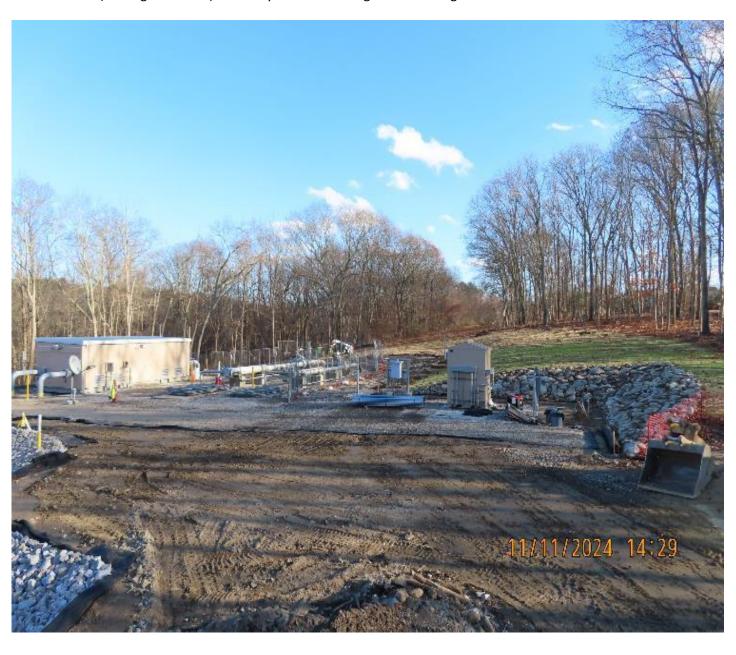
**Photo 3:** View (looking southeast) of valve yard and new regulator building.

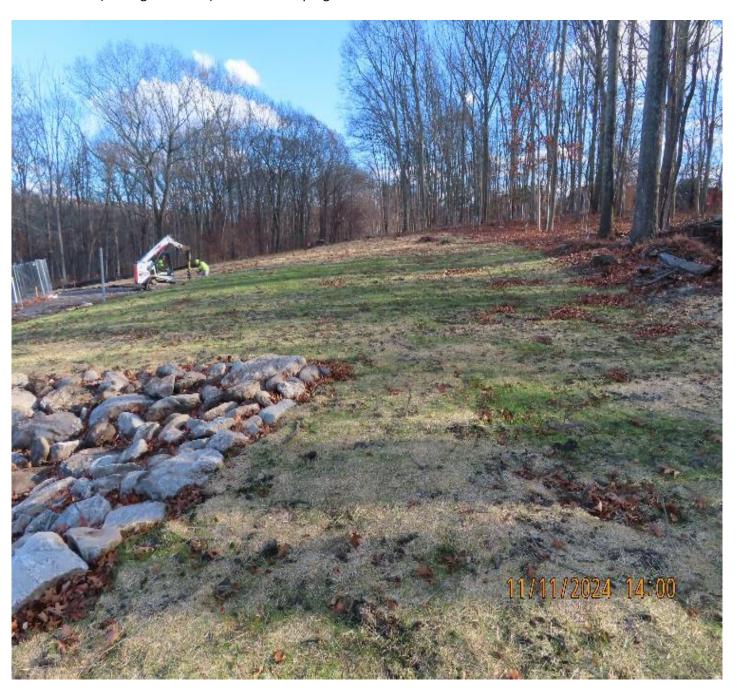
**Photo 4:** View (looking southeast) of restoration progress in southern areas of the worksite.

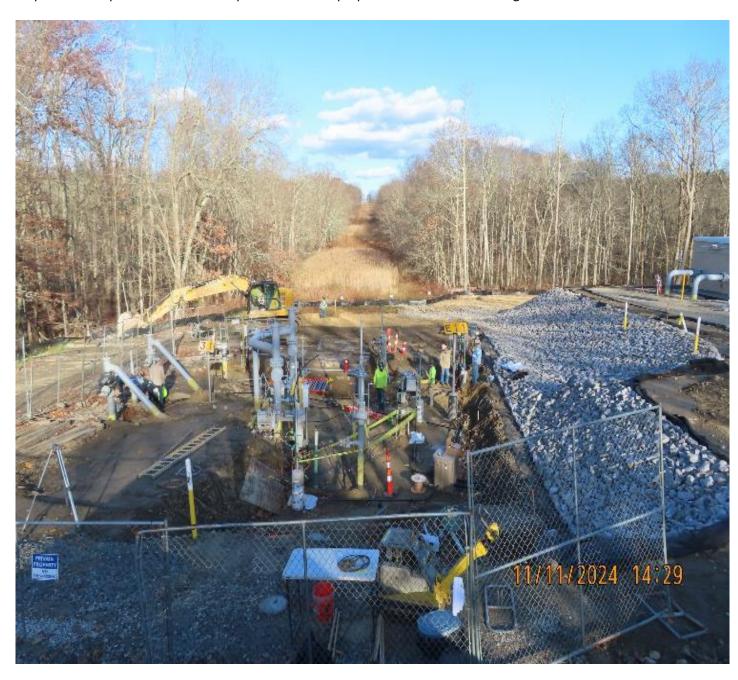
**Photo 5:** View (looking northeast) of valve yard area where backfilling and grading work is approximately 90 percent complete. Note culvert replacement and riprap installation in the drainage swale.

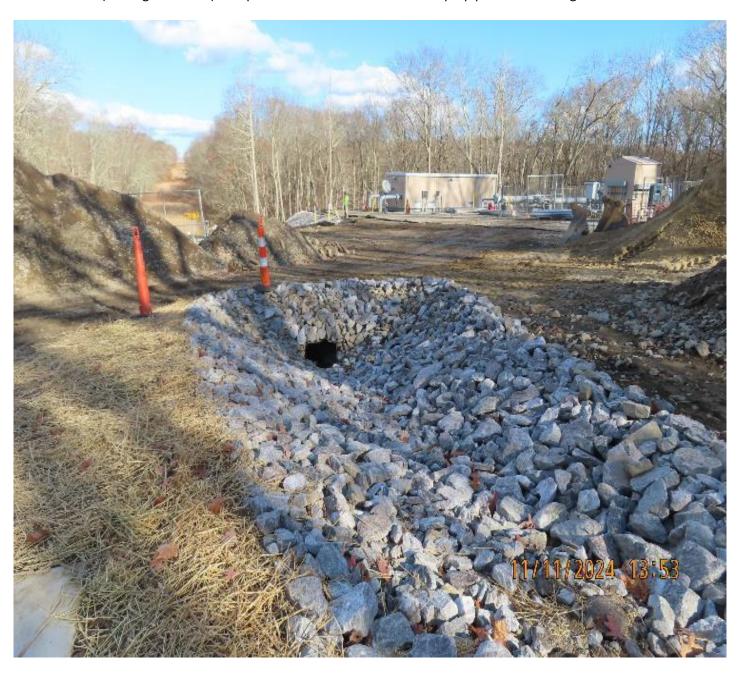
- Installed riprap along slopes near regulator building and other sloped areas according to the approved design.
- Re-installed 24-inch culvert in swale between valve yard and new RTU building. Installed riprap armoring where needed for long-term erosion control.

**Photo 6:** View (looking northeast) of replaced 24-inch culvert and new riprap placed in drainage swale.

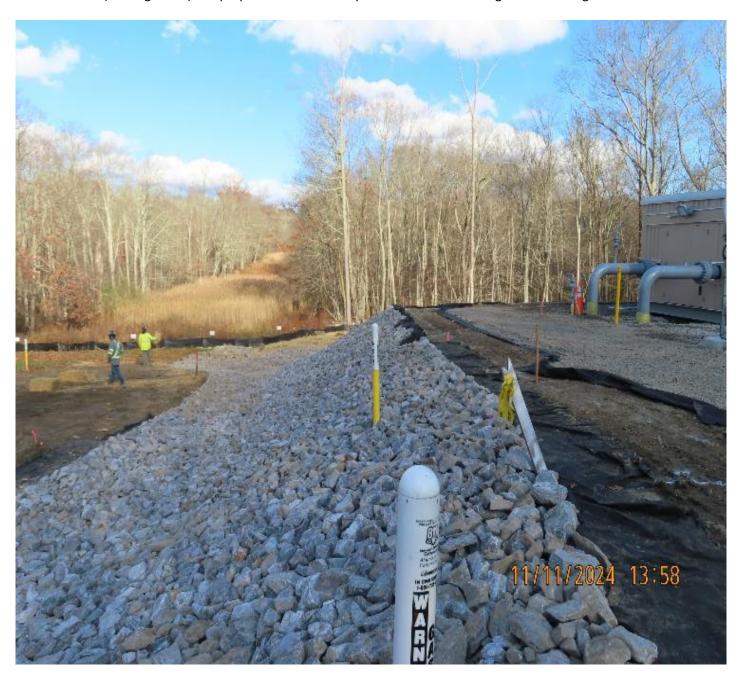
Photo 7: View (looking north) of riprap installation on slope northwest of new regulator building.

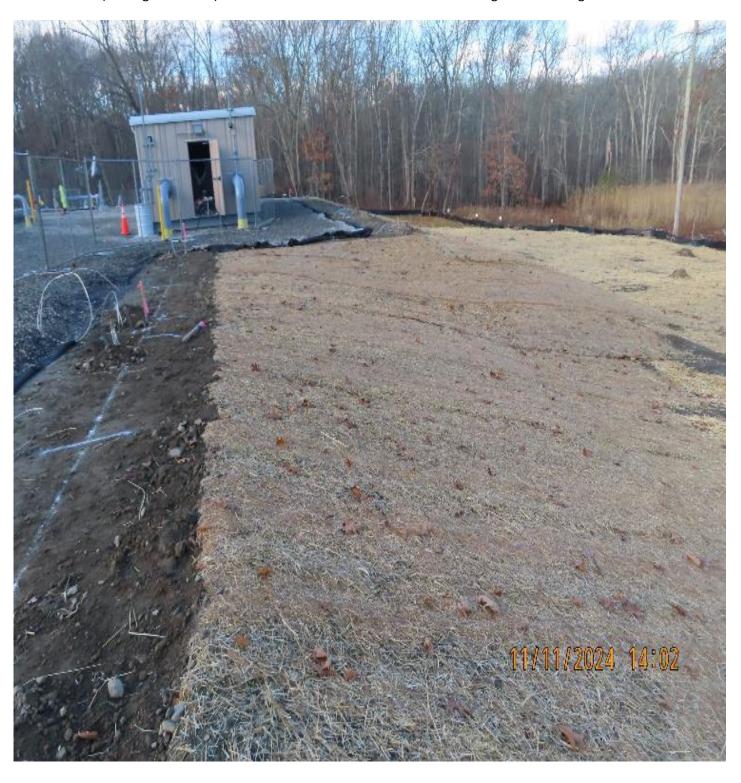
**Photo 8:** View (looking northwest) of stabilized area on northeast side of new regulator building.
