Re: *Algonquin Gas Transmission, LLC*
E-1 System Regulator Installation Project, Docket No. CP24-21-000
Report No. 19

**E-1 System Regulation
WEEKLY REPORT #19**

Project:	E-1 System Regulation
FERC Docket Number:	CP24-21-000
Report Number:	19
Reporting Period:	November 14 through November 20, 2024

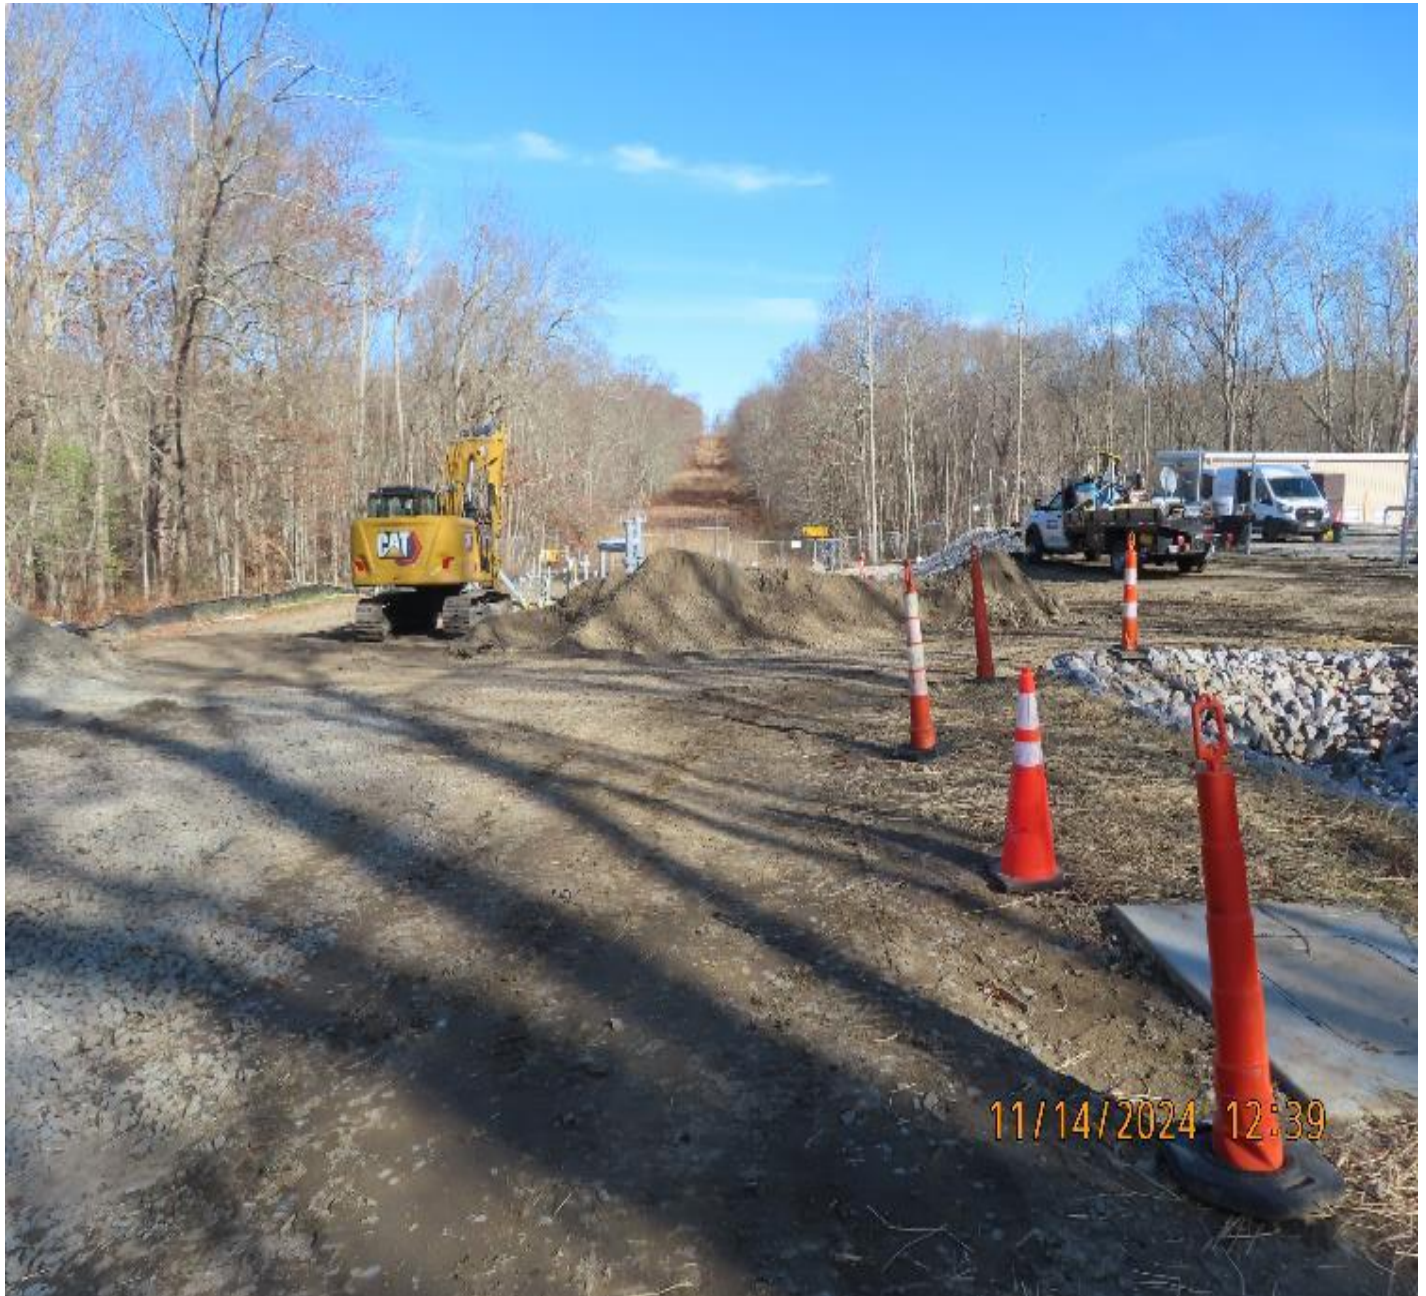
Photo 1: View (looking northeast) of excavation work occurring on southern side of the main work area.

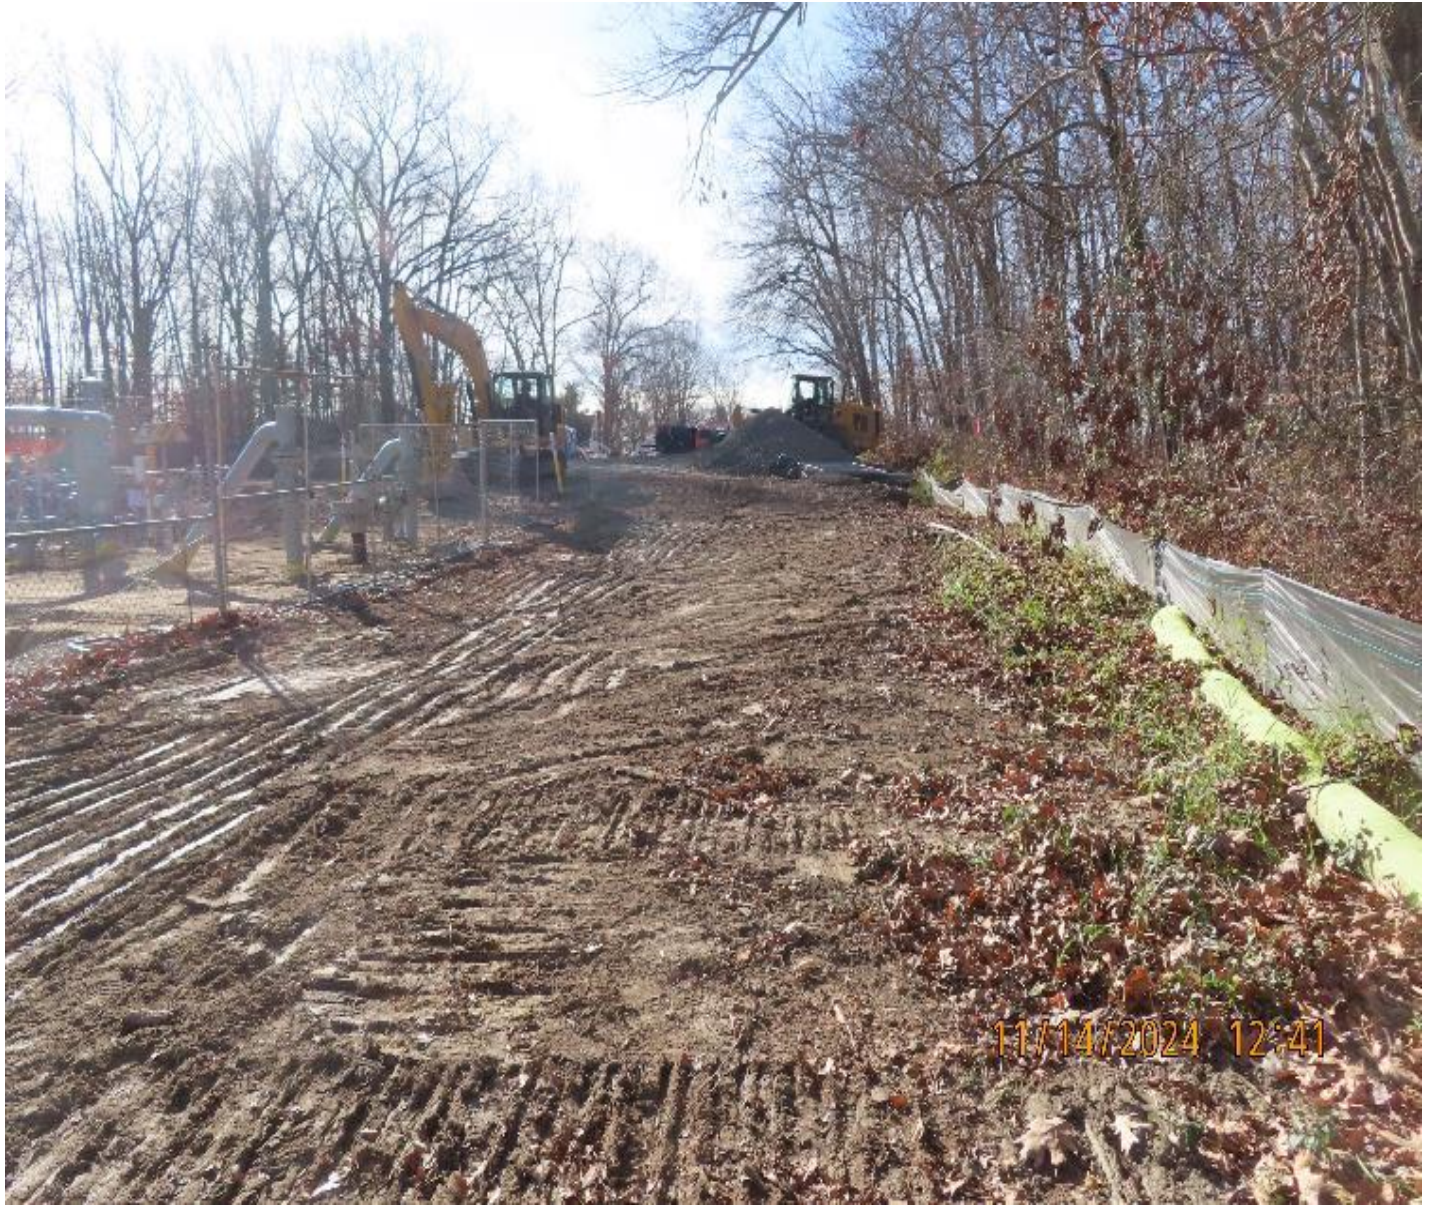
Photo 2: View (looking southwest) of west side of the valve yard where mats have been removed to prepare for placement of gravel surfacing for permanent access improvements.

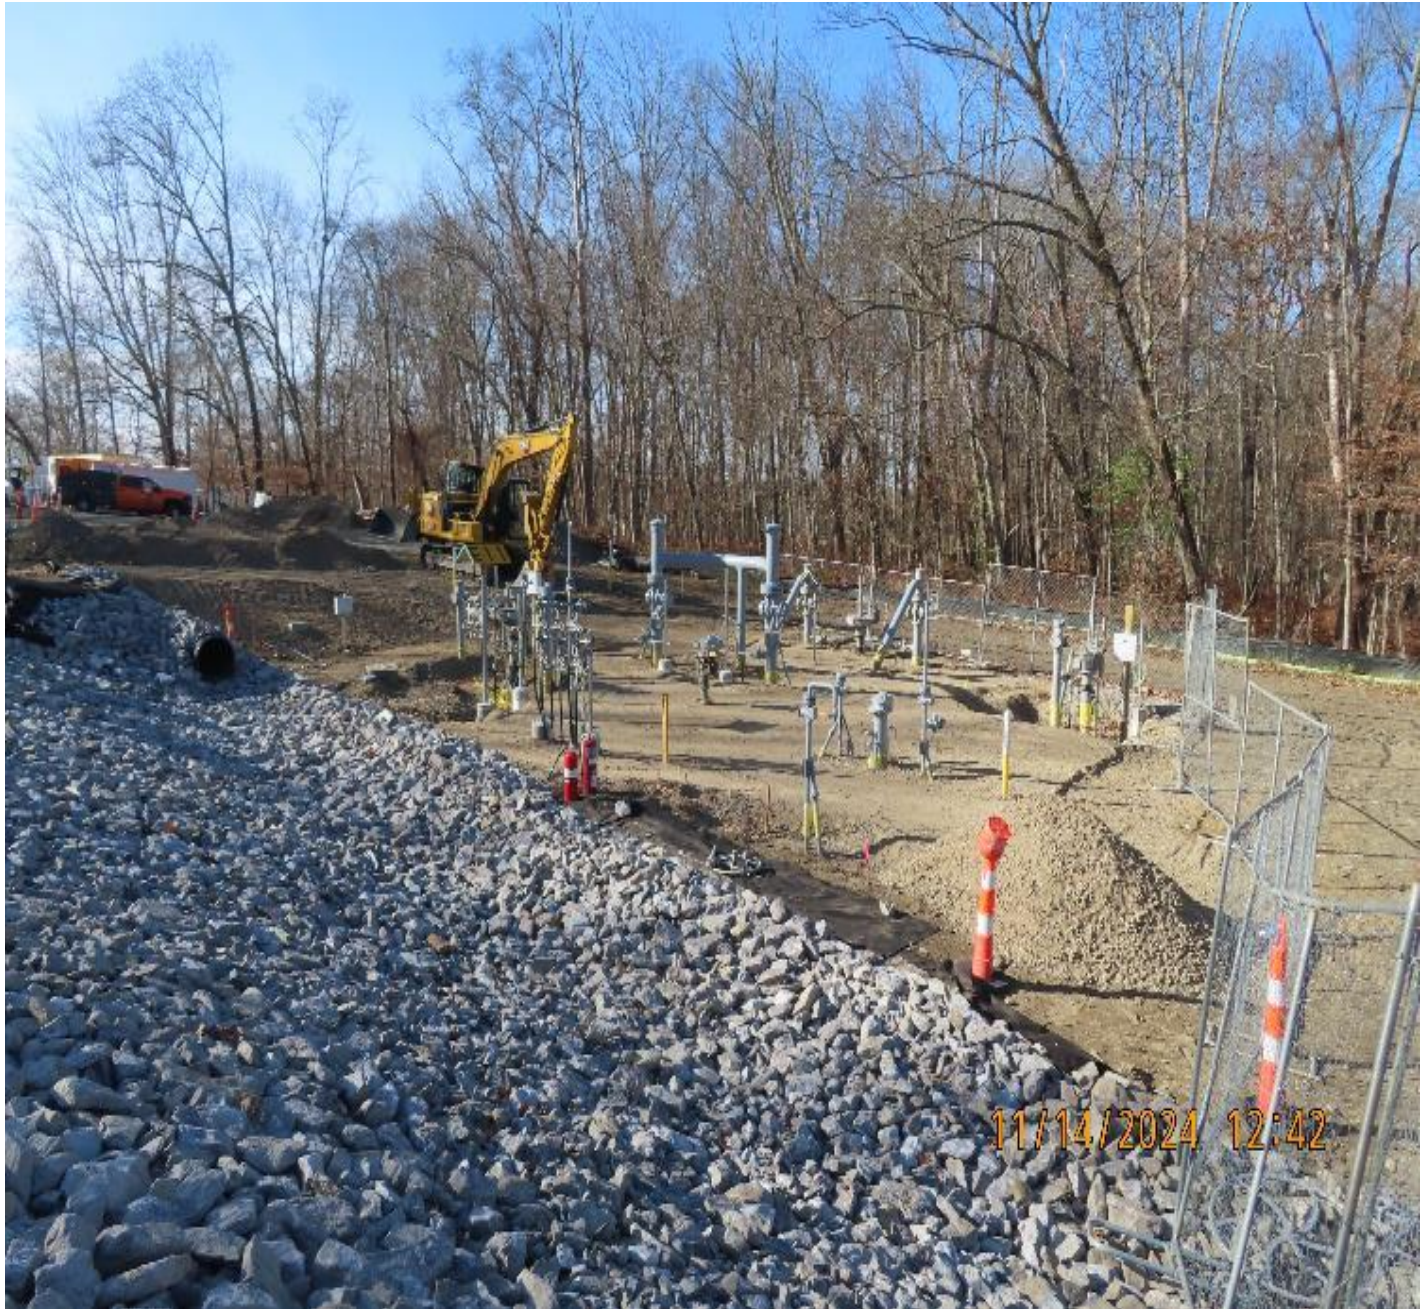
Photo 3: View (looking west) of remaining backfilling work being completed in valve yard. Placement of rock riprap is complete.

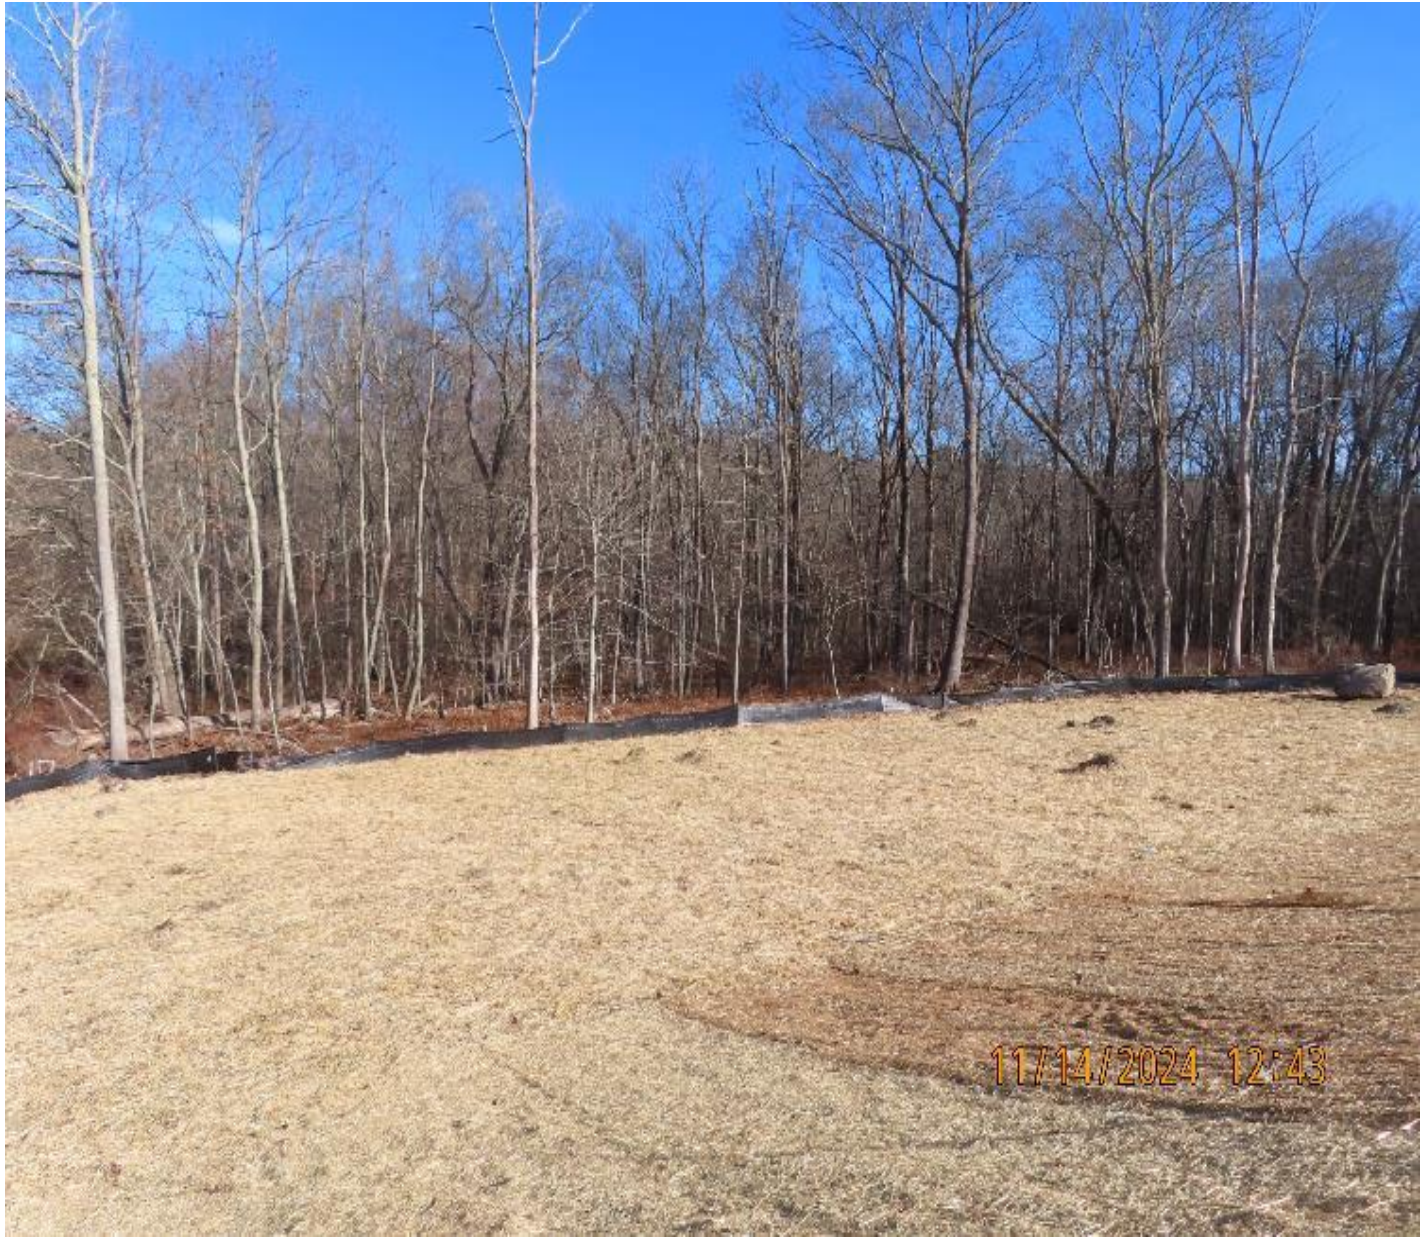
Photo 4: View (looking northeast) of restored and stabilized sloped area along northern portion of the worksite.

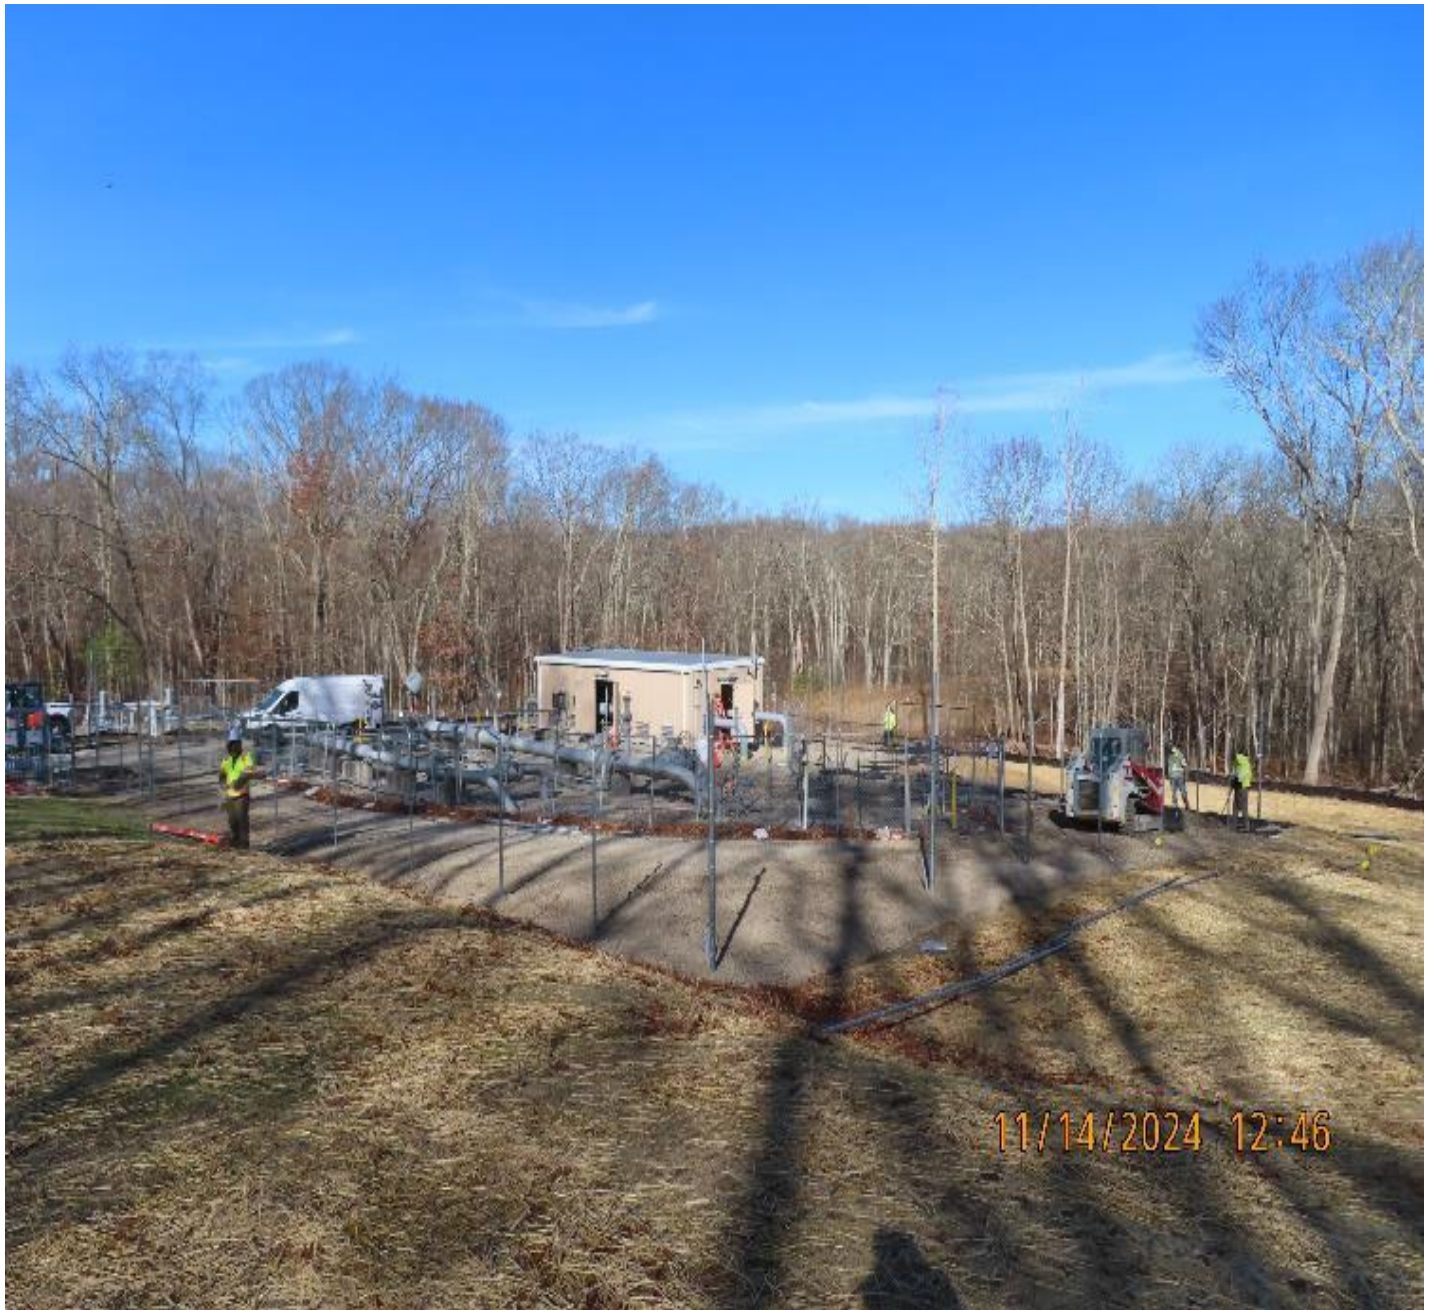
Photo 5: View (looking northwest) of new regulator site as permanent security fencing is being installed.

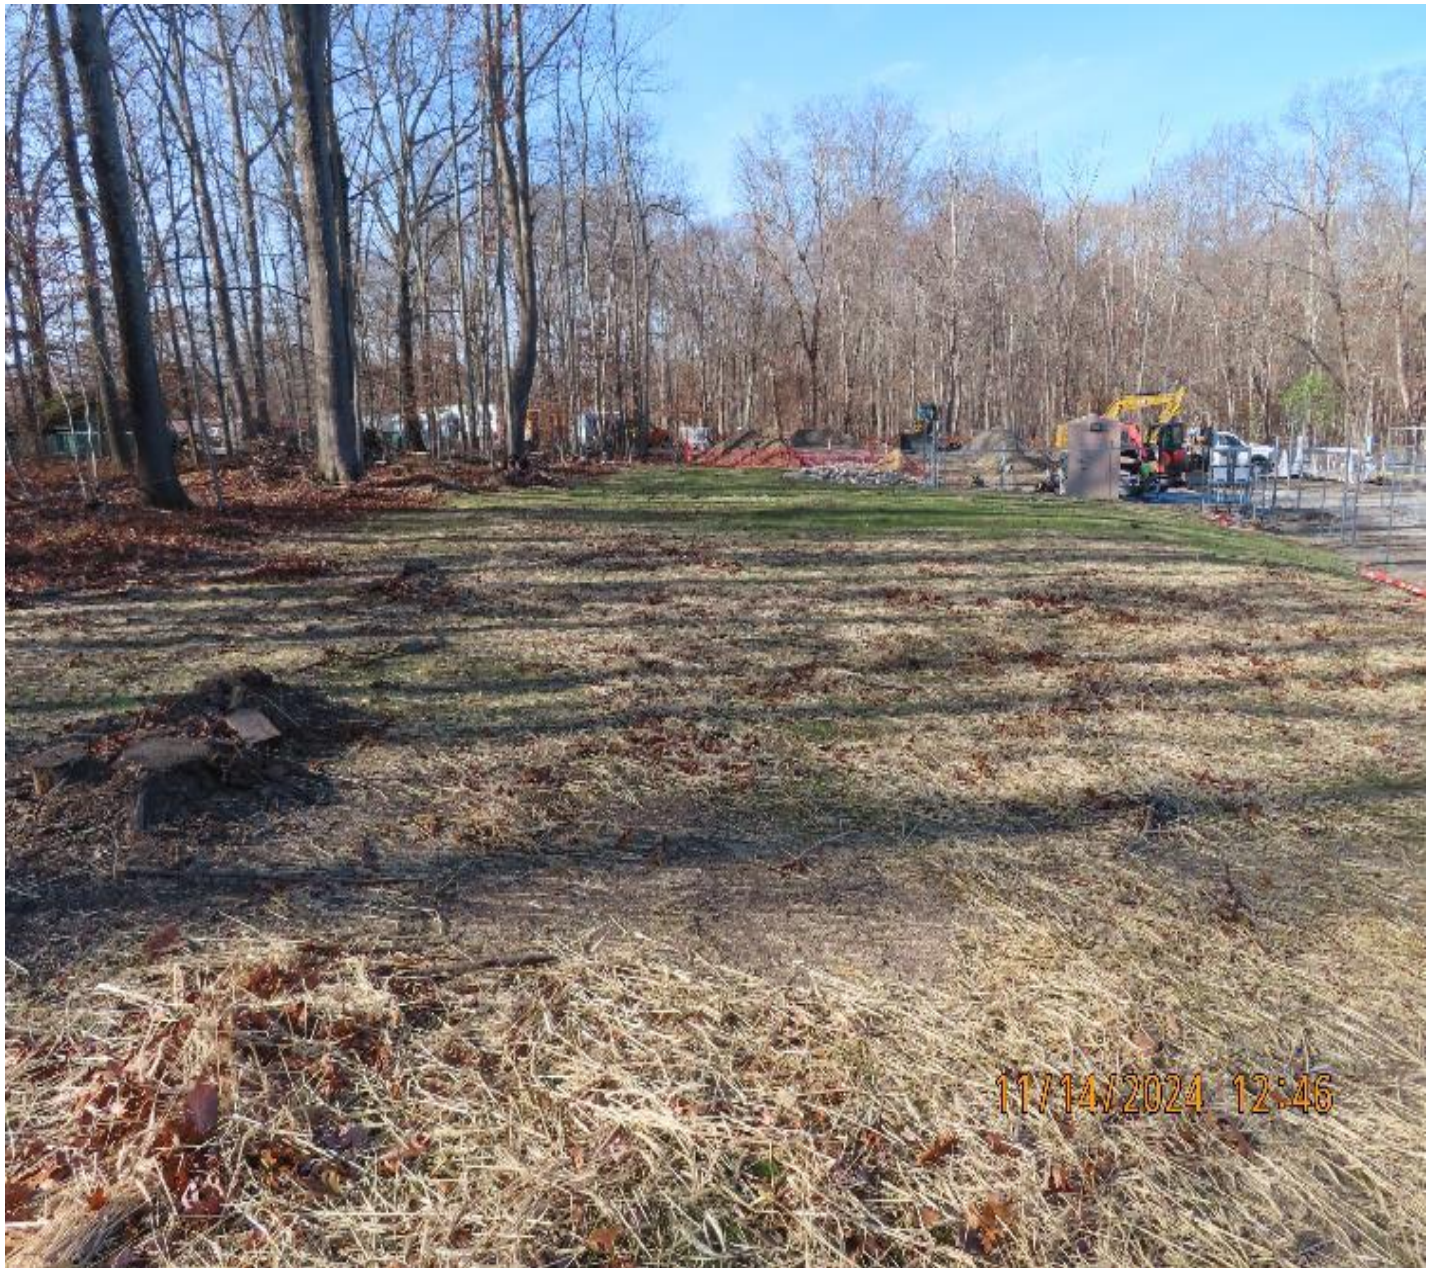
Photo 6: View (looking west) of restored and stabilized conditions in southern portion of the worksite.

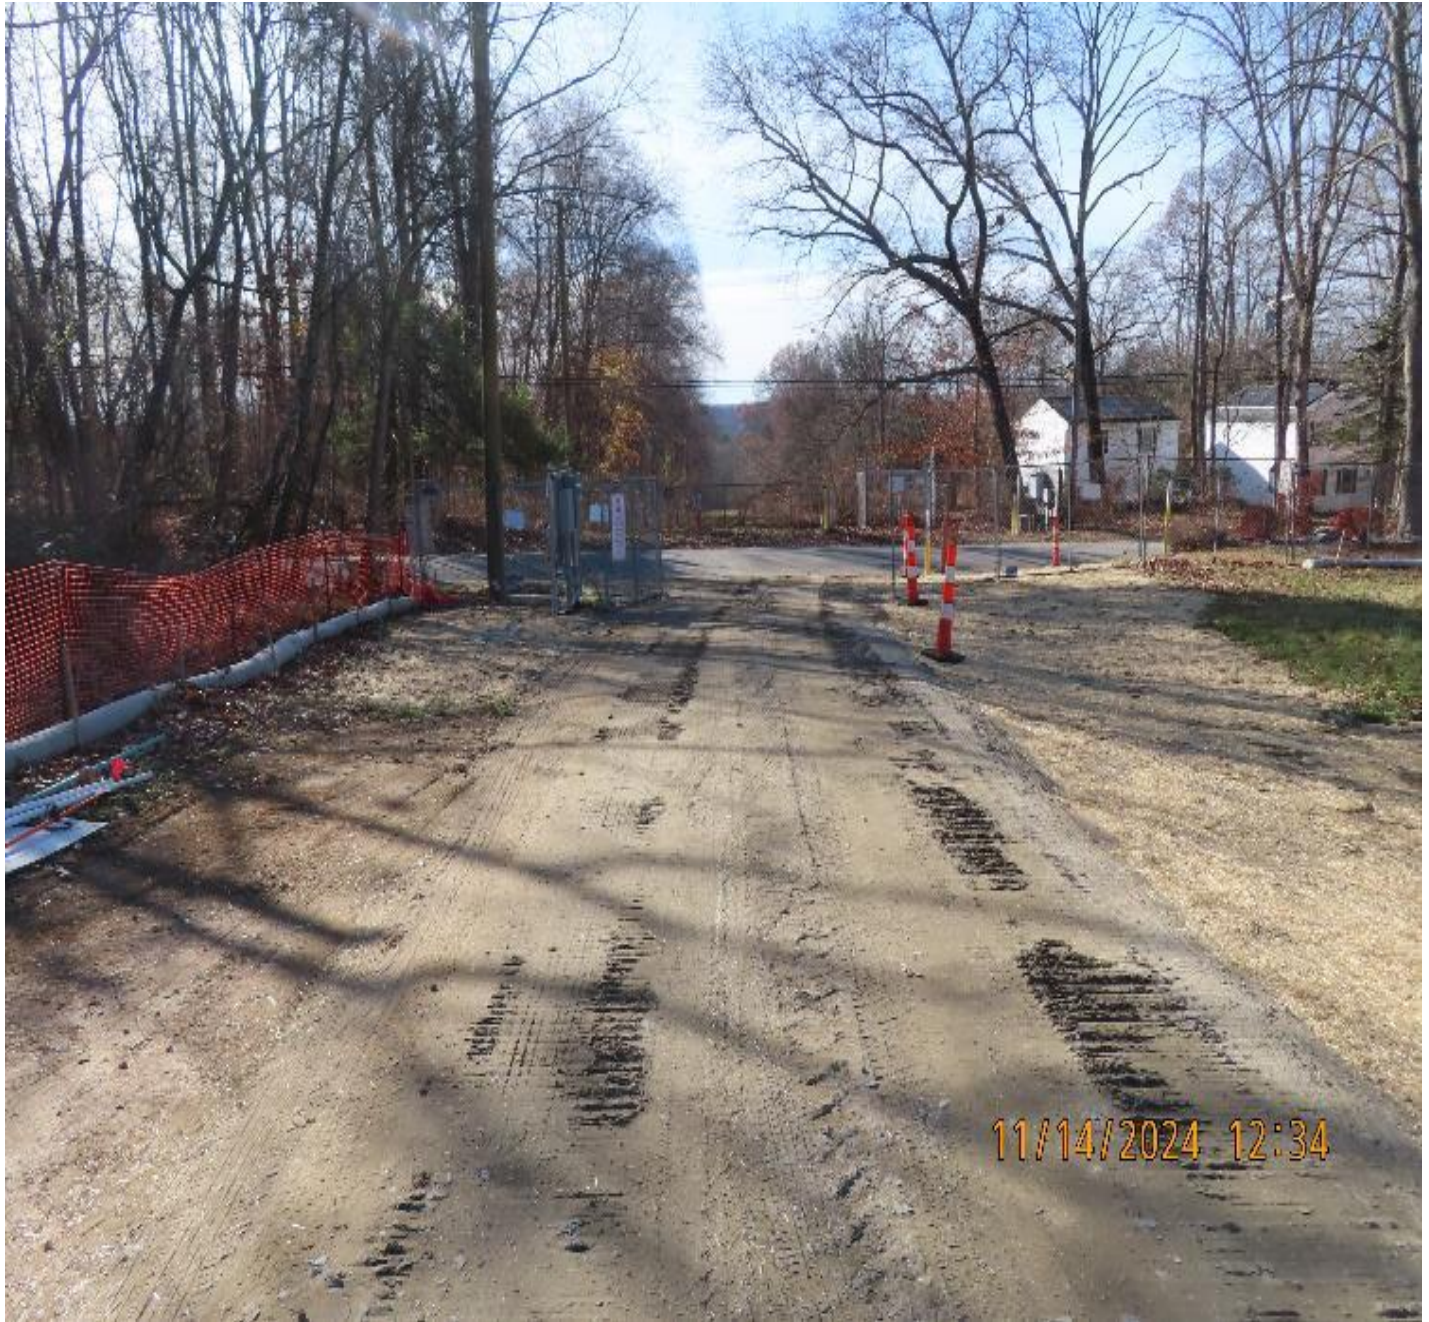
Photo 7: View (looking northeast) of worksite entrance after crushed rock applied for permanent improvement.

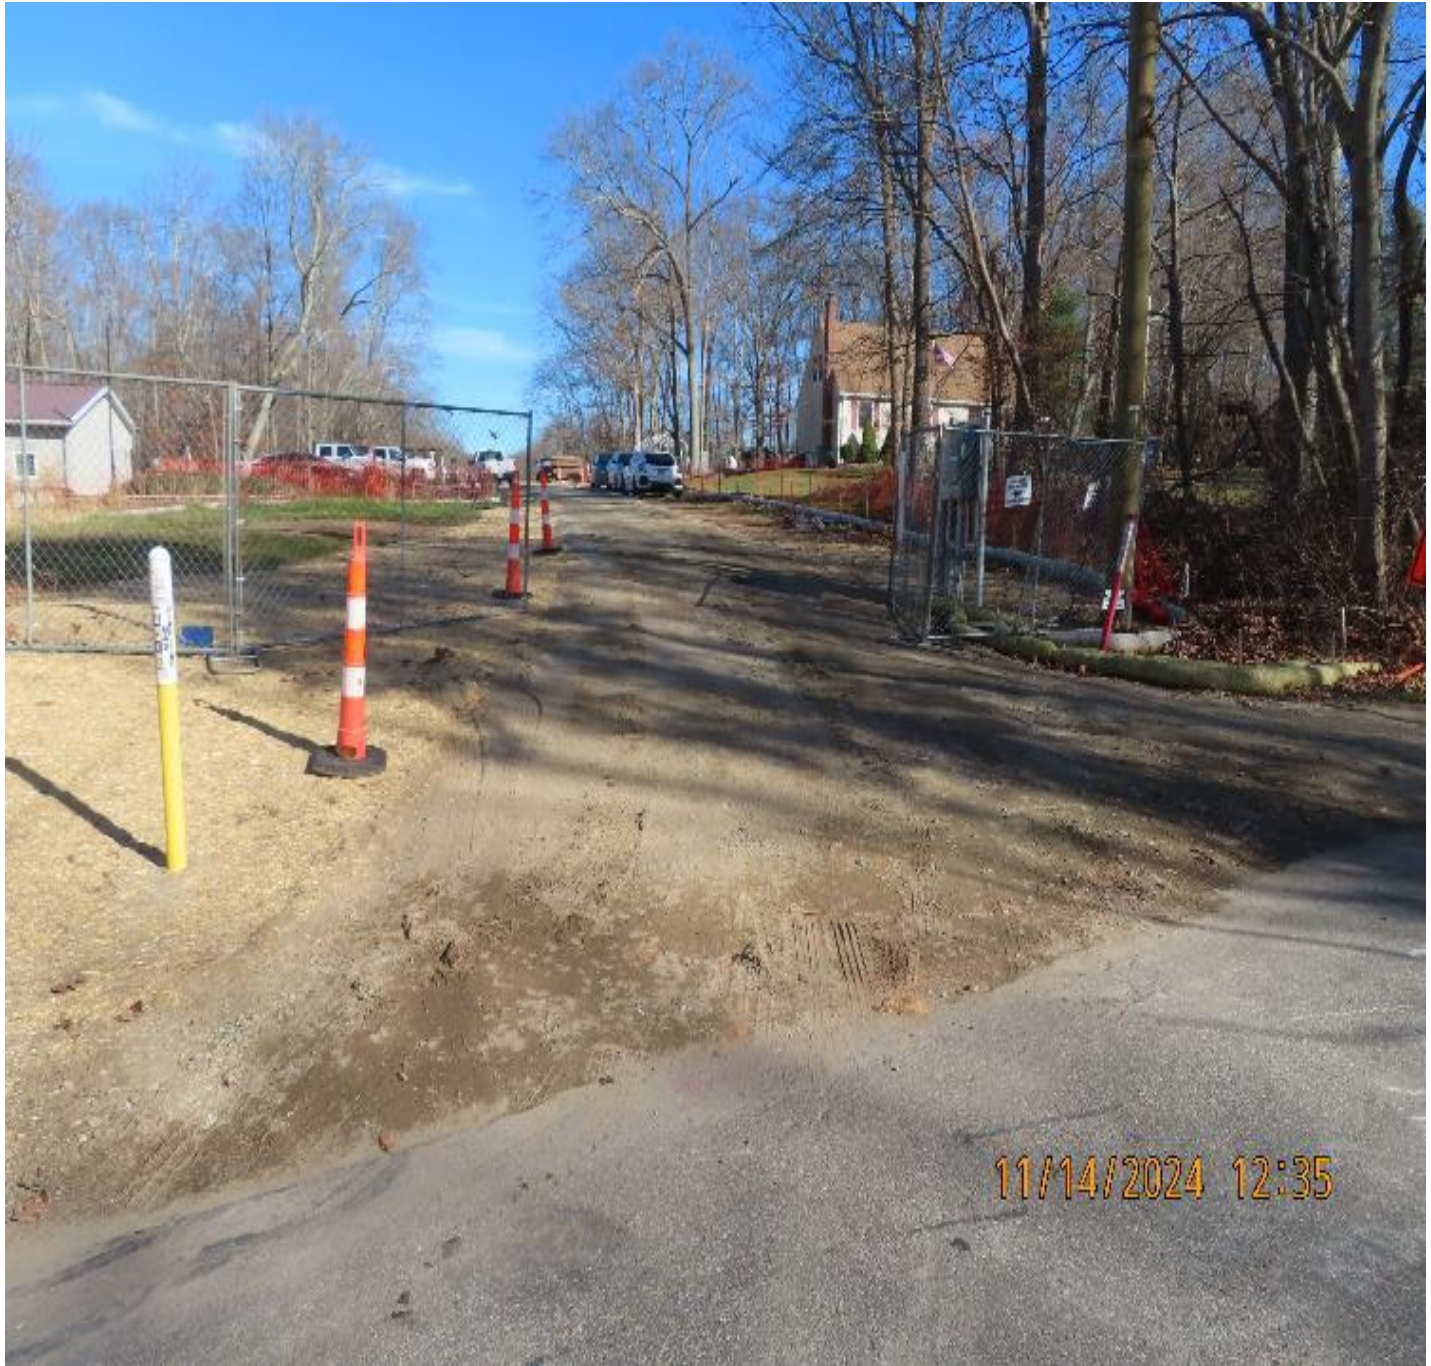
Photo 8: View (looking northeast) of worksite entrance after crushed rock applied to access road.
