Re: *Algonquin Gas Transmission, LLC*
E-1 System Regulator Installation Project, Docket No. CP24-21-000
Report No. 20

**E-1 System Regulation
WEEKLY REPORT #20**

Project:	E-1 System Regulation
FERC Docket Number:	CP24-21-000
Report Number:	20
Reporting Period:	November 21 through November 27, 2024

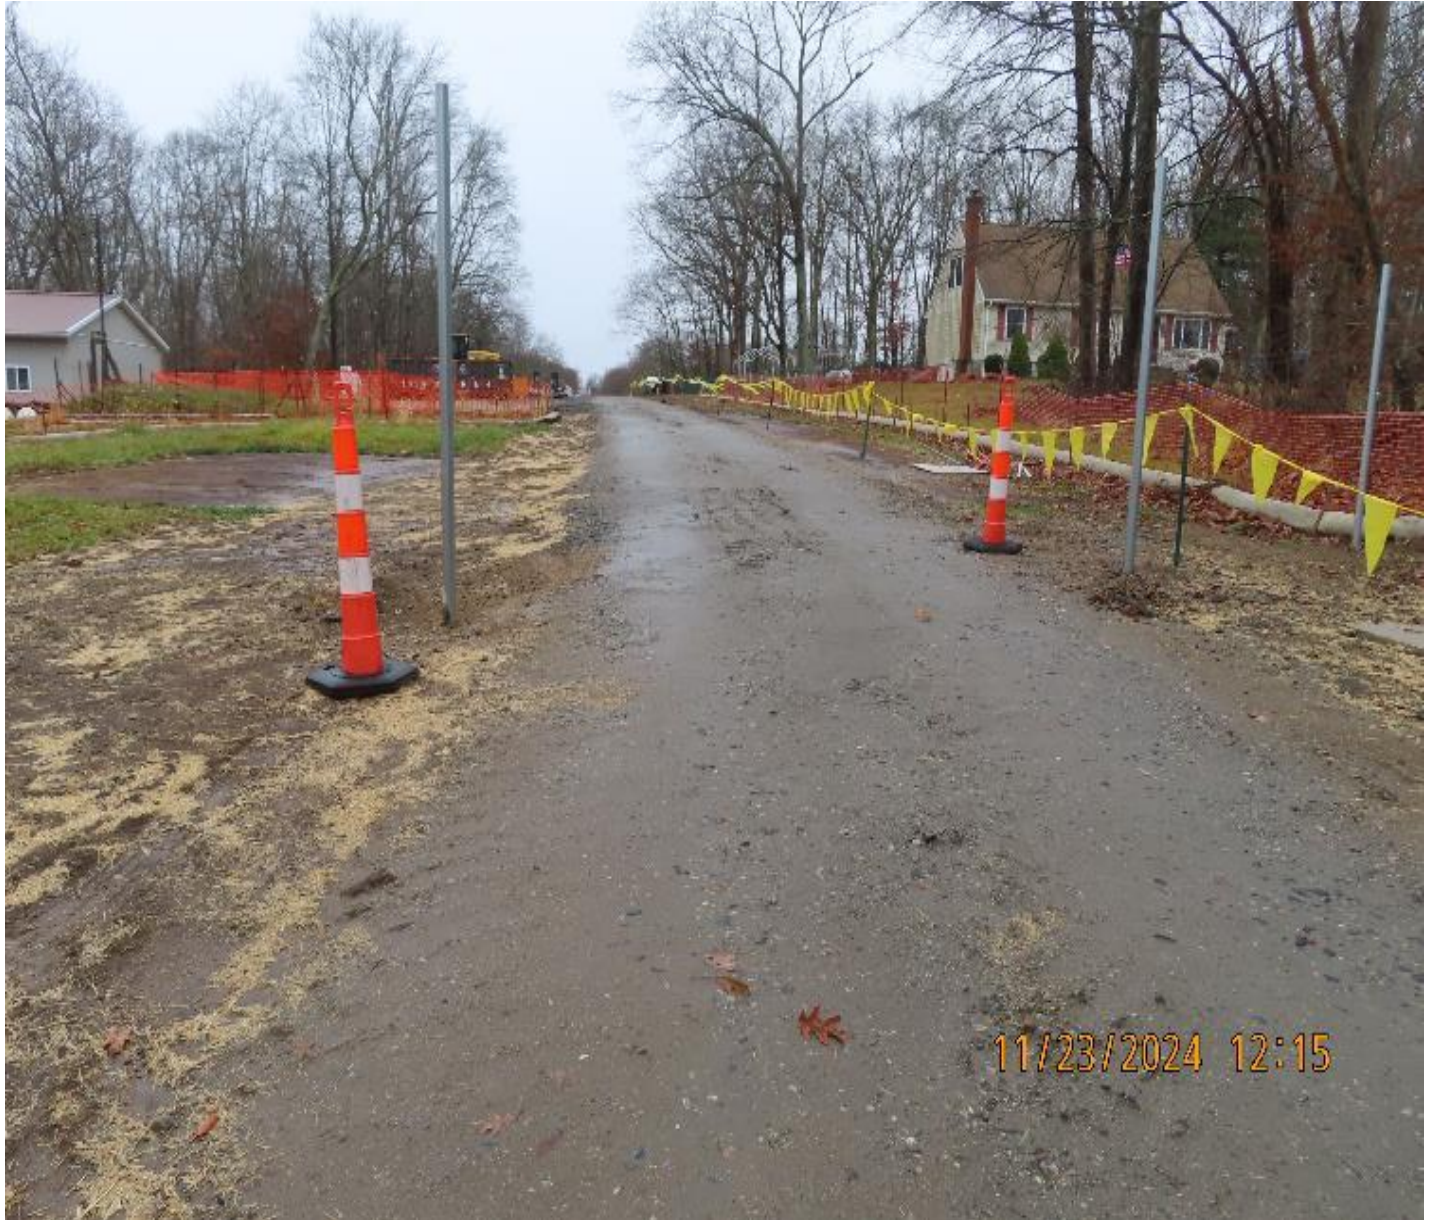
Photo 1: View (looking northeast) of access road conditions after rain event. Additional mulch will be placed in seeded areas along both sides of the road.

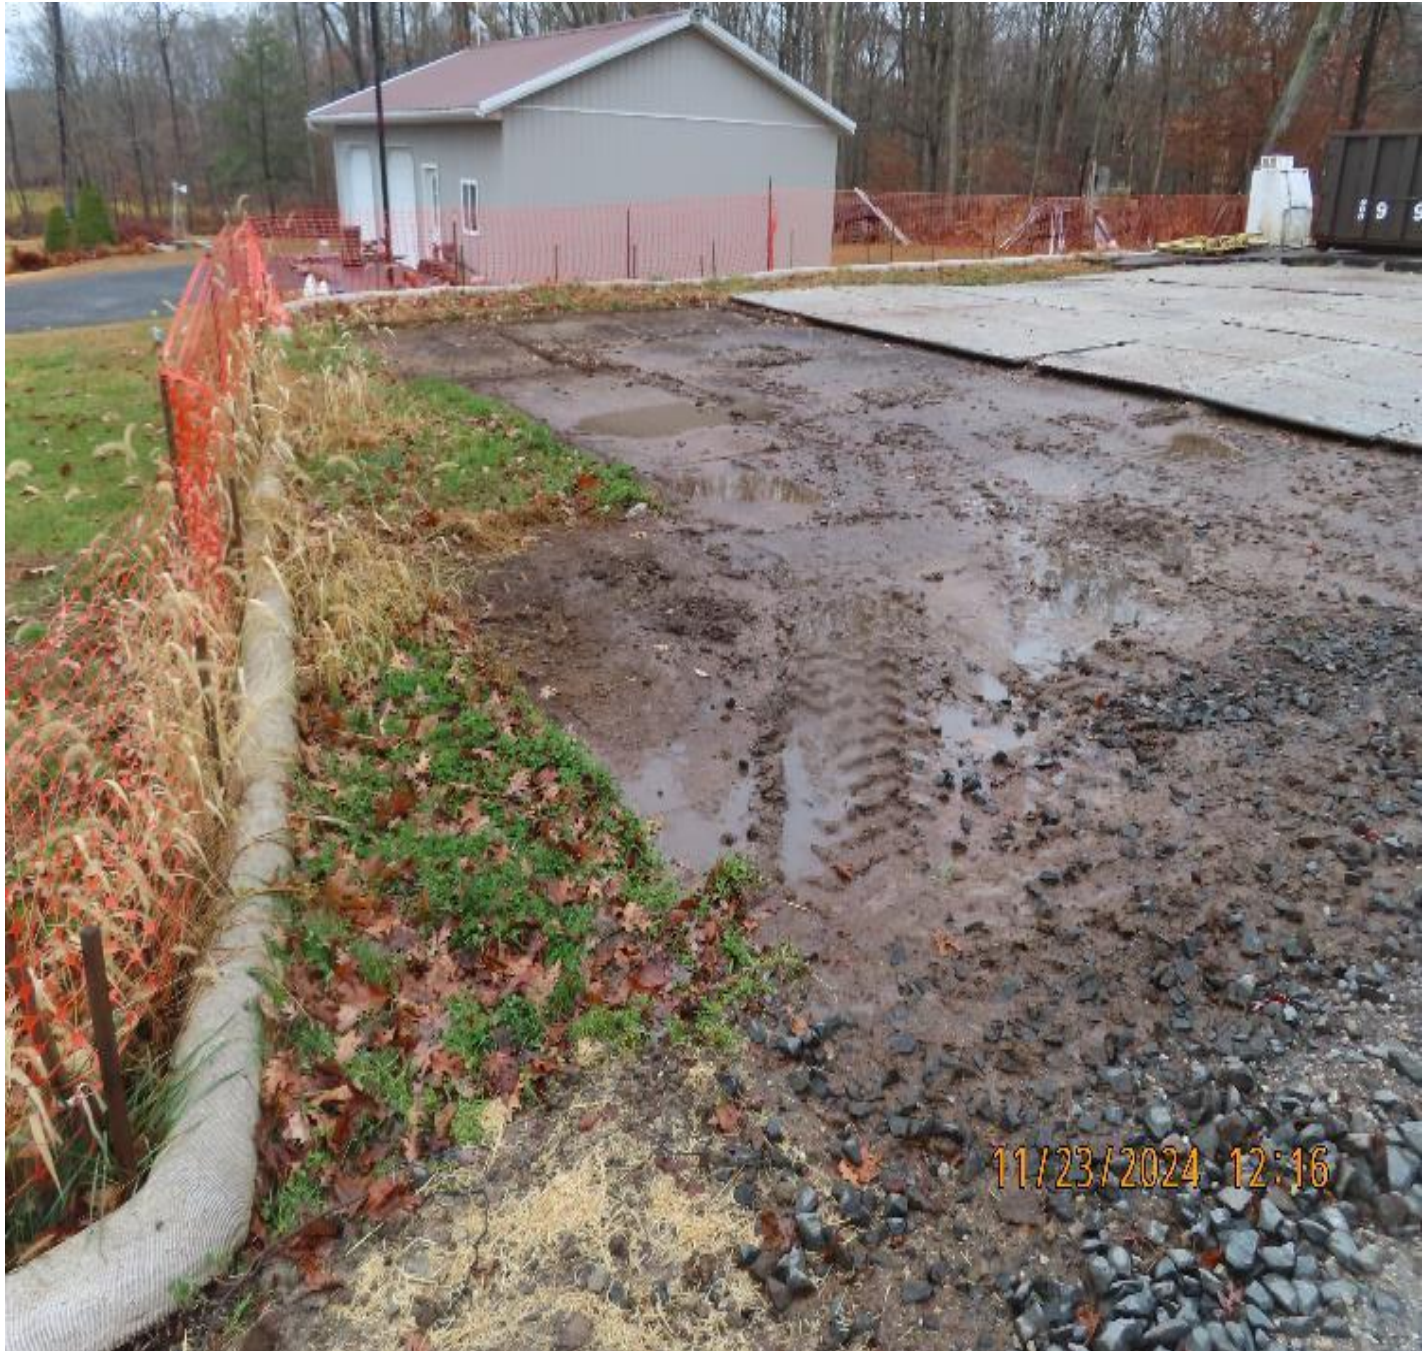
Photo 2: View (looking northwest) of ground surface of workspace immediately after removal of composite matting (before seed application and temporary stabilization).

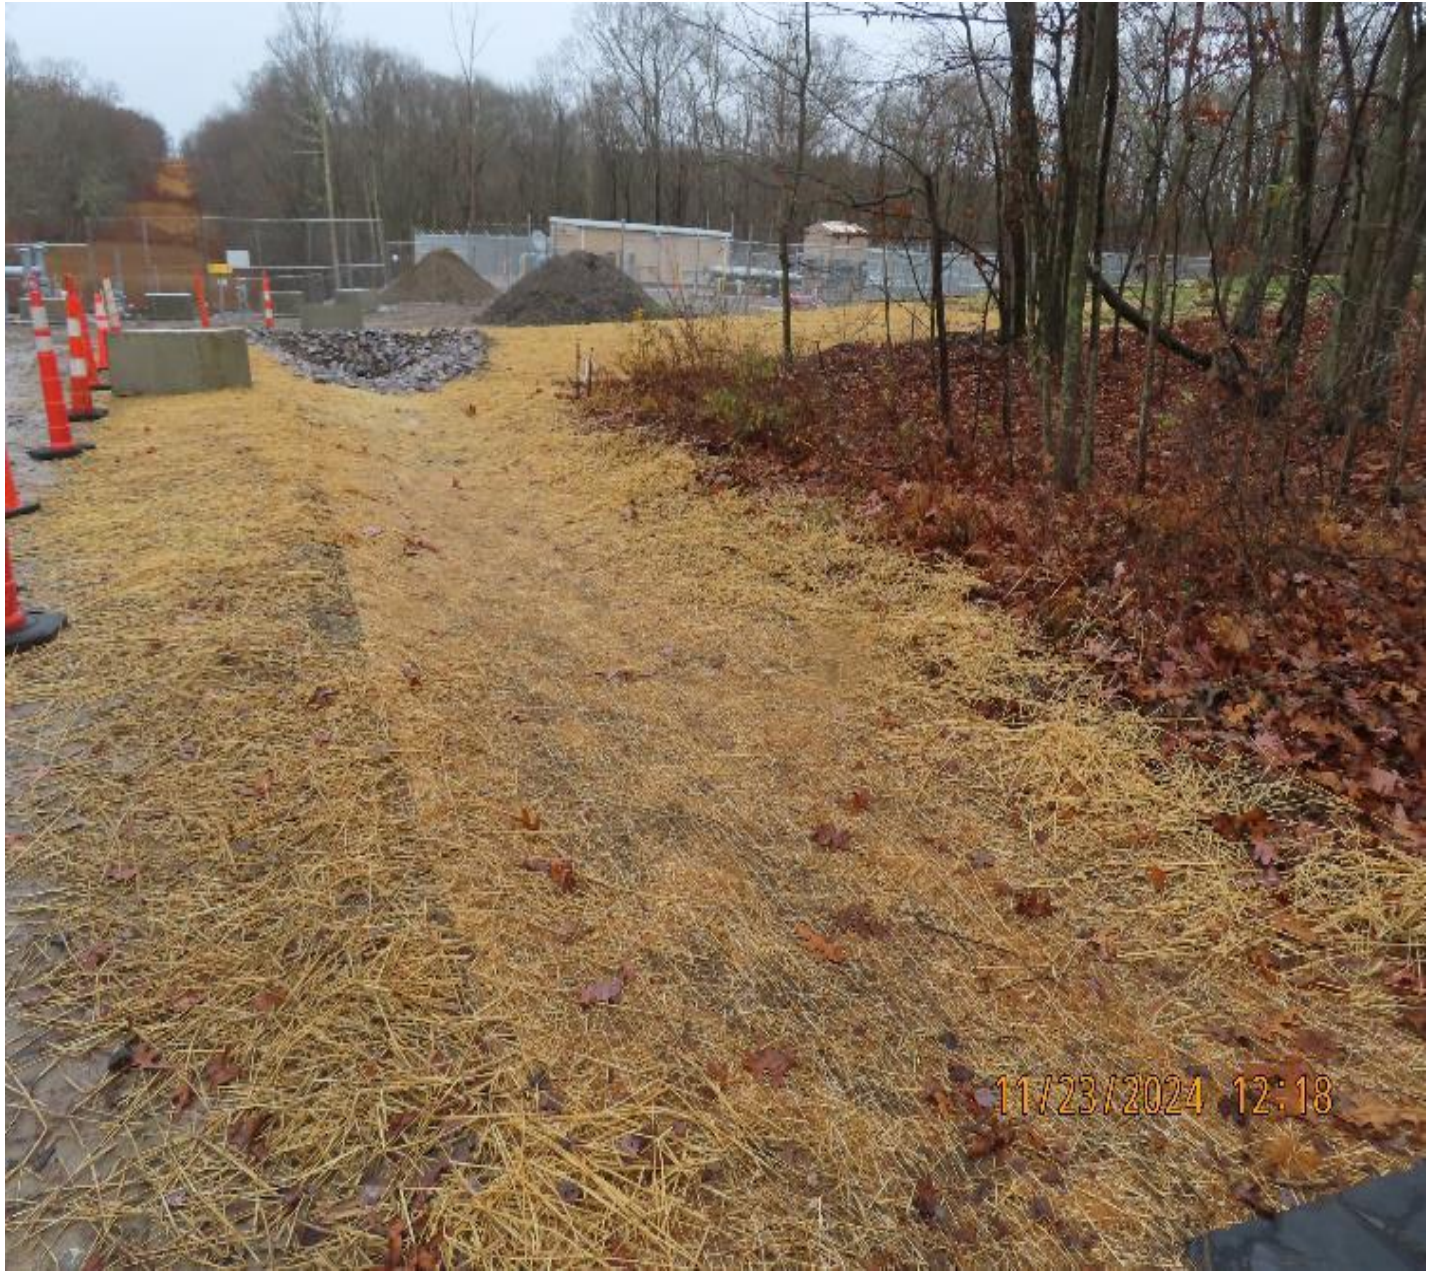
Photo 3: View (looking northeast) of stabilized drainage swale that bisects the site southwest to northeast

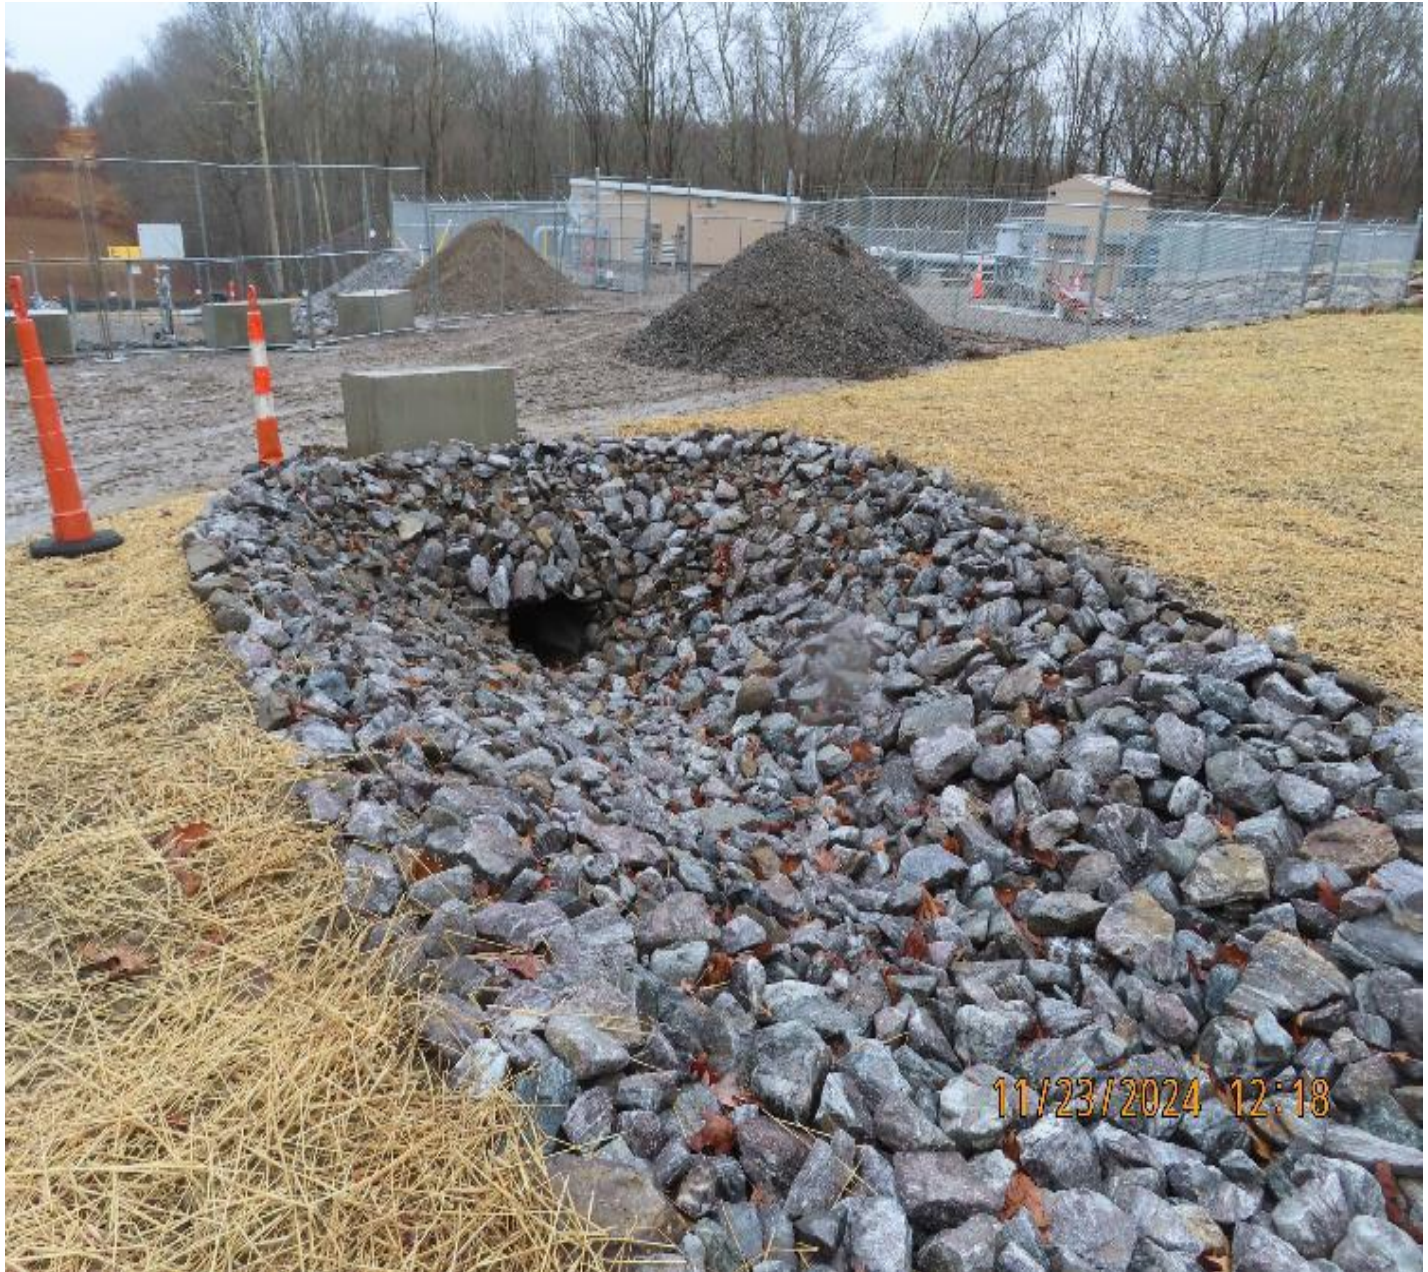
Photo 4: View (looking northeast) of riprap installed around entrance to the culvert that runs beneath the access road to the regulator and RTU buildings.

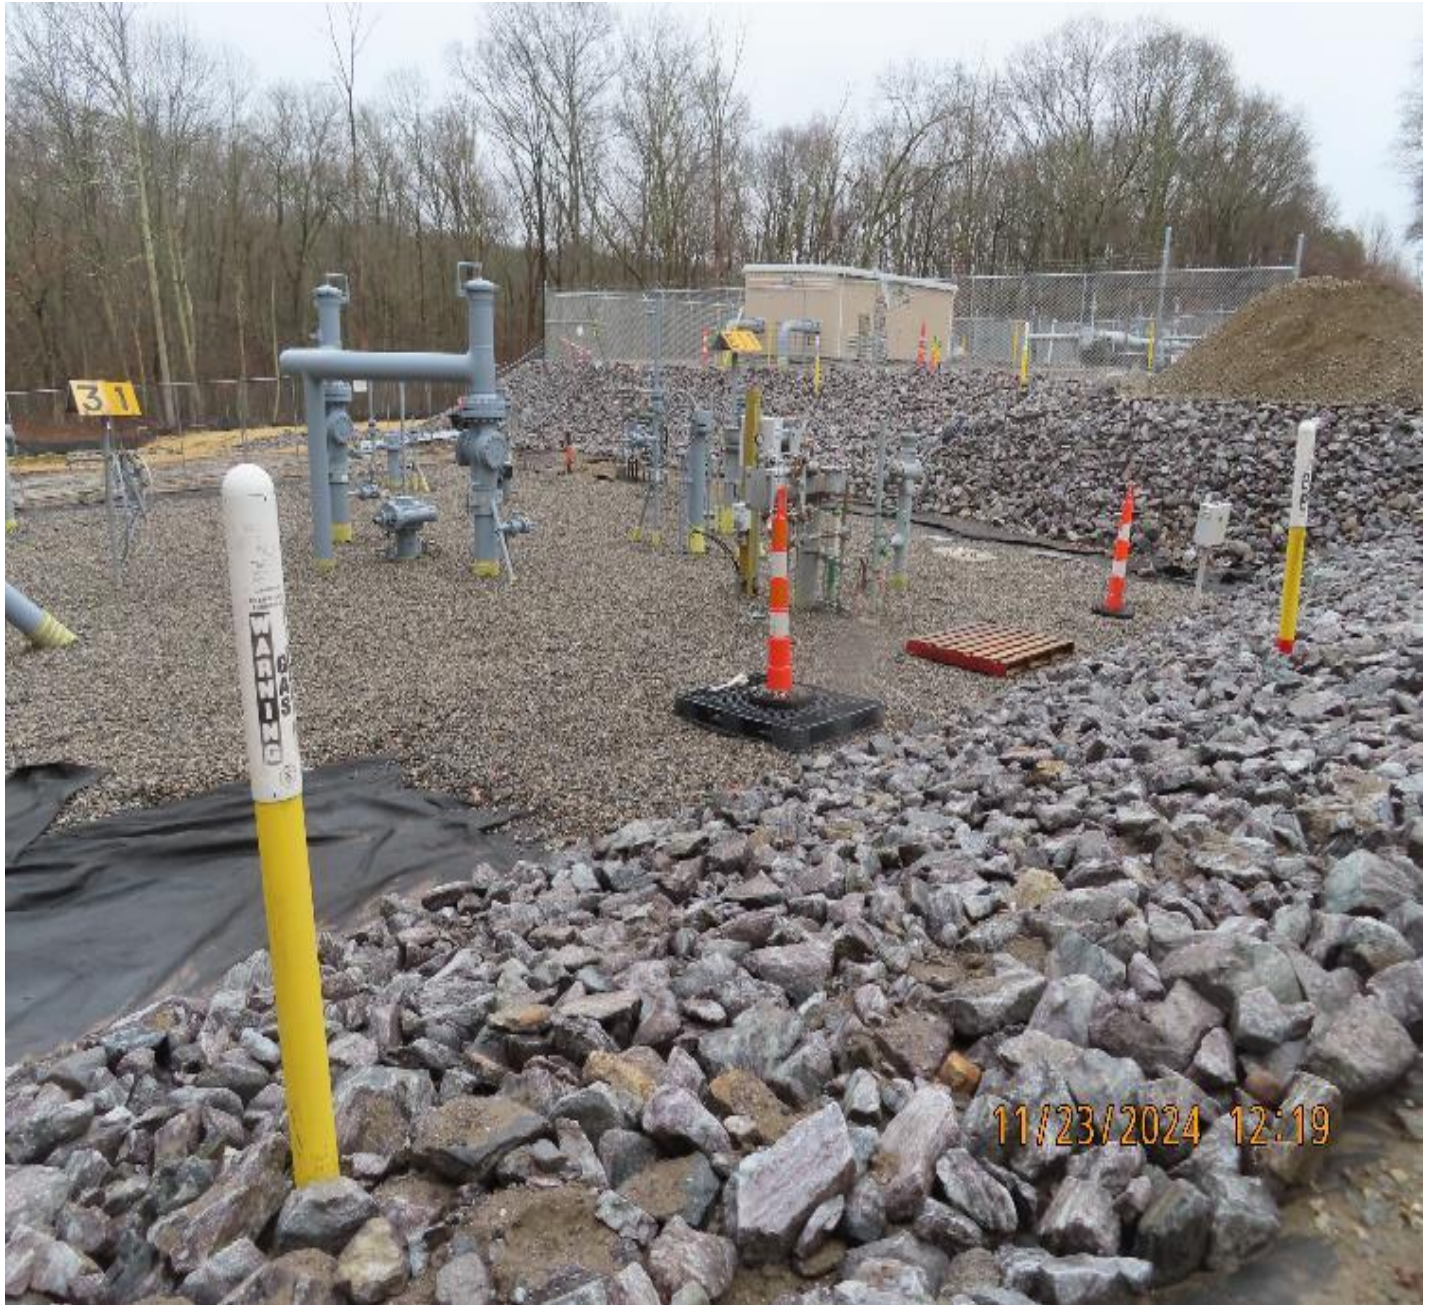
Photo 5: View (looking east) of valve yard with stone surfacing work at approximately 80 percent complete.

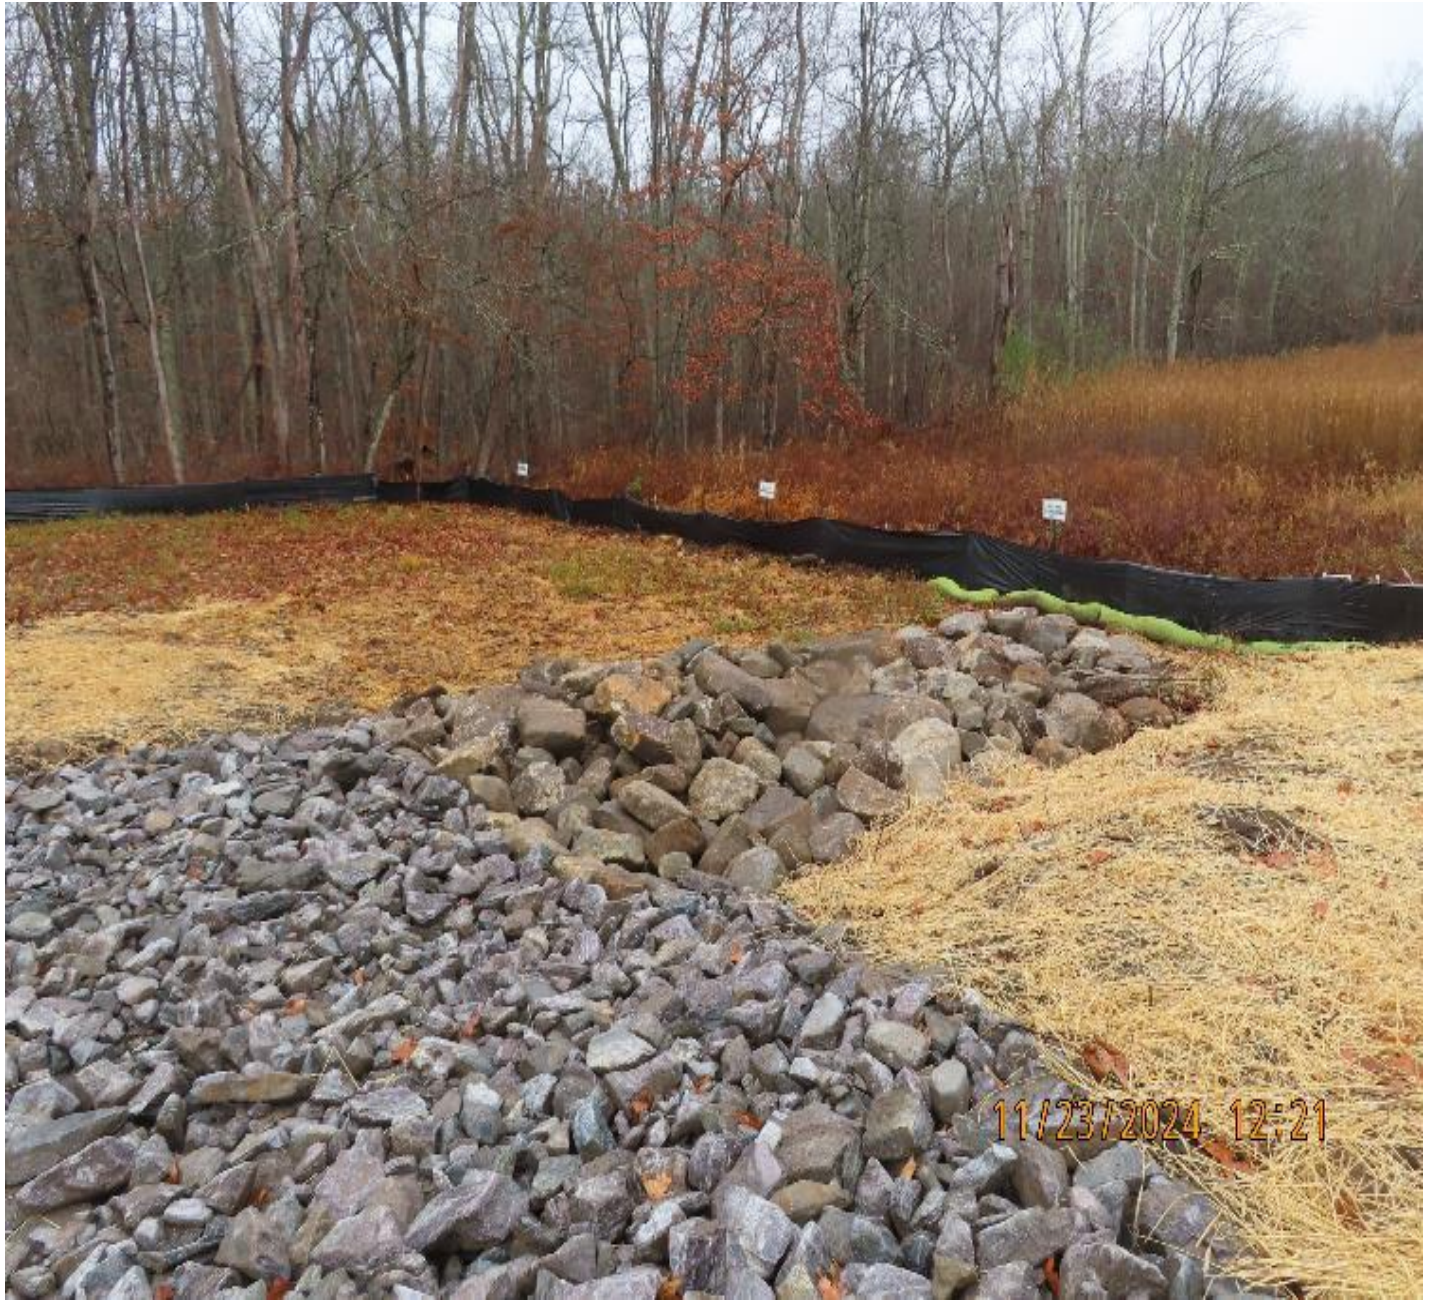
Photo 6: View (looking north) of riprap armored drainage swale that directs stormwater runoff away from the site.

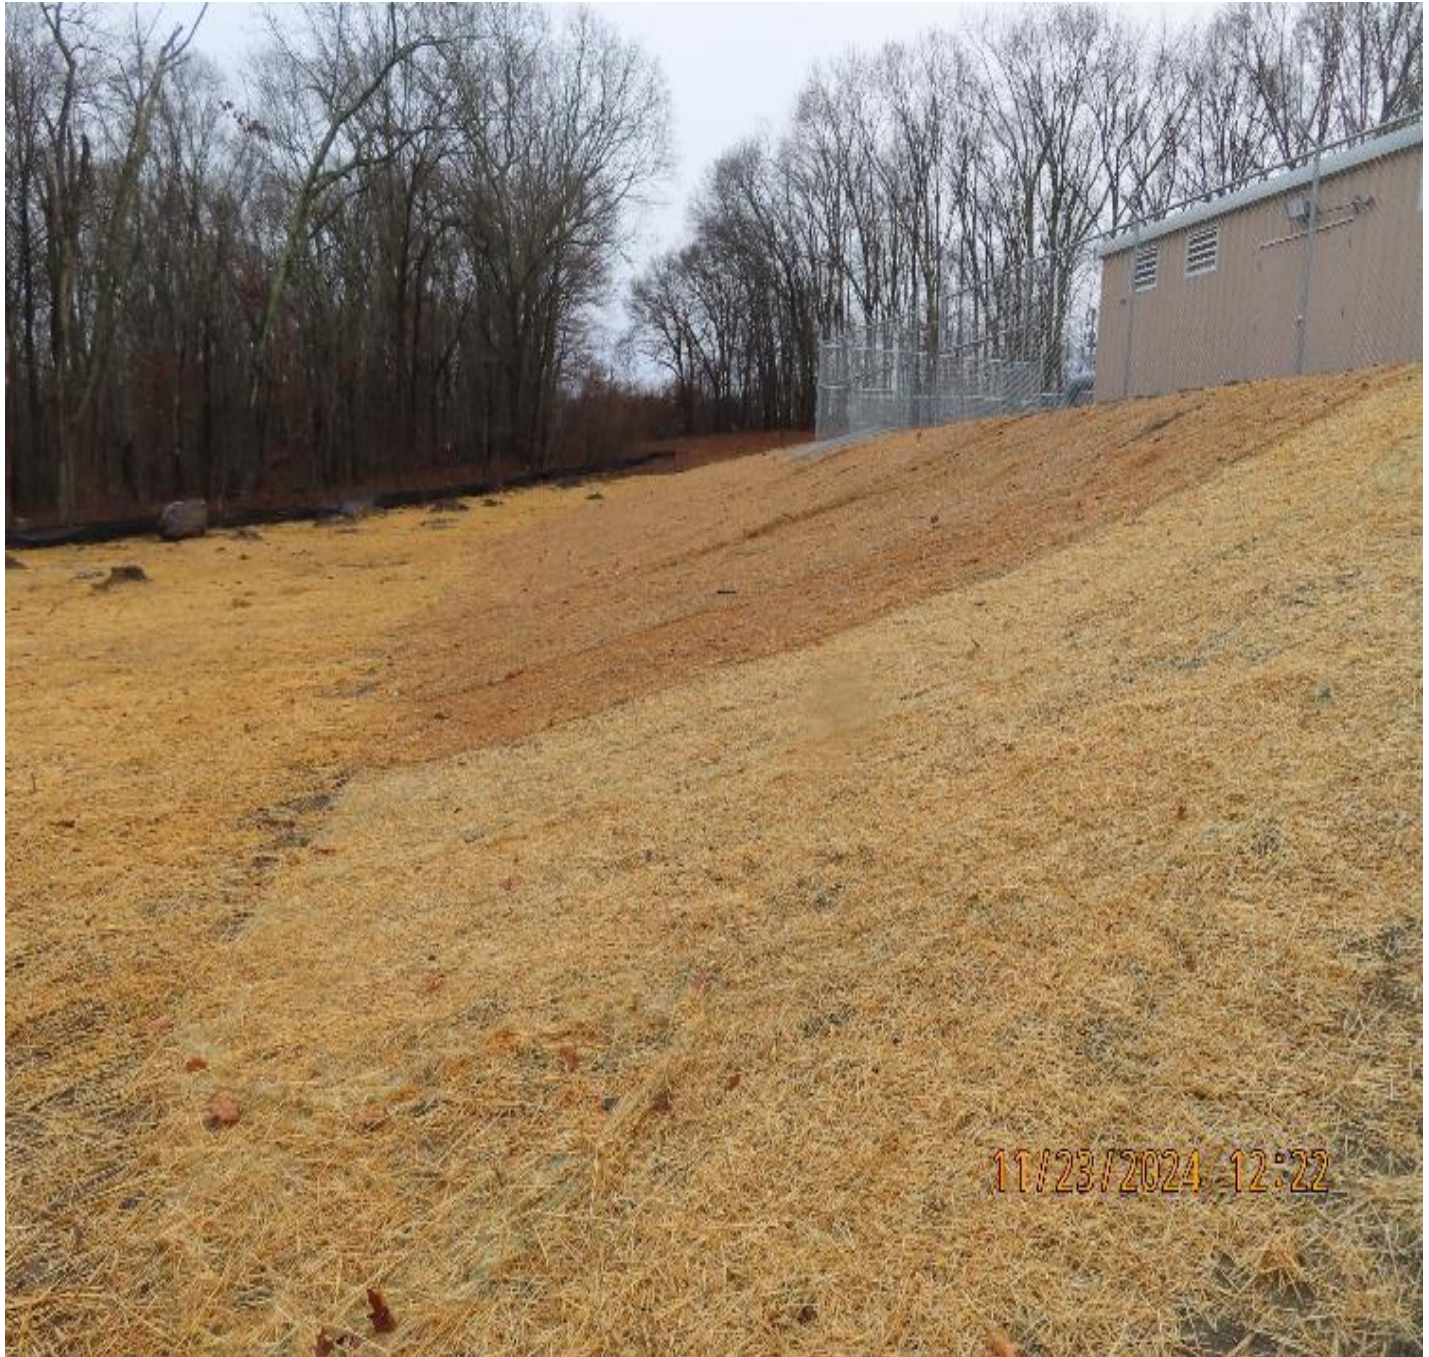
Photo 7: View (looking southeast) of stabilized slope along the northeast side of the new regulator building.

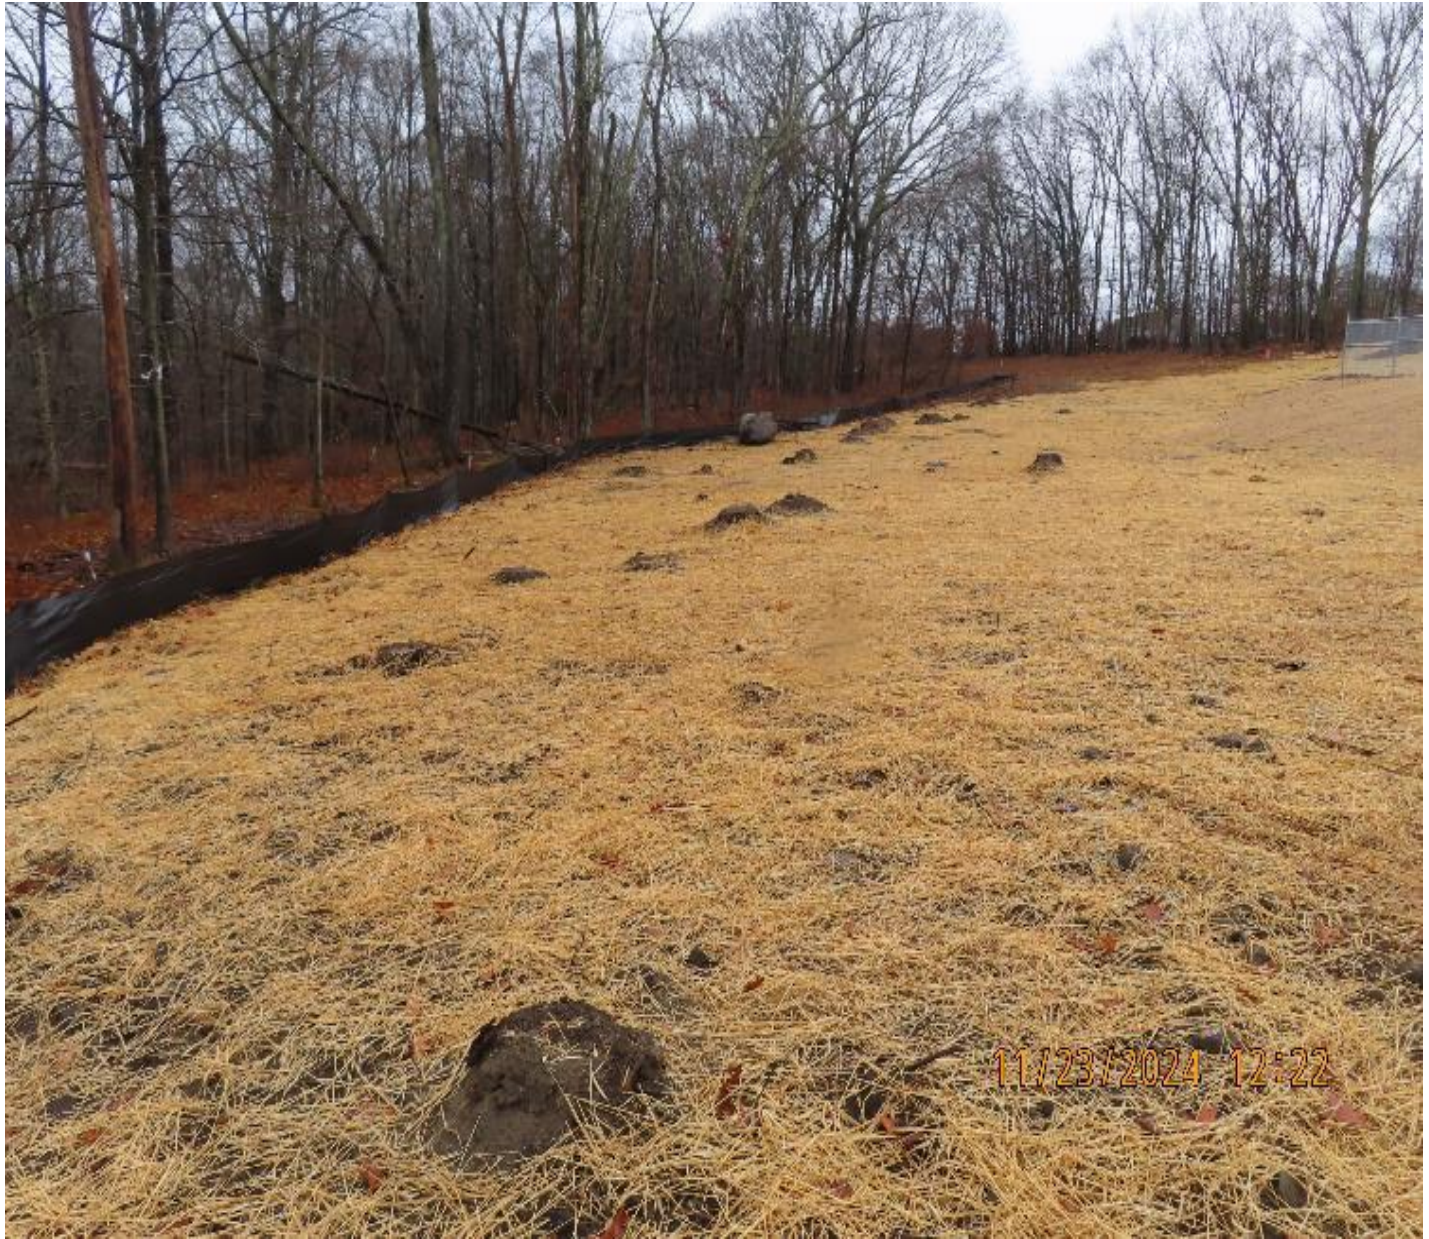
Photo 8: View (looking southeast) of winter stabilization conditions in eastern part of the worksite. The brown clumps are tree stumps that were left in place.
