Re: *Algonquin Gas Transmission, LLC*  
E-1 System Regulator Installation Project, Docket No. CP24-21-000  
Report No. 21

**E-1 System Regulation  
WEEKLY REPORT #21**

Project:	E-1 System Regulation
FERC Docket Number:	CP24-21-000
Report Number:	21
Reporting Period:	November 28 through December 4, 2024

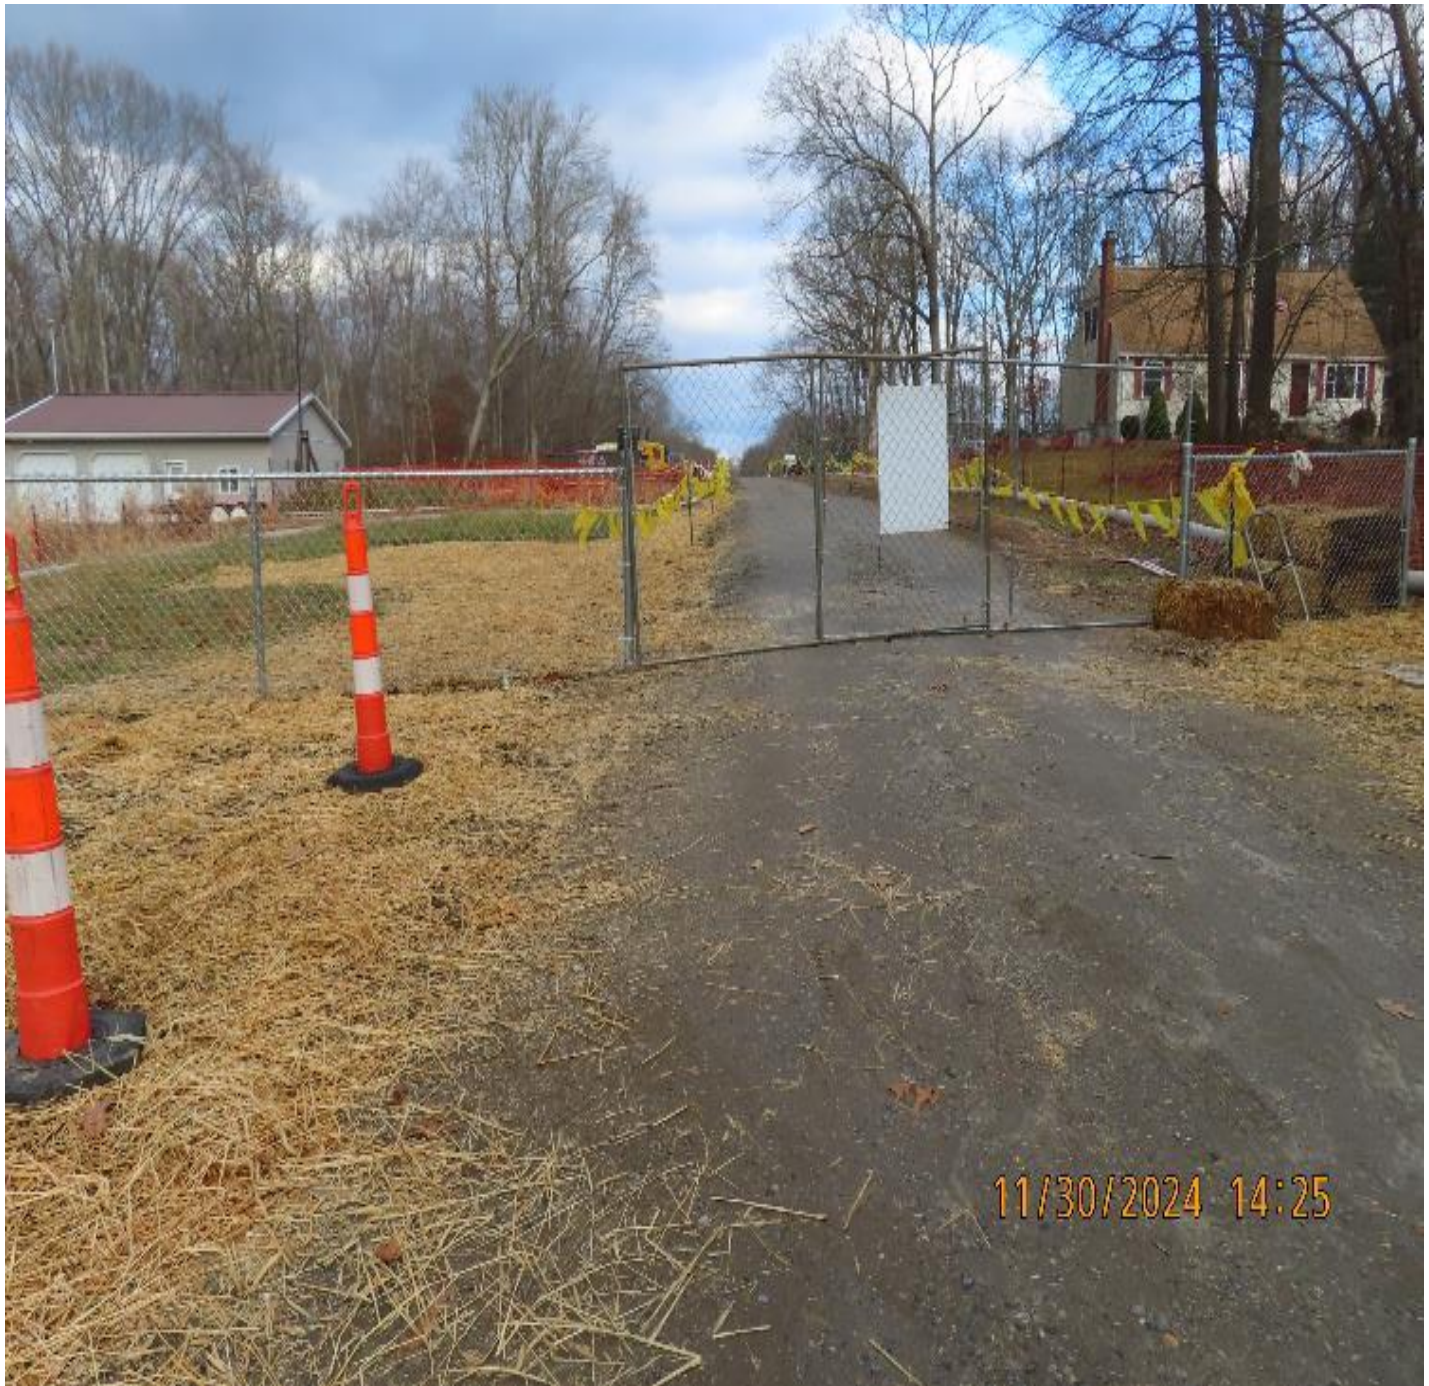
**Photo 1:** View (looking northeast) of site access entrance after mulch was placed along the edges.

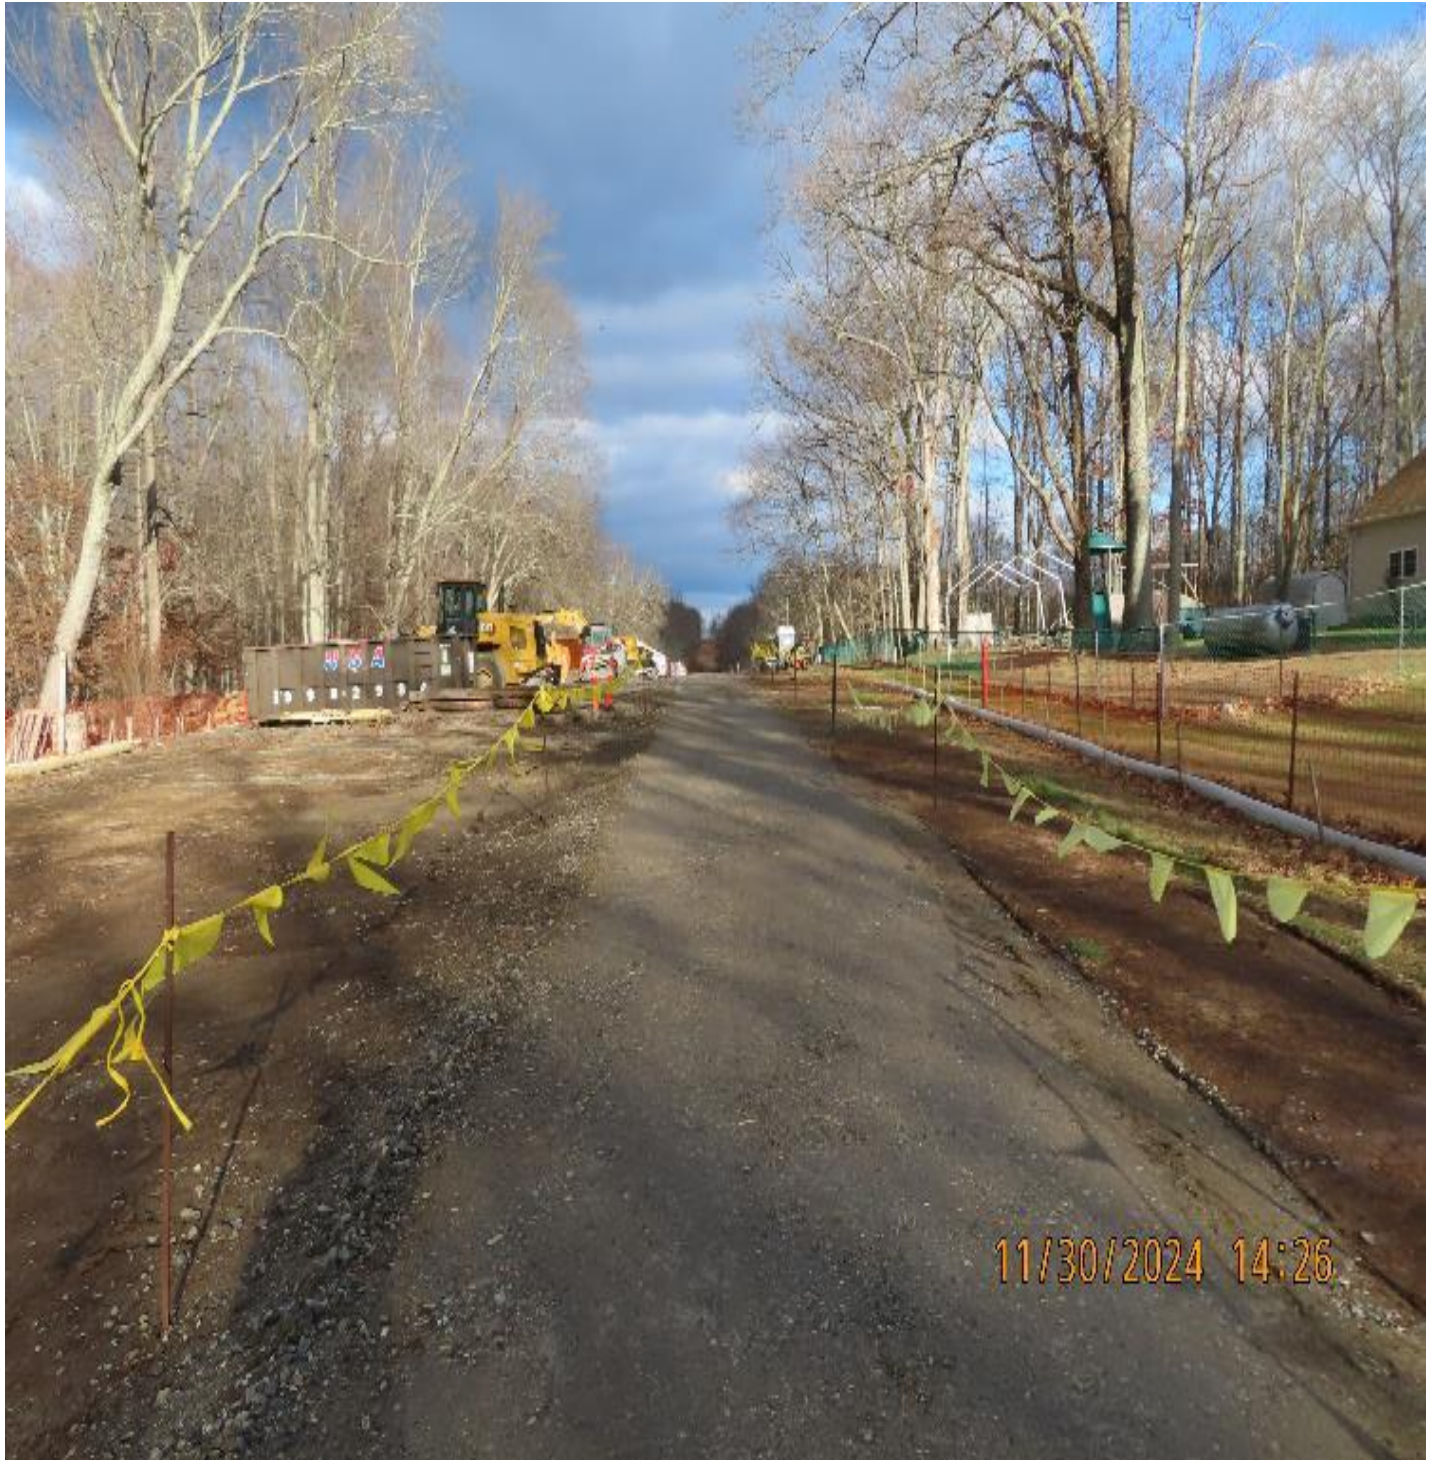
**Photo 2:** View (looking northeast) of access road after mats placed along the edges for parking and materials staging were removed. Soil decompaction and stabilization work in this area is pending.

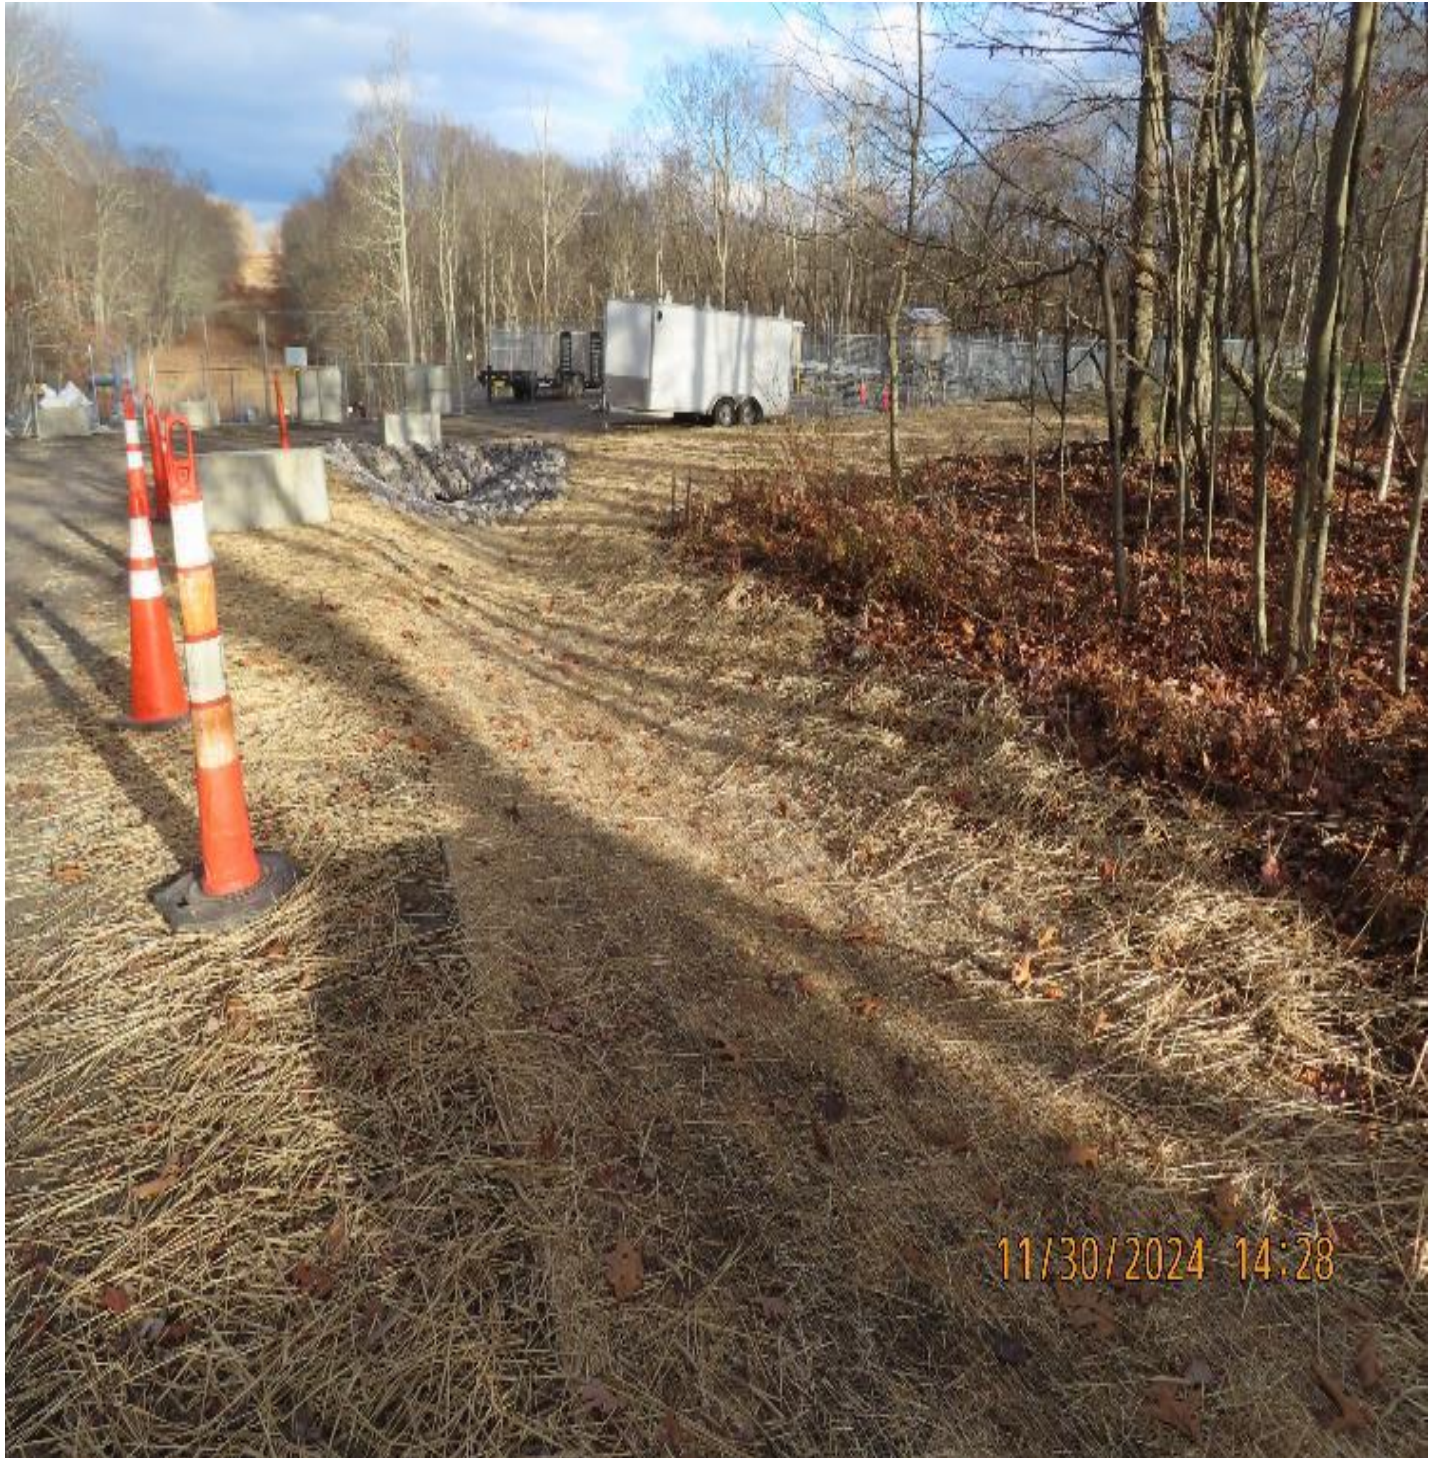
**Photo 3:** View (looking northeast) of stormwater swale along southwest side of valve yard after grading and temporary stabilization work.

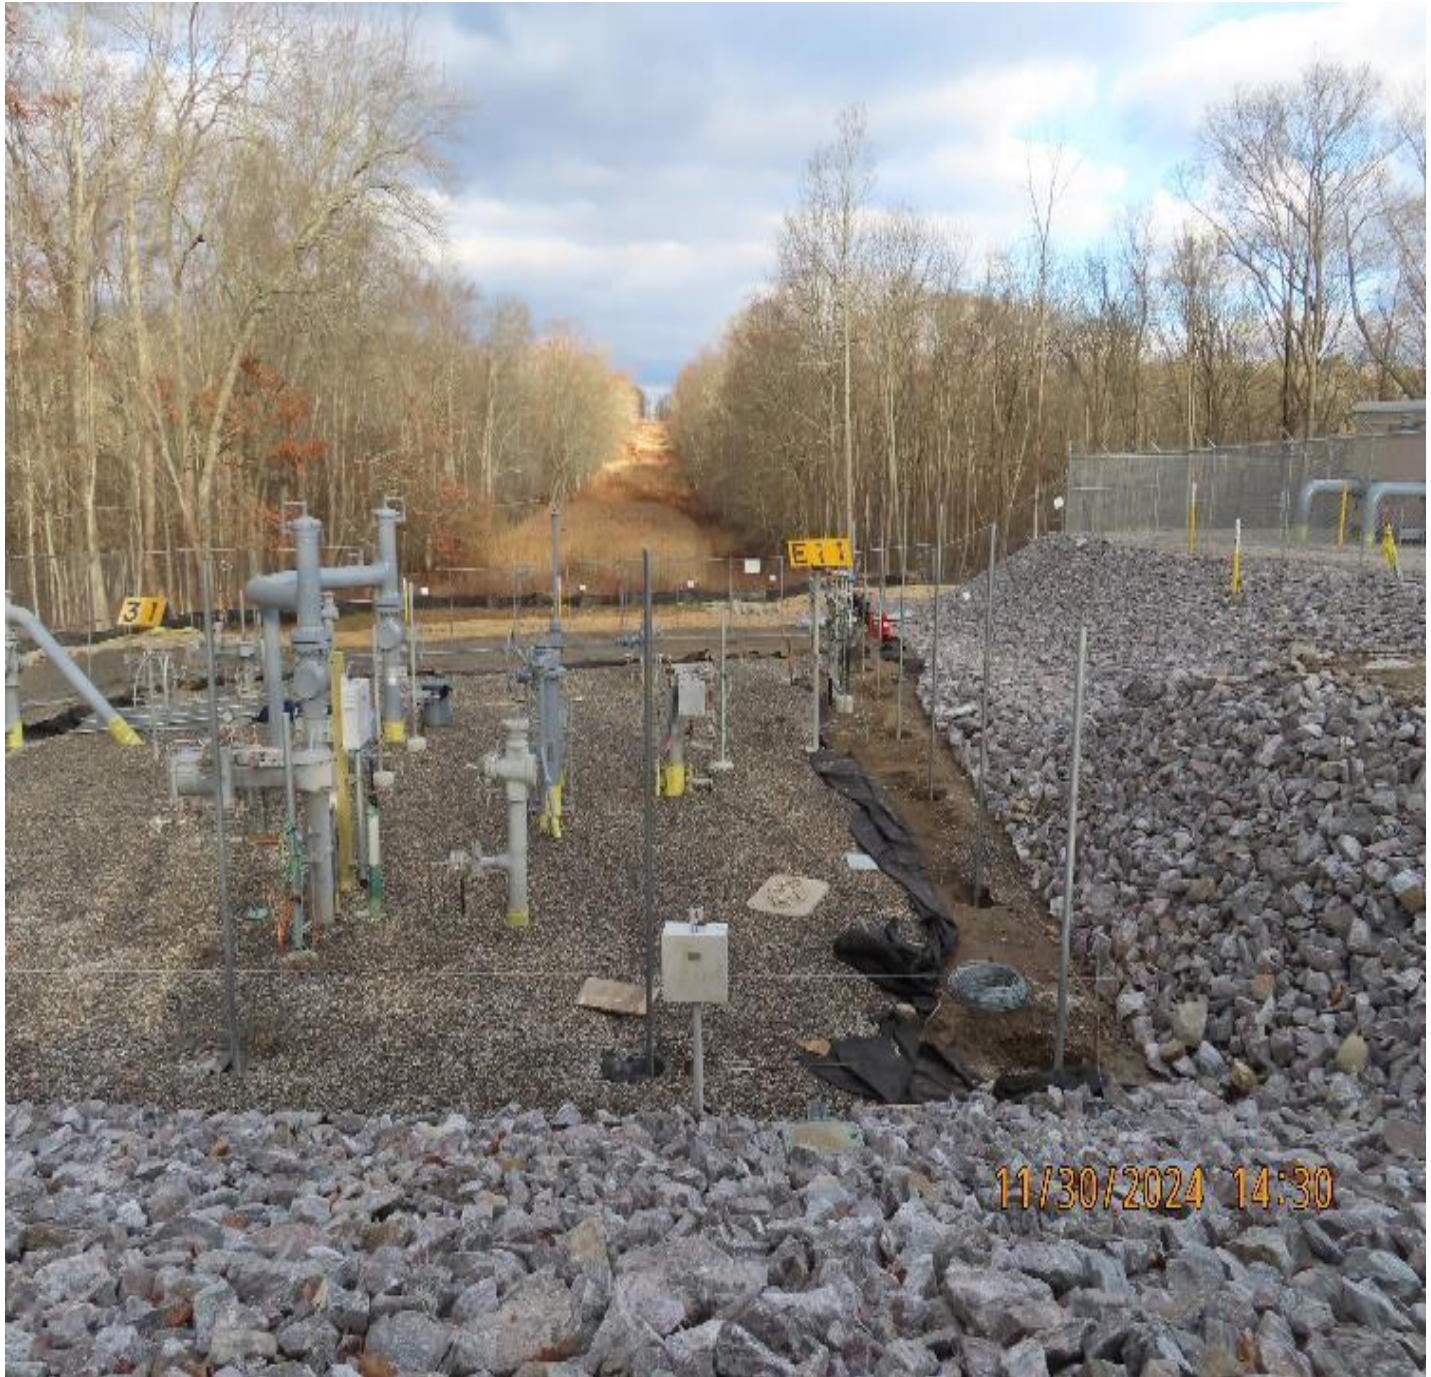
**Photo 4:** View (looking northeast) of valve yard with remaining security fence installation work in progress.

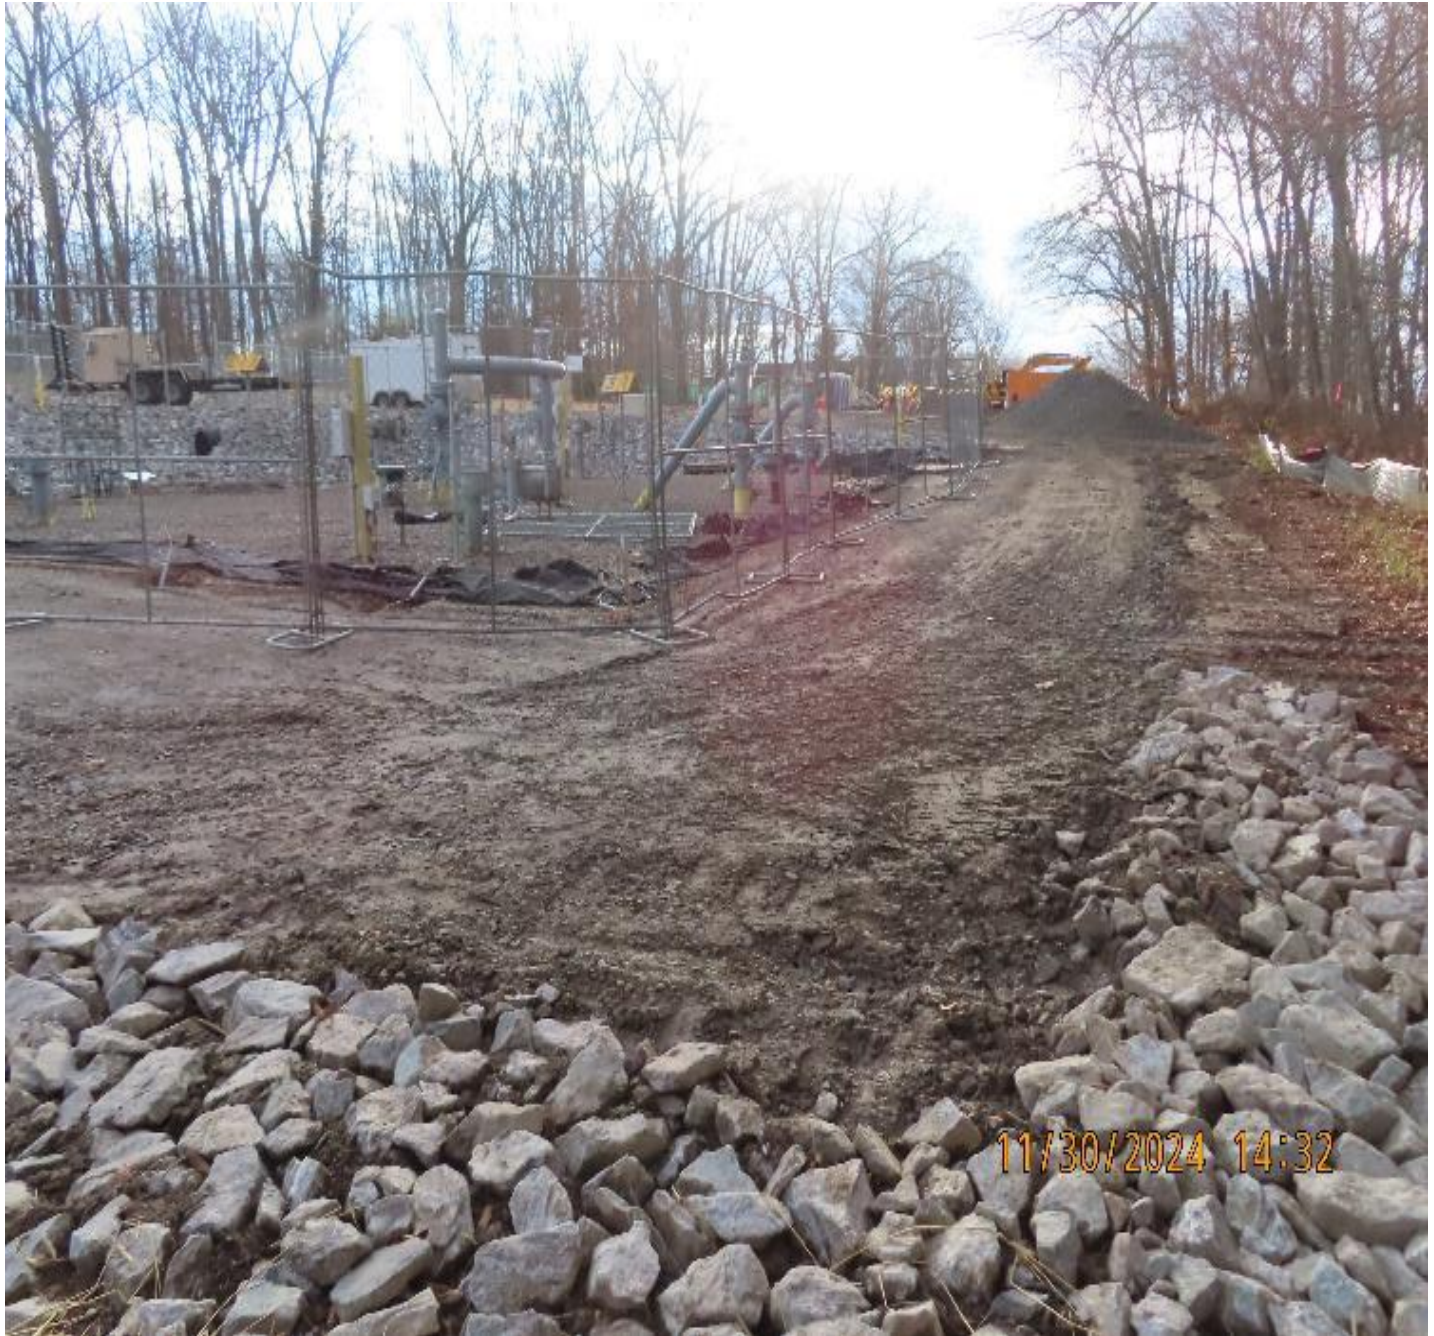
**Photo 5:** View (looking southwest) of new access road along west side of the valve yard after rough grading.

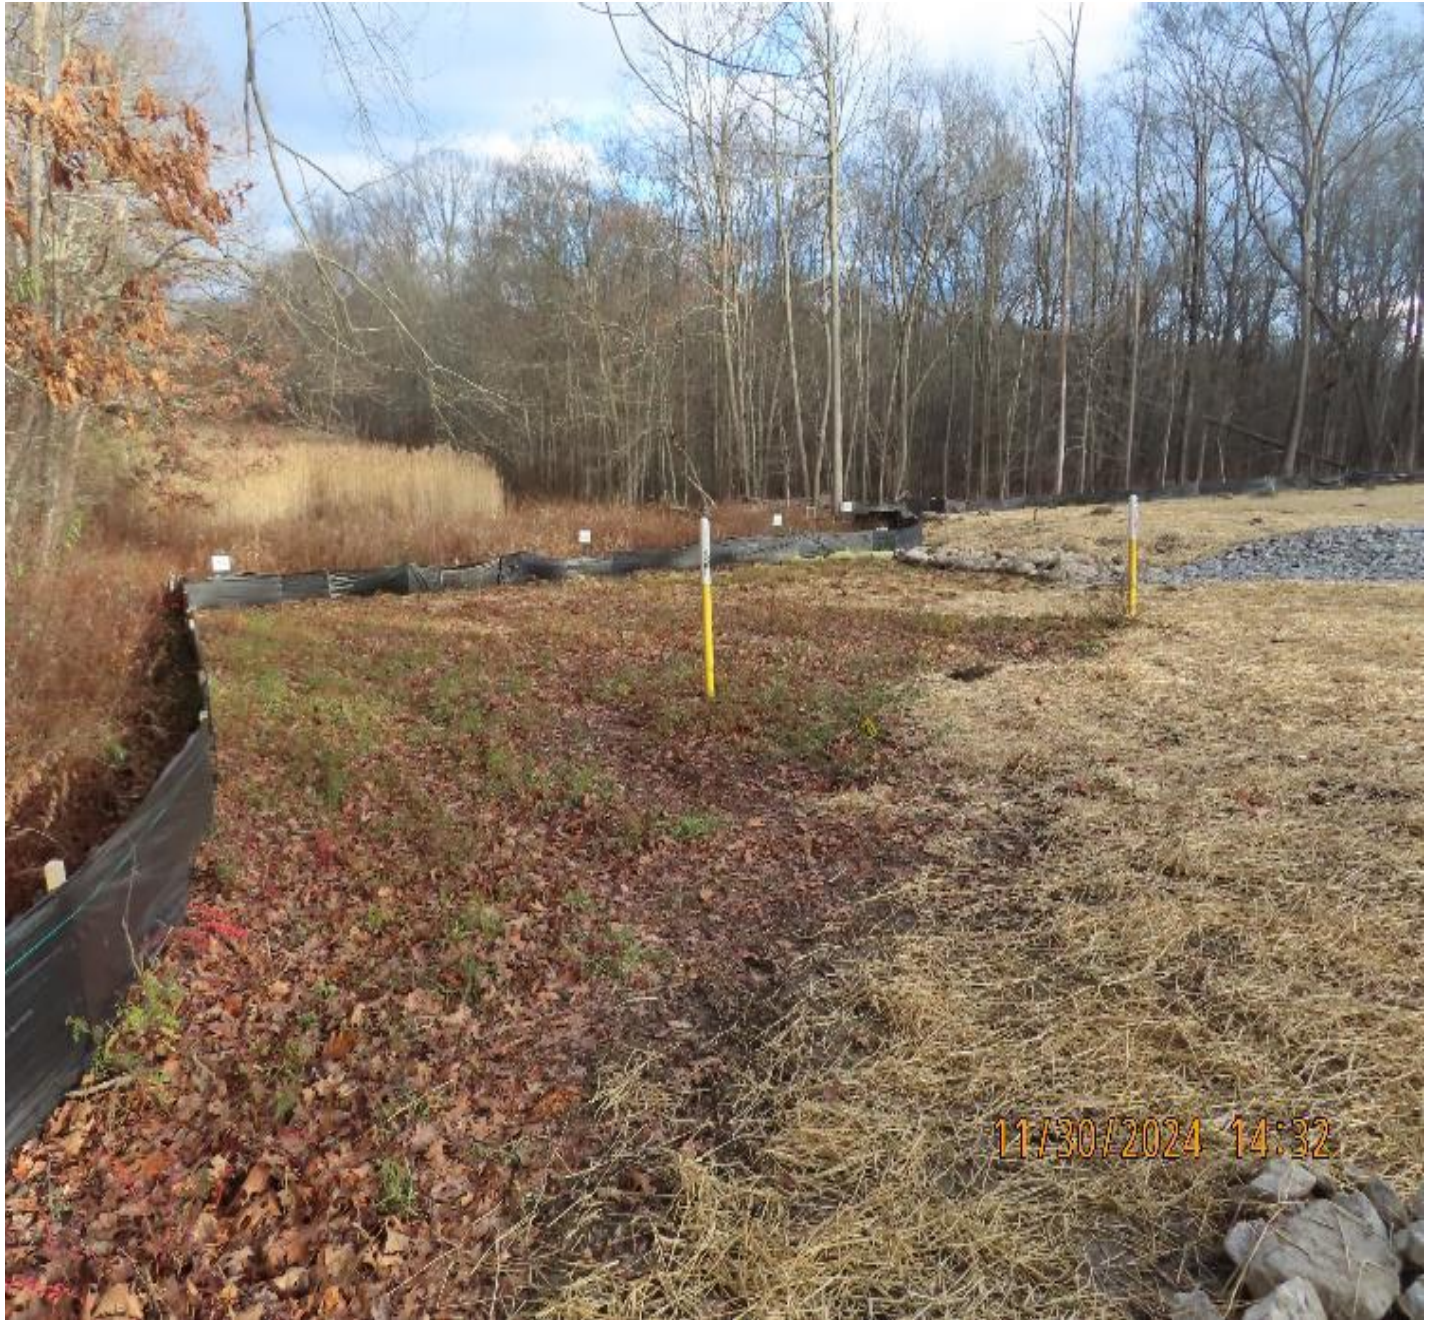
**Photo 6:** View (looking northeast) of silt fencing and recently stabilized ground downslope of the main work area.

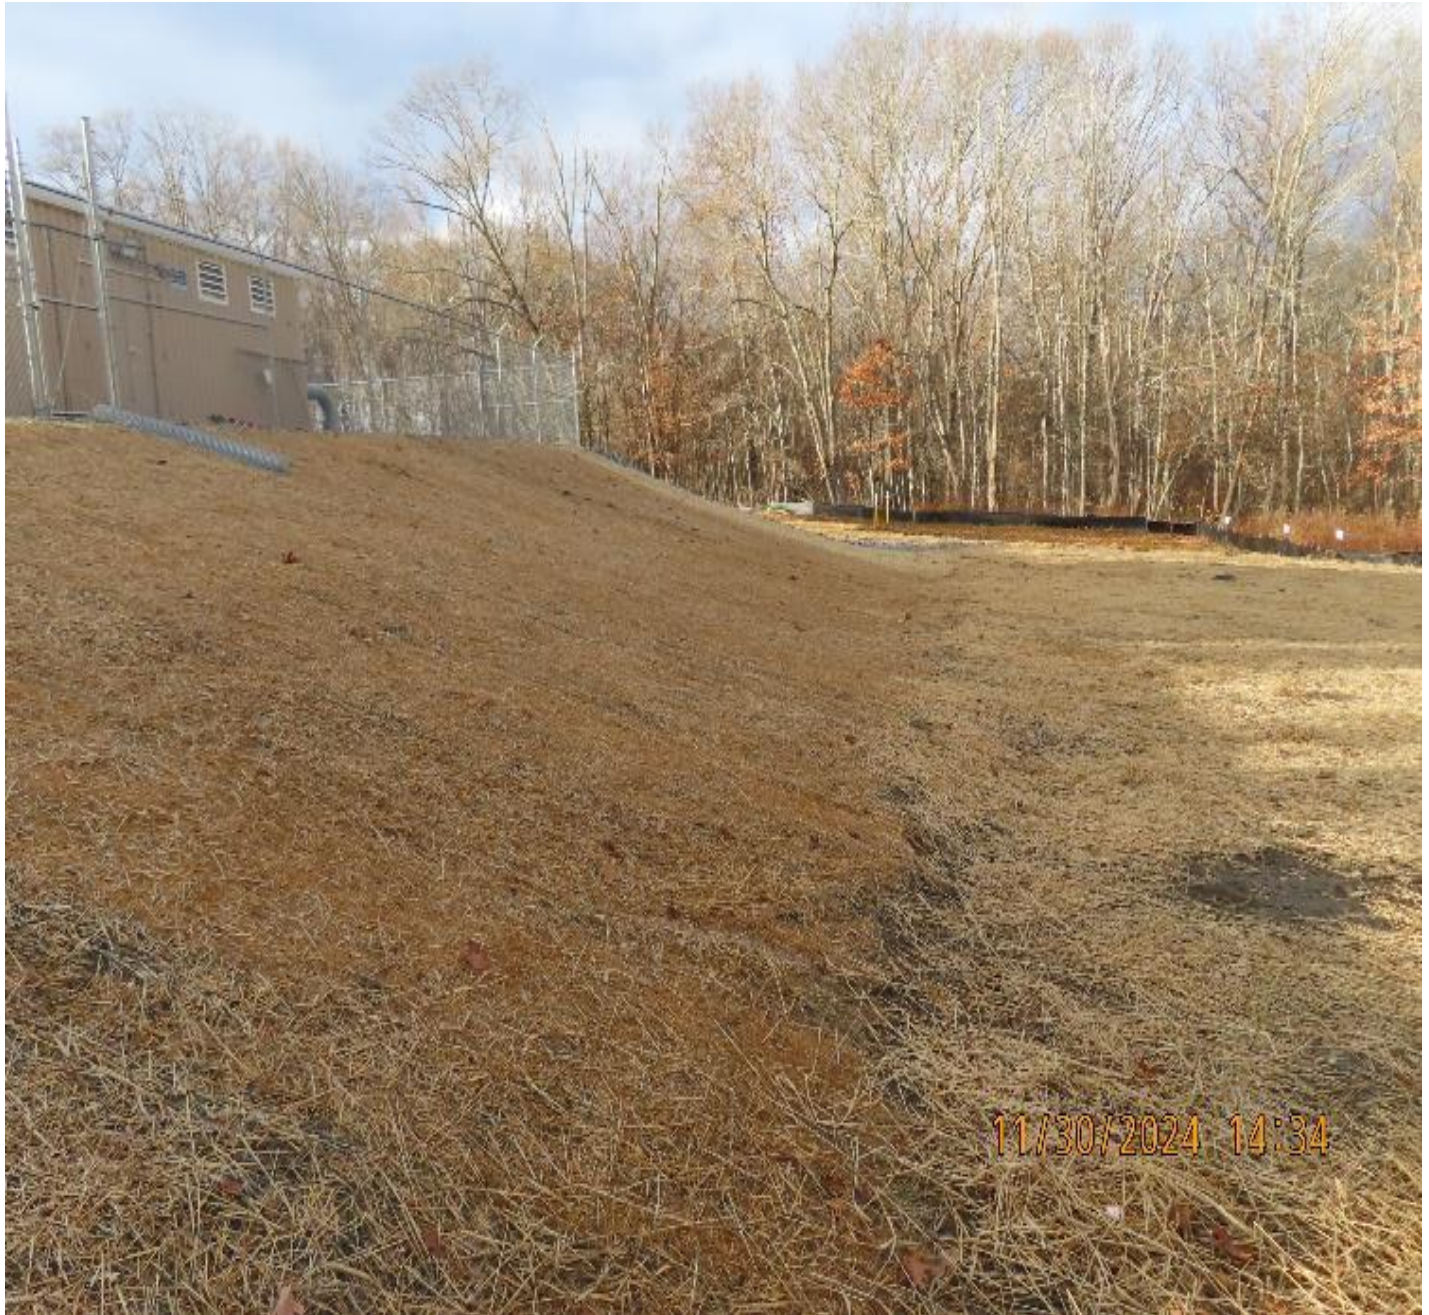
**Photo 7:** View (looking northwest) of stabilized slope along north side of new regulator building.

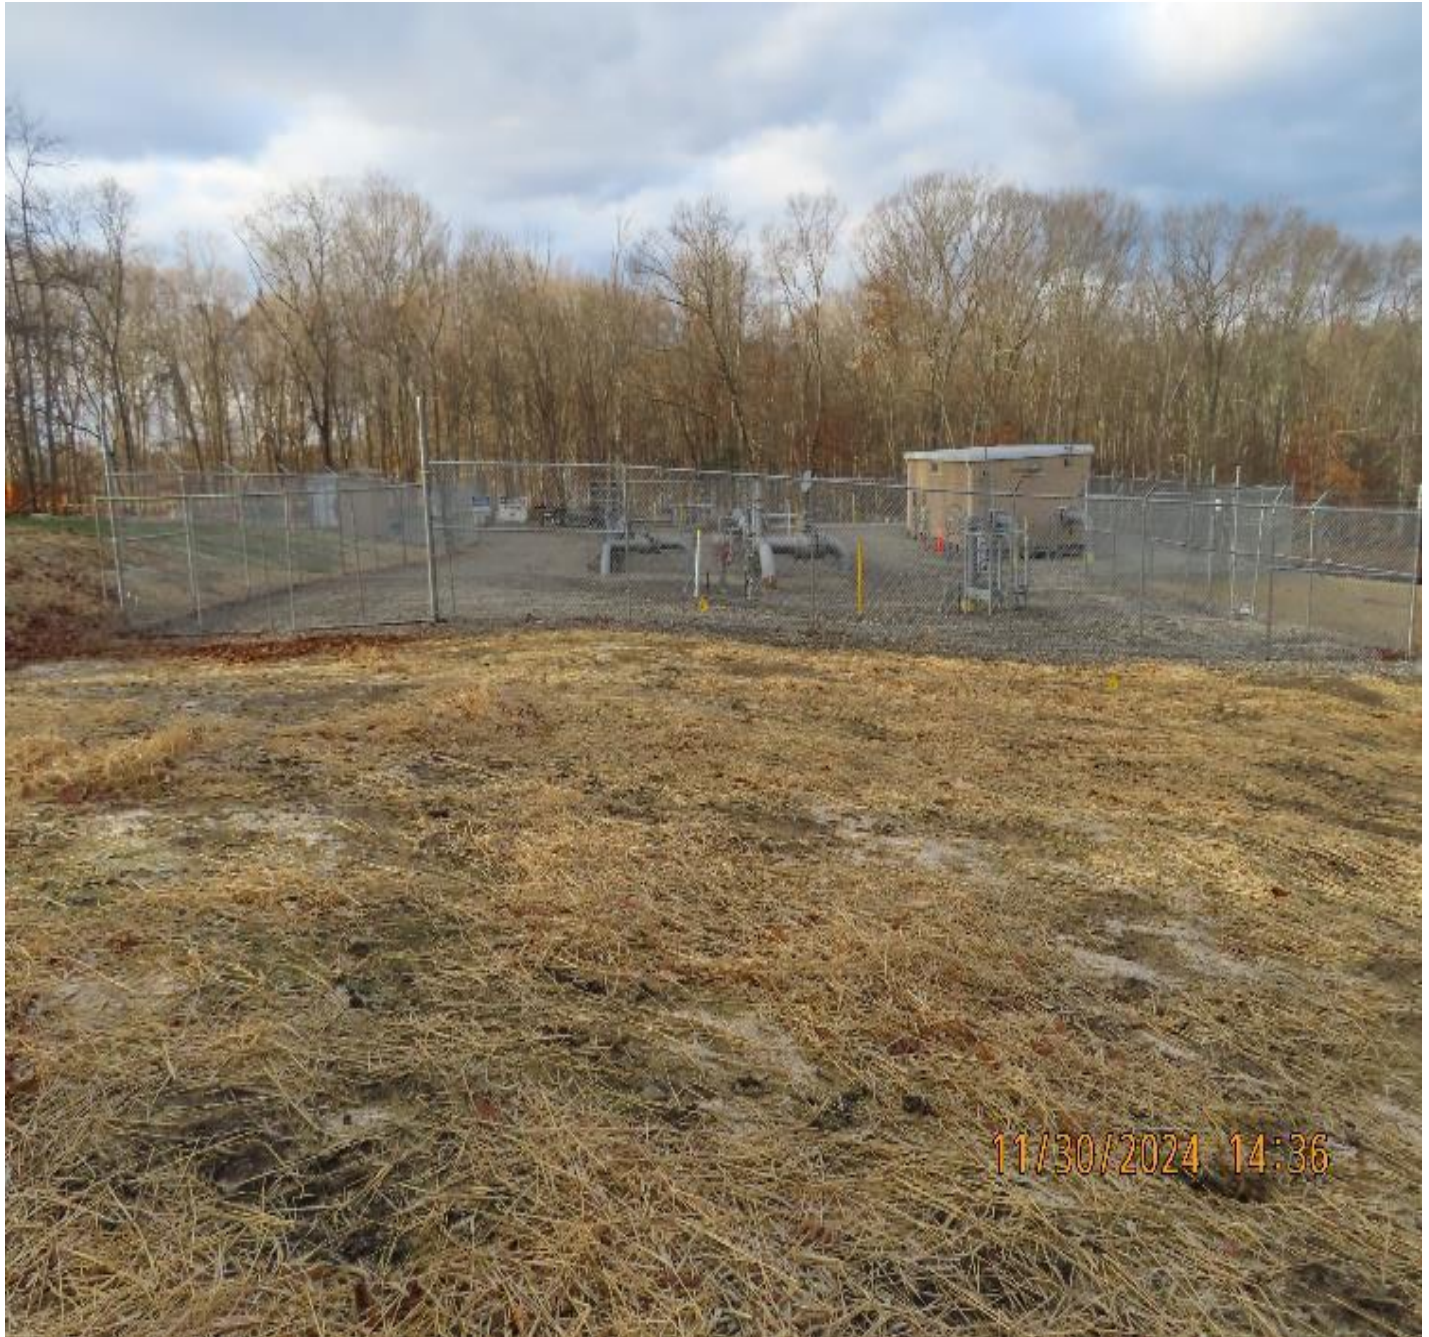
**Photo 8:** View (looking northwest) of valve yard after stone surfacing work was complete.
