Re: *Algonquin Gas Transmission, LLC*
E-1 System Regulator Installation Project, Docket No. CP24-21-000
Report No. 23

**E-1 System Regulation
WEEKLY REPORT #22**

Project:	E-1 System Regulation
FERC Docket Number:	CP24-21-000
Report Number:	22
Reporting Period:	December 12 through December 18, 2024

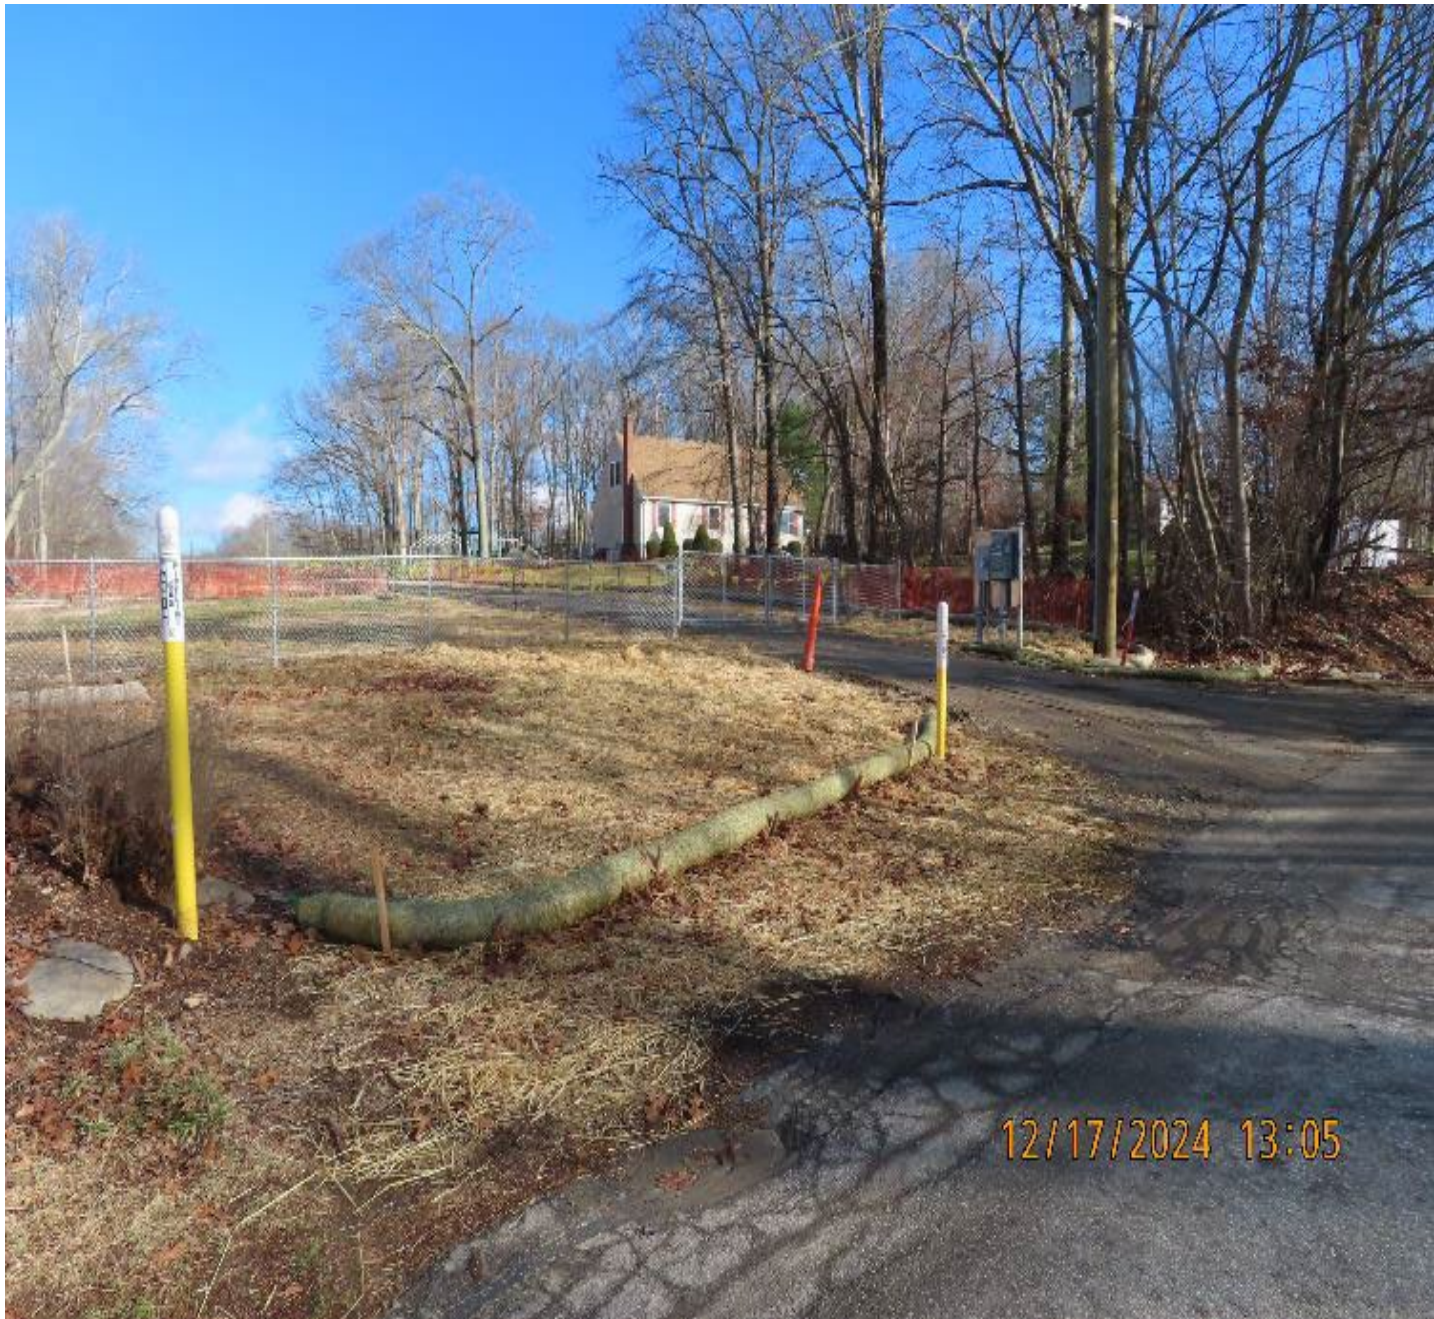
Photo 1: View (looking northeast) of site entrance off Hip Hop Road after contractor demobilization.

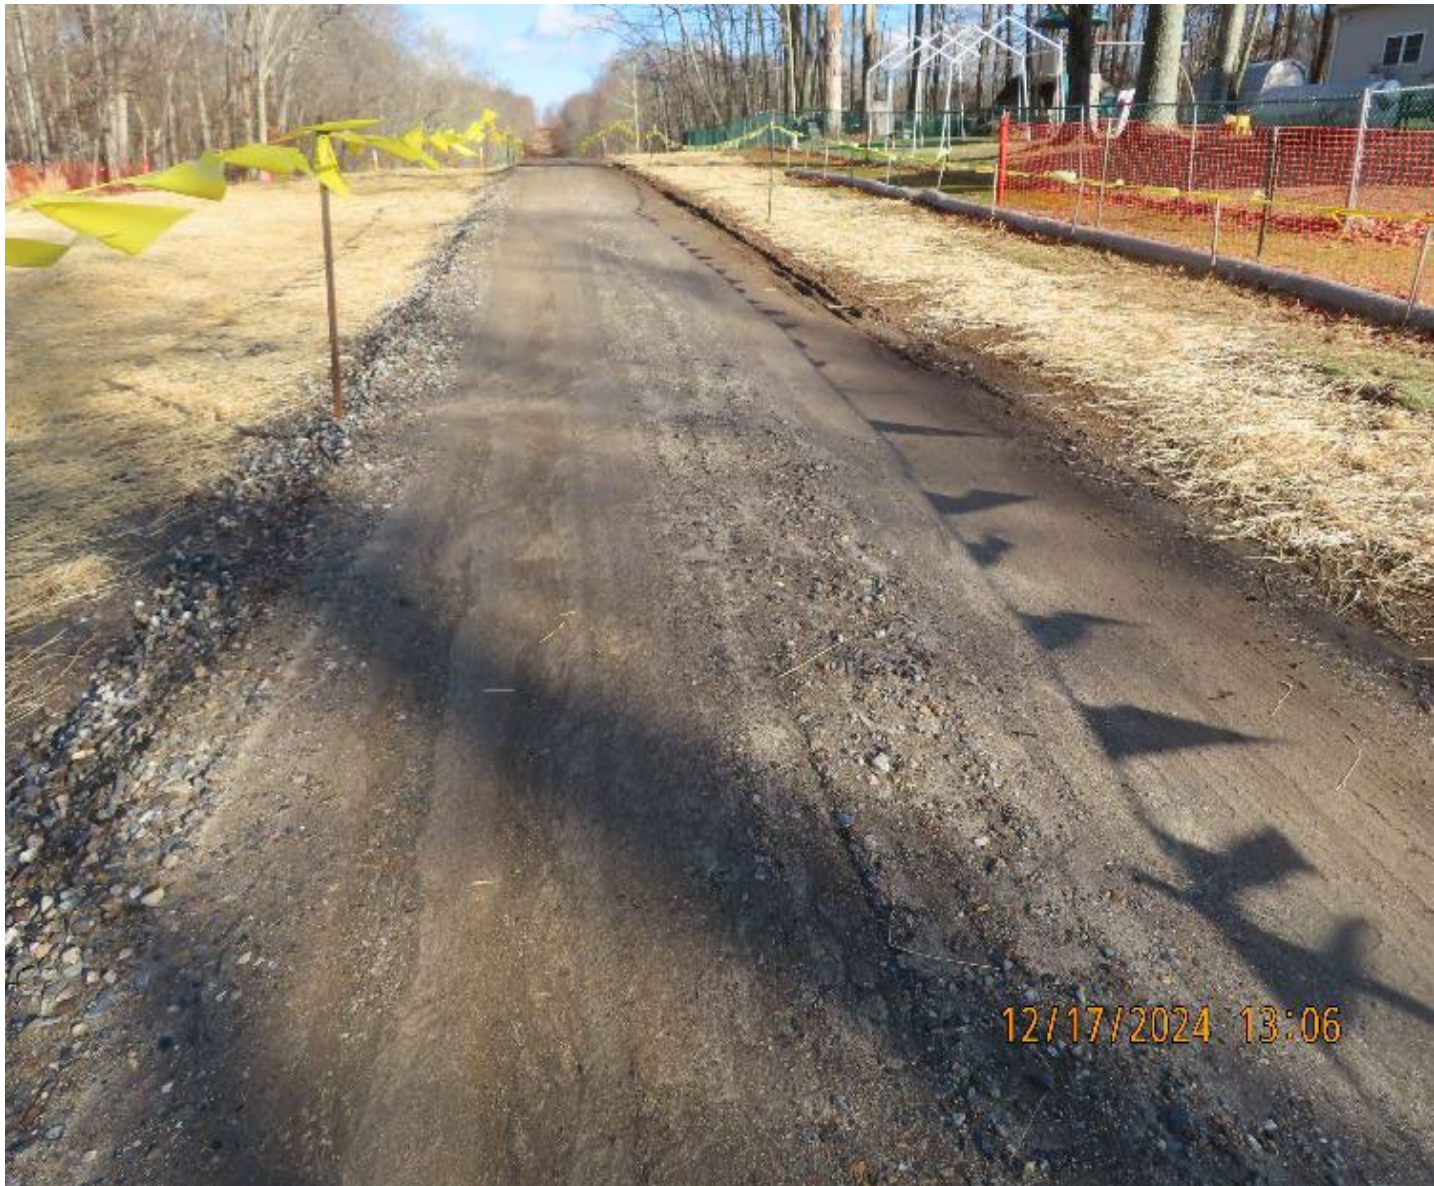
Photo 2: View (looking northeast) off access road after contractor demobilization.

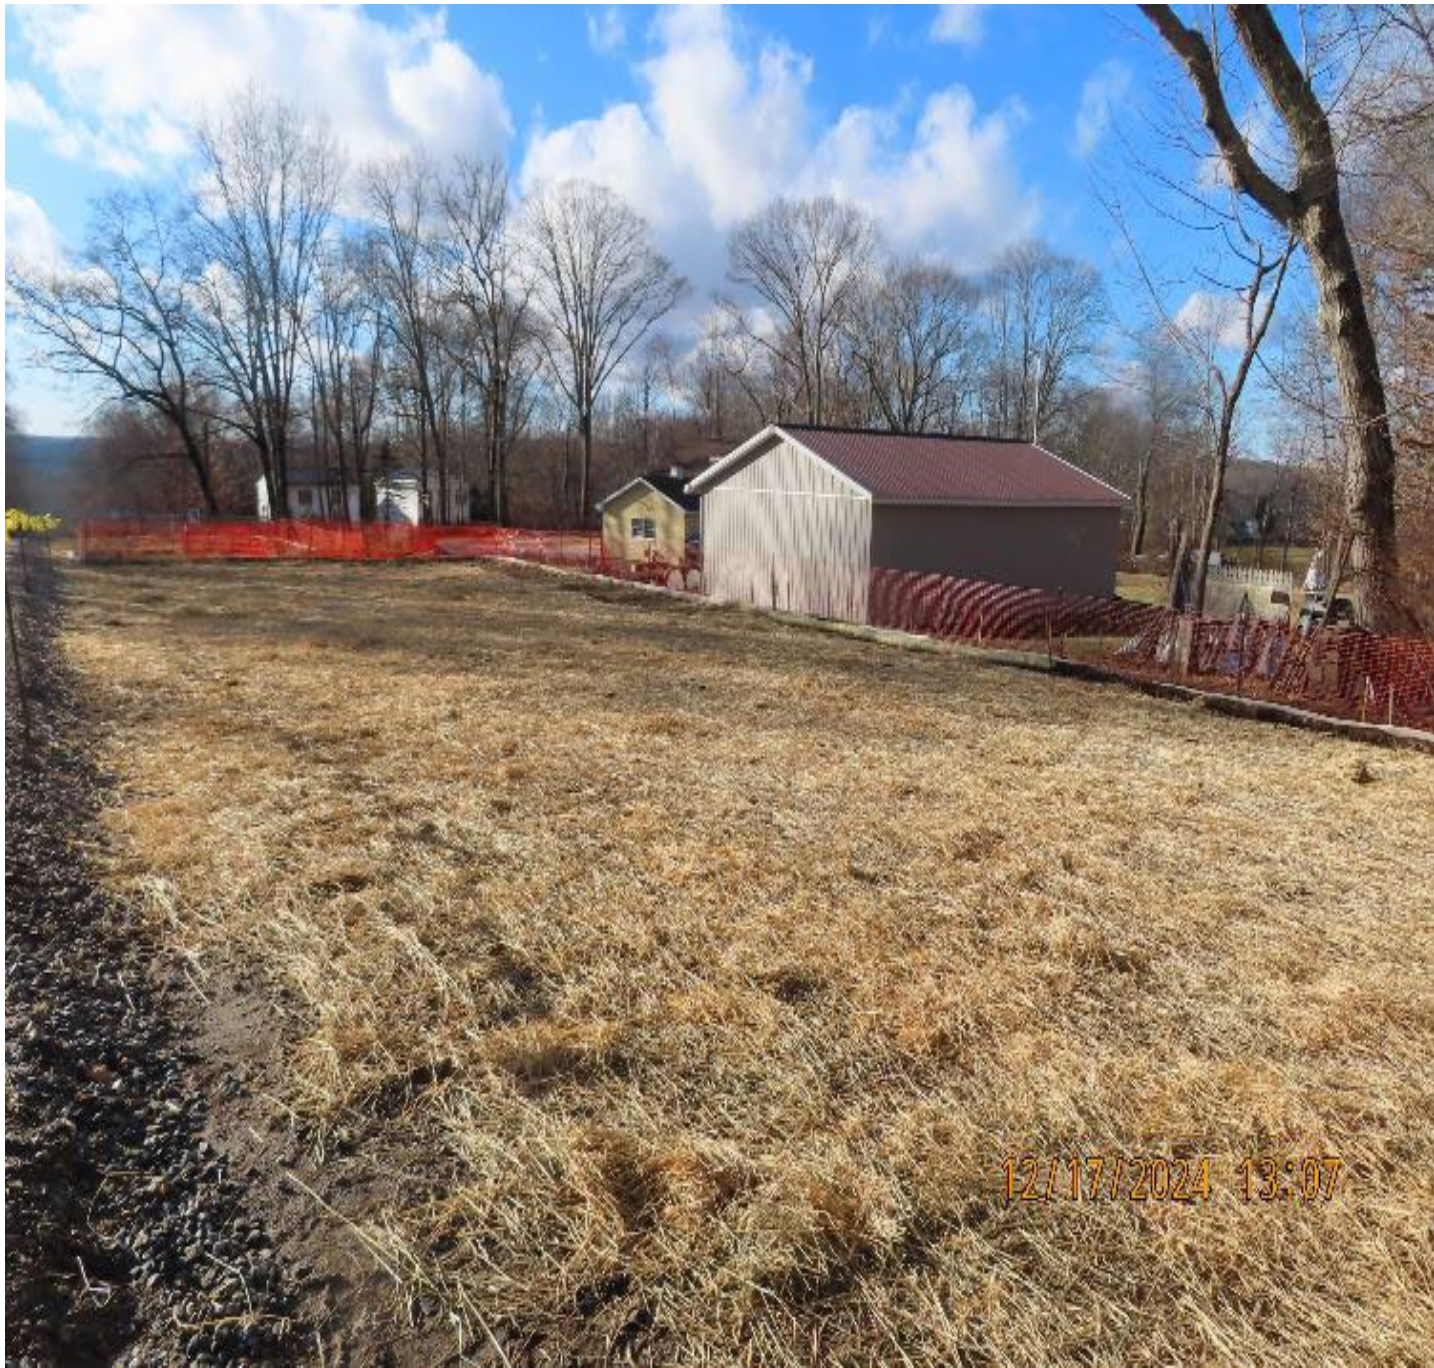
Photo 3: View (looking southwest) of former staging area after contractor demobilization.

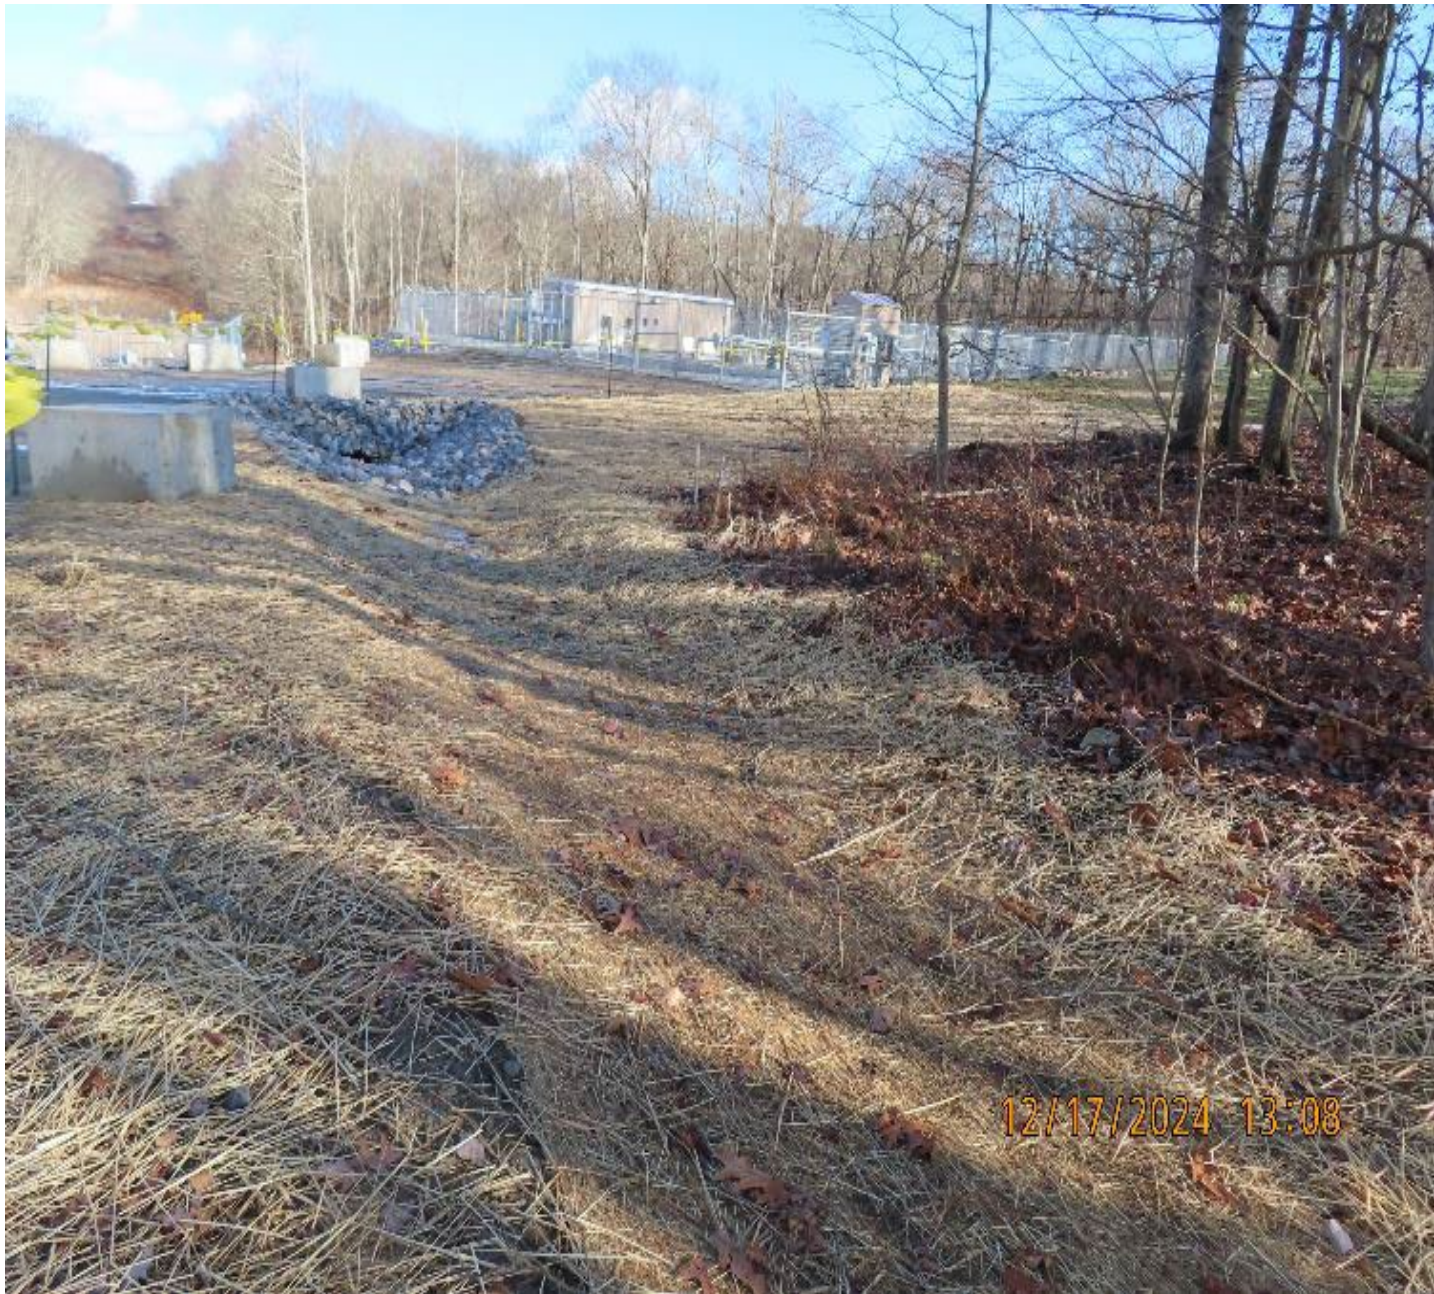
Photo 4: View (looking northeast) of drainage swale draining to culvert in central area of site.

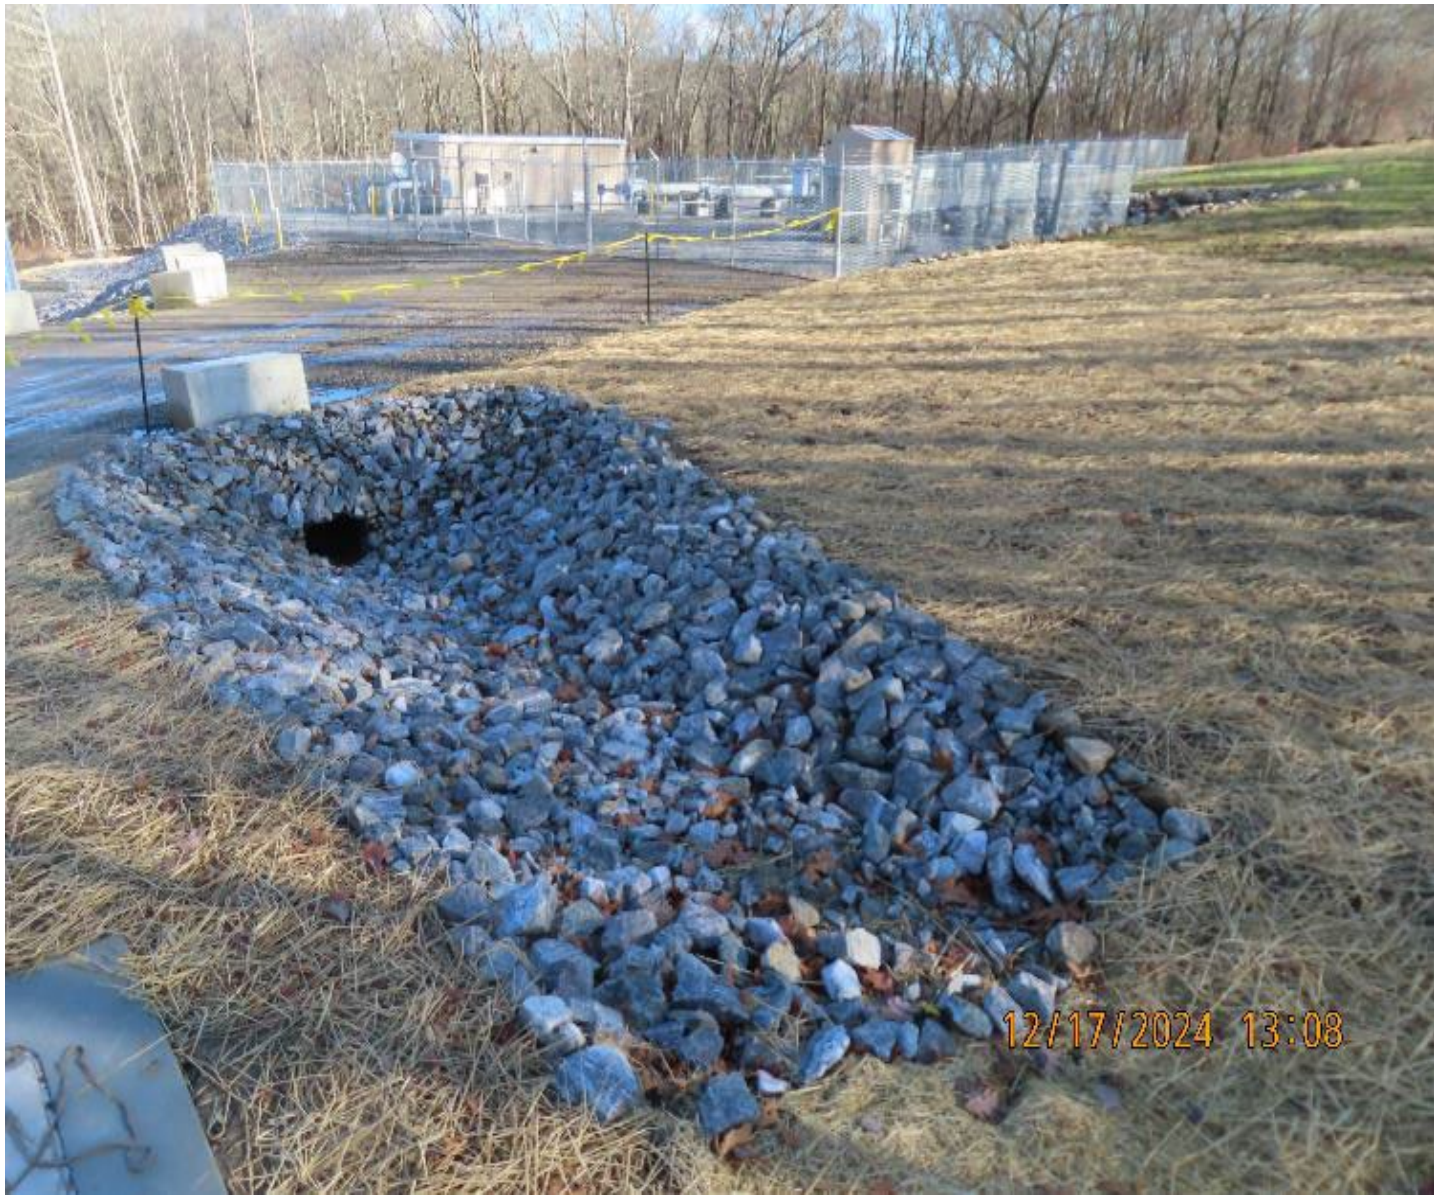
Photo 5: View (looking east) of rock-stabilized culvert inlet.

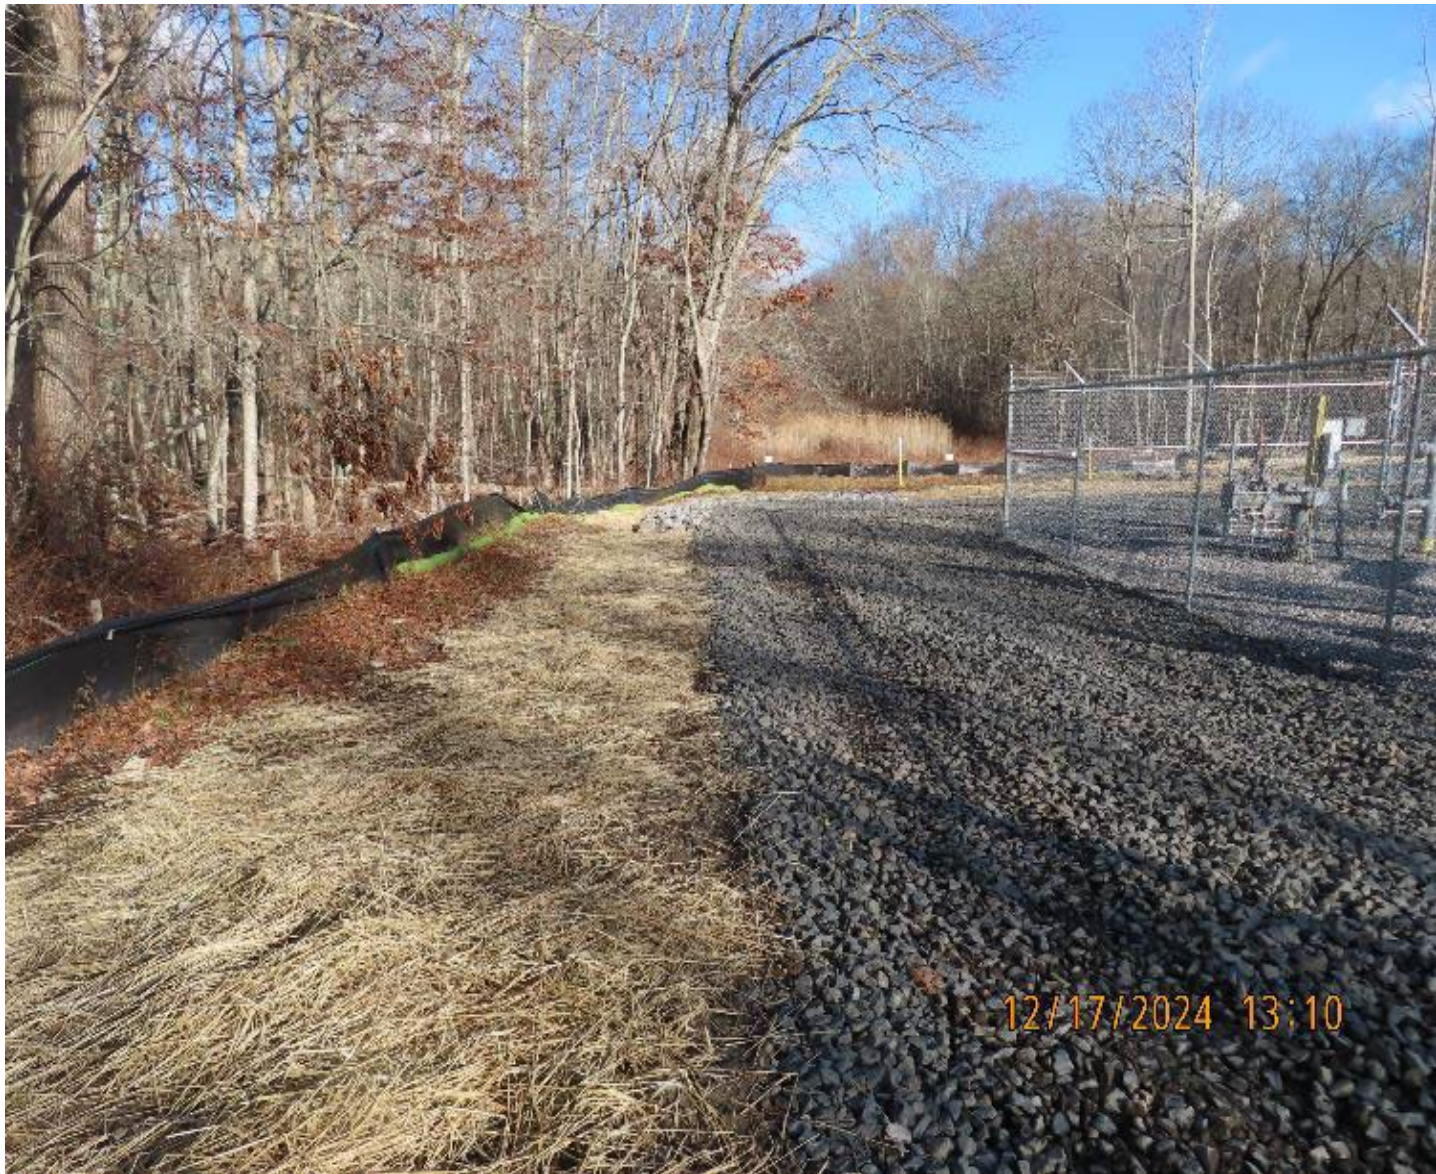
Photo 6: View (looking northeast) of rock travel lane constructed along west side of the valve yard.

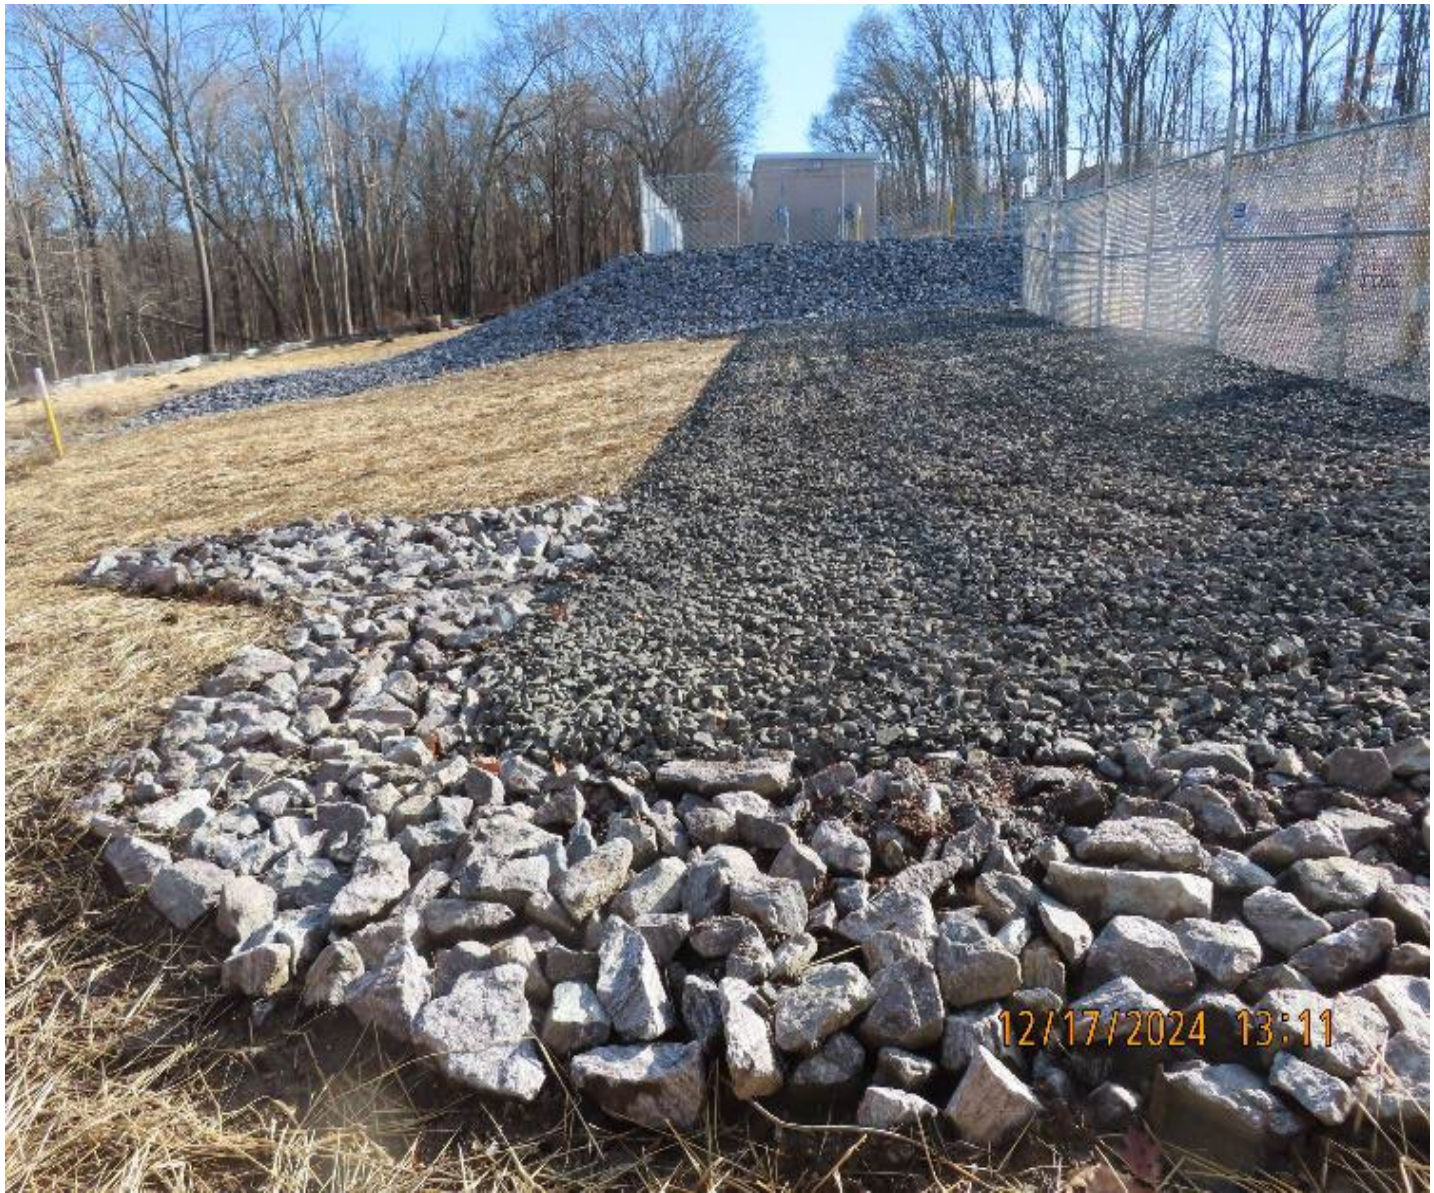
Photo 7: View (looking east) along north side of the valve yard.

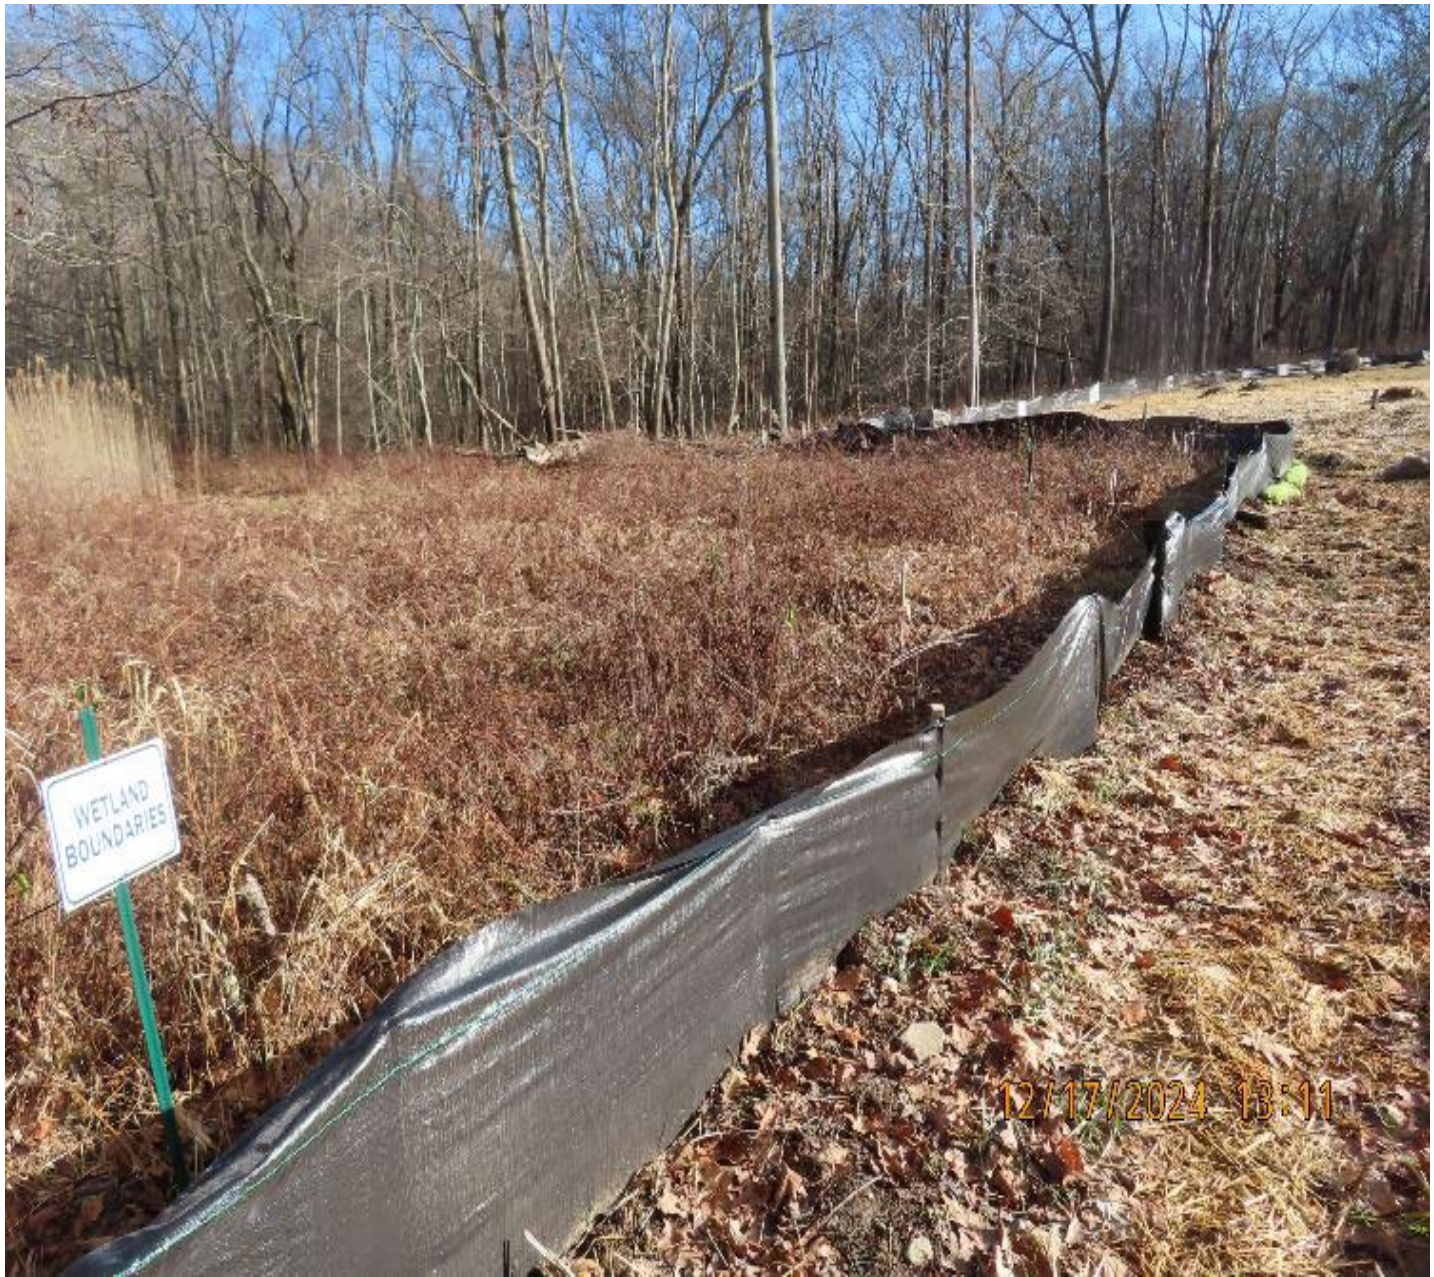
Photo 8: View (looking northeast) of silt fence between restored workspace and wetland W-CZ-01.

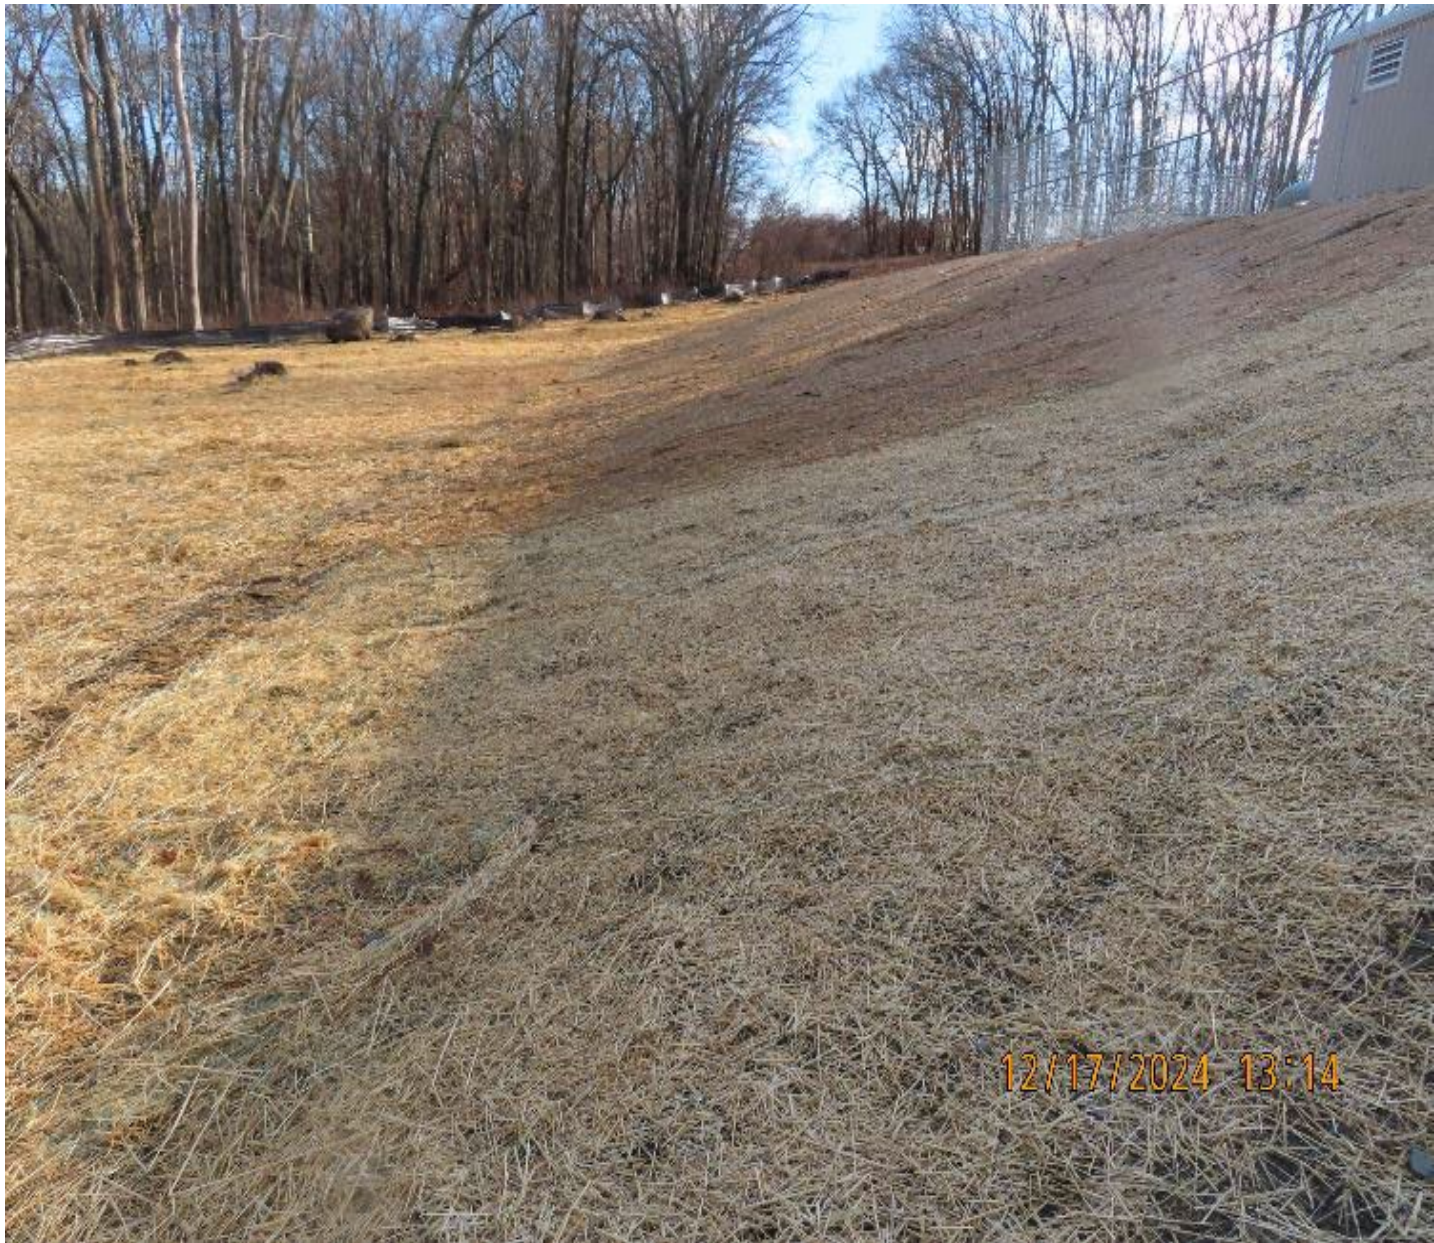
Photo 9: View (looking east) of stabilized slope along north side of the new regulator building.

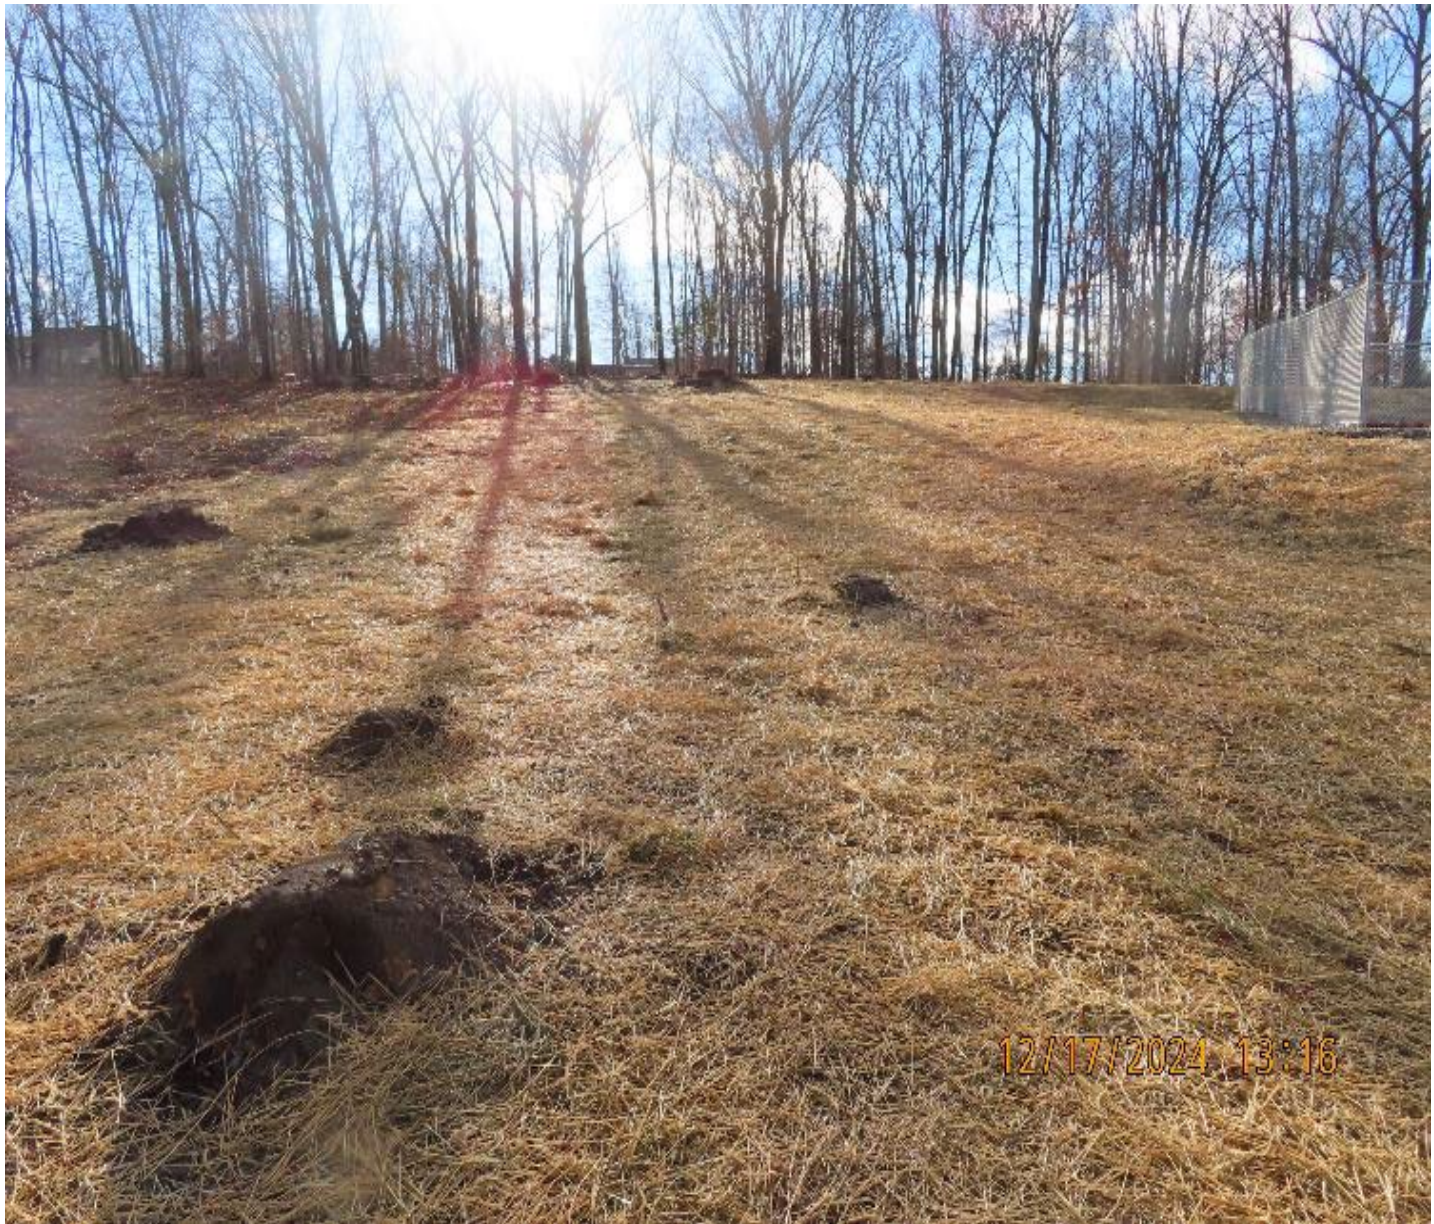
Photo 10: View (looking southeast) of stabilized area on east side of new regulator building.
