Re: *Algonquin Gas Transmission, LLC*
E-1 System Regulator Installation Project, Docket No. CP24-21-000
Report No. 26

**E-1 System Regulation
WEEKLY REPORT #26**

Project:	E-1 System Regulation
FERC Docket Number:	CP24-21-000
Report Number:	26
Reporting Period:	January 2 through January 8, 2024

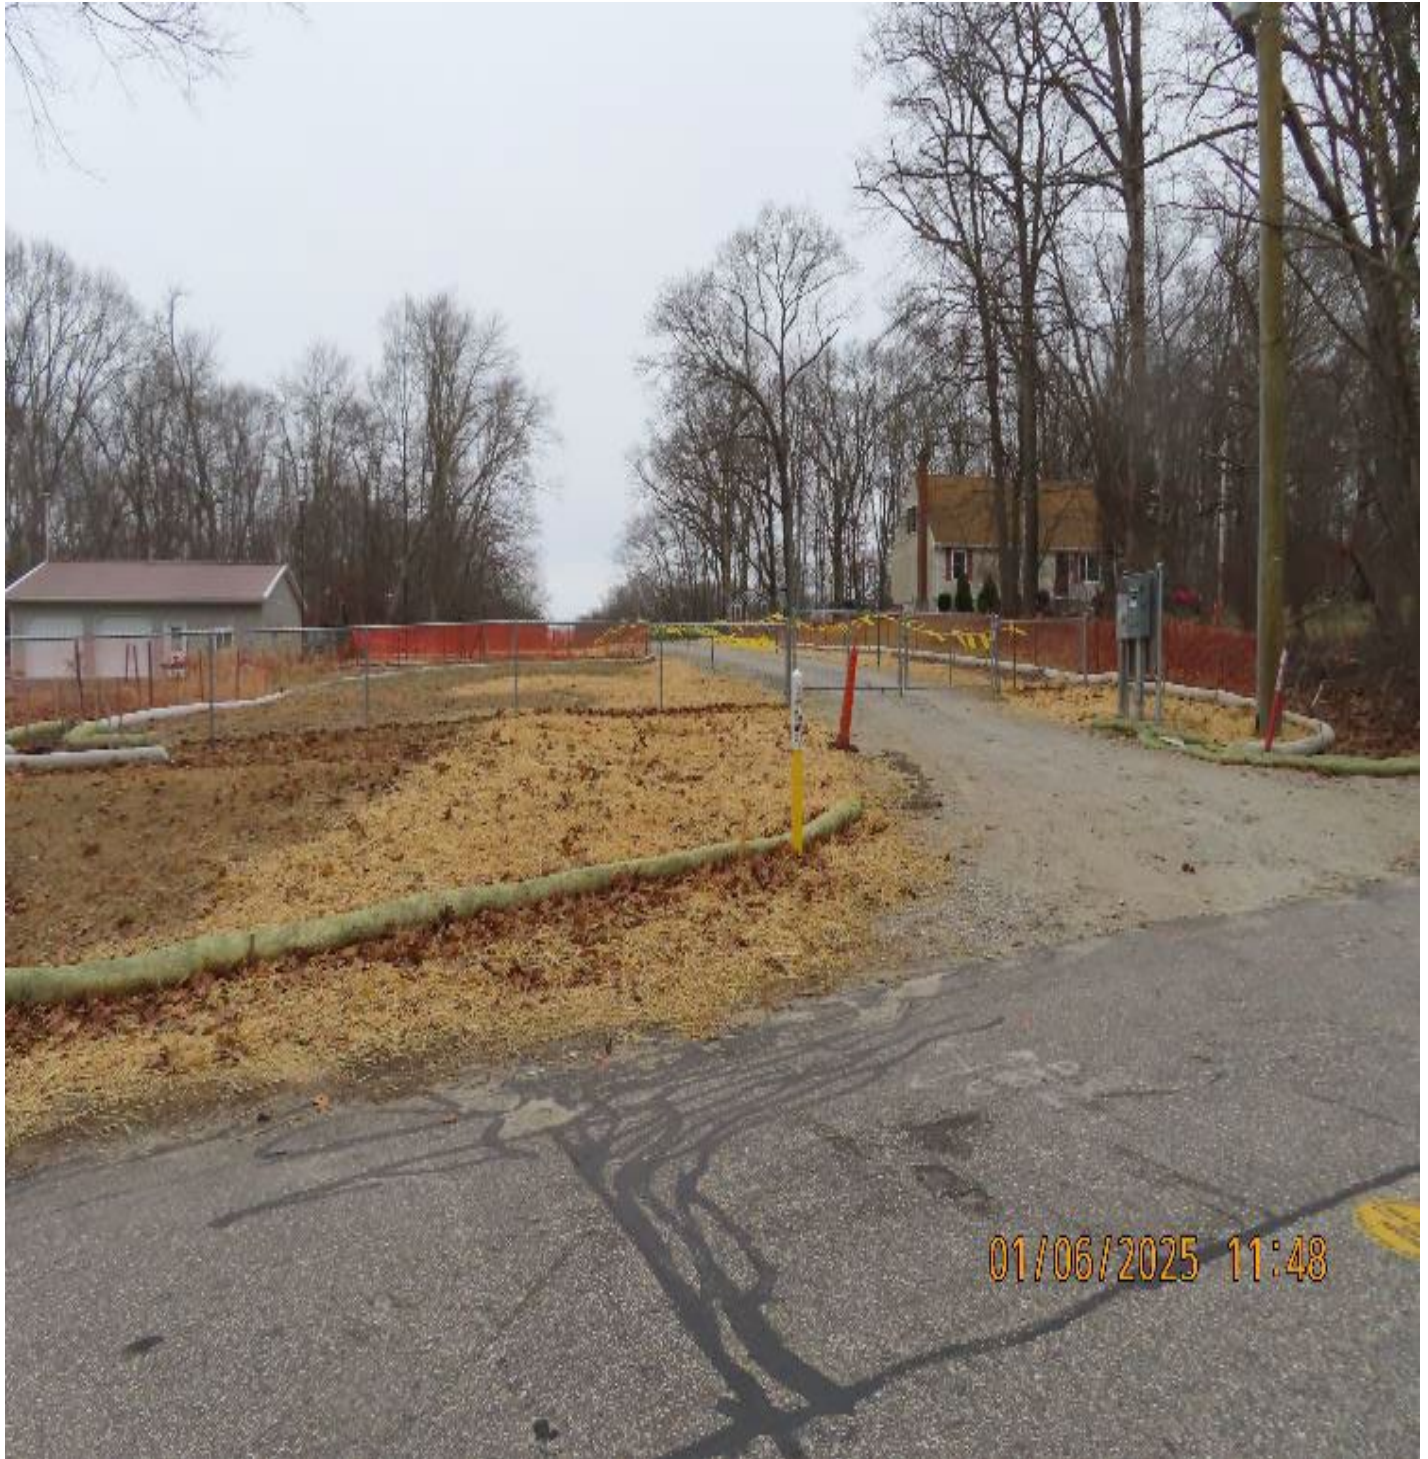
Photo 1: View (looking northeast) of site entrance off Hop River Road.

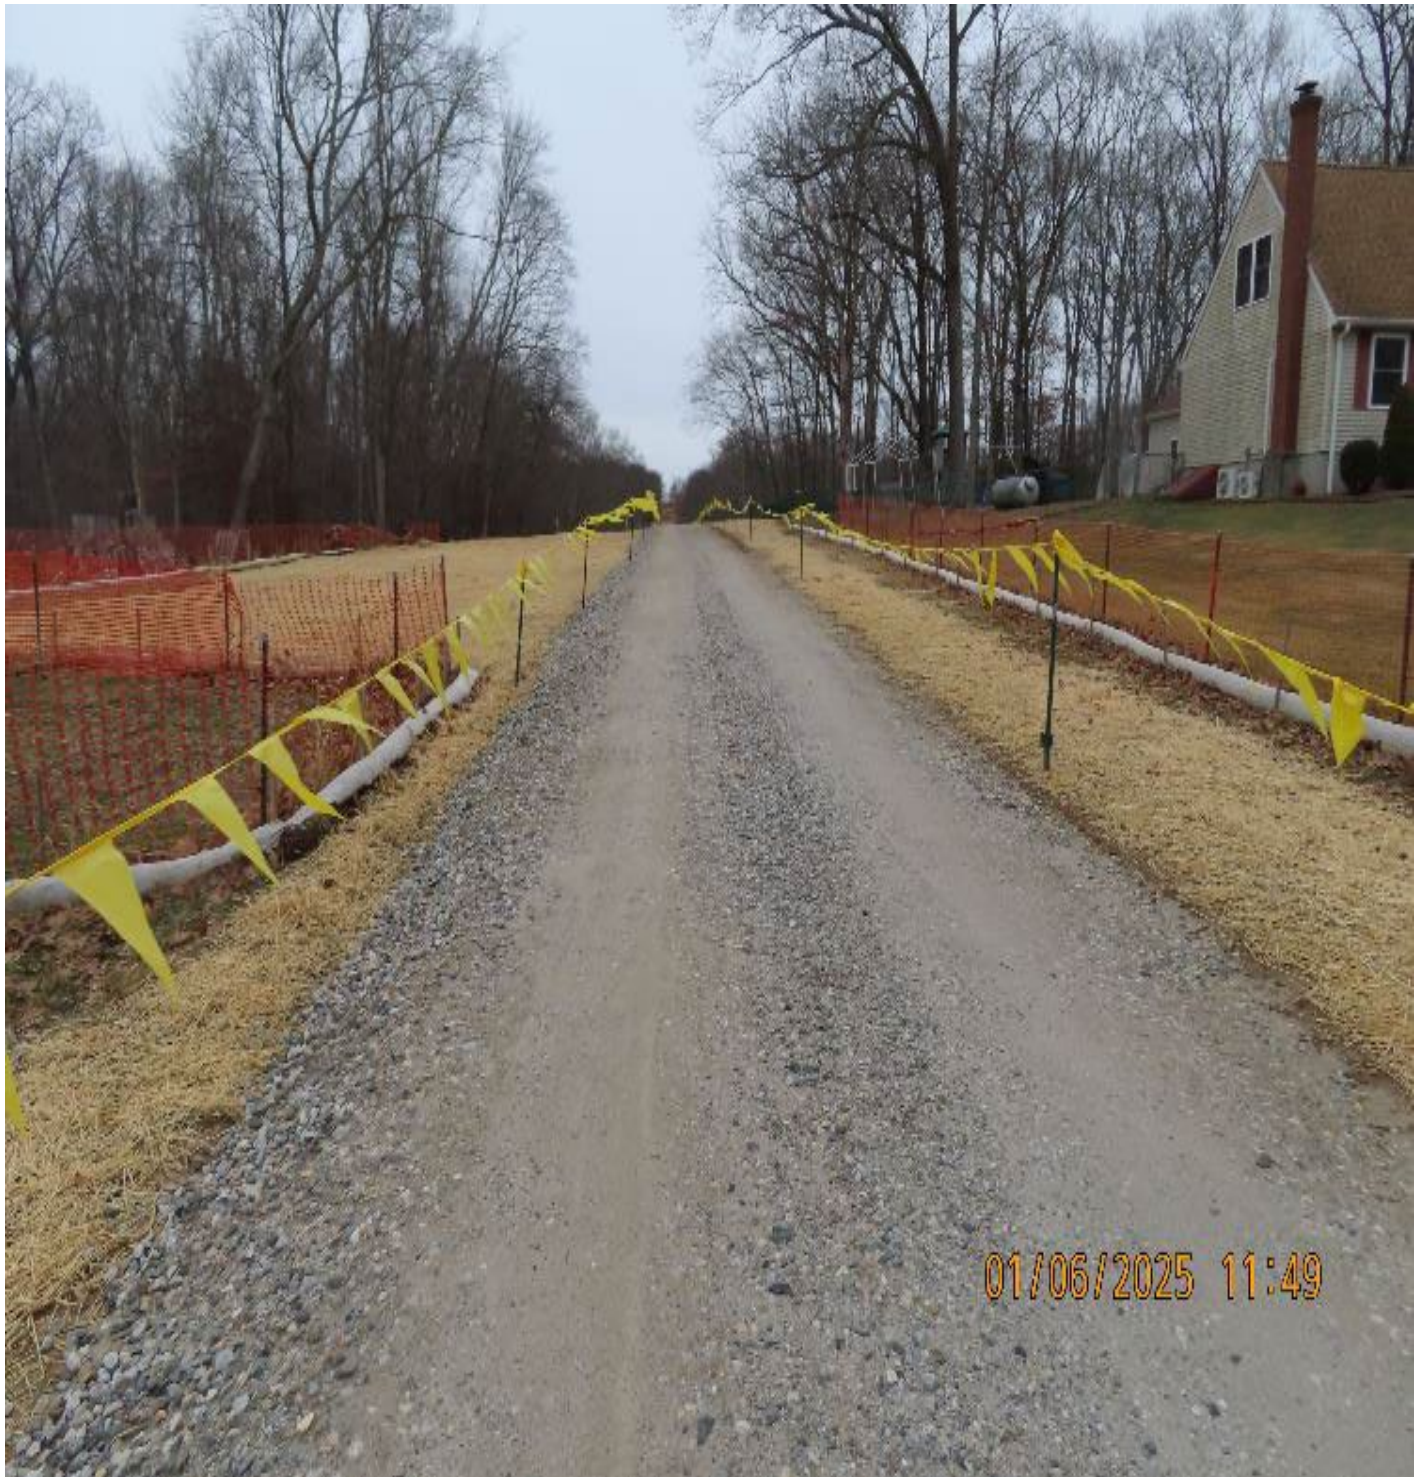
Photo 2: View (looking northeast) of access road conditions in residential area.

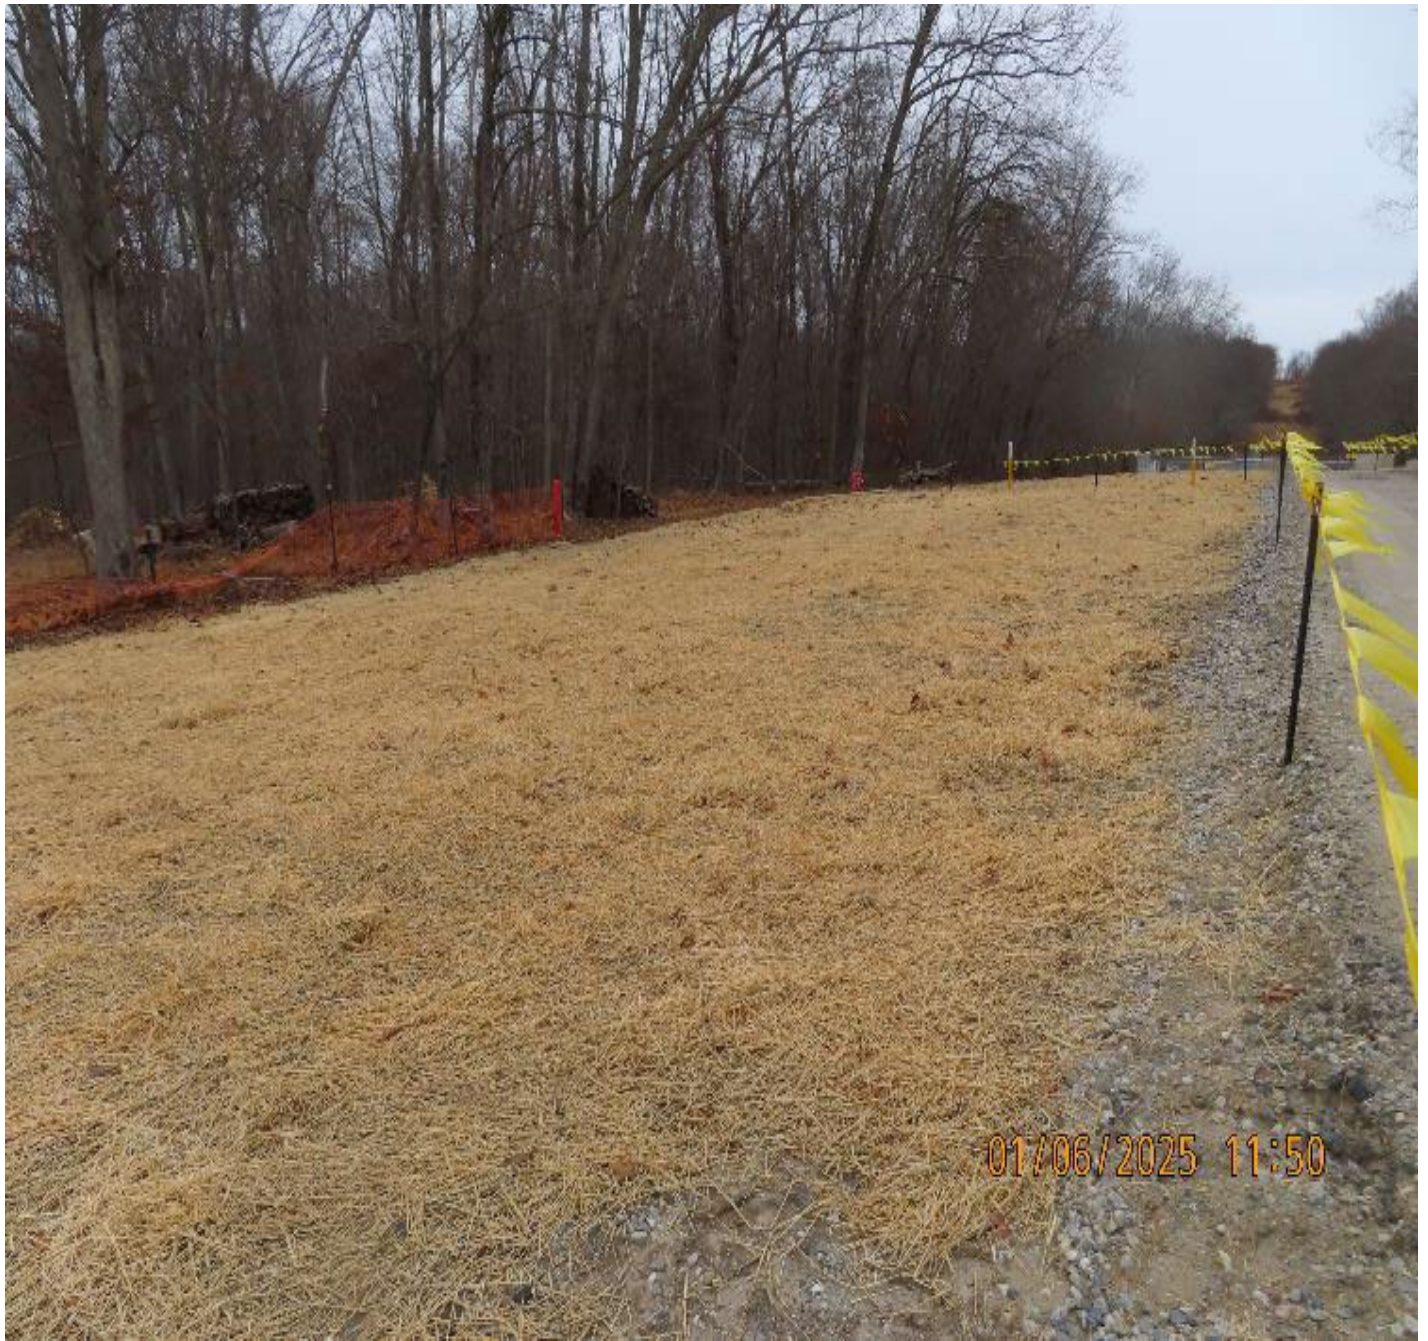
Photo 3: View (looking northeast) of former job trailer and refueling area.

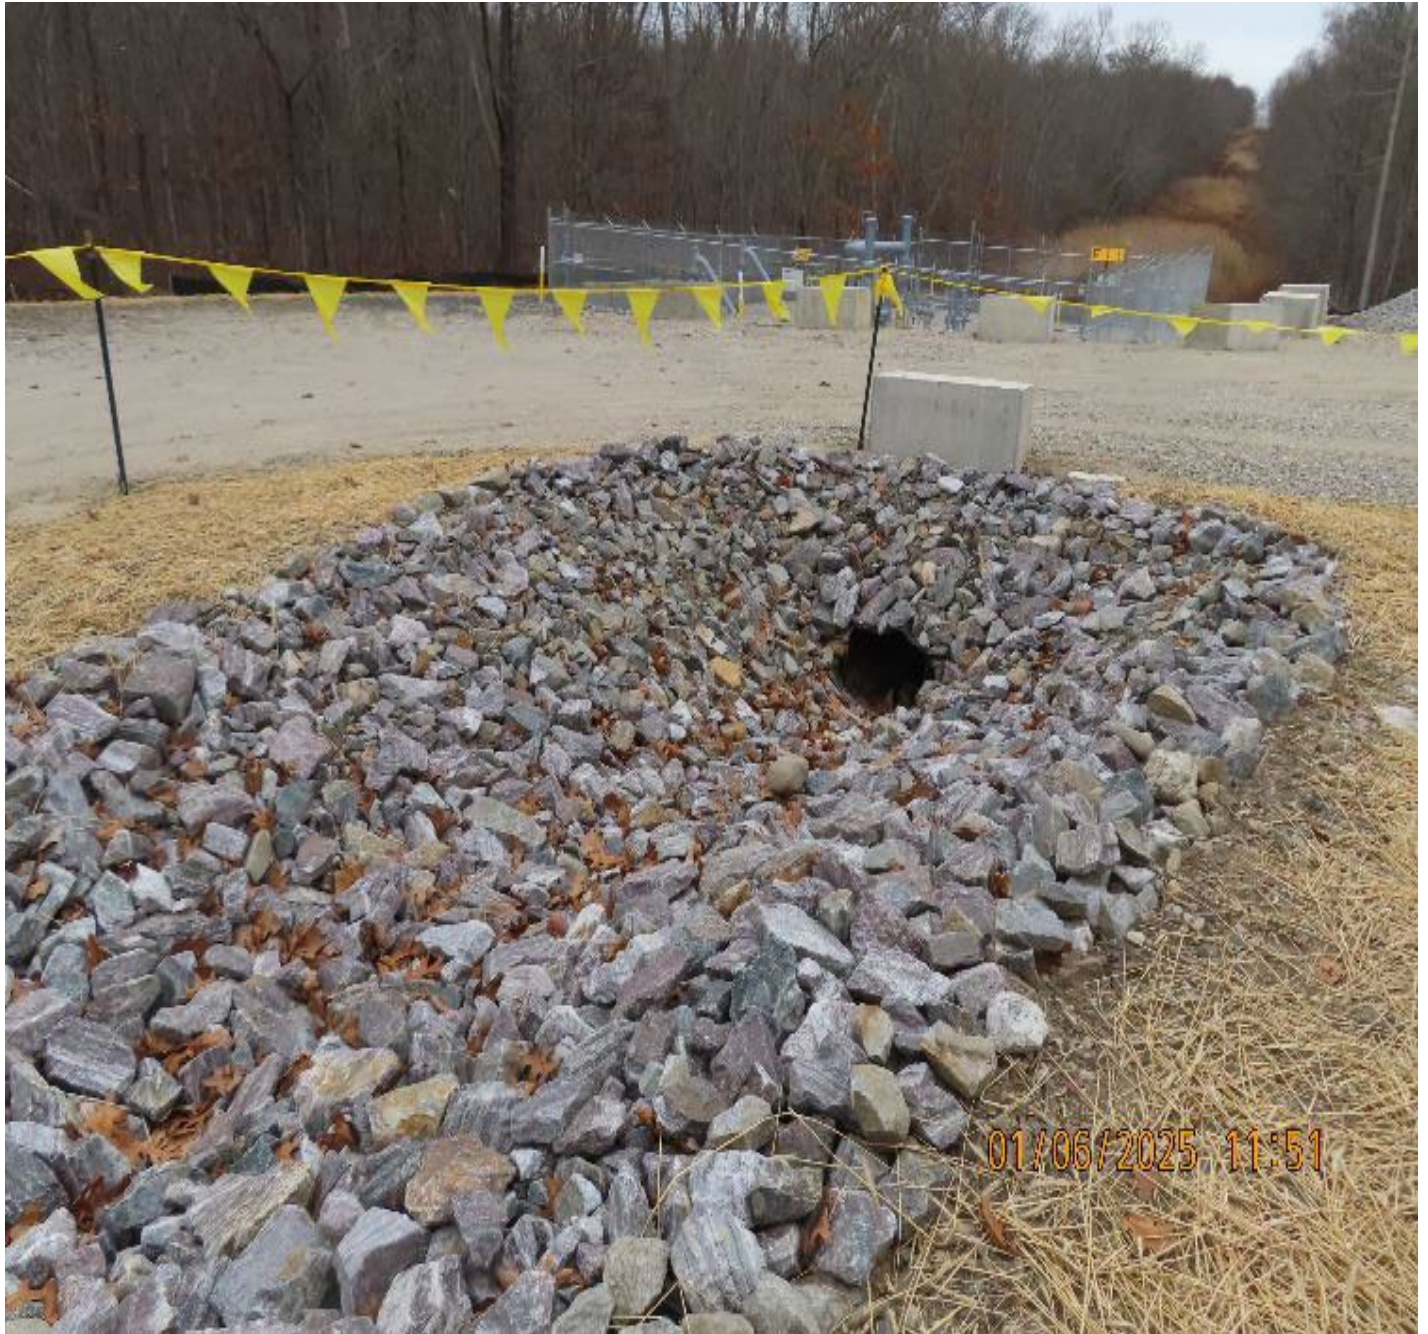
Photo 4: View (looking north) of access road culverted drainage crossing.

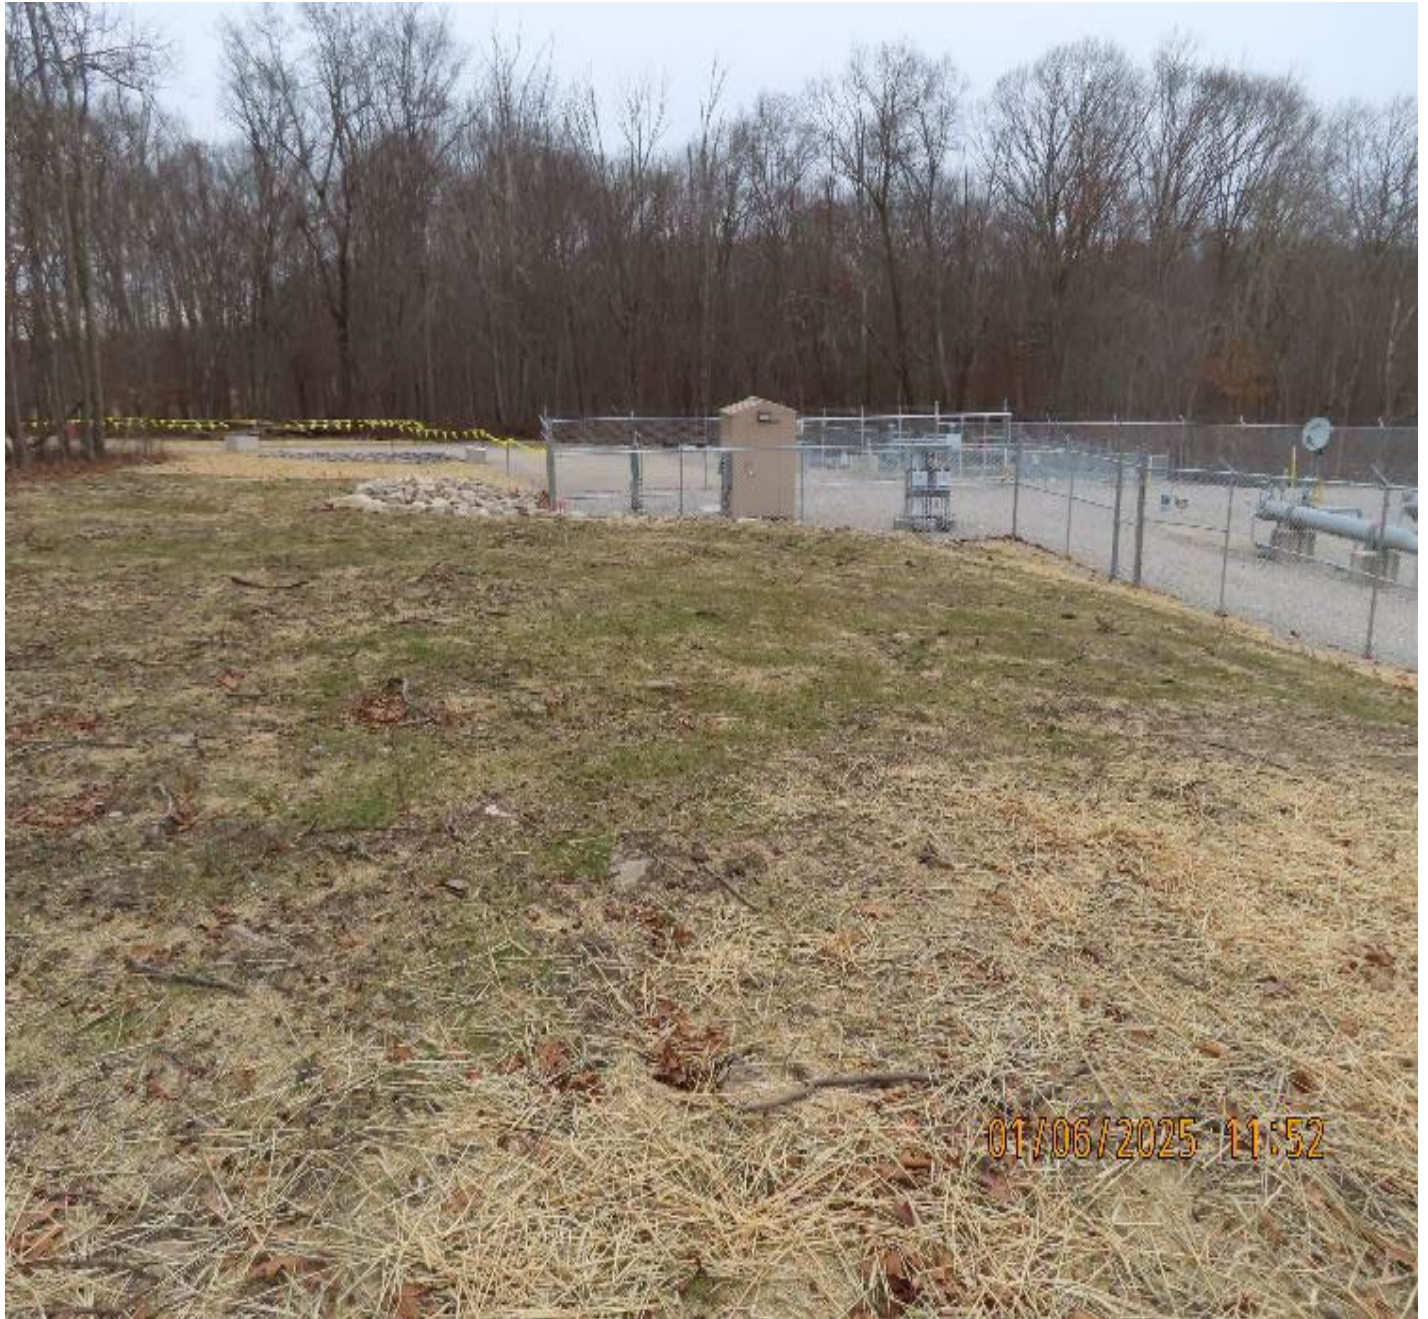
Photo 5: View (looking northwest) of south workspace near valve station.

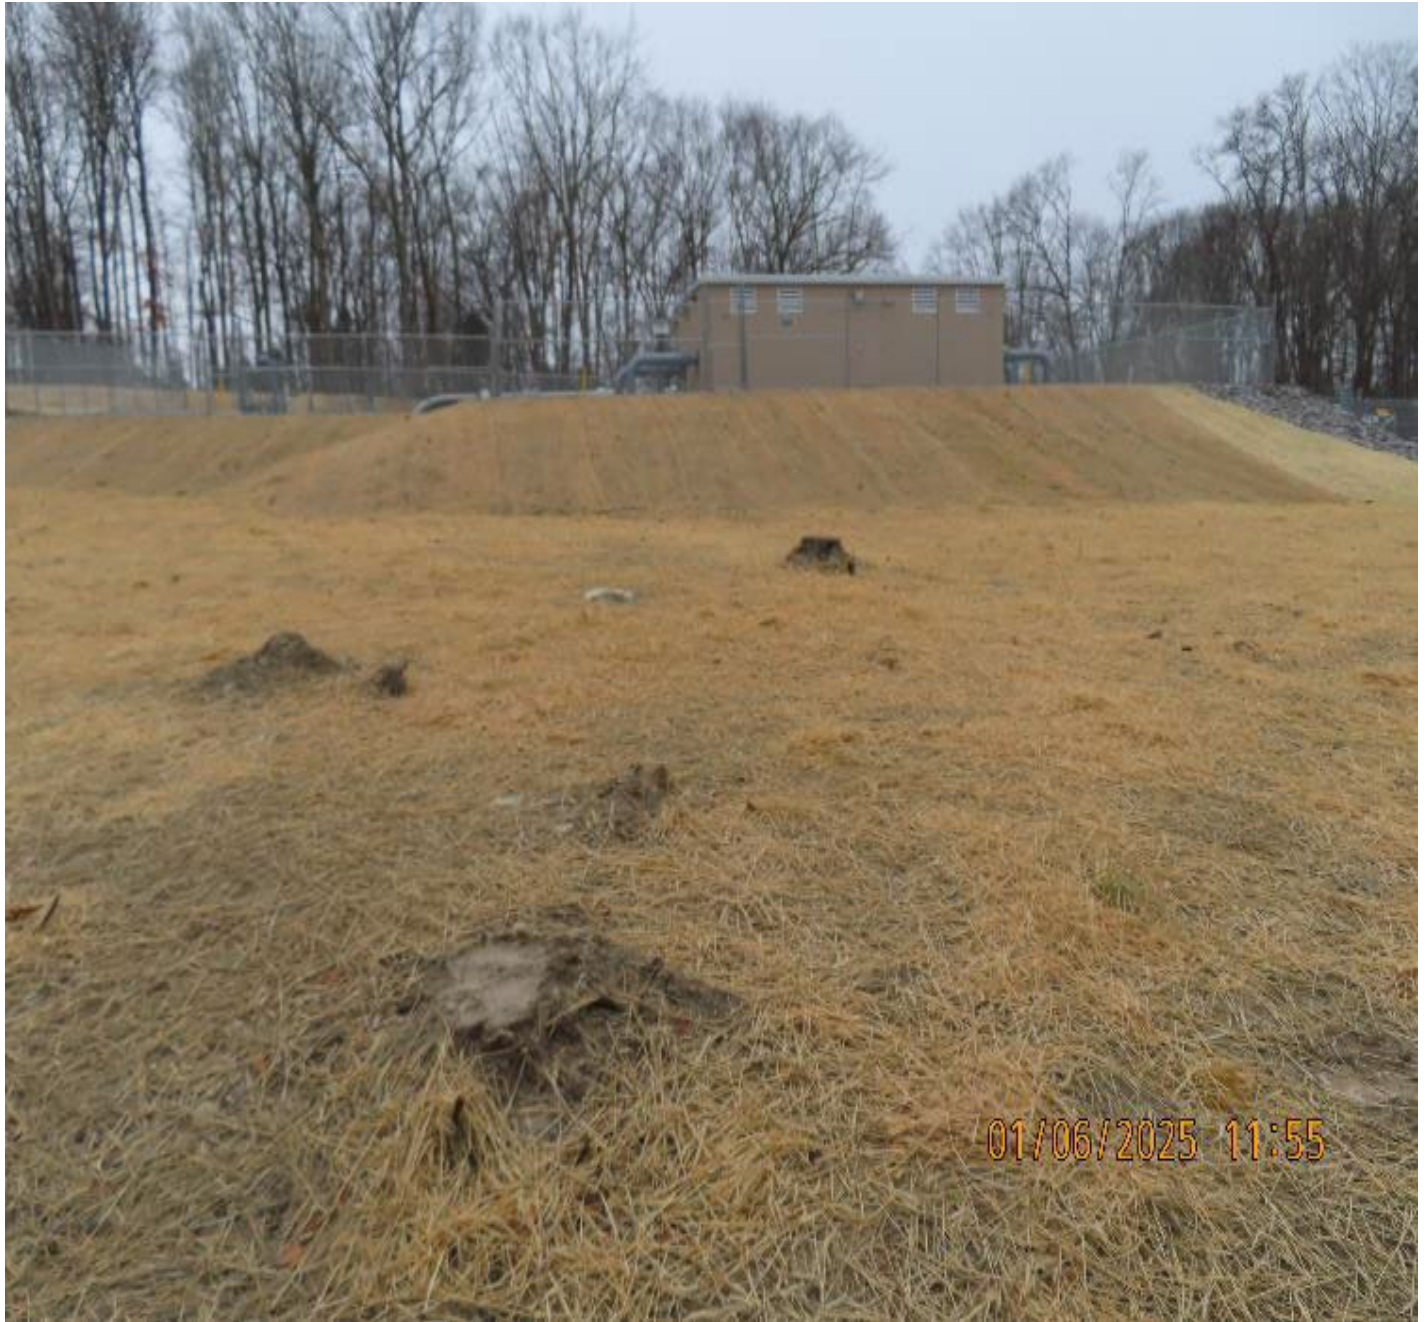
Photo 6: View (looking southwest) of former workspace and embankment downslope of the new regulator building.

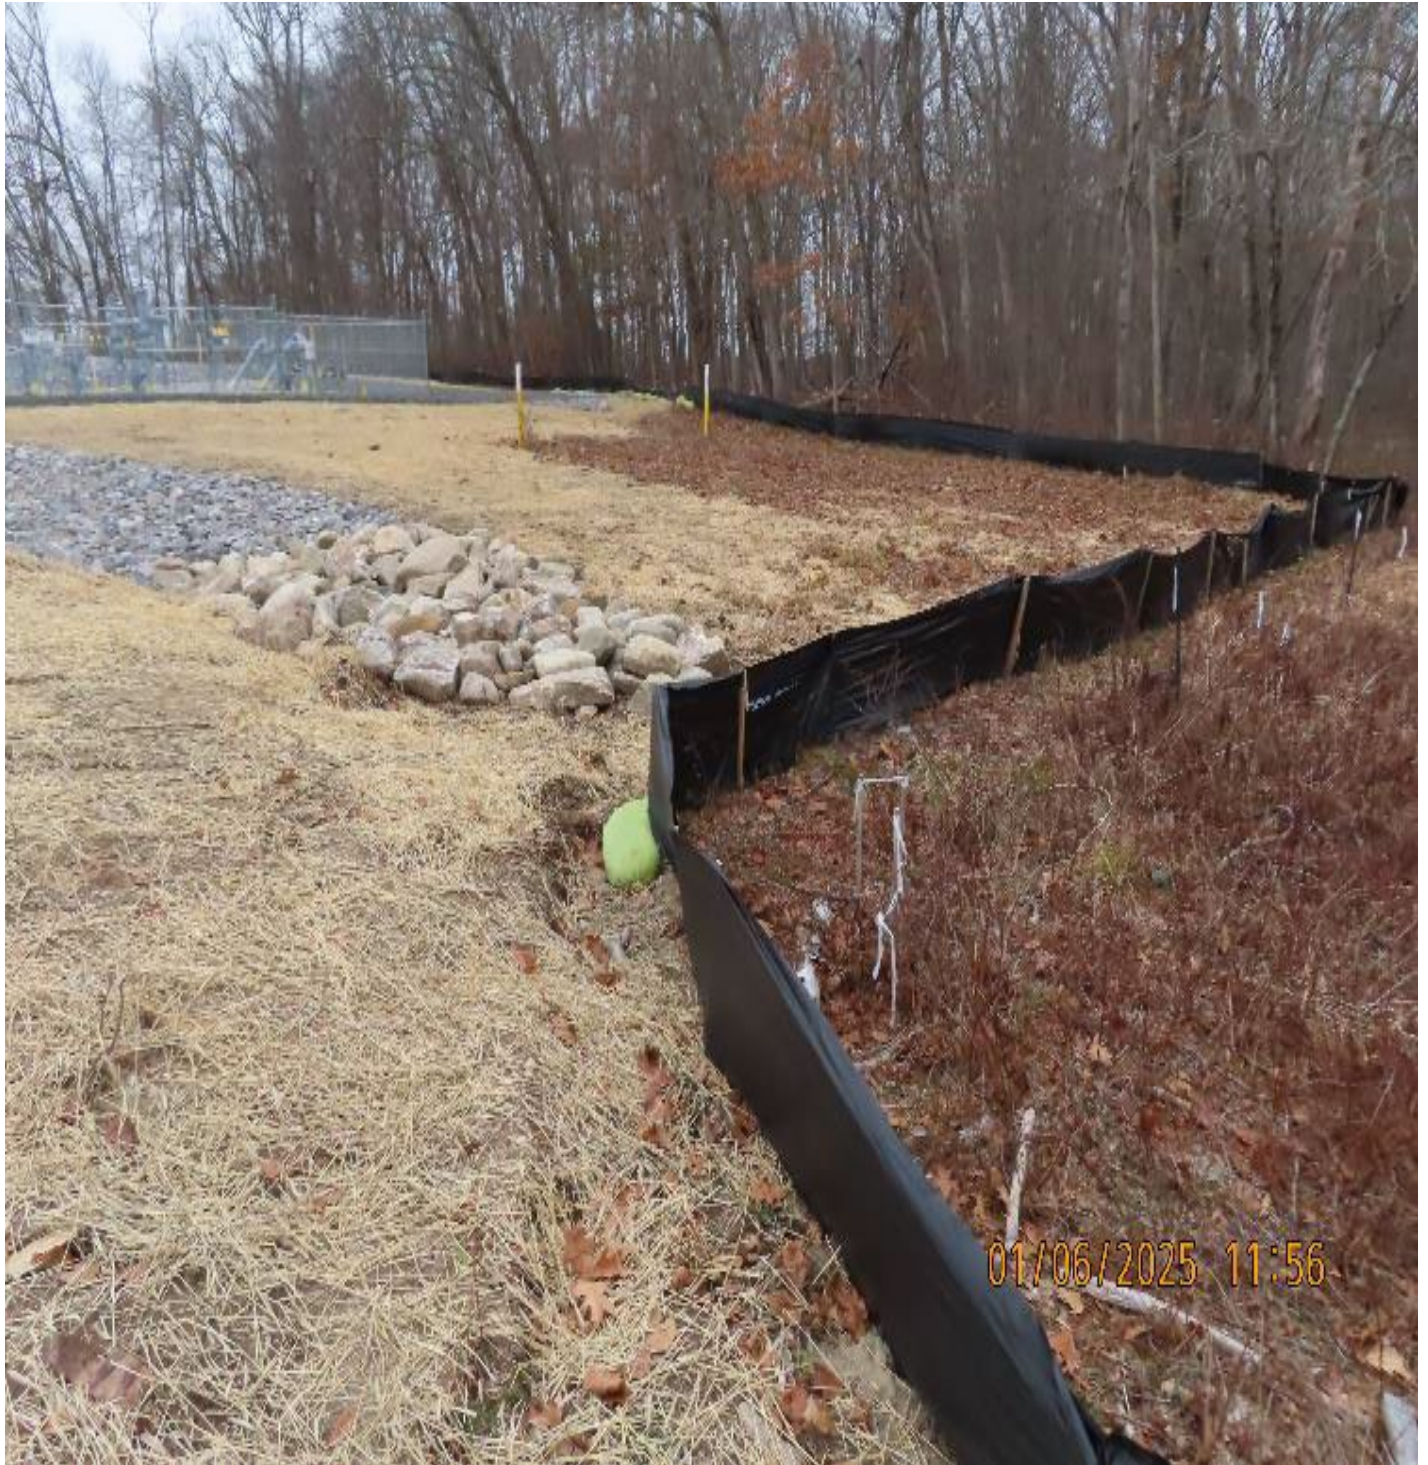
Photo 7: View (looking west) at silt fencing along wetland W-CZ-01.

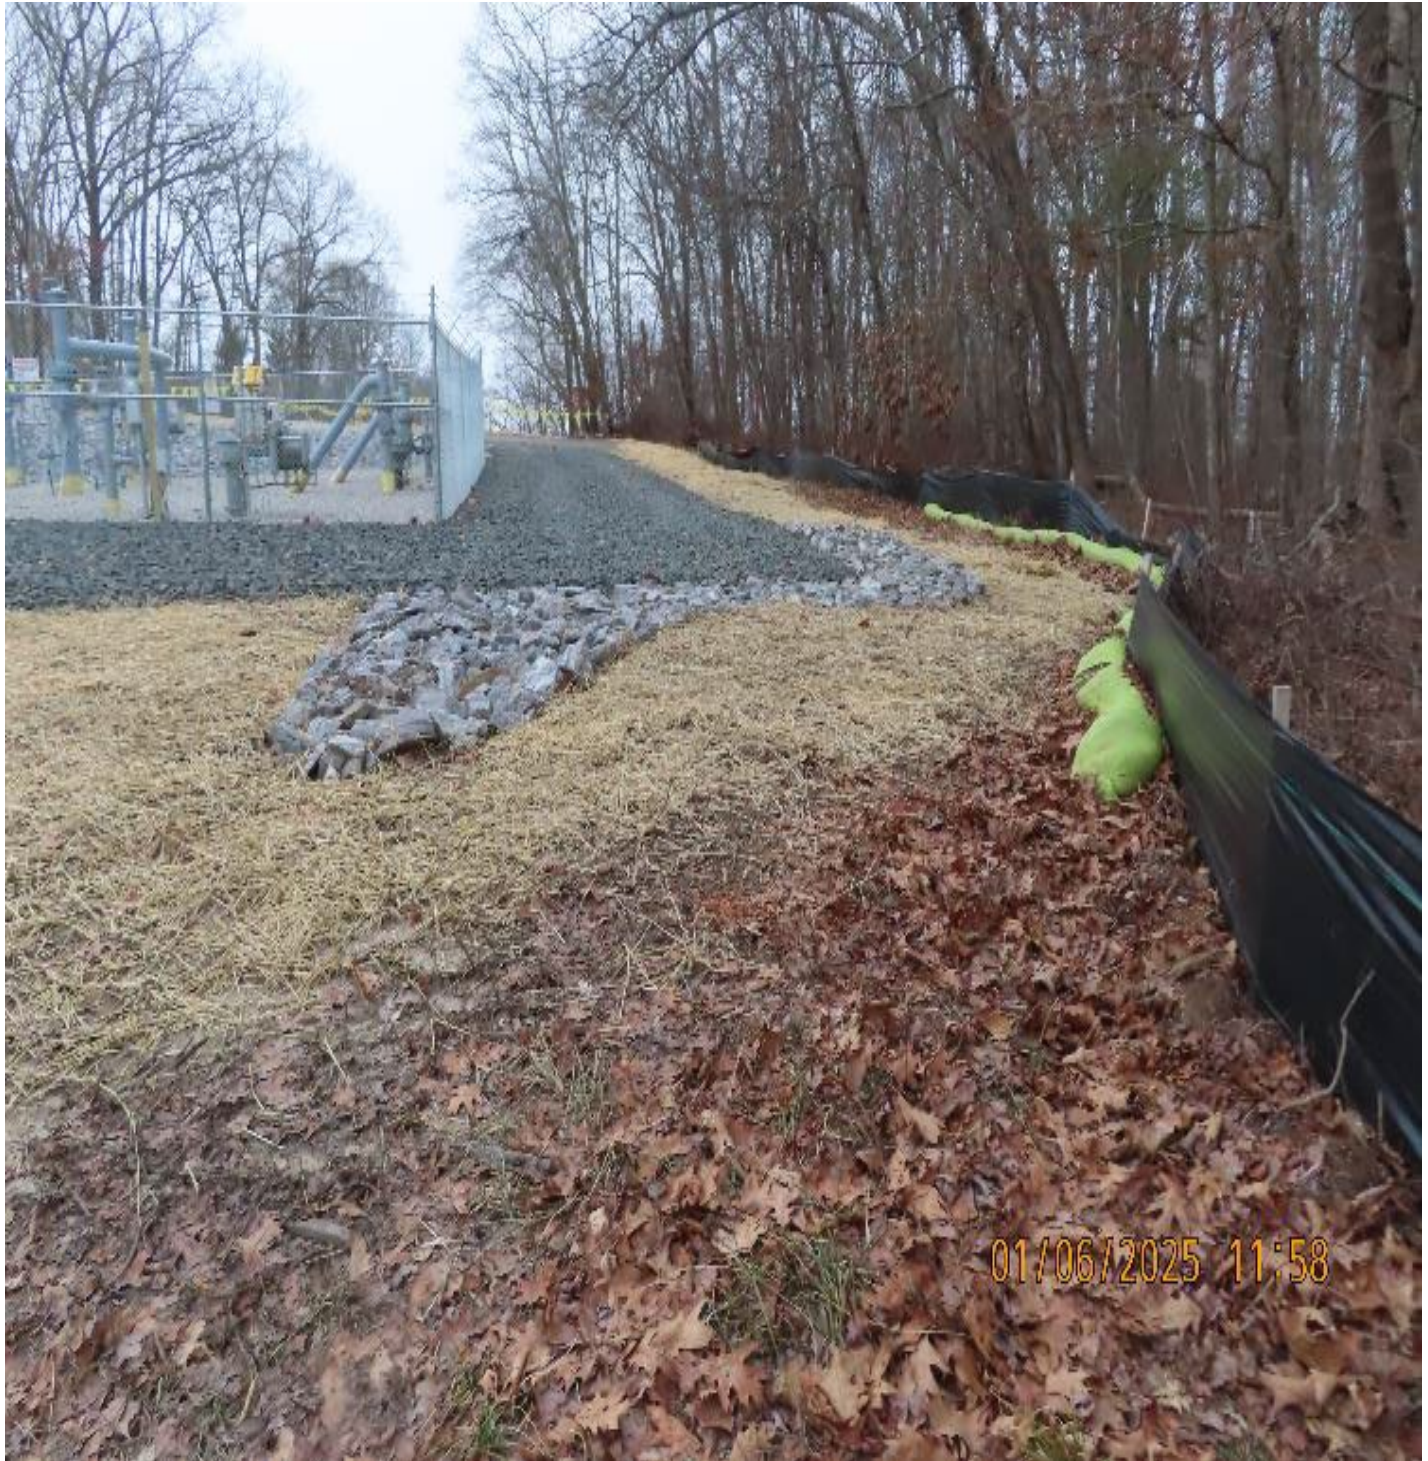
Photo 8: View (looking southwest) of new access road along west side of the valve station.
