Re: *Algonquin Gas Transmission, LLC*
E-1 System Regulator Installation Project, Docket No. CP24-21-000
Report No. 27

**E-1 System Regulation
WEEKLY REPORT #27**

Project:	E-1 System Regulation
FERC Docket Number:	CP24-21-000
Report Number:	27
Reporting Period:	January 9 through January 15, 2025

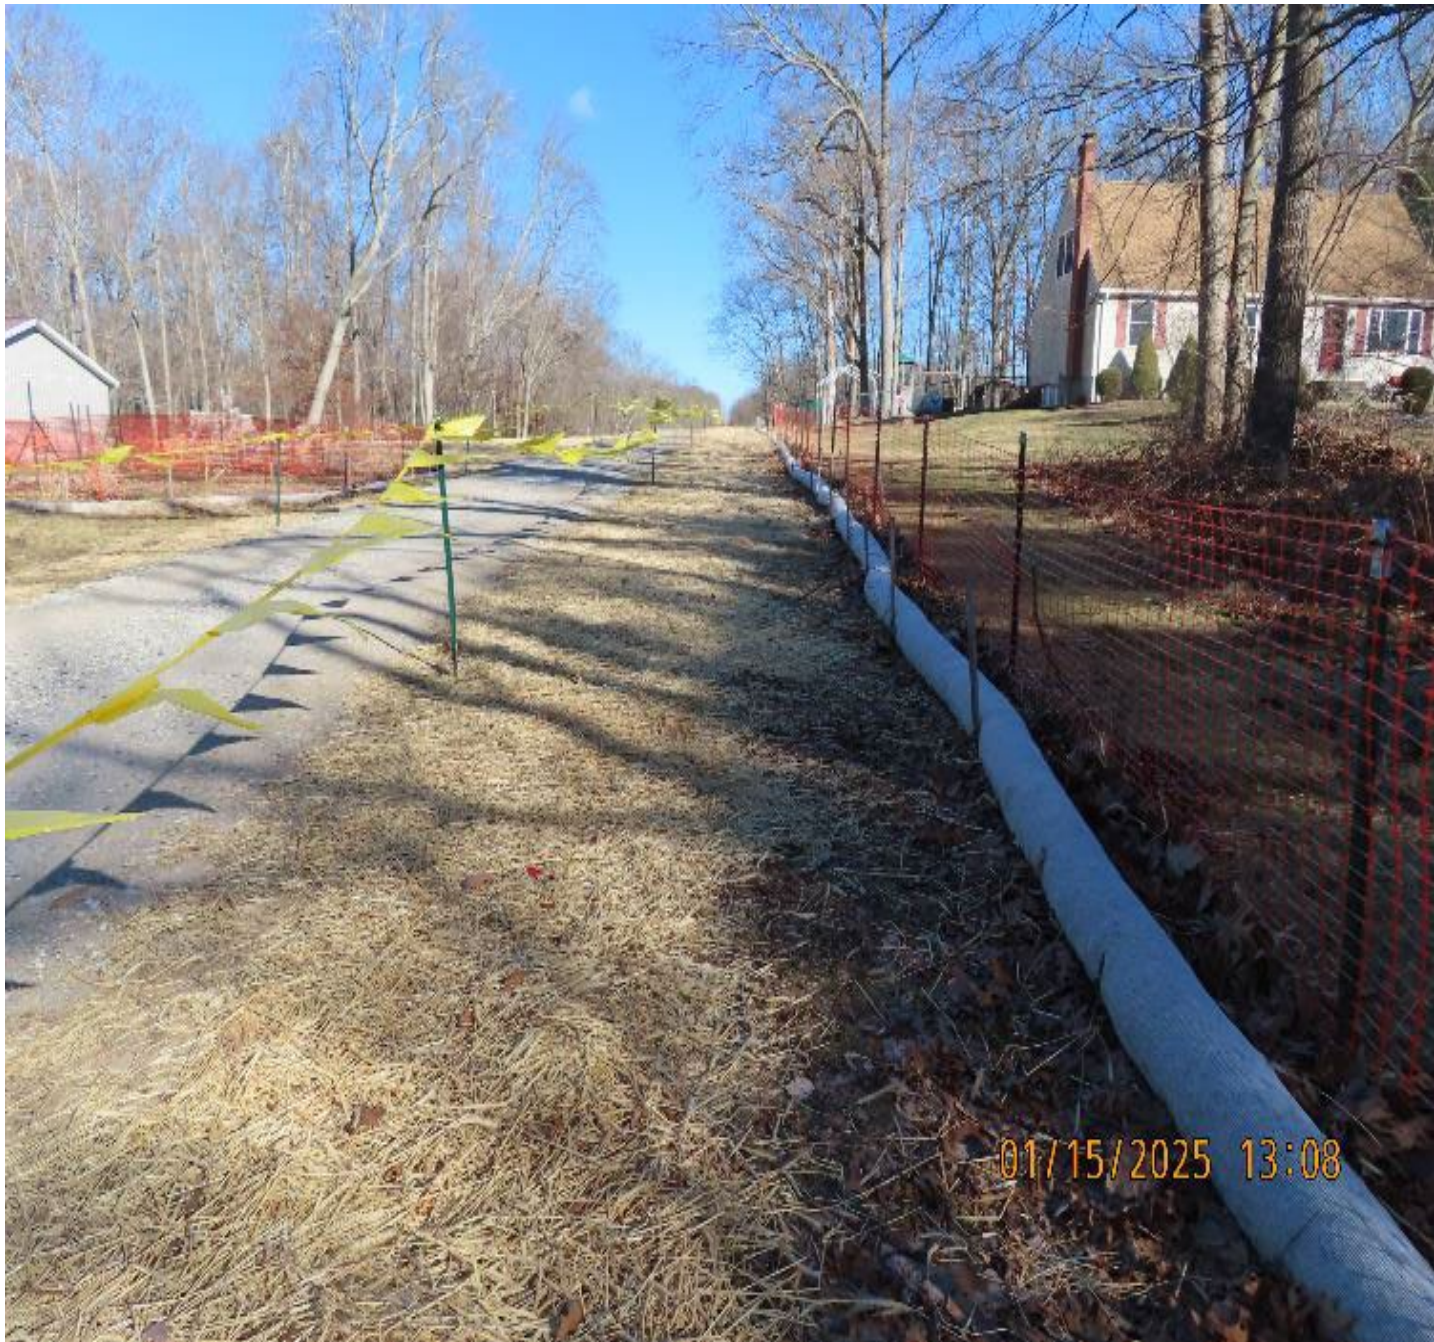
Photo 1: View (looking northeast) of access from Hop River Road.

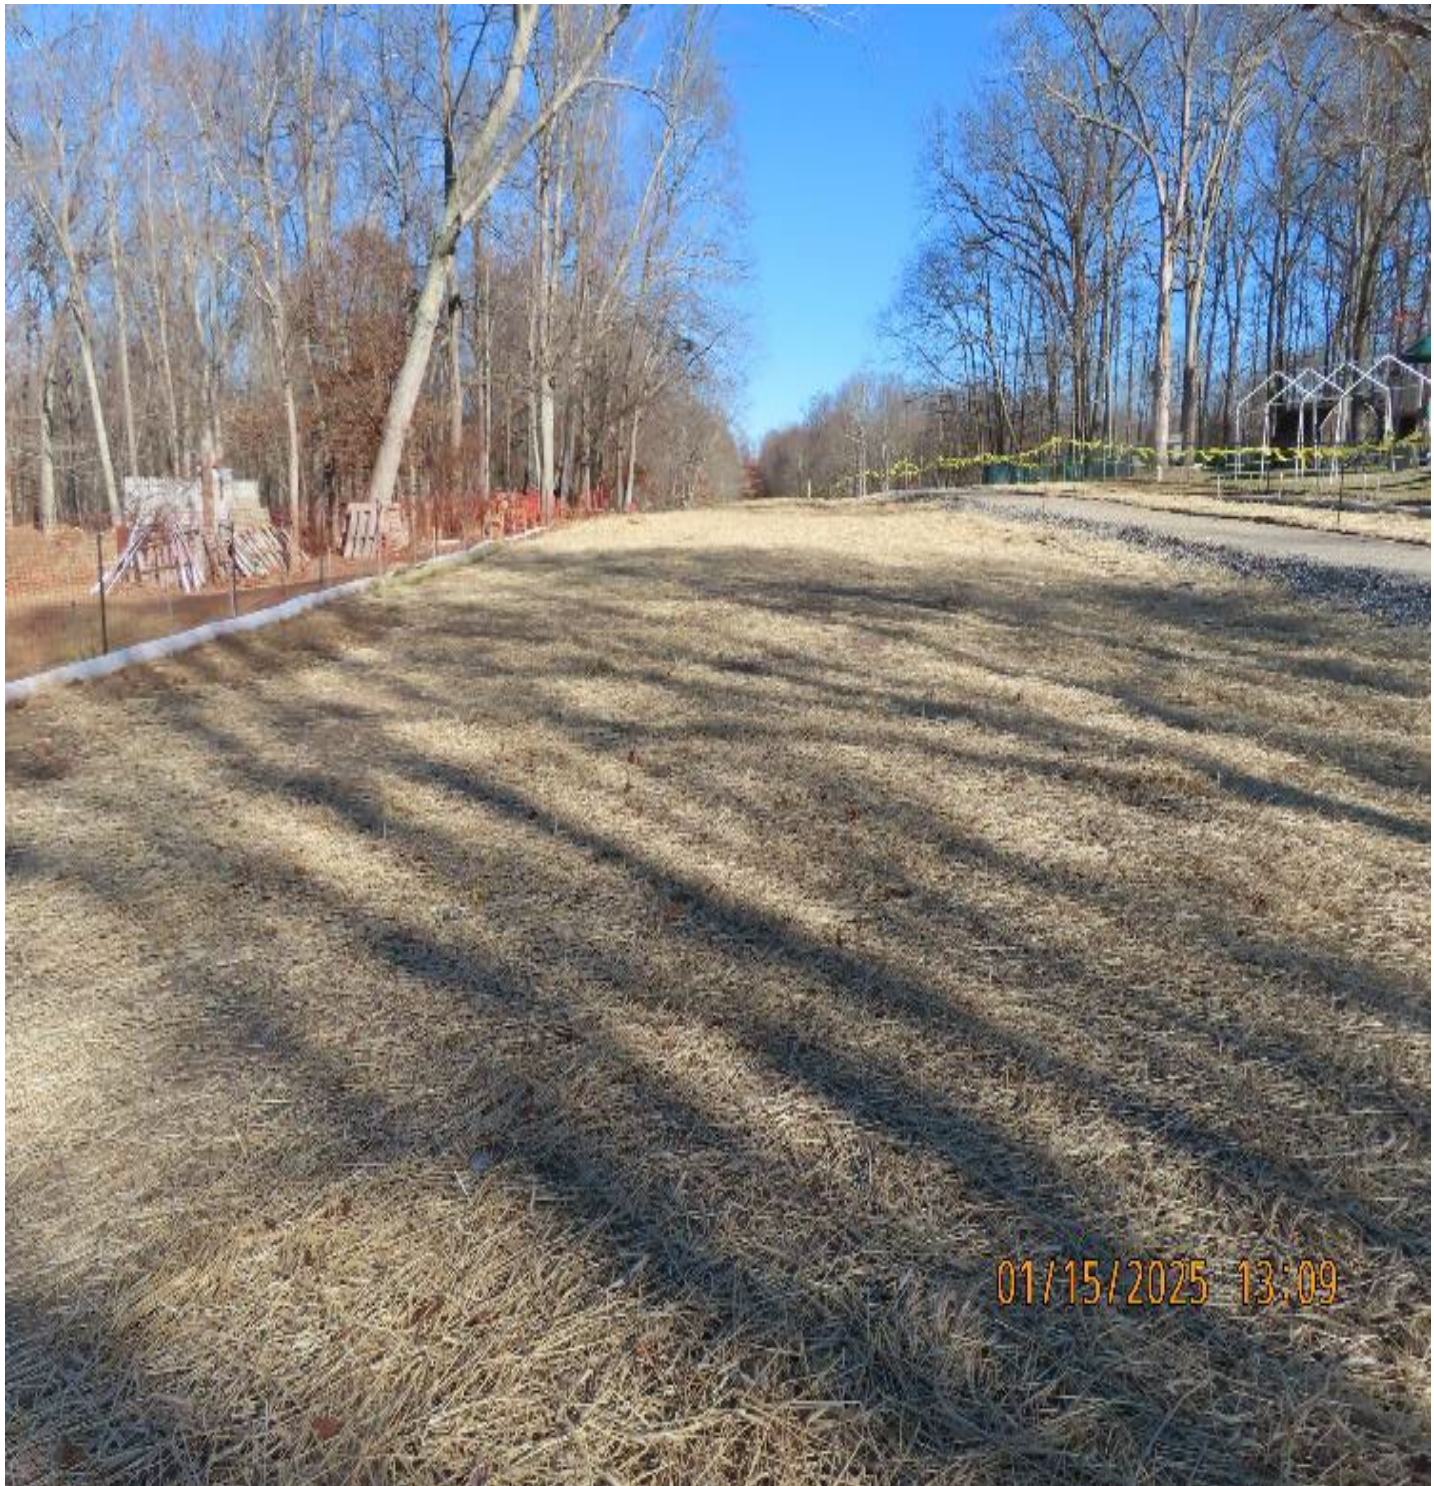
Photo 2: View (looking northeast) of former staging area south of main construction area.

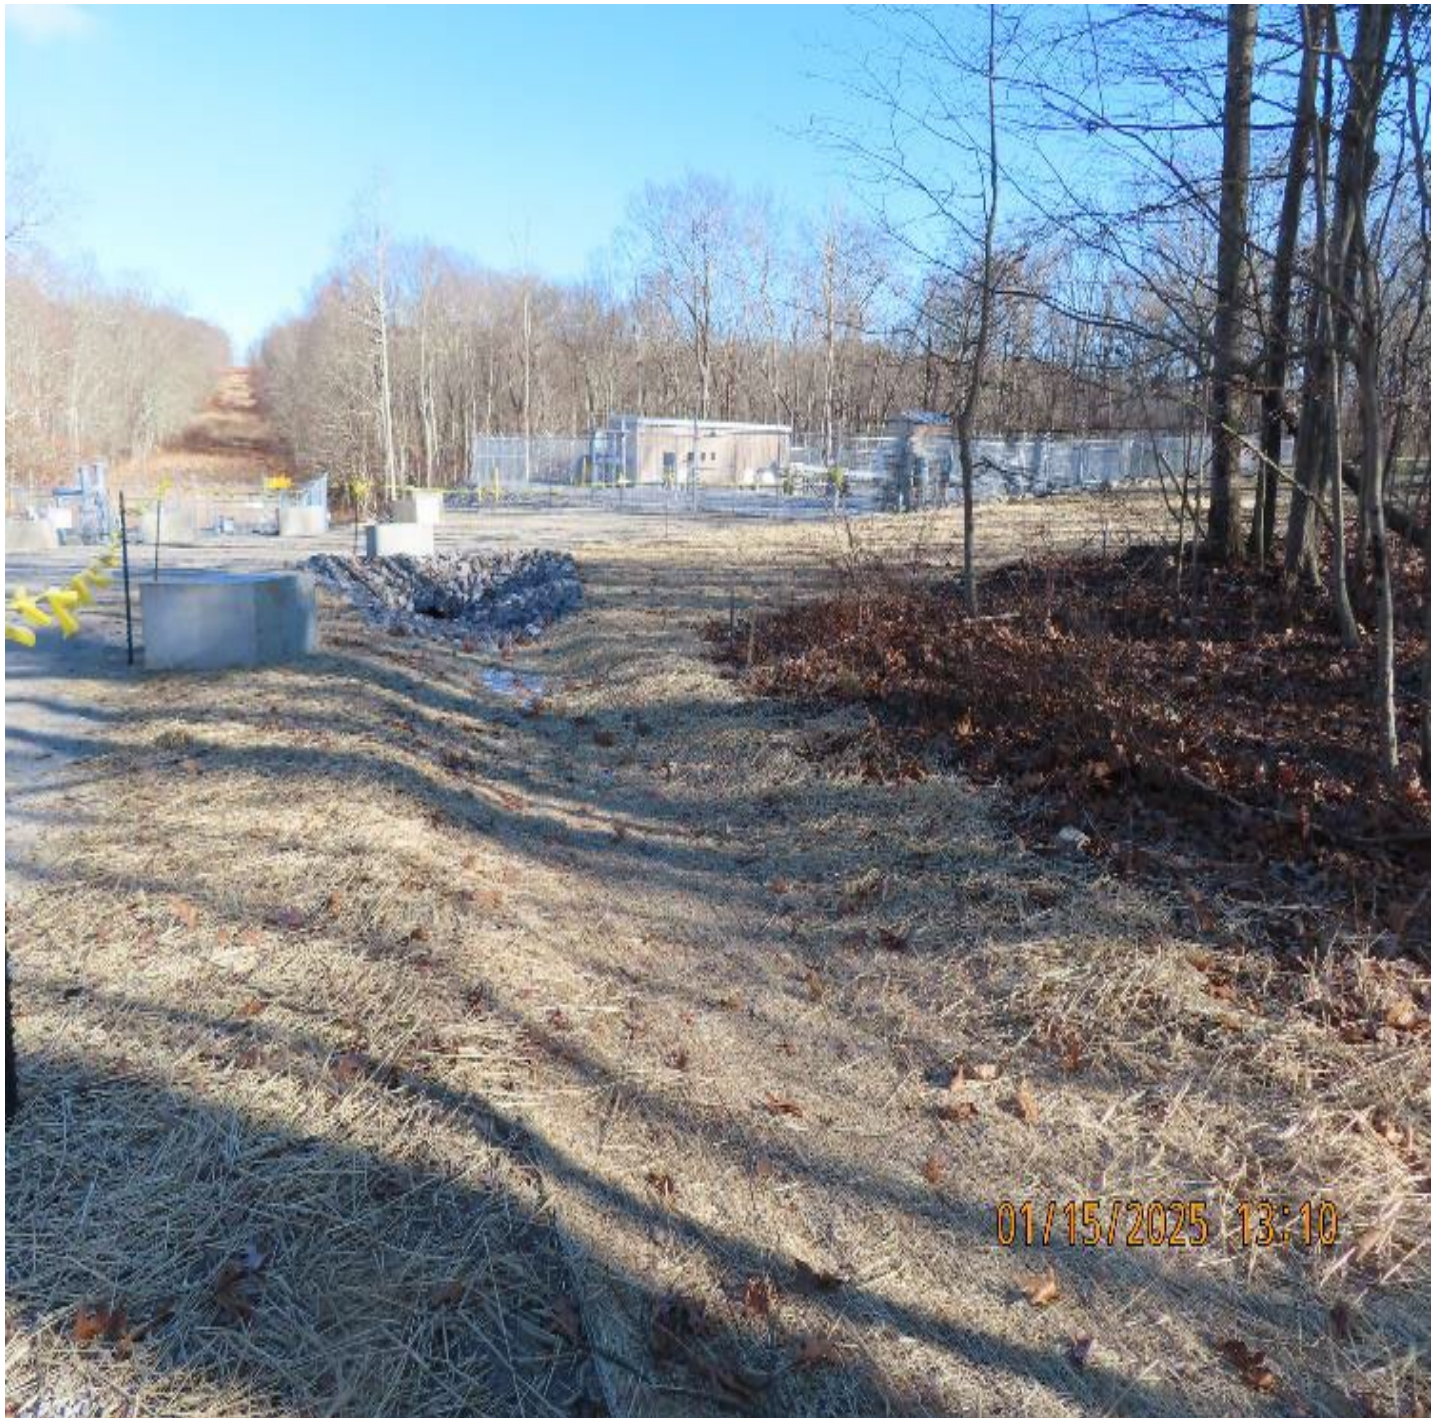
Photo 3: View (looking northeast) of restored drainage swale to culvert below access road into valve yard.

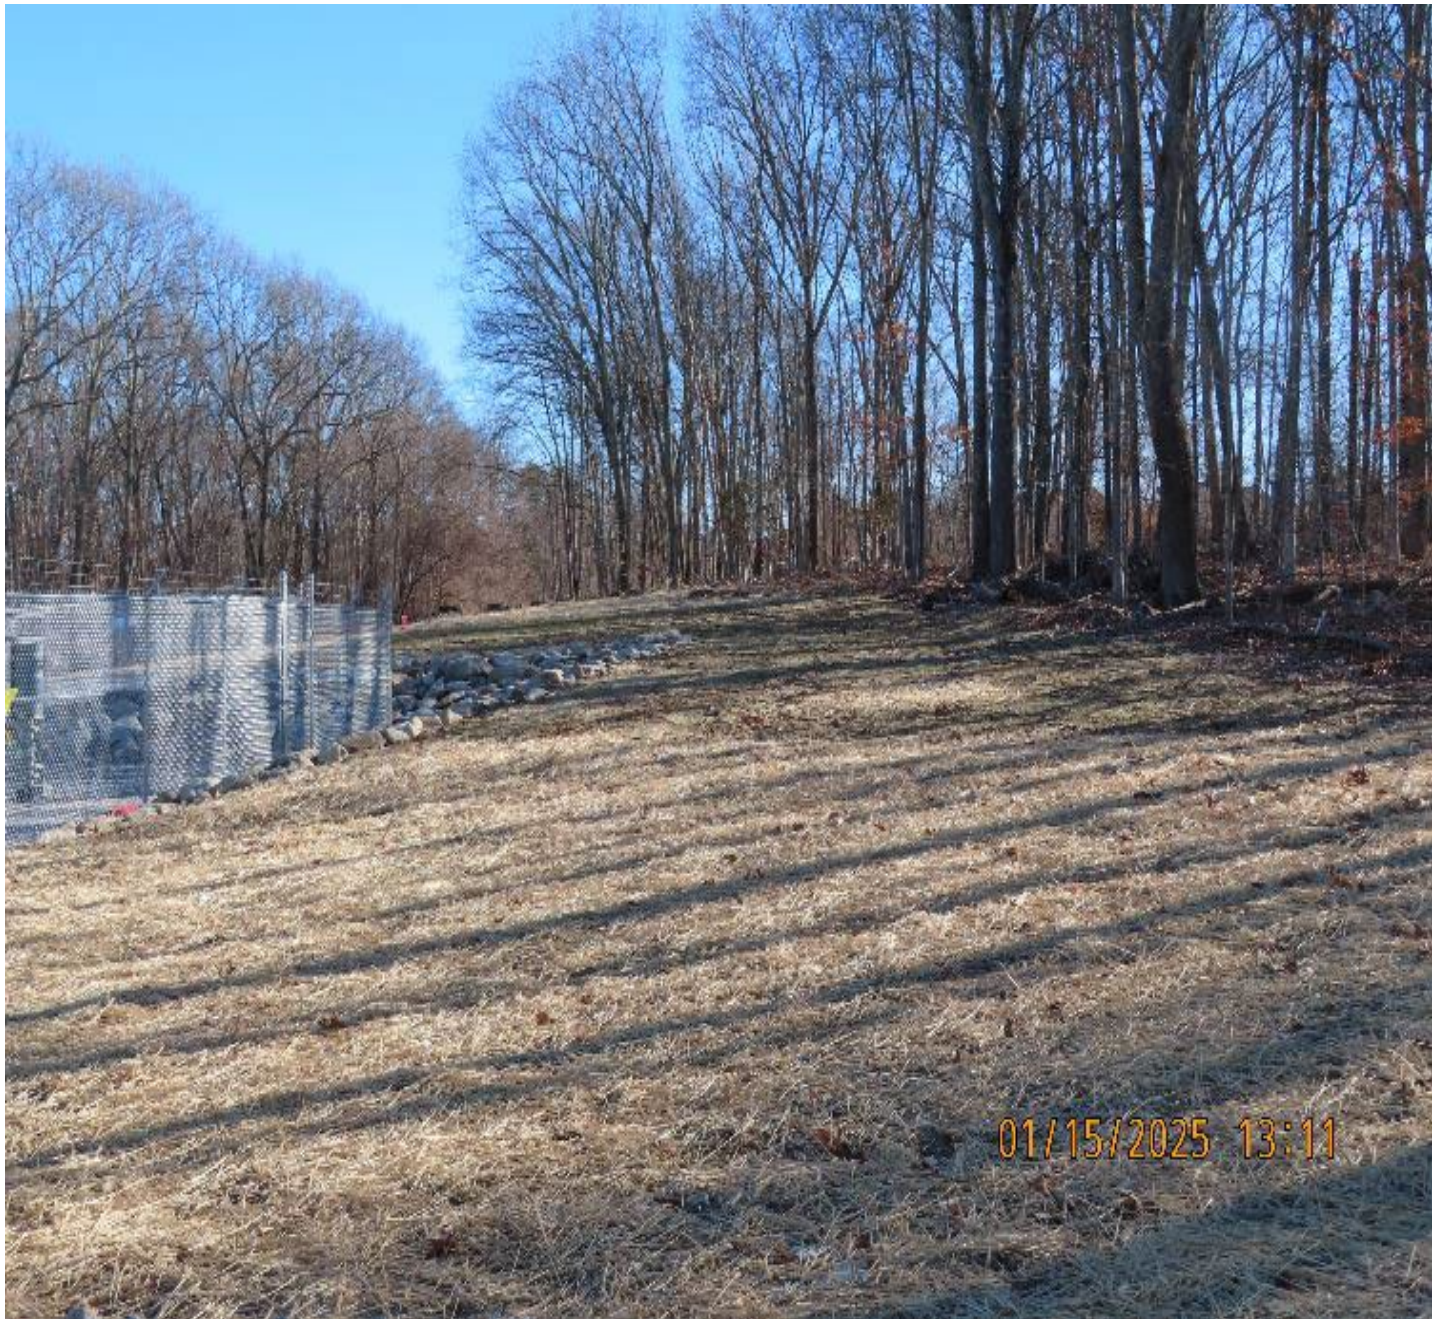
Photo 4: View (looking southeast) of restored area along south side of the valve yard.

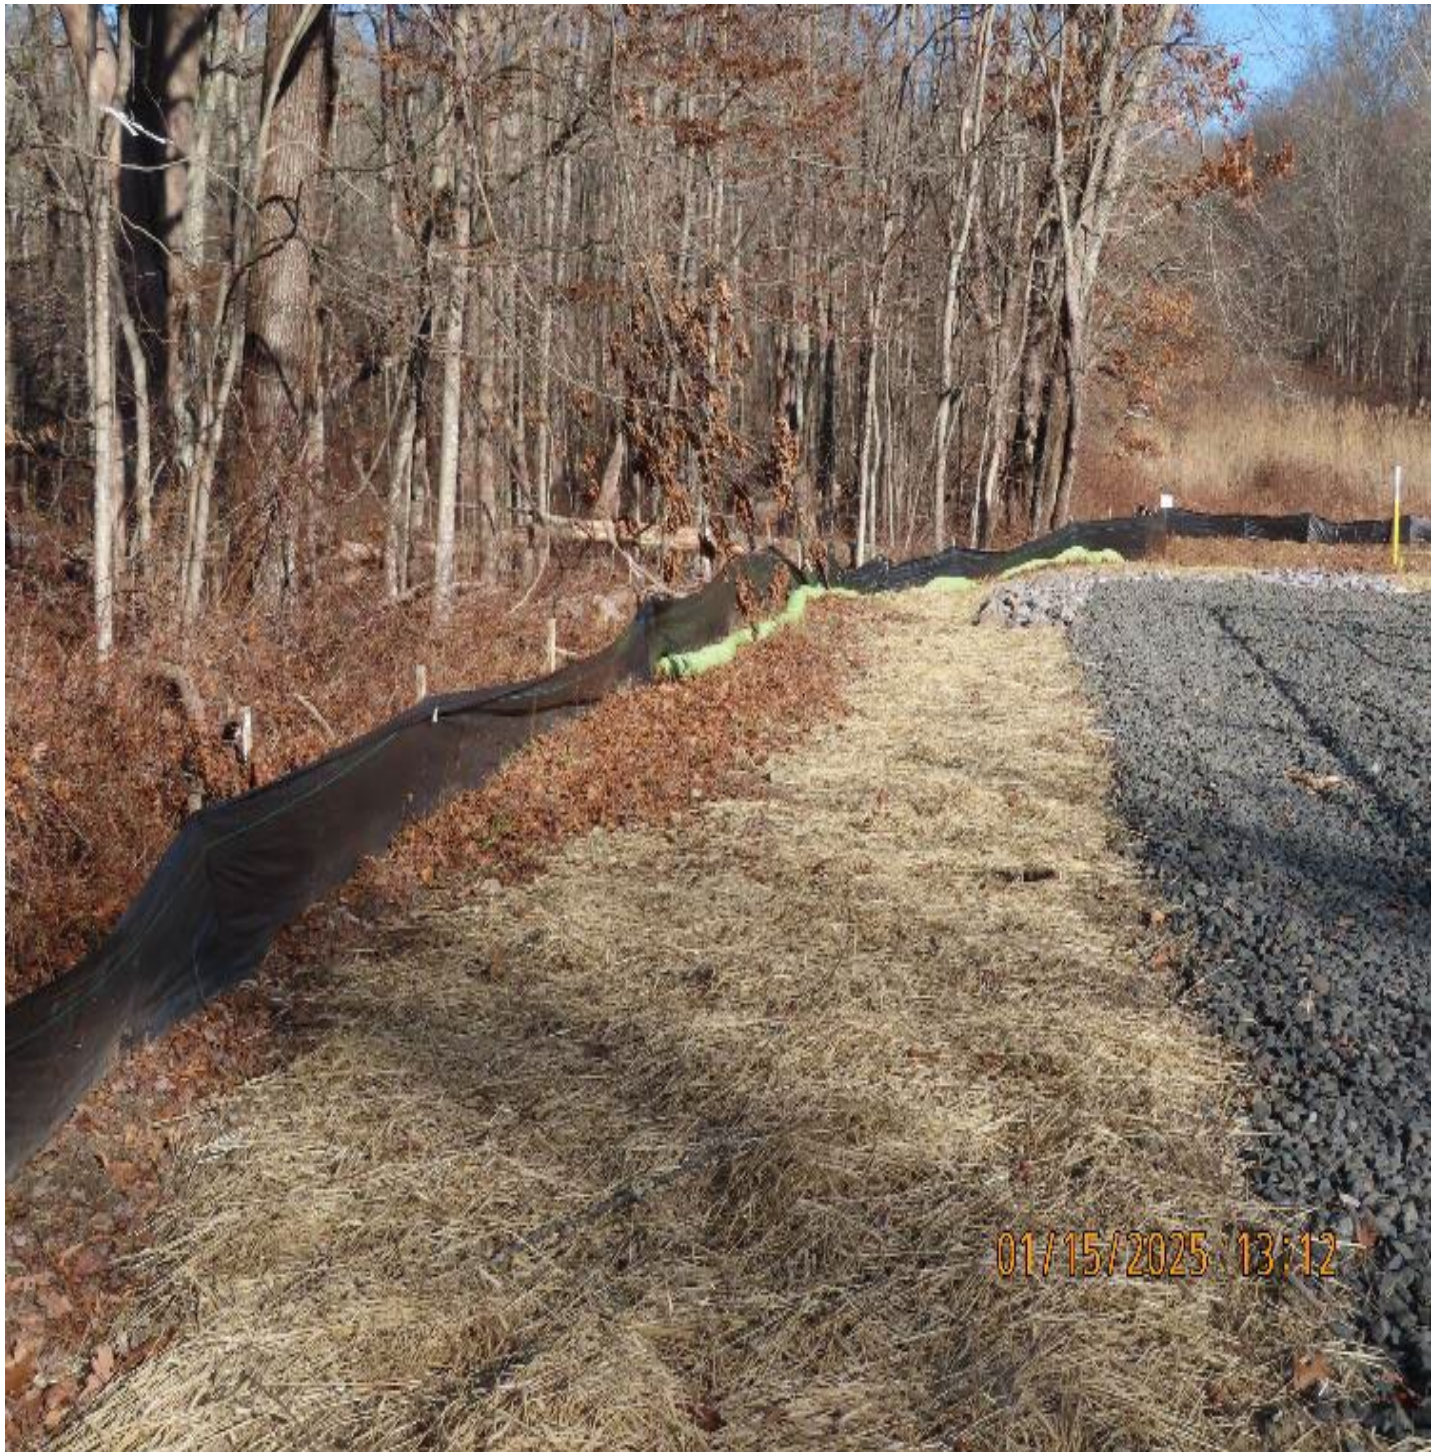
Photo 5: View (looking northeast) of silt fence and filter sock along western workspace boundary.

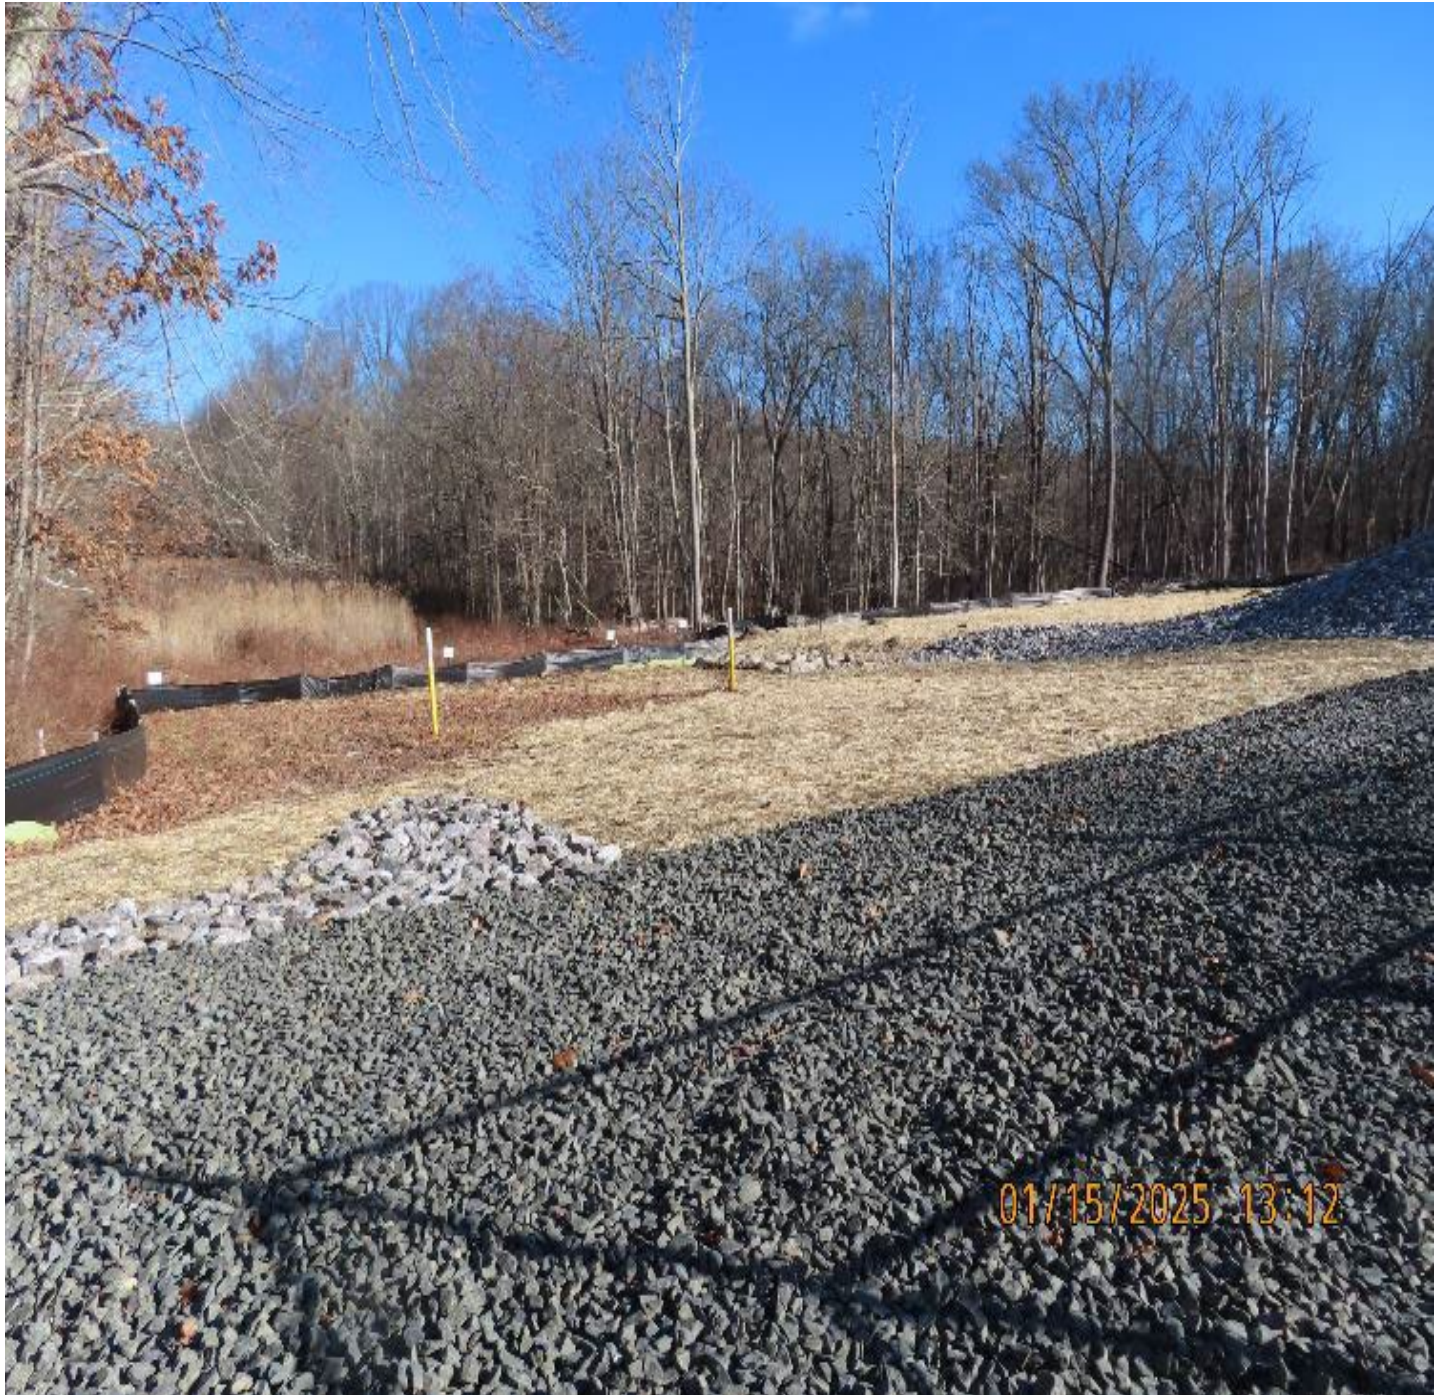
Photo 6: View (looking northeast) of new stone surfacing for access to the north gate of the valve yard.

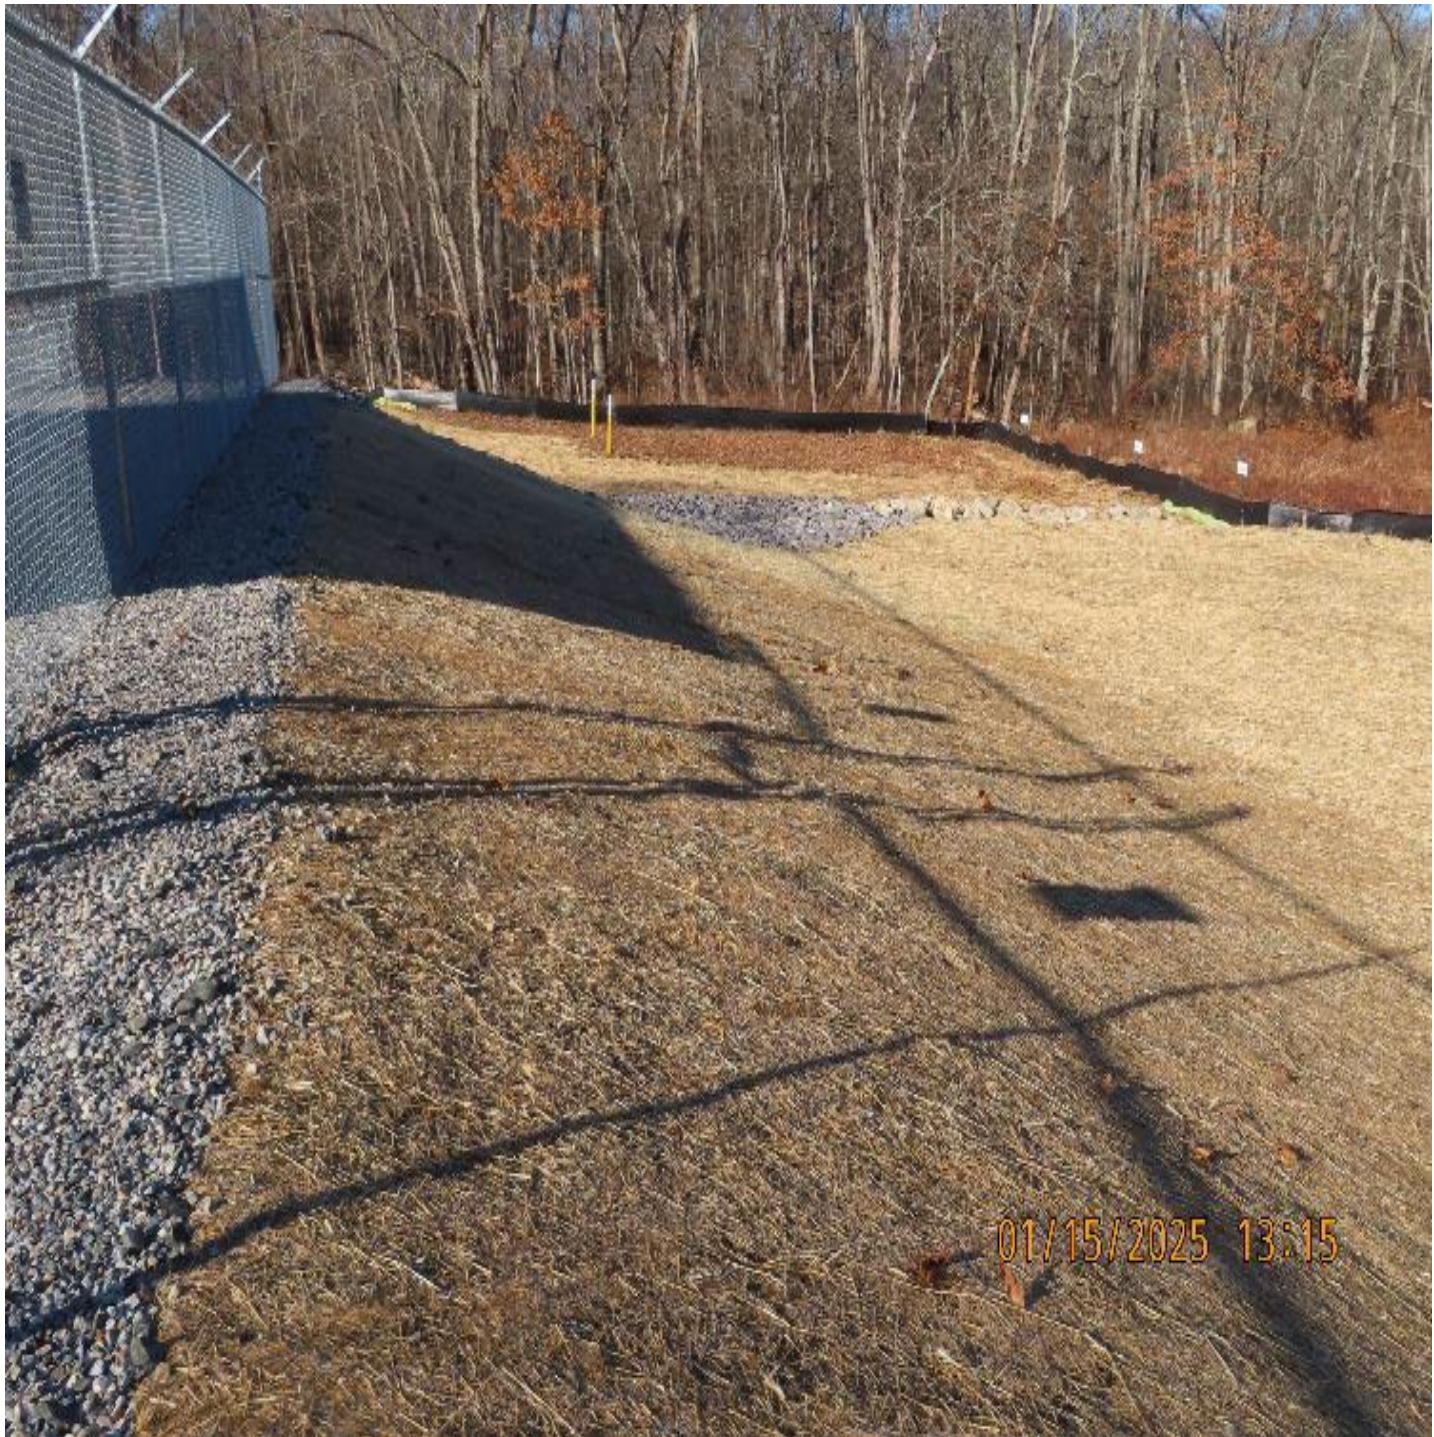
Photo 7: View (looking northwest) of north embankment for the new regulatory building.

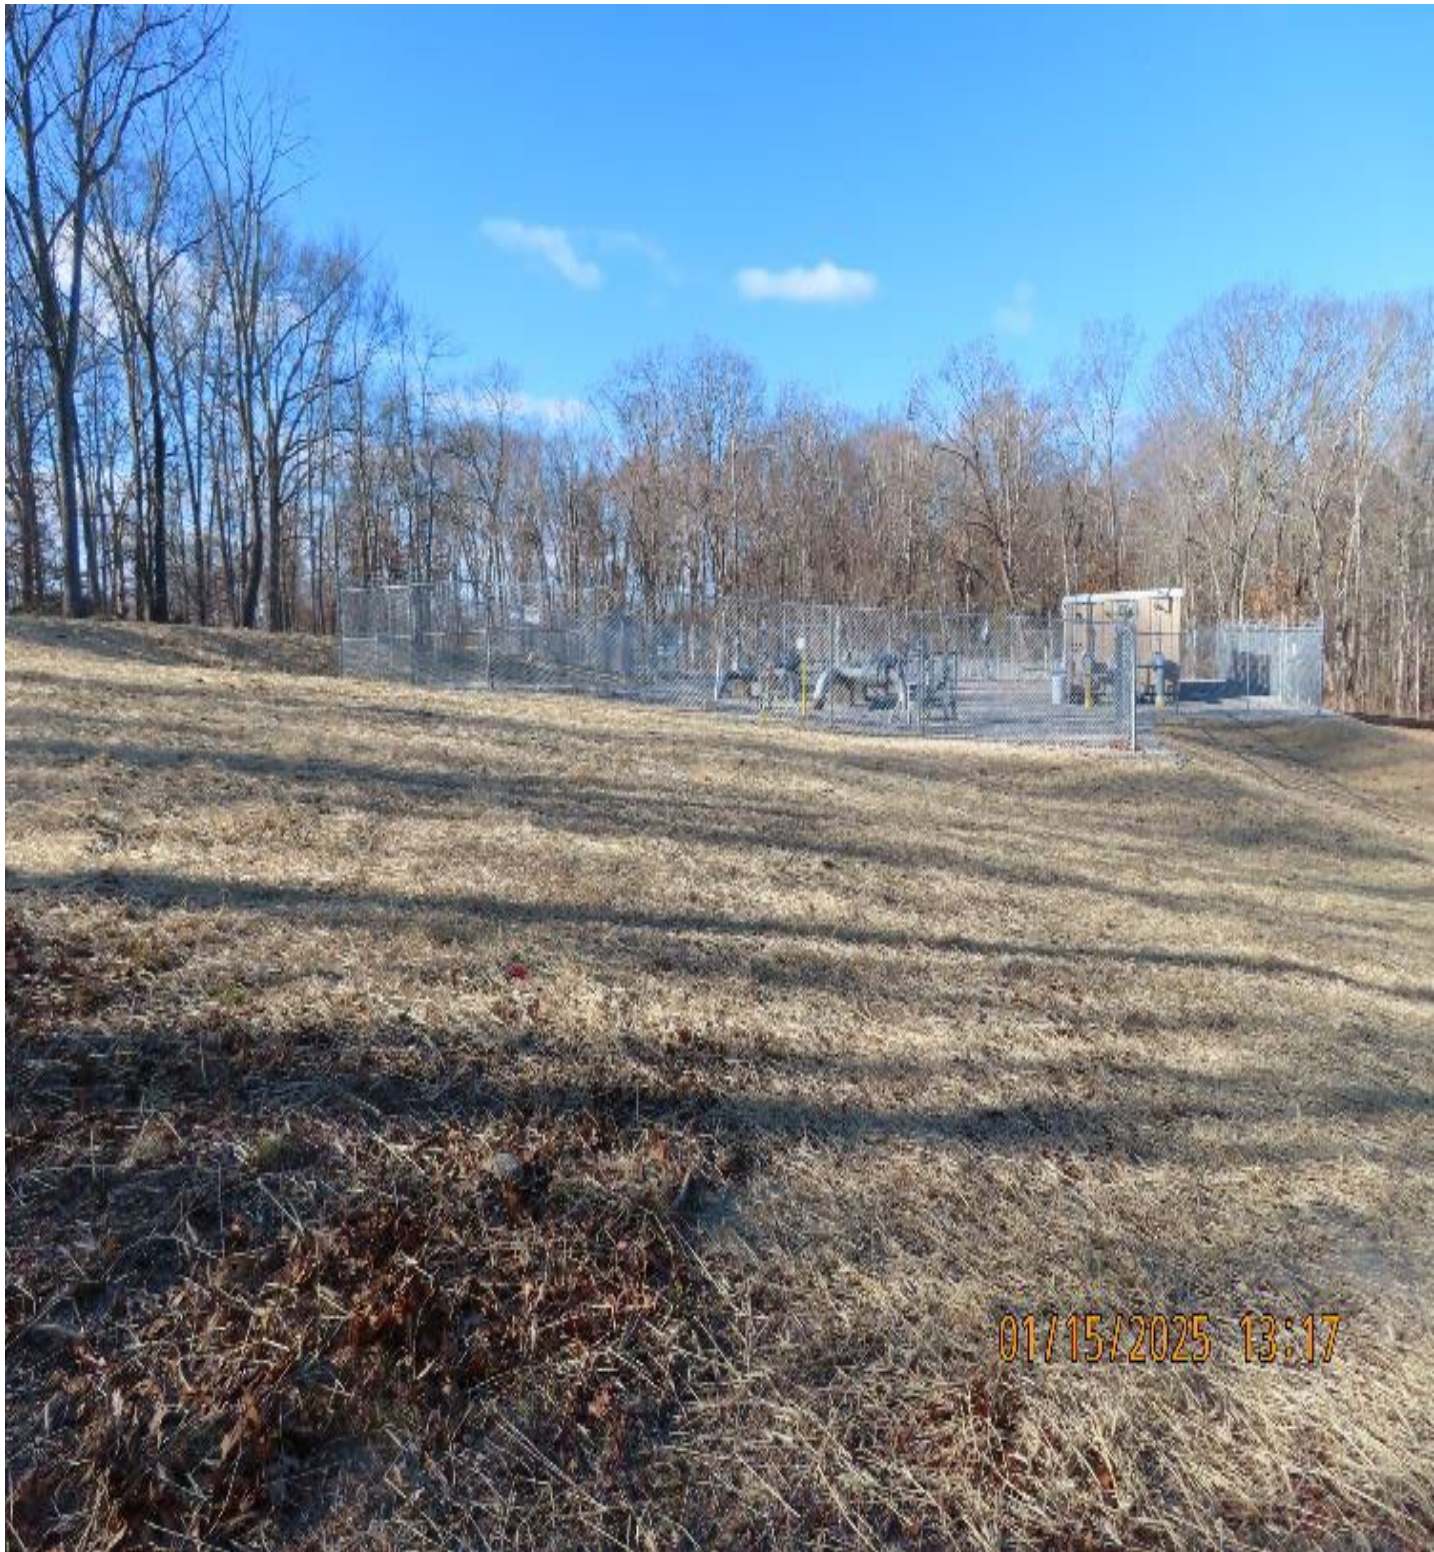
Photo 8: View (looking northwest) of stabilized conditions around the valve yard.
