Re: *Algonquin Gas Transmission, LLC*
E-1 System Regulator Installation Project, Docket No. CP24-21-000
Report No. 28

**E-1 System Regulation
WEEKLY REPORT #28**

Project:	E-1 System Regulation
FERC Docket Number:	CP24-21-000
Report Number:	28
Reporting Period:	January 16 through January 22, 2025

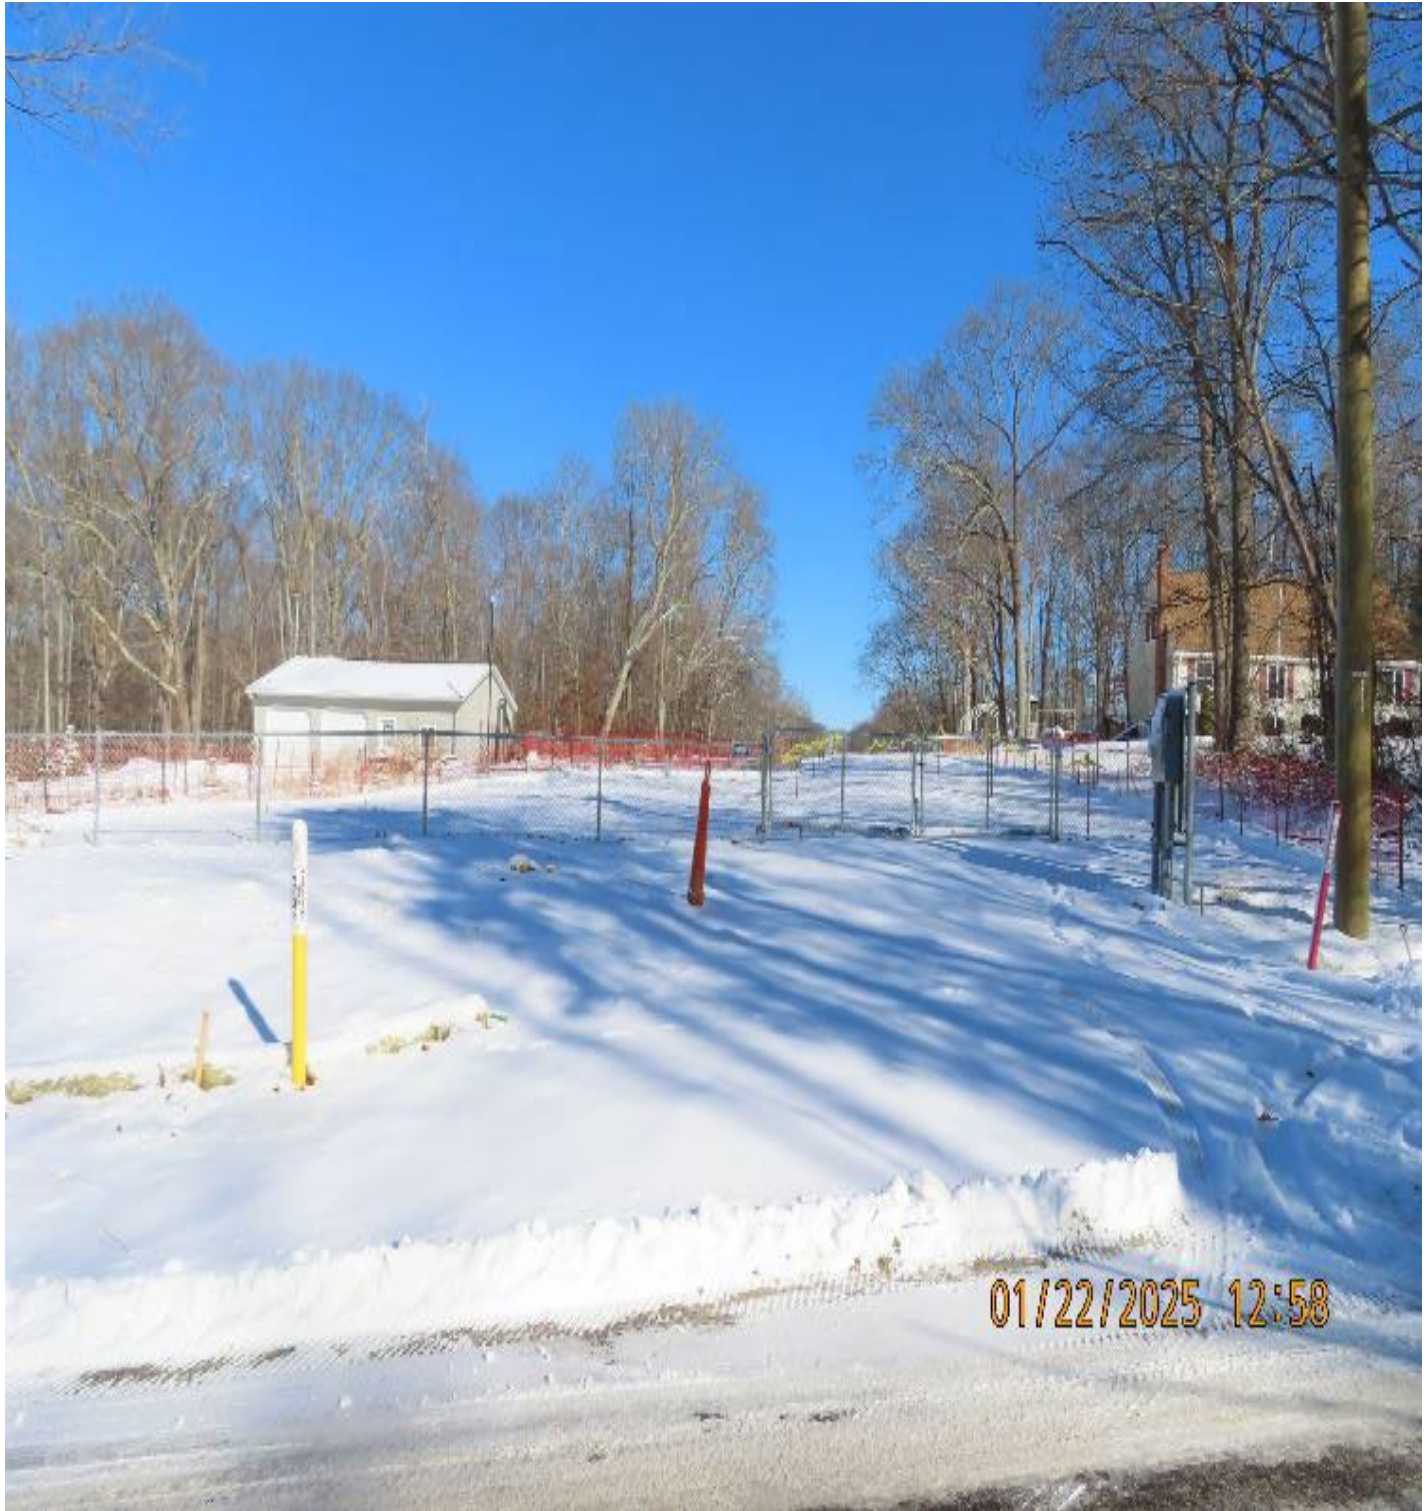
Photo 1: View (looking northeast) of site entrance off Hop River Road.

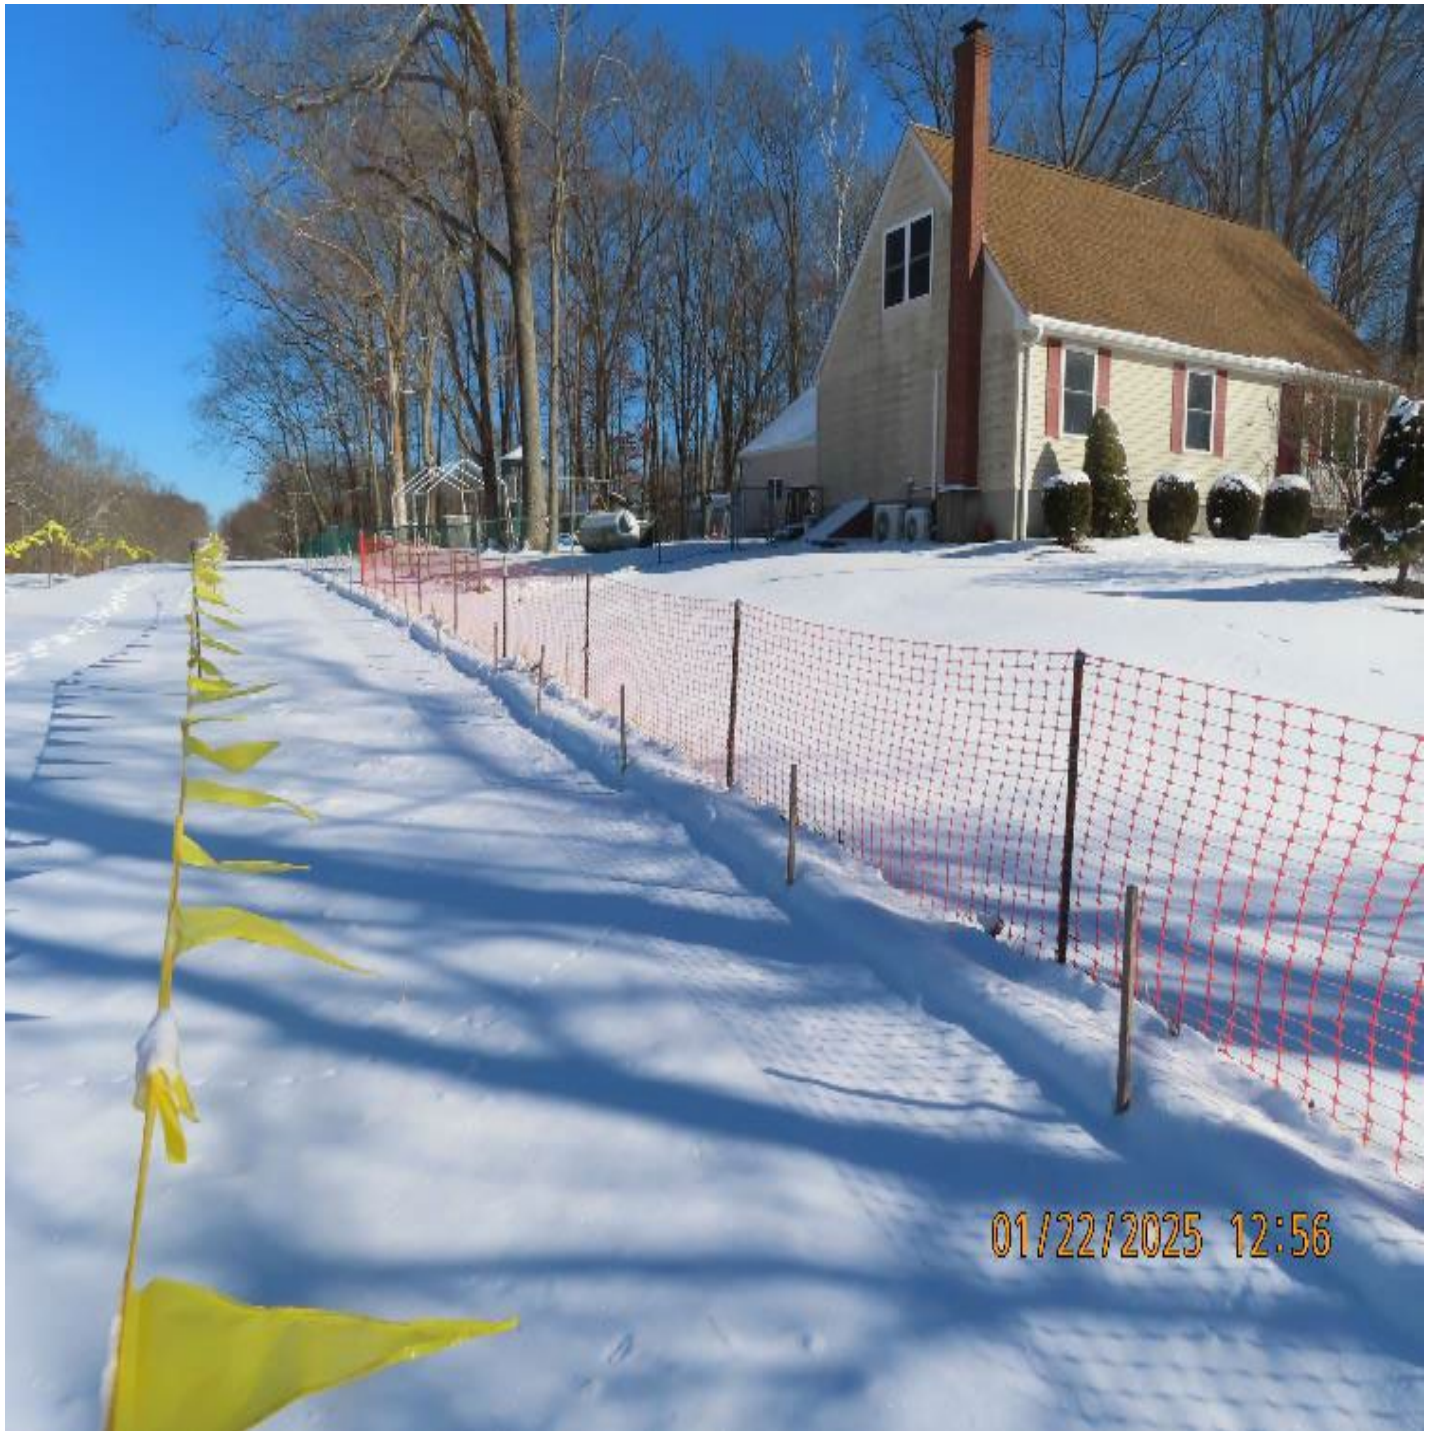
Photo 2: View (looking northeast) of access road along residential property.

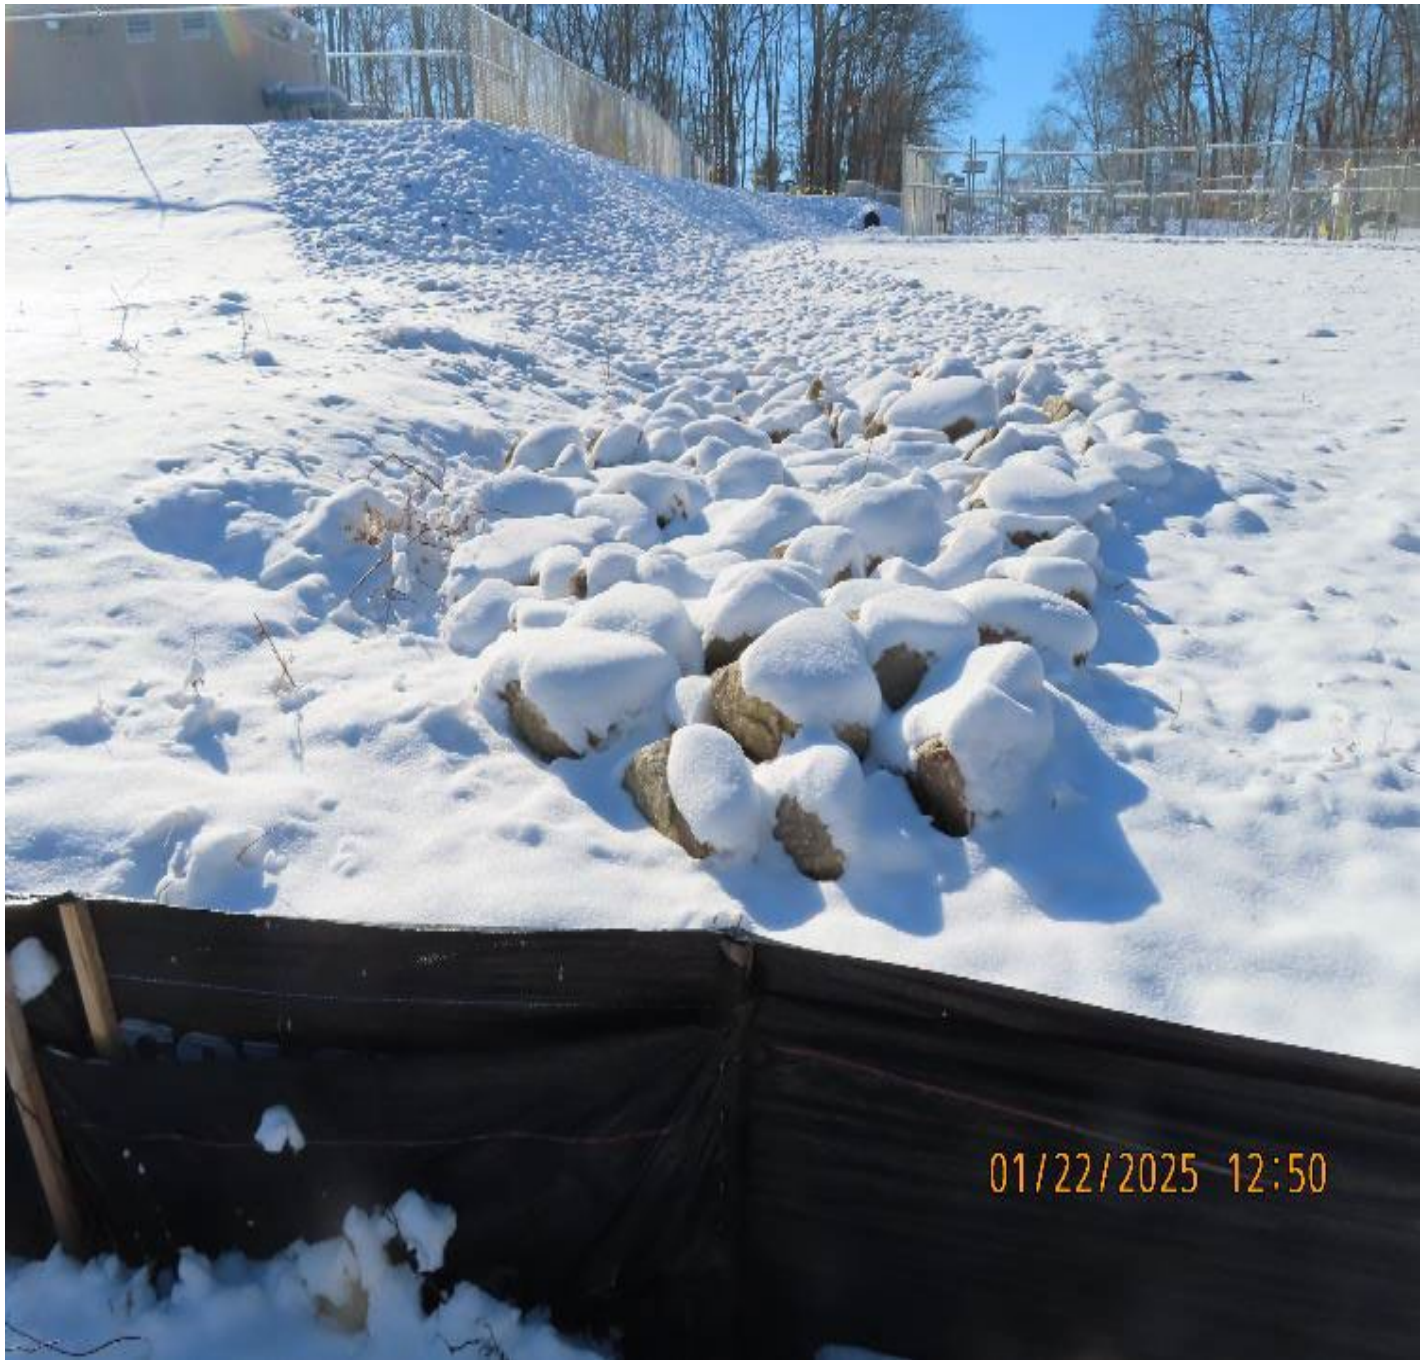
Photo 3: View (looking south) of culvert outlet and rock-armored drainage swale.

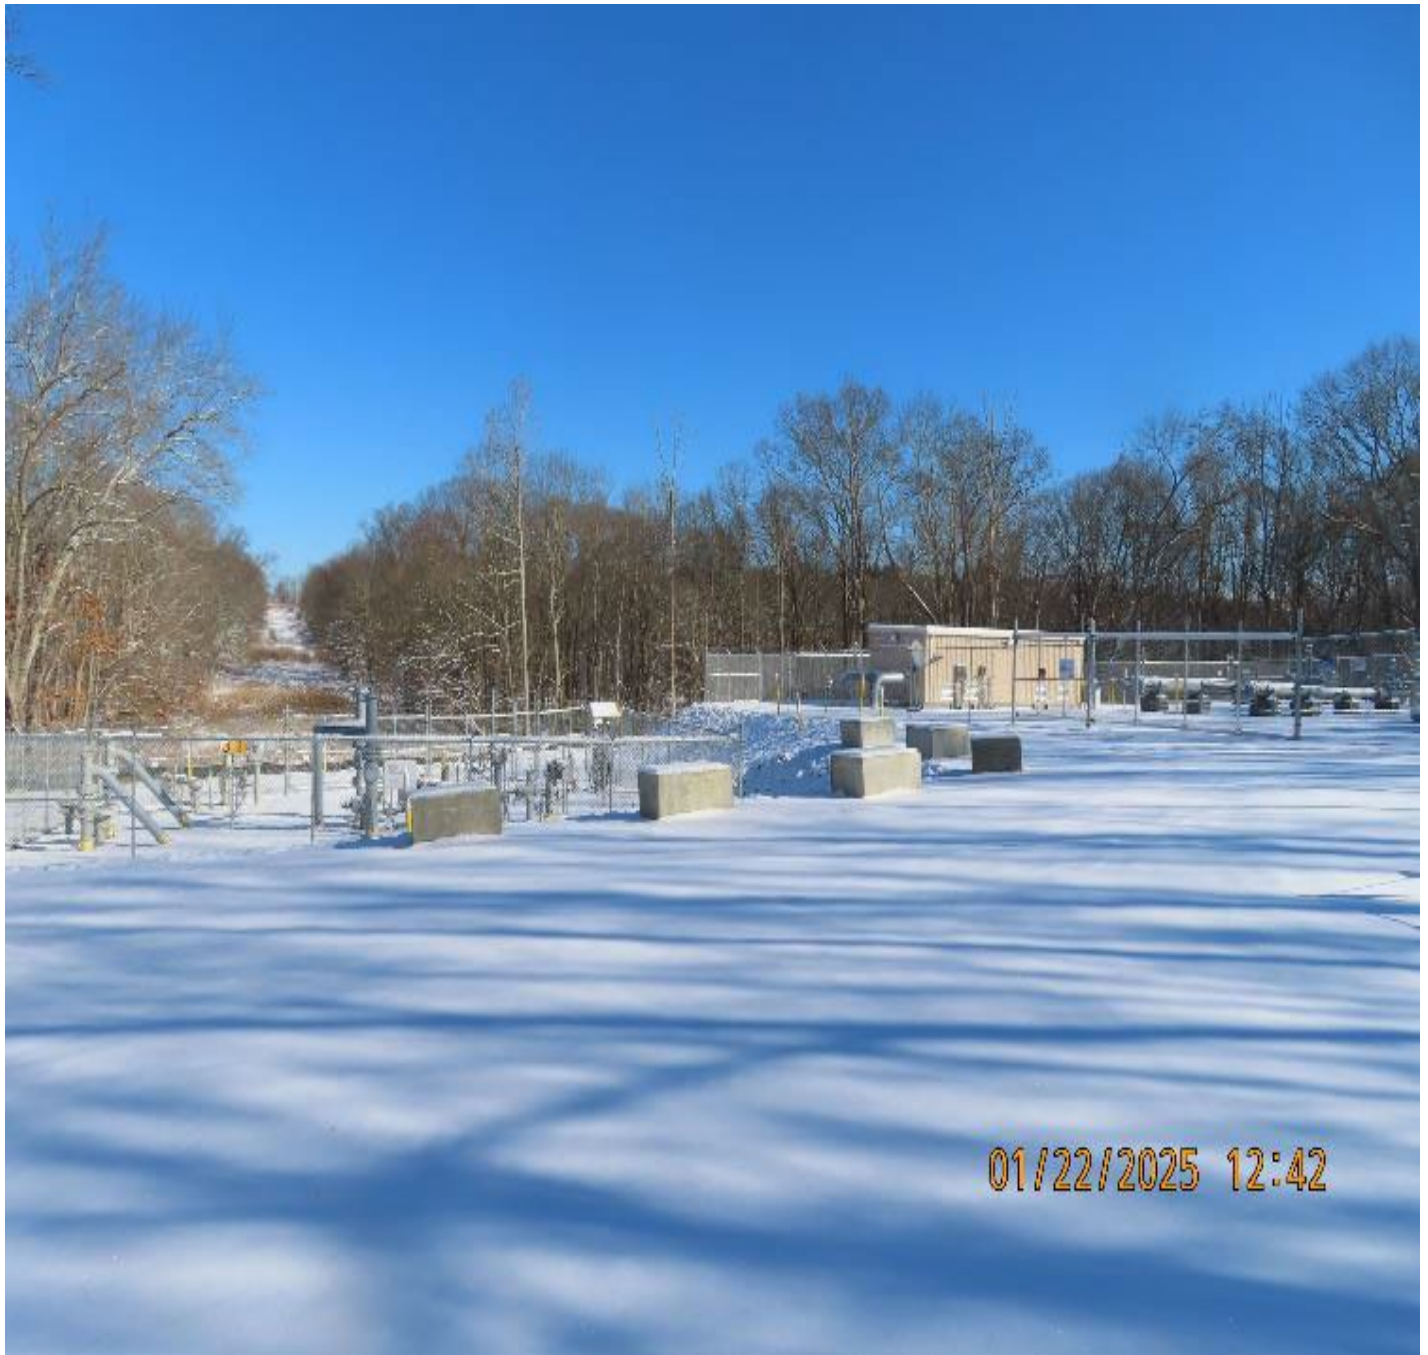
Photo 4: View (looking northeast) of valve yard.

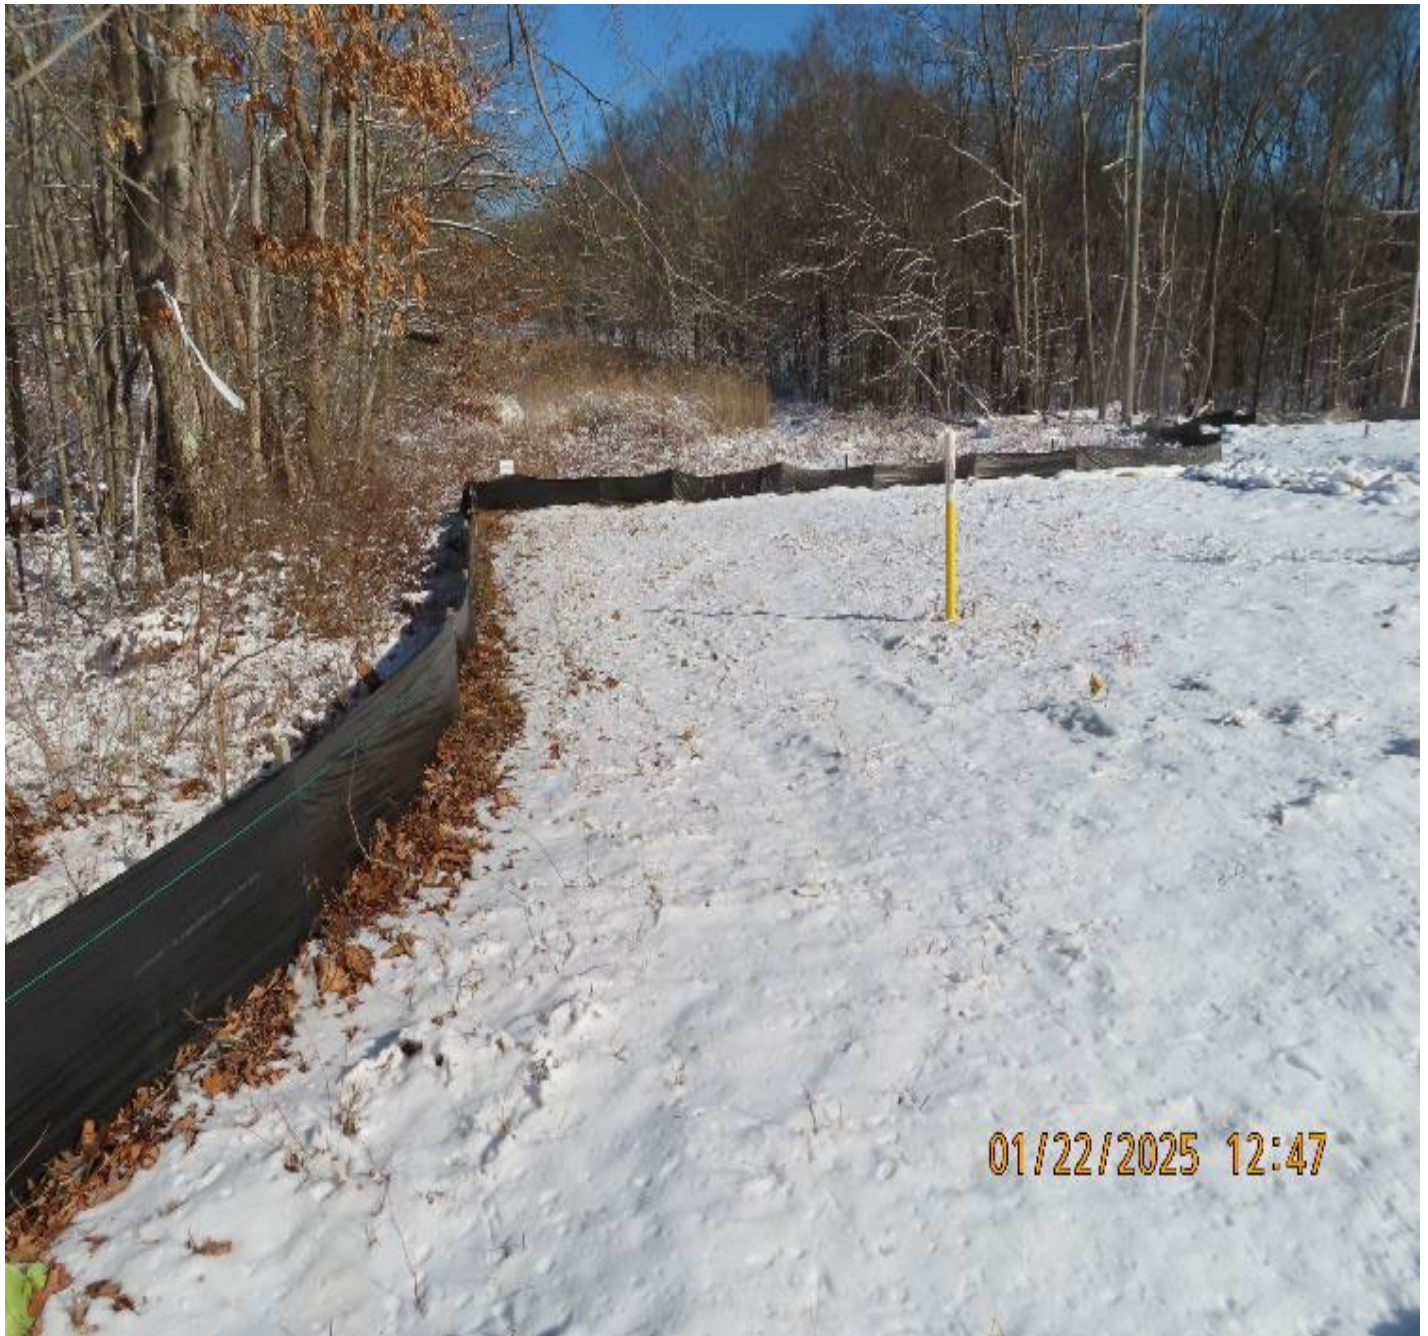
Photo 5: View (looking northeast) of silt fence along northwest corner of former workspace.

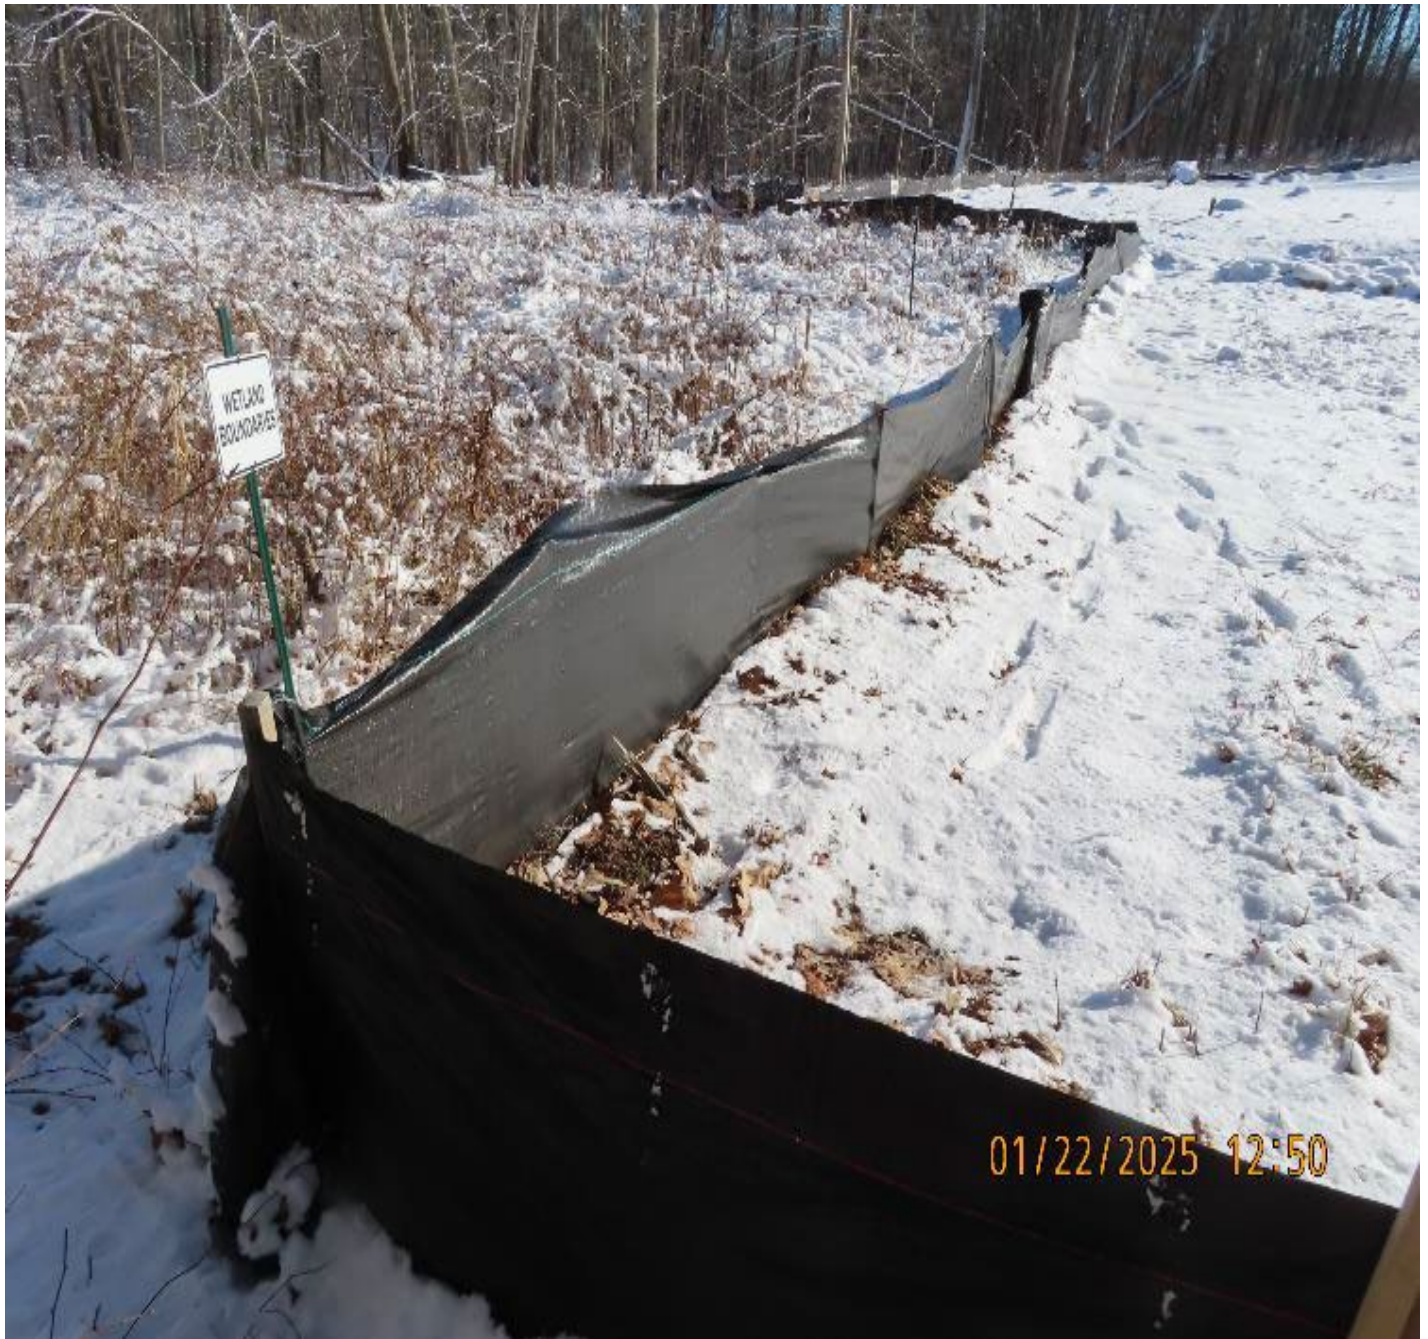
Photo 6: View (looking southeast) of silt fencing along Wetland W-CZ-01.
