Re: Algonquin Gas Transmission, LLC

E-1 System Regulator Installation Project, Docket No. CP24-21-000

Report No. 31

# E-1 System Regulation WEEKLY REPORT #31

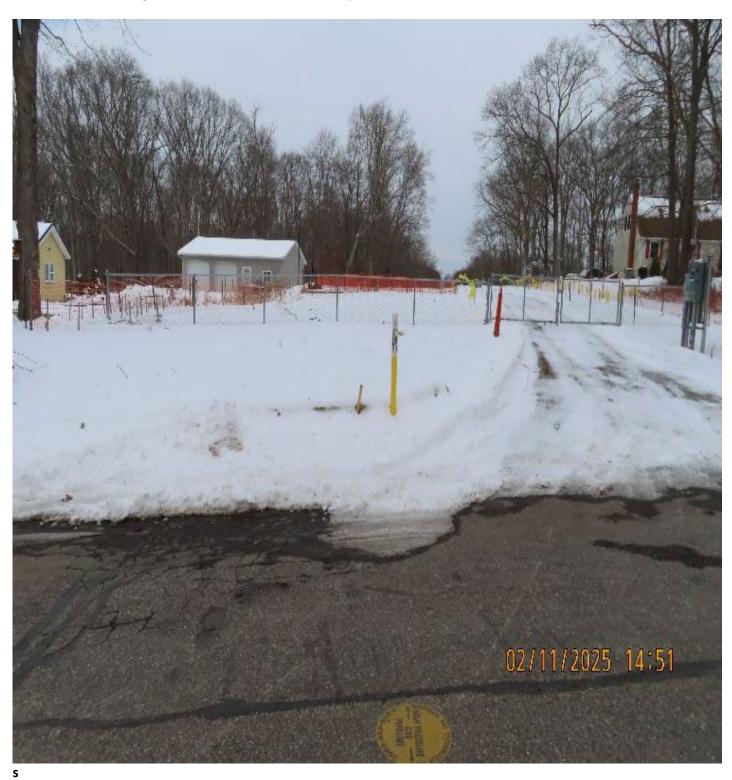
**Photo 1:** View (looking northeast) of site access from Hop River Road.

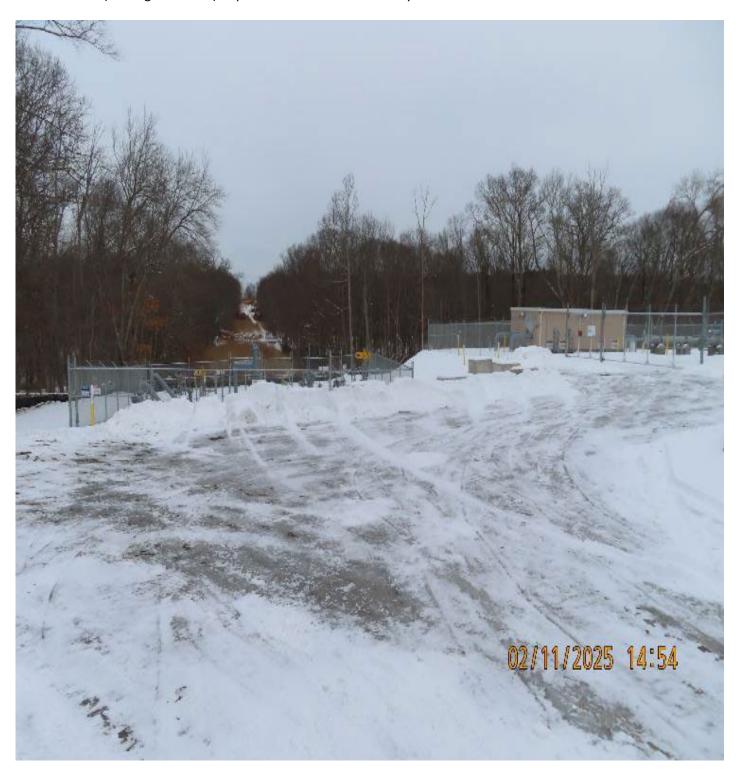
**Photo 2:** View (looking northeast) of plowed access road to valve yard.

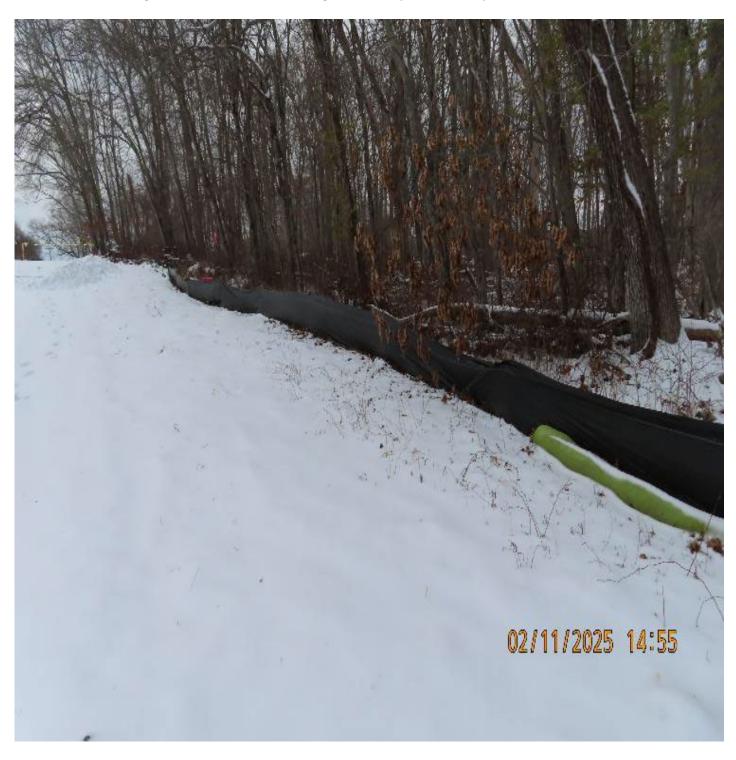
**Photo 3:** View (looking southwest) of silt fence along west workspace boundary.

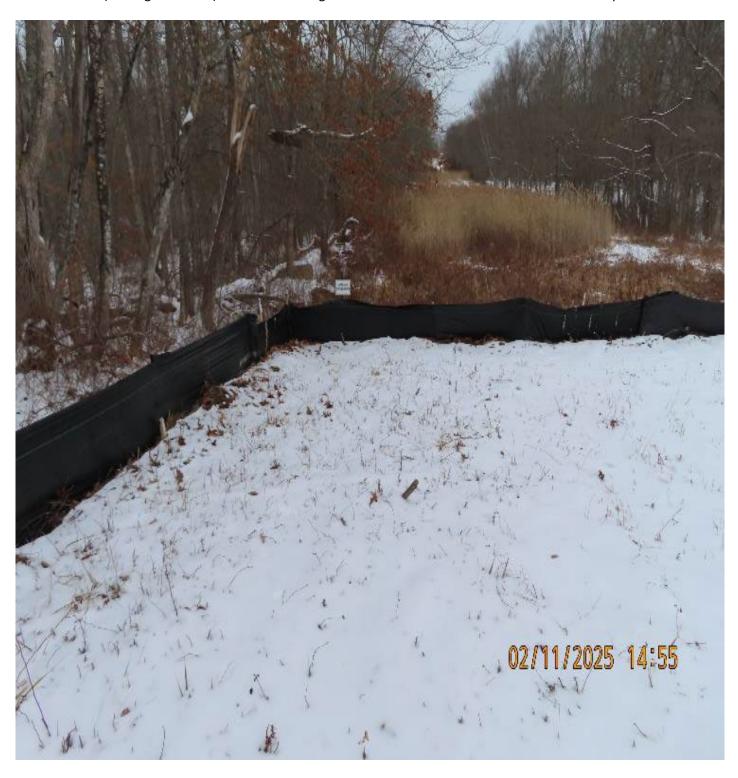
**Photo 4:** View (looking northeast) of silt fence along Wetland W-CZ-01 at northwest corner of workspace.

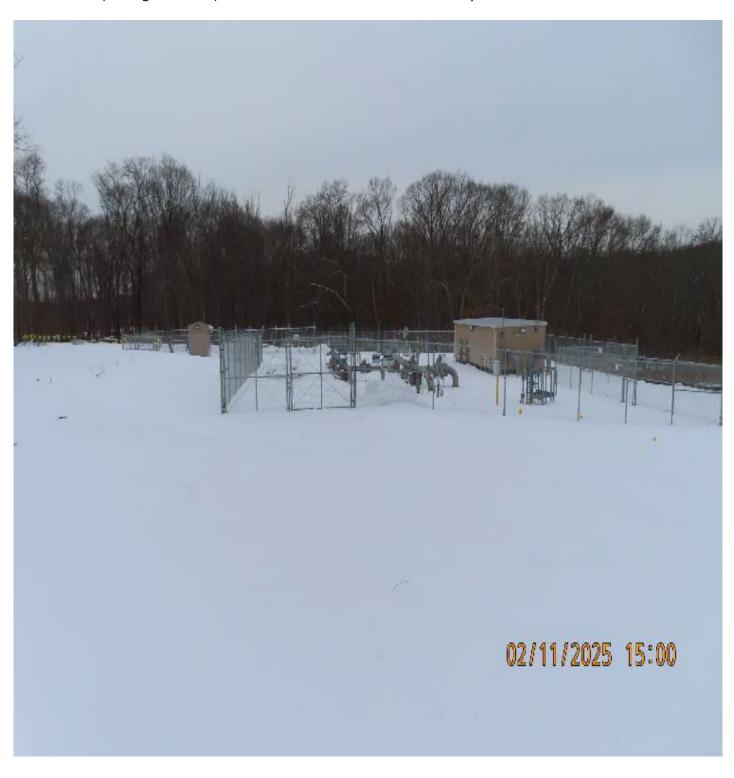
**Photo 5:** View (looking northwest) at snow covered conditions around valve yard.
