Re: *Algonquin Gas Transmission, LLC*
E-1 System Regulator Installation Project, Docket No. CP24-21-000
Report No. 34

**E-1 System Regulation
WEEKLY REPORT #34**

Project:	E-1 System Regulation
FERC Docket Number:	CP24-21-000
Report Number:	34
Reporting Period:	February 27 through March 5, 2025

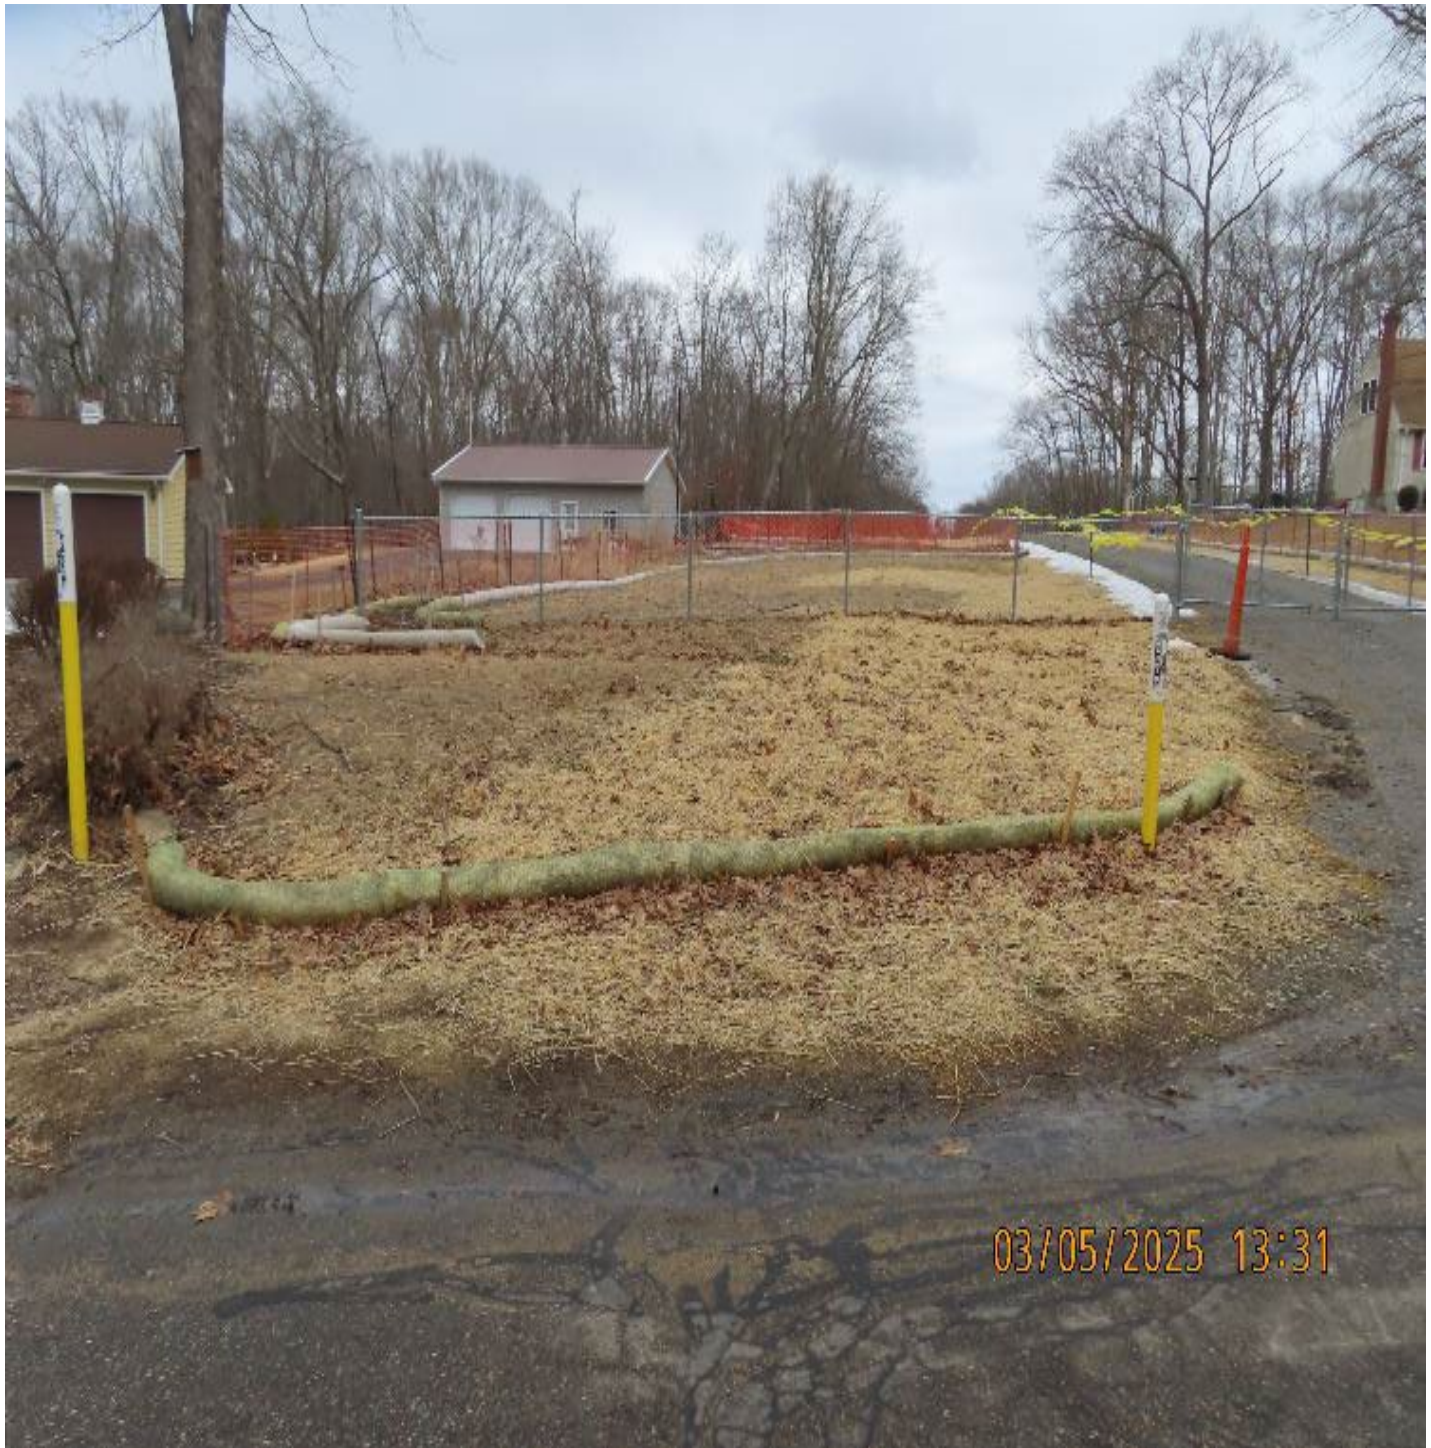
Photo 1: View (looking northeast) of site entrance from Hop River Road.

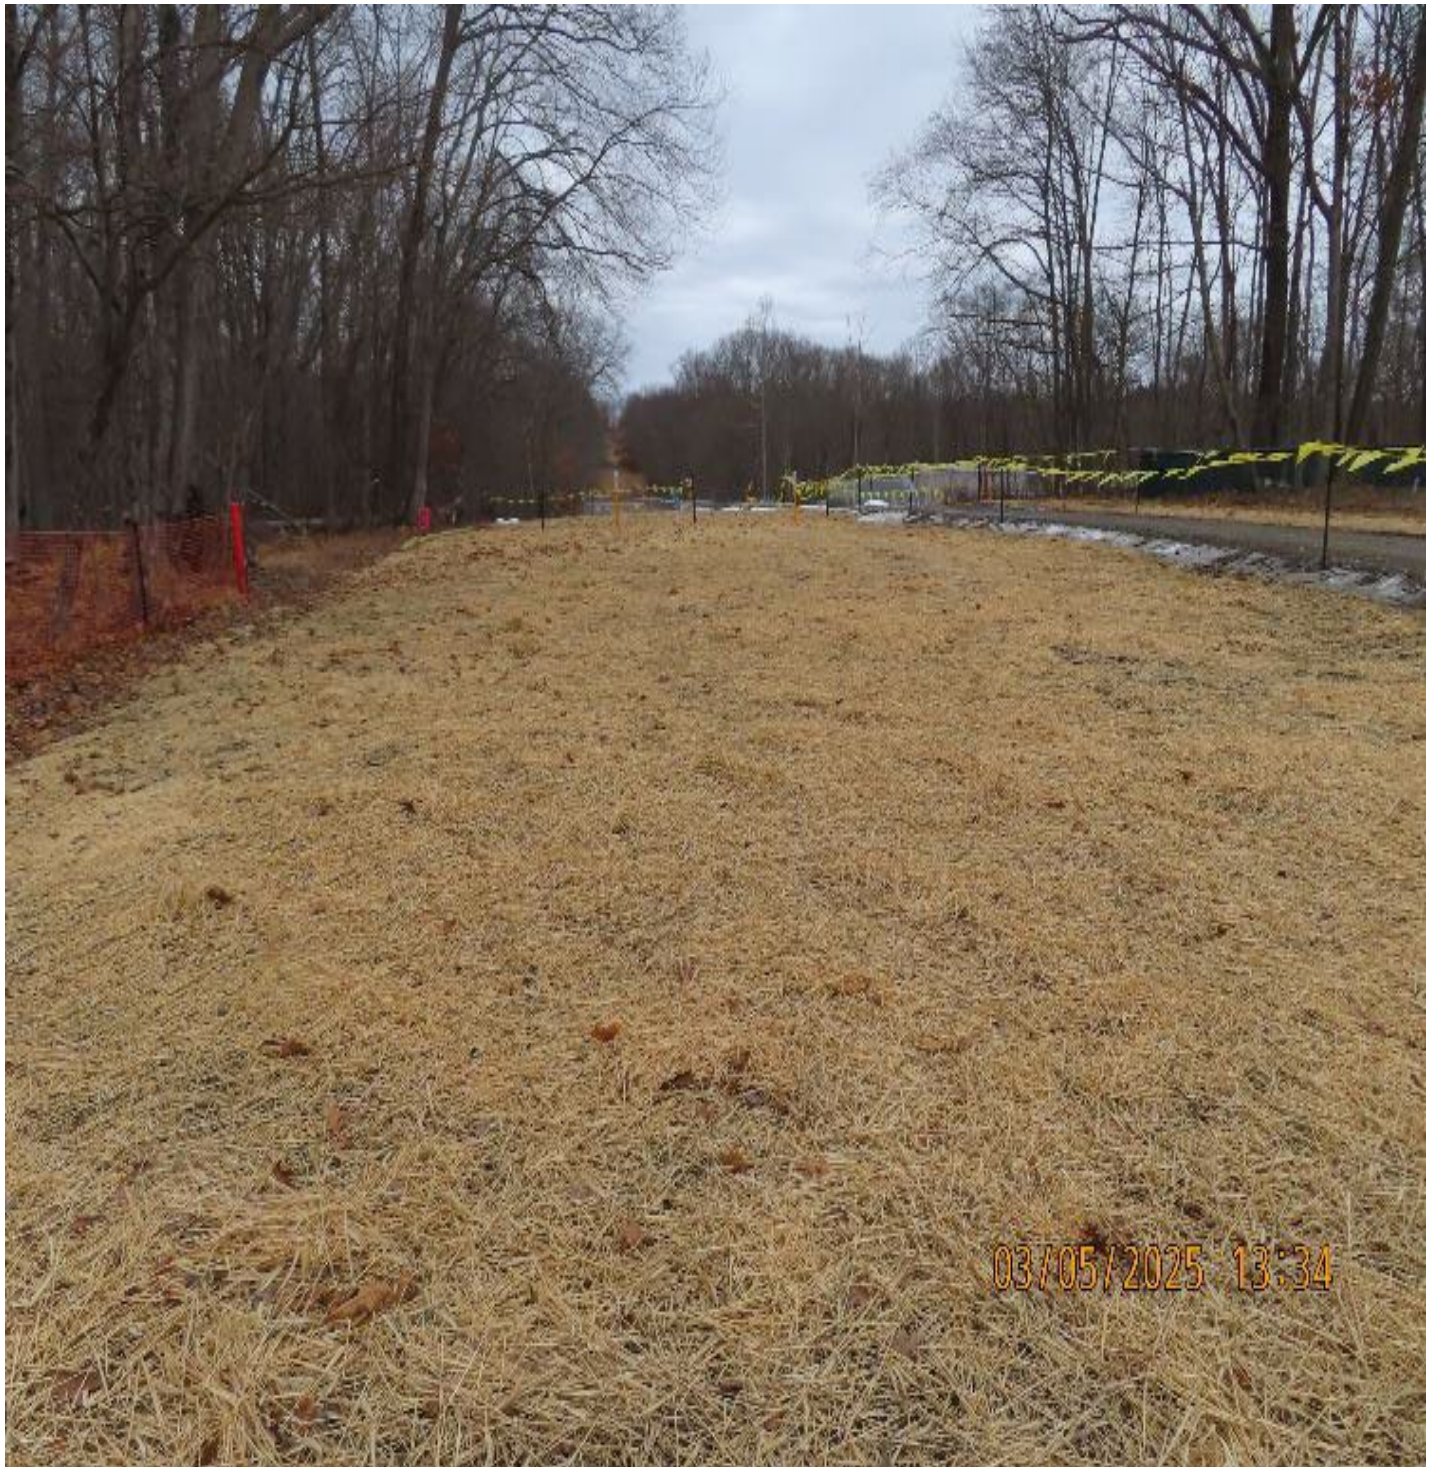
Photo 2: View (looking northeast) of former staging area along access road.

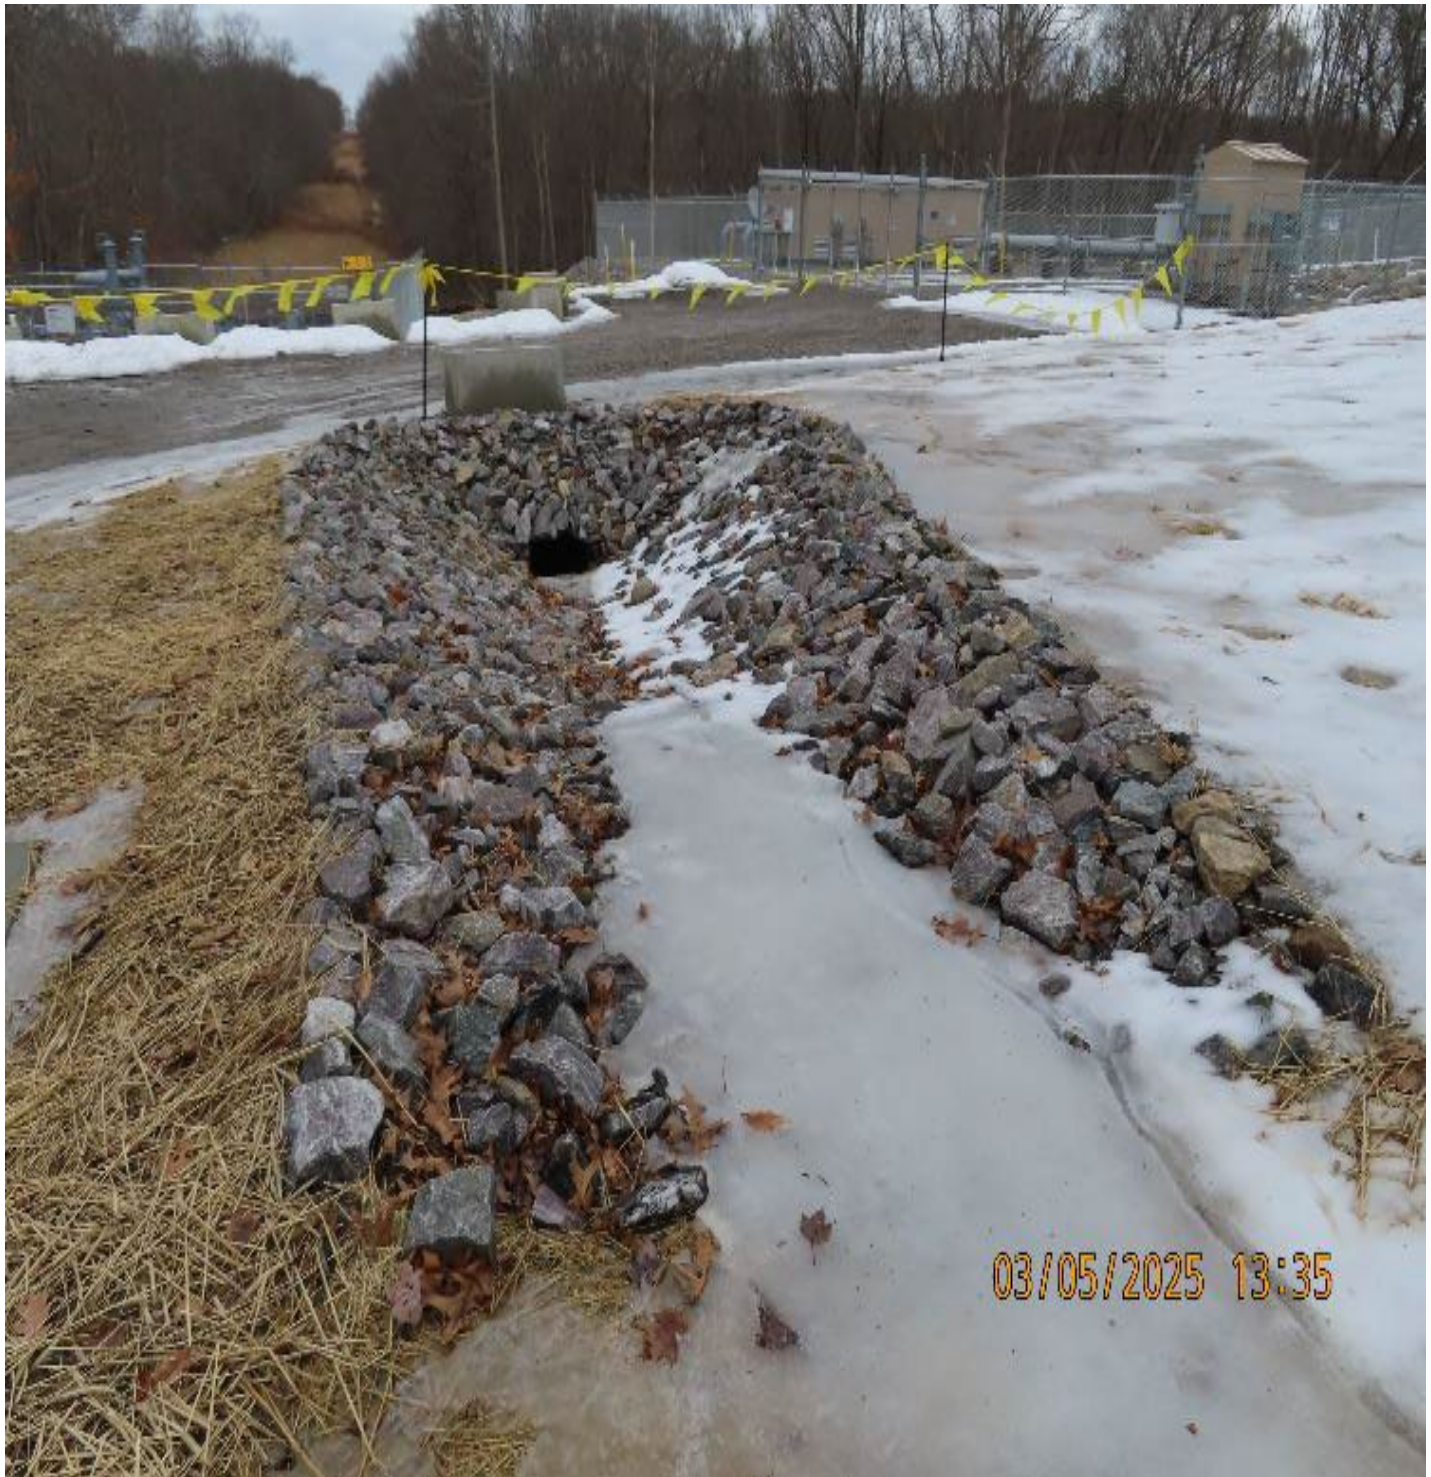
Photo 3: View (looking northeast) of drainage swale and culvert under entrance to the valve yard.

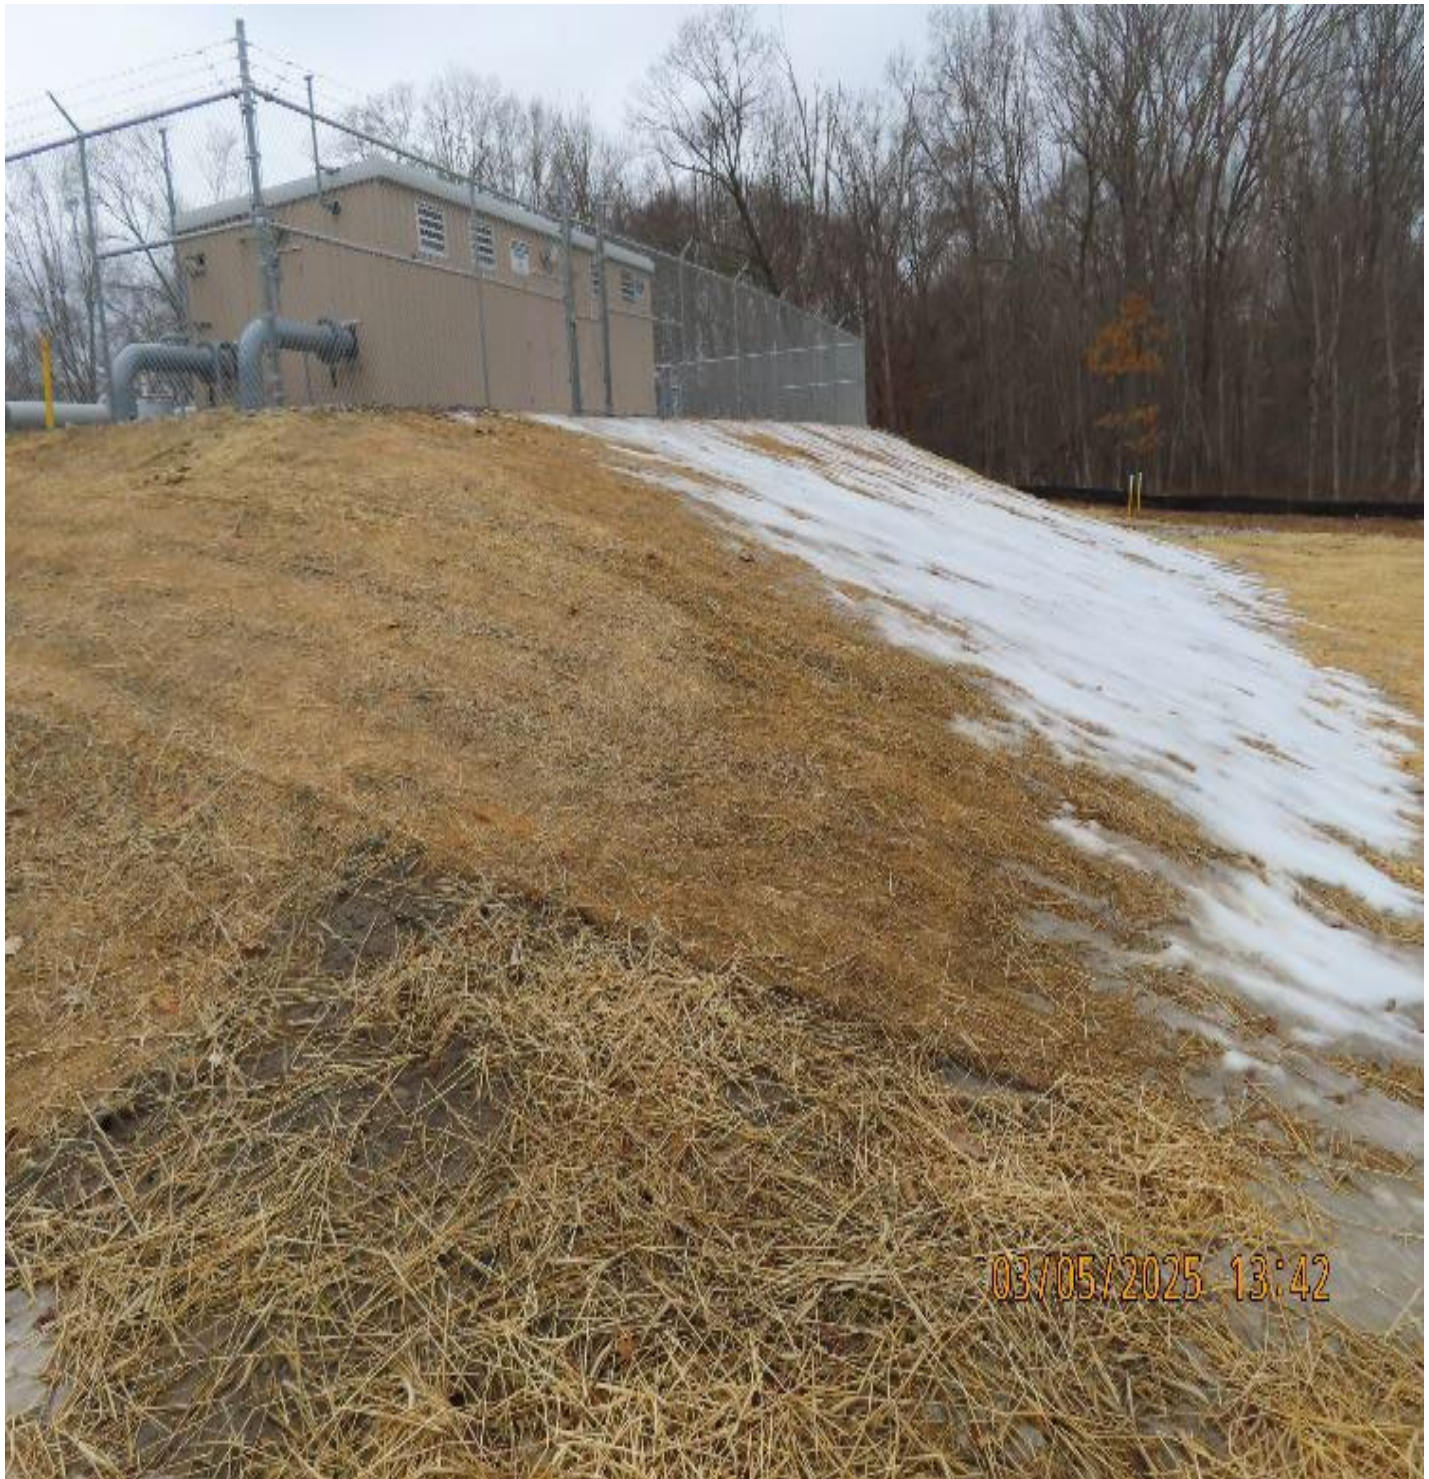
Photo 4: View (looking west) at restored slope north of the new regulator building.

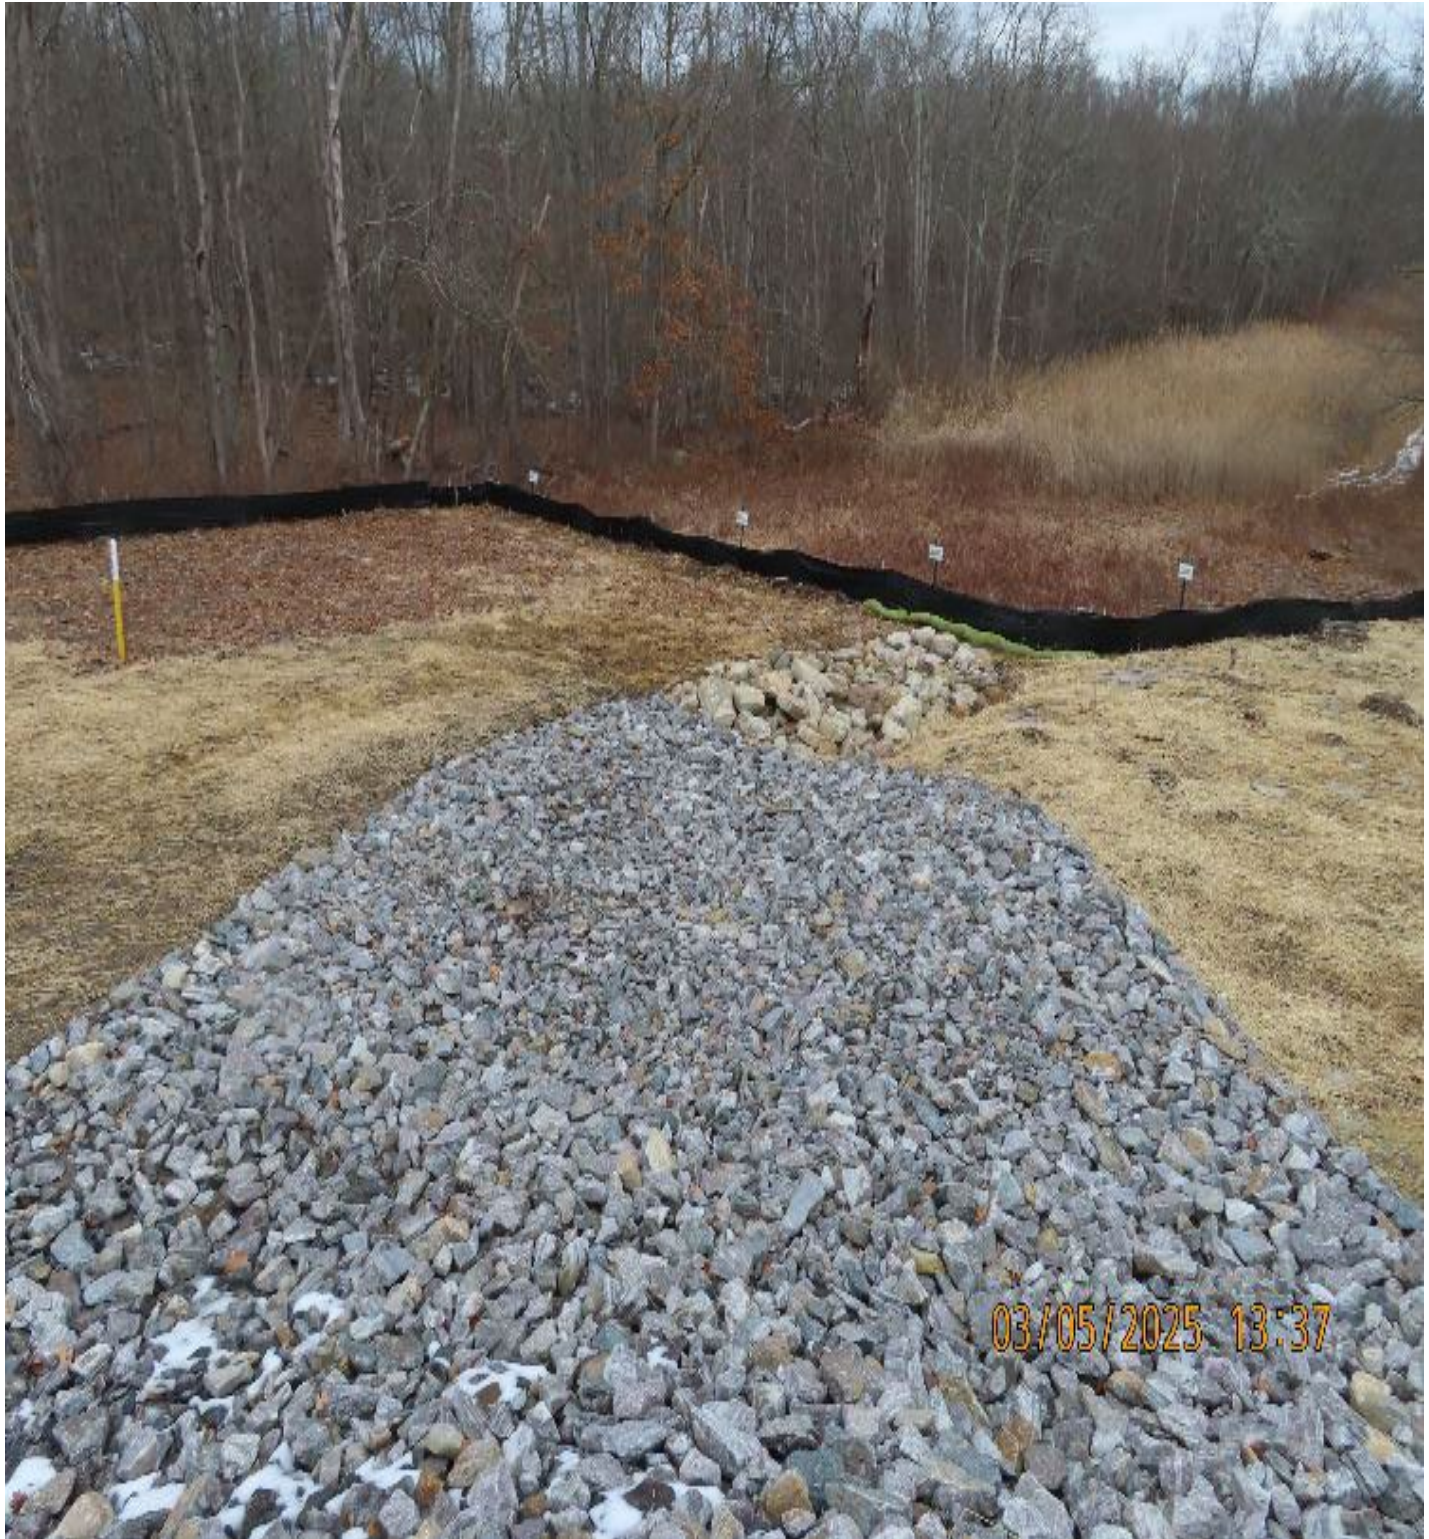
Photo 5: View (looking north) of drainage swale and perimeter silt fence at northwest corner of former workspace.

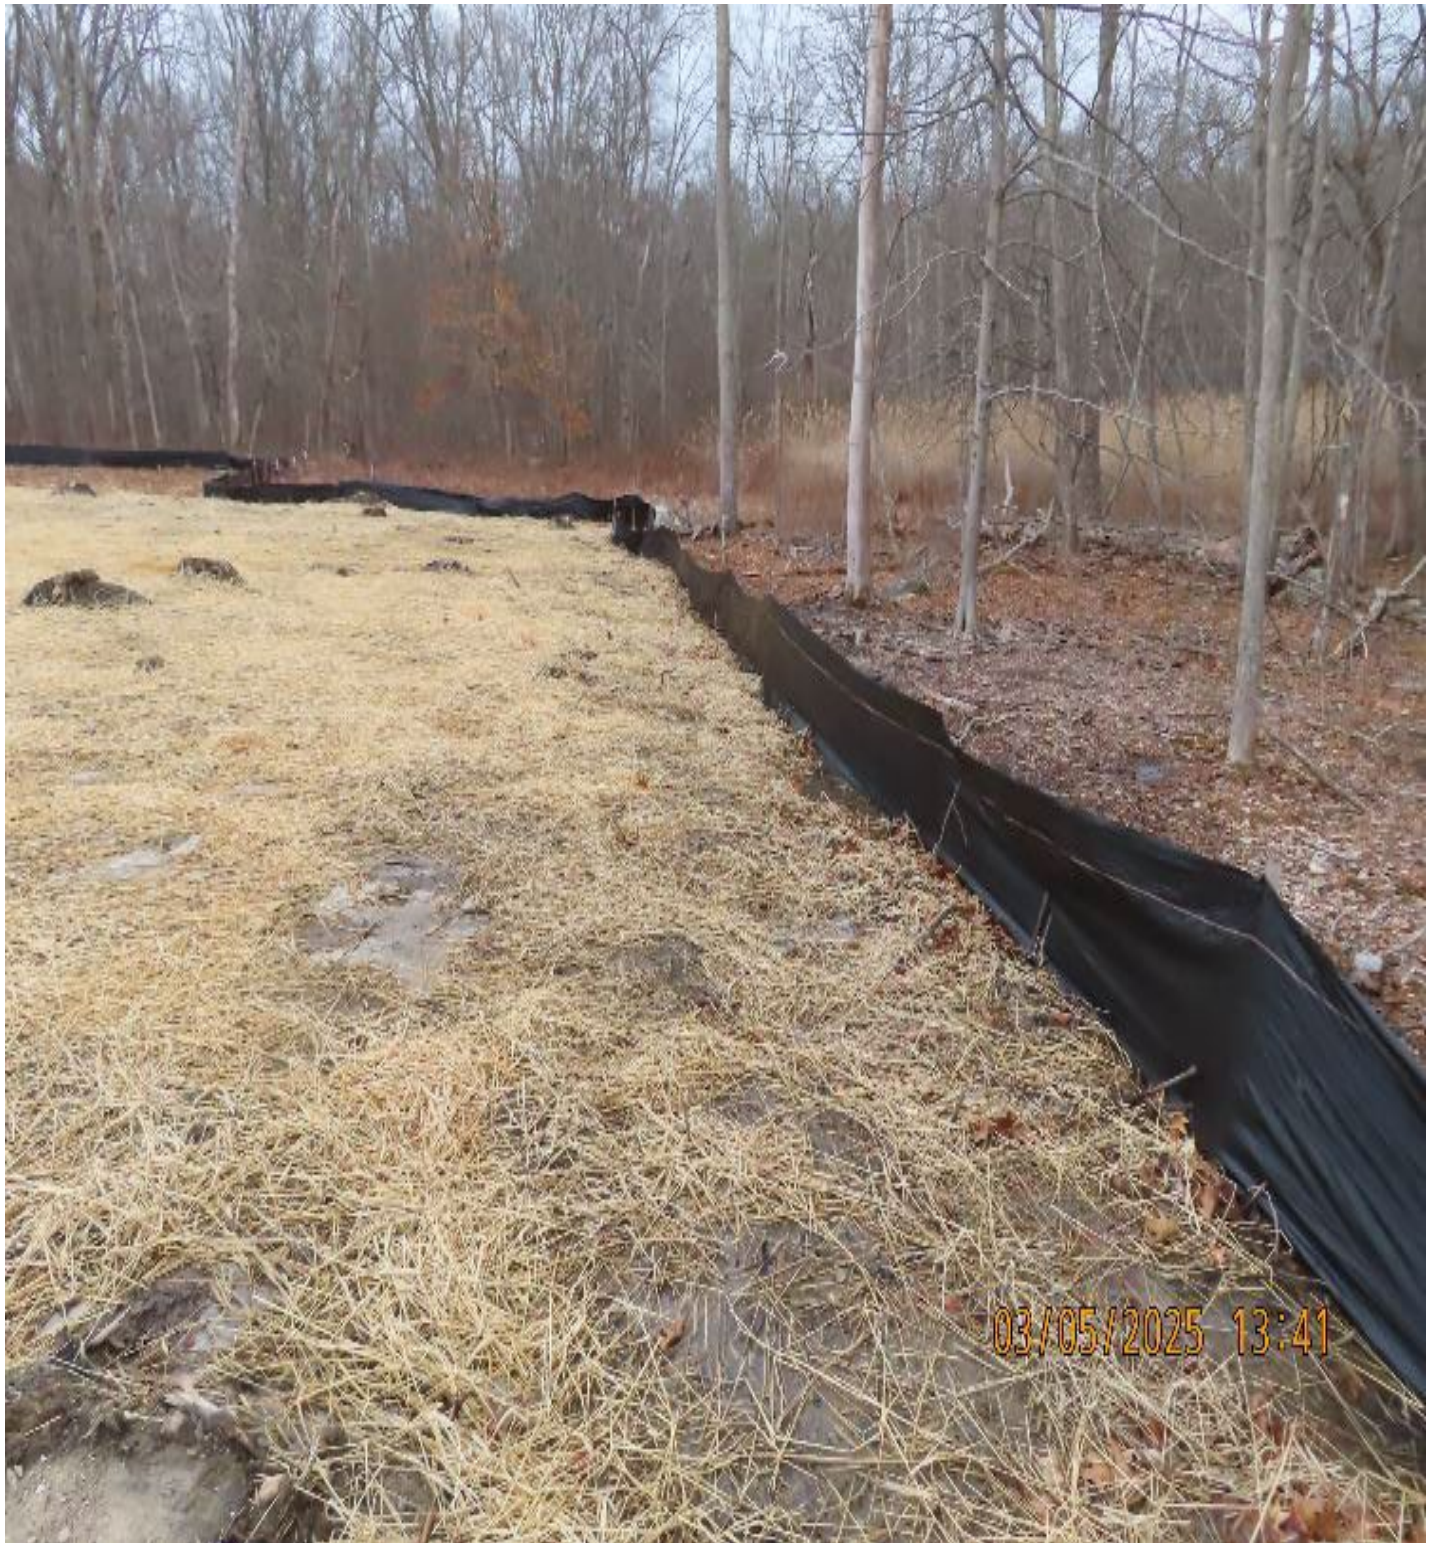
Photo 6: View (looking northwest) of perimeter silt fence along downslope side of former workspace.
