Re: *Algonquin Gas Transmission, LLC*  
E-1 System Regulator Installation Project, Docket No. CP24-21-000  
Report No. 35

**E-1 System Regulation  
BI-WEEKLY REPORT #35**

Project:	E-1 System Regulation
FERC Docket Number:	CP24-21-000
Report Number:	35
Reporting Period:	March 6 through March 19, 2025

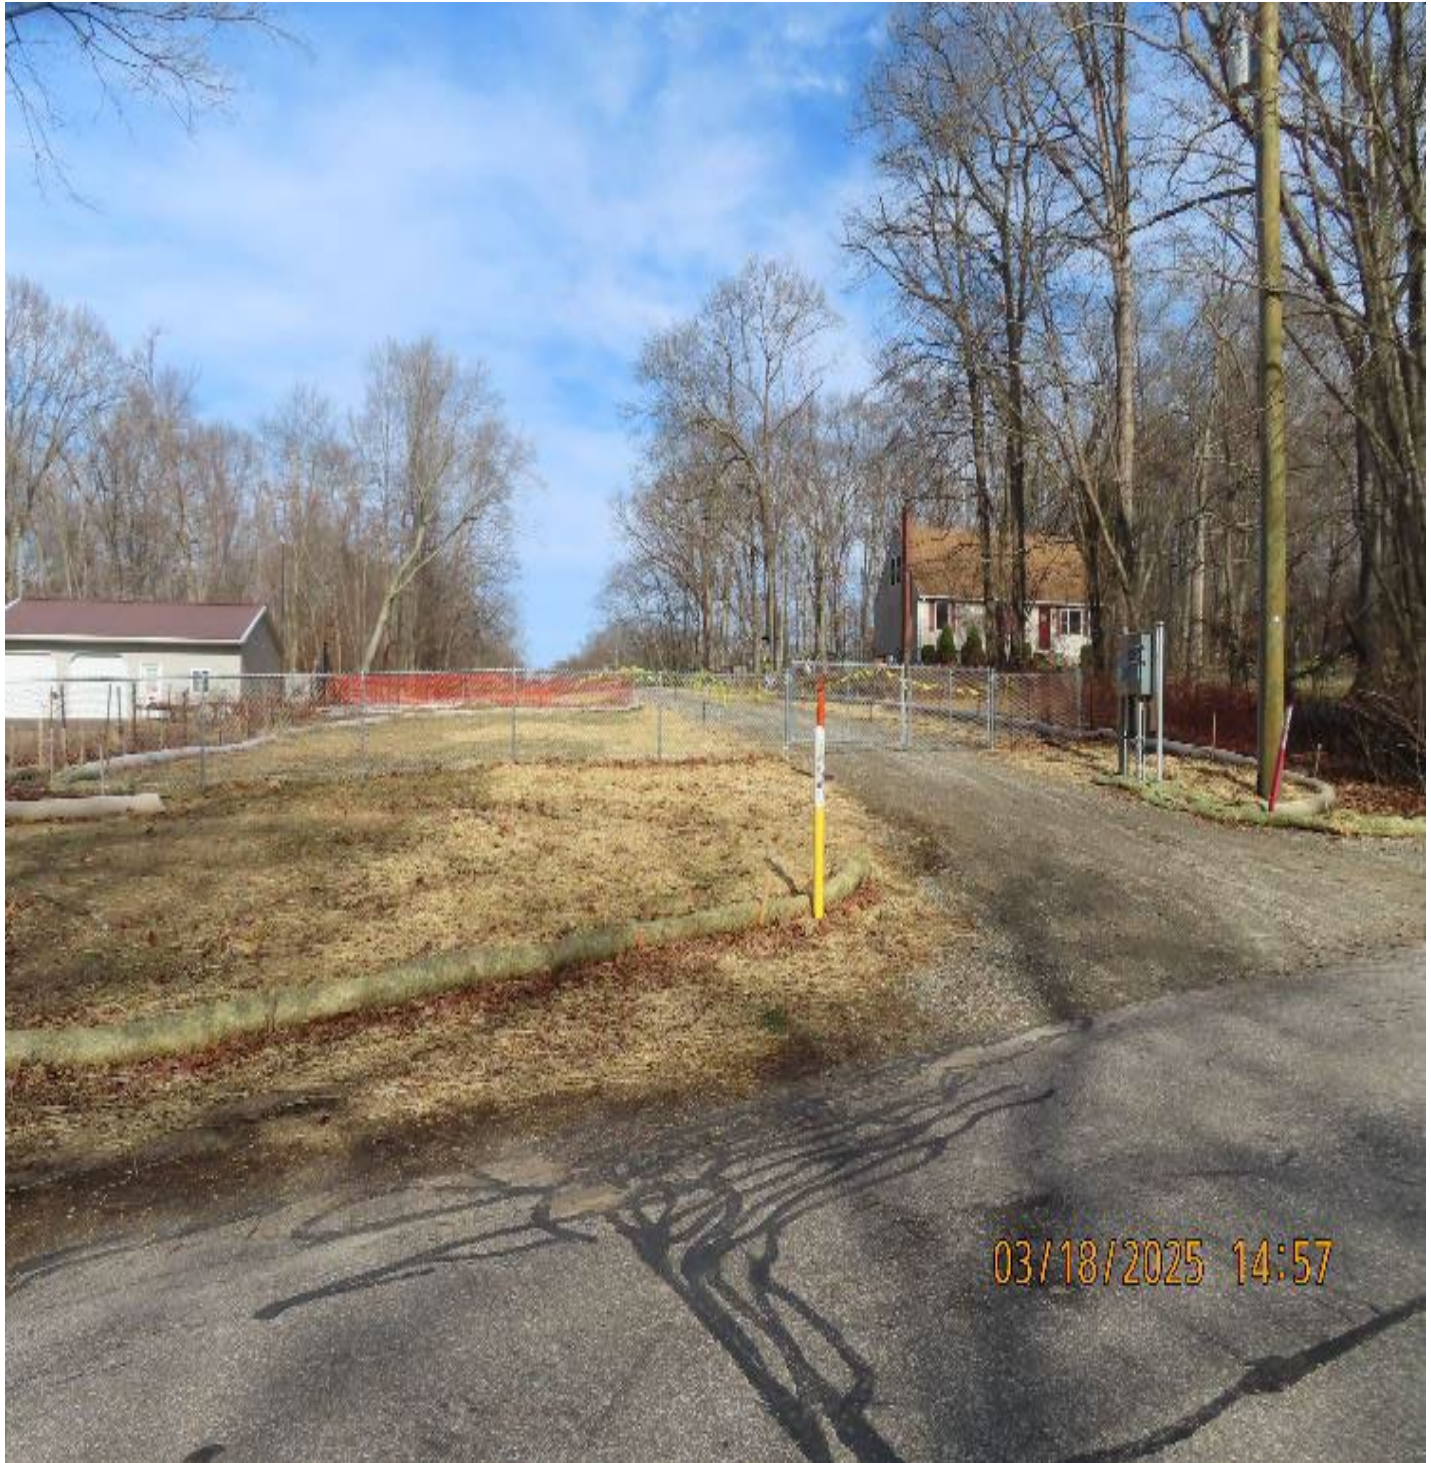
**Photo 1:** View (looking northeast) of site access from Hop River Road.

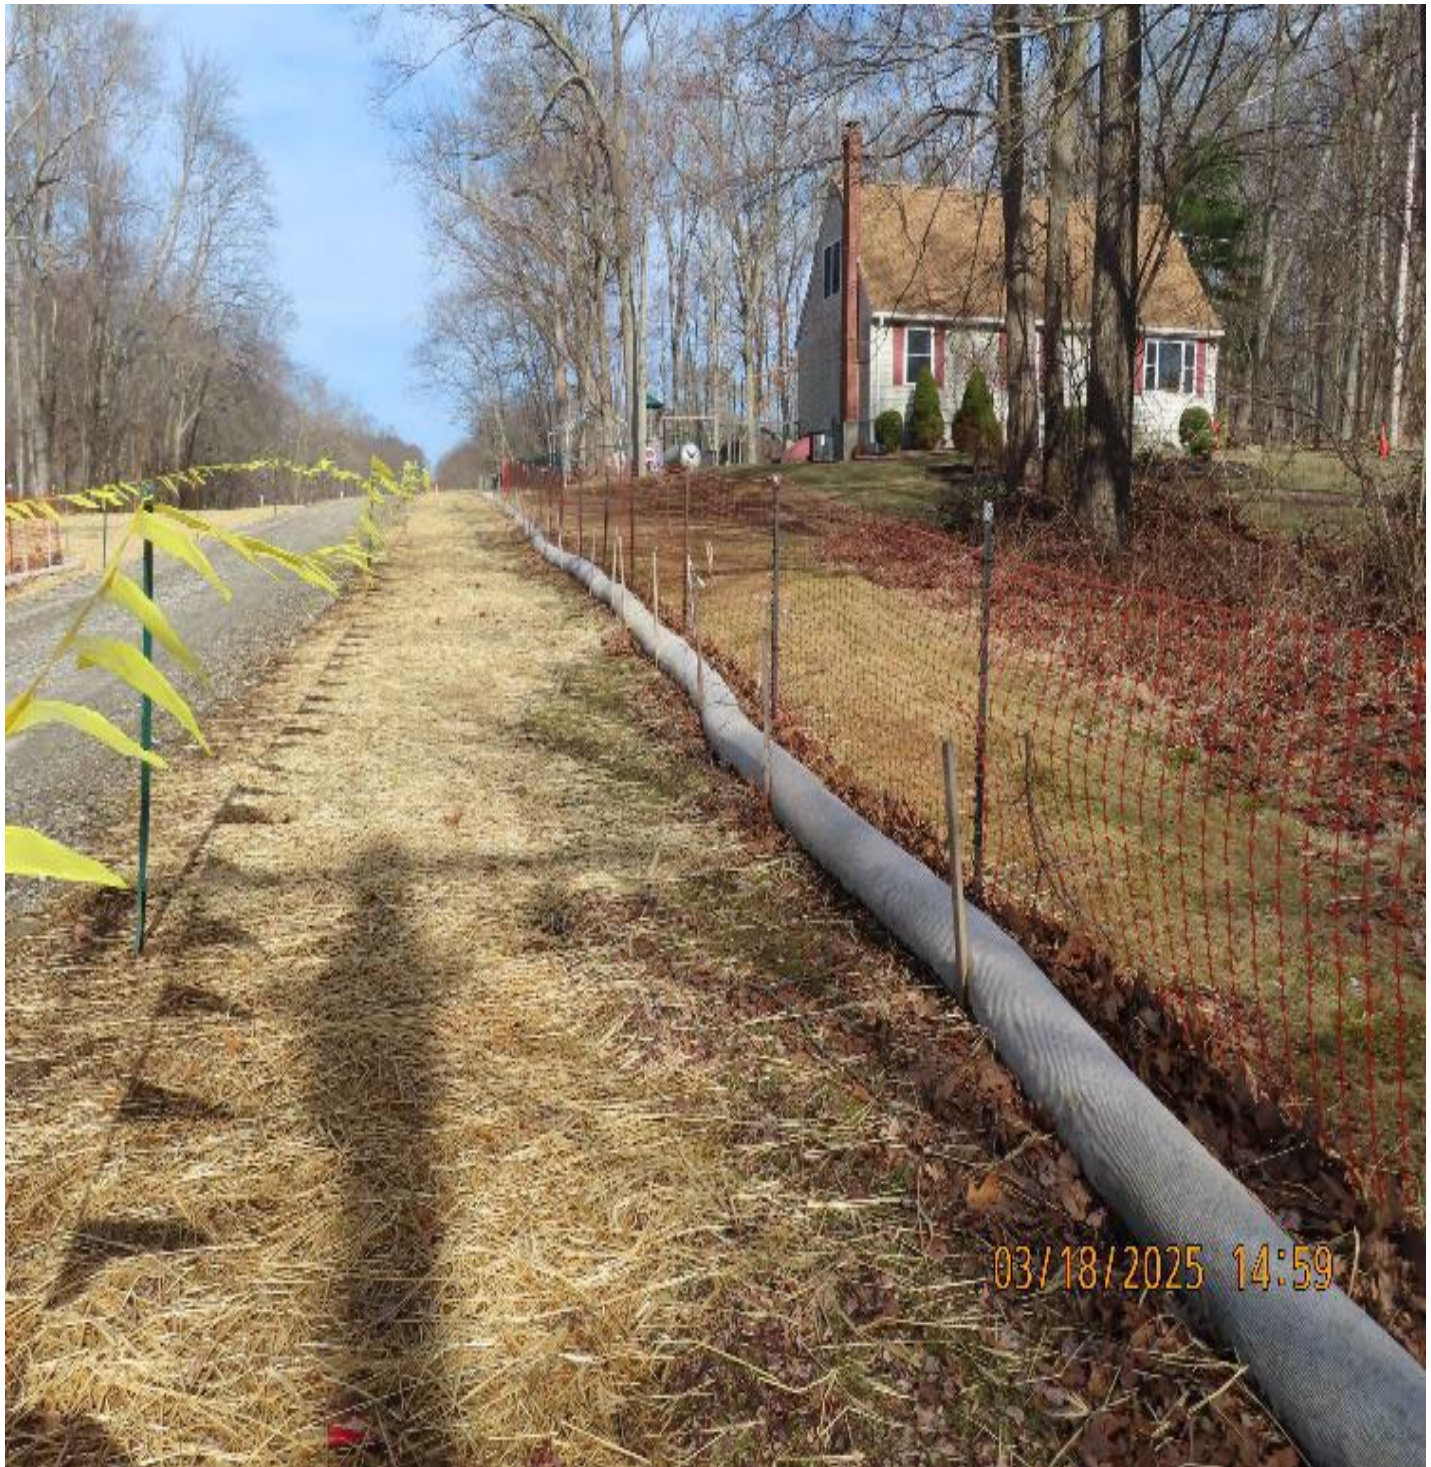
**Photo 2:** View (looking northeast) of access road in residential area.

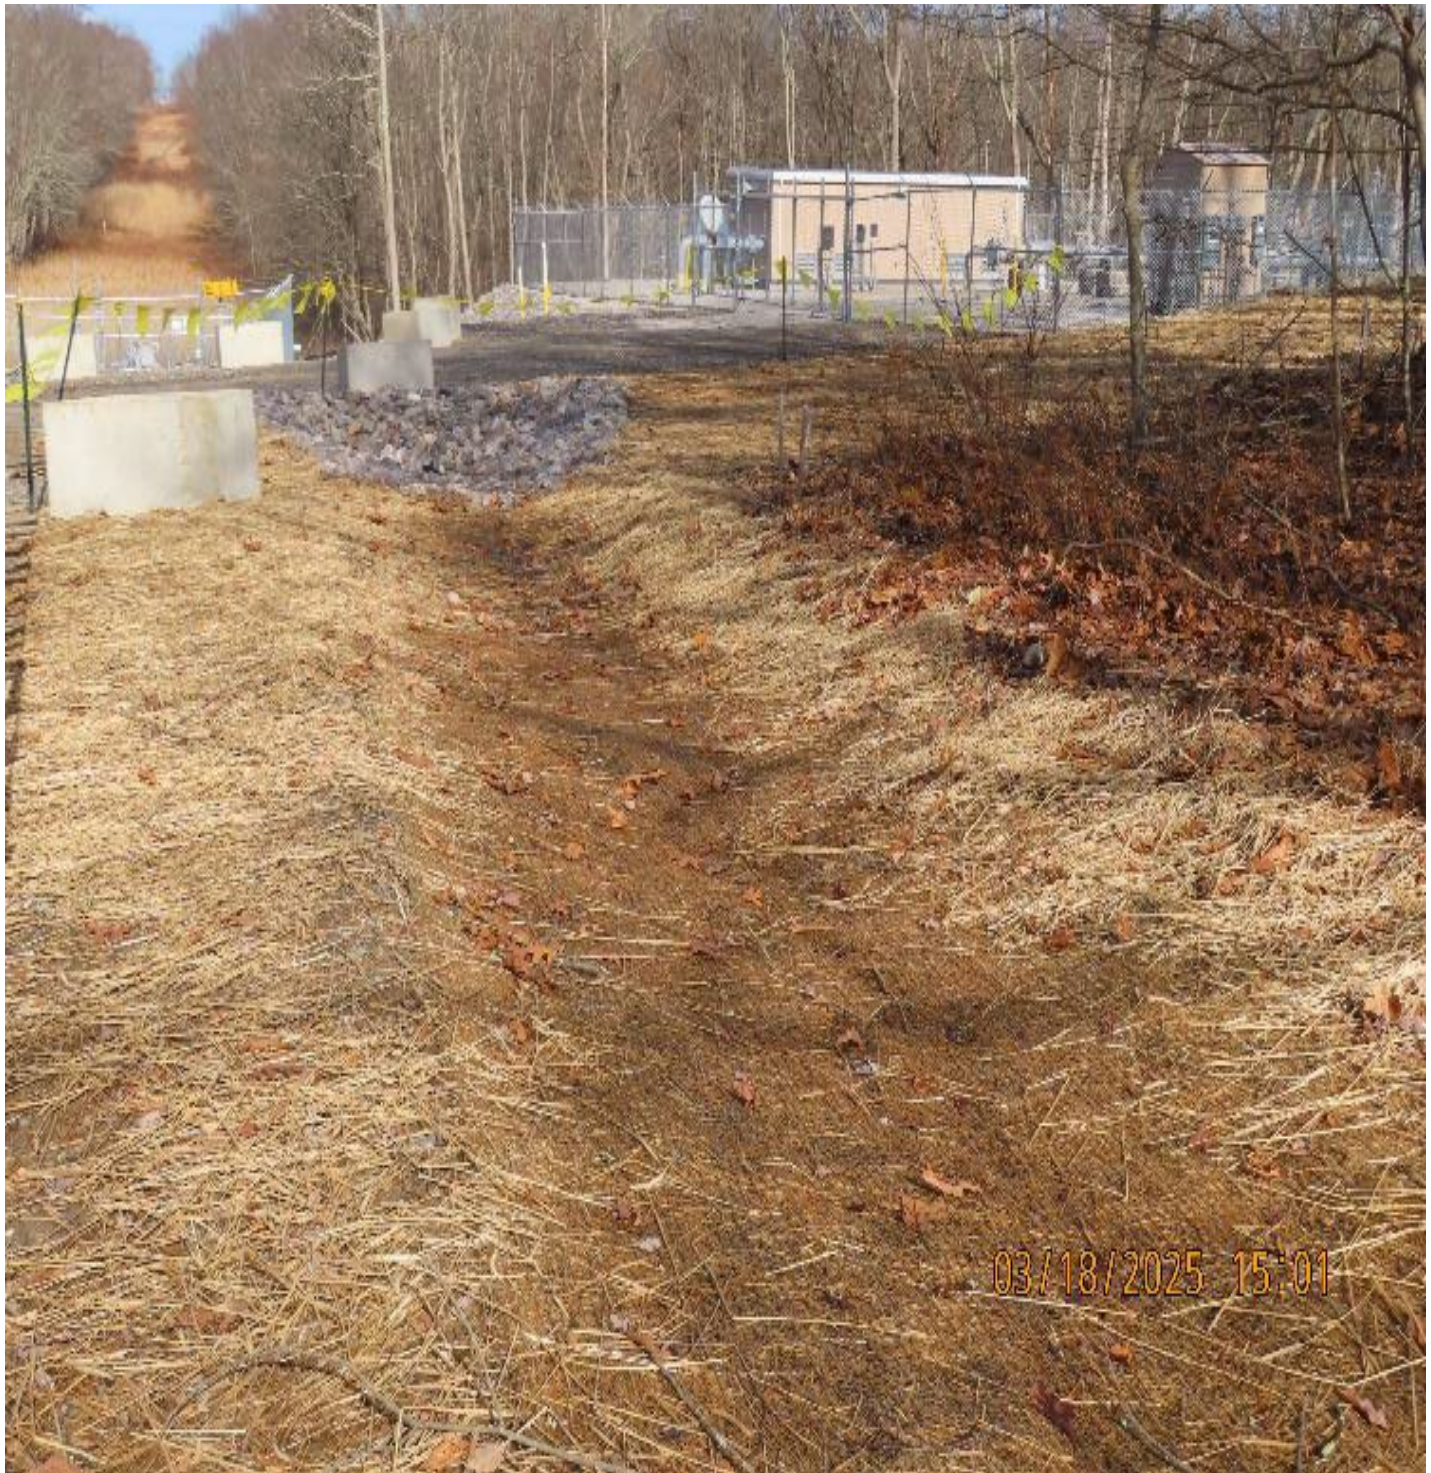
**Photo 3:** View (looking northeast) of drainage swale leading to culverted entrance into the valve yard.

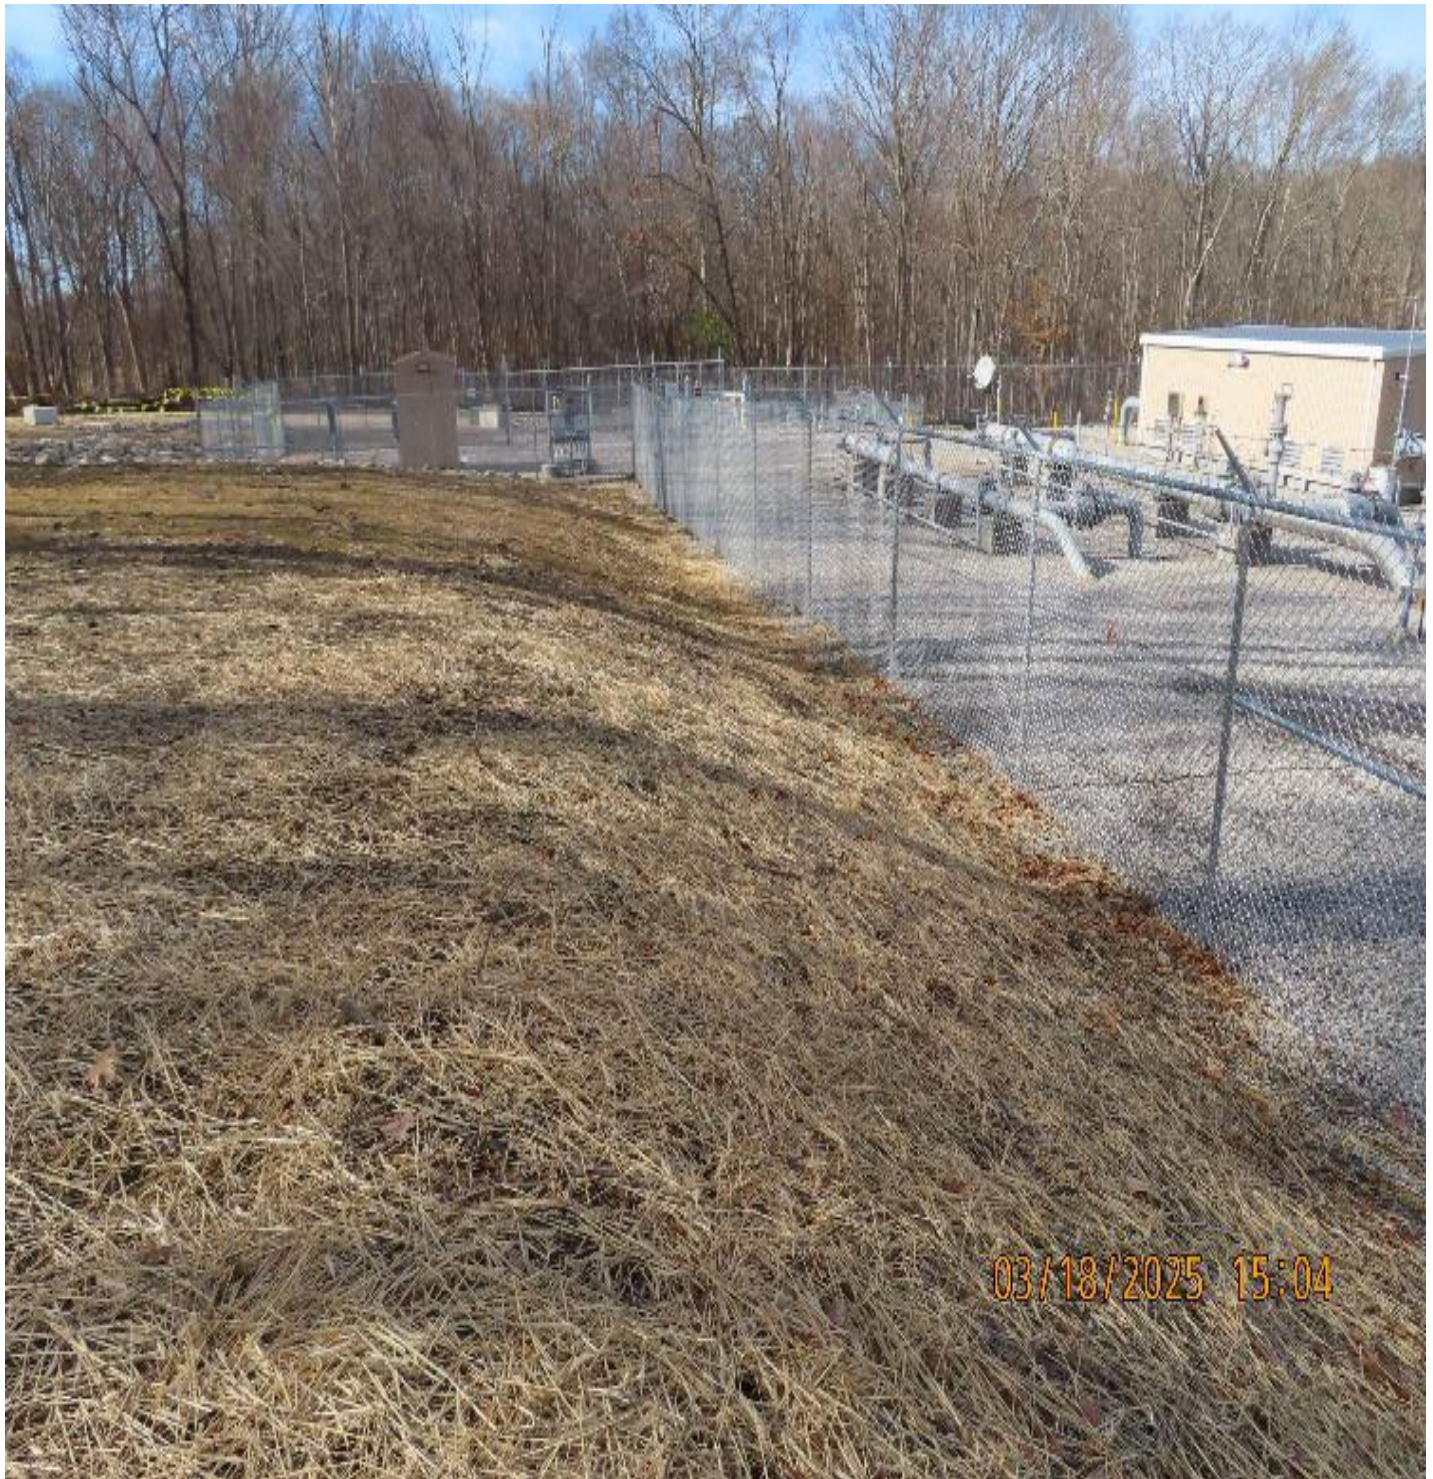
**Photo 4:** View (looking west) of stabilized slope south of the valve yard.

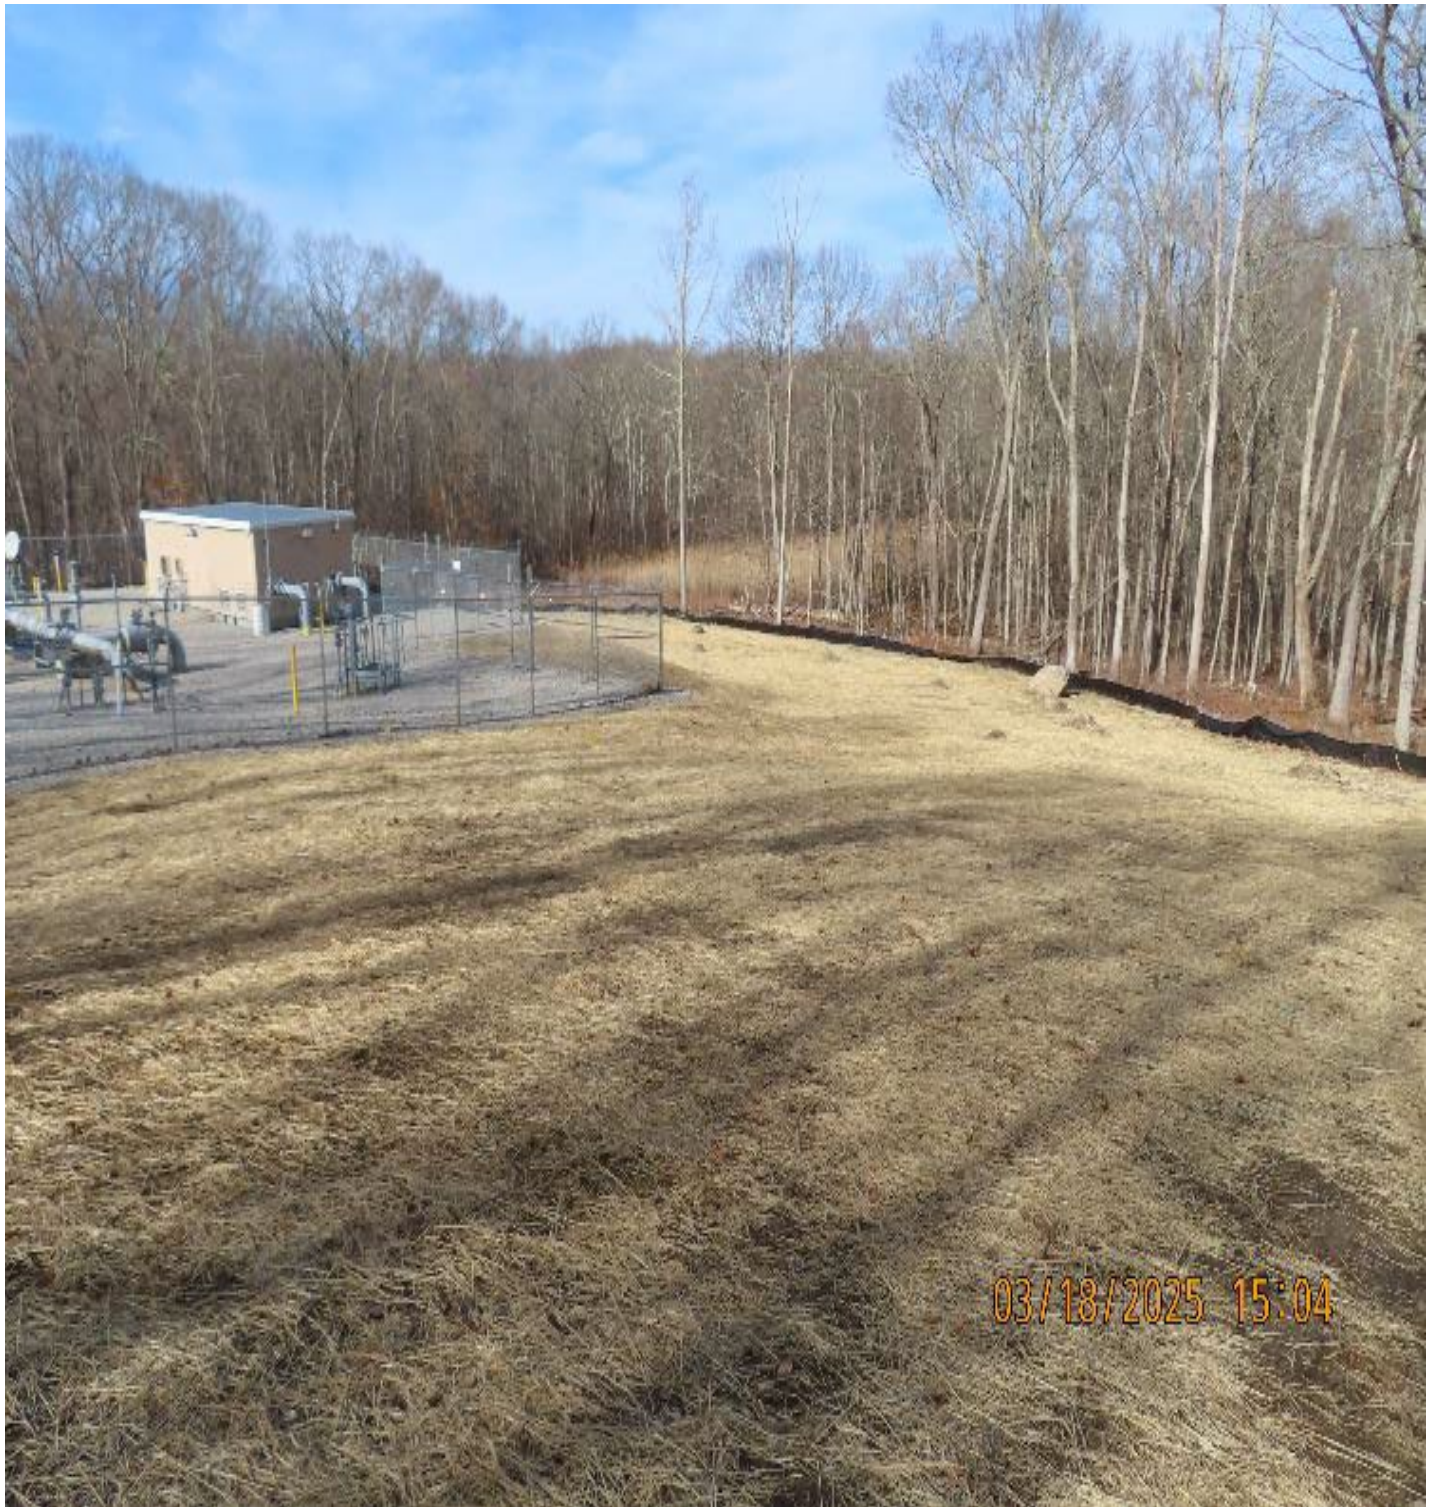
**Photo 5:** View (looking north) of stabilized areas around the valve yard and new regulator building.

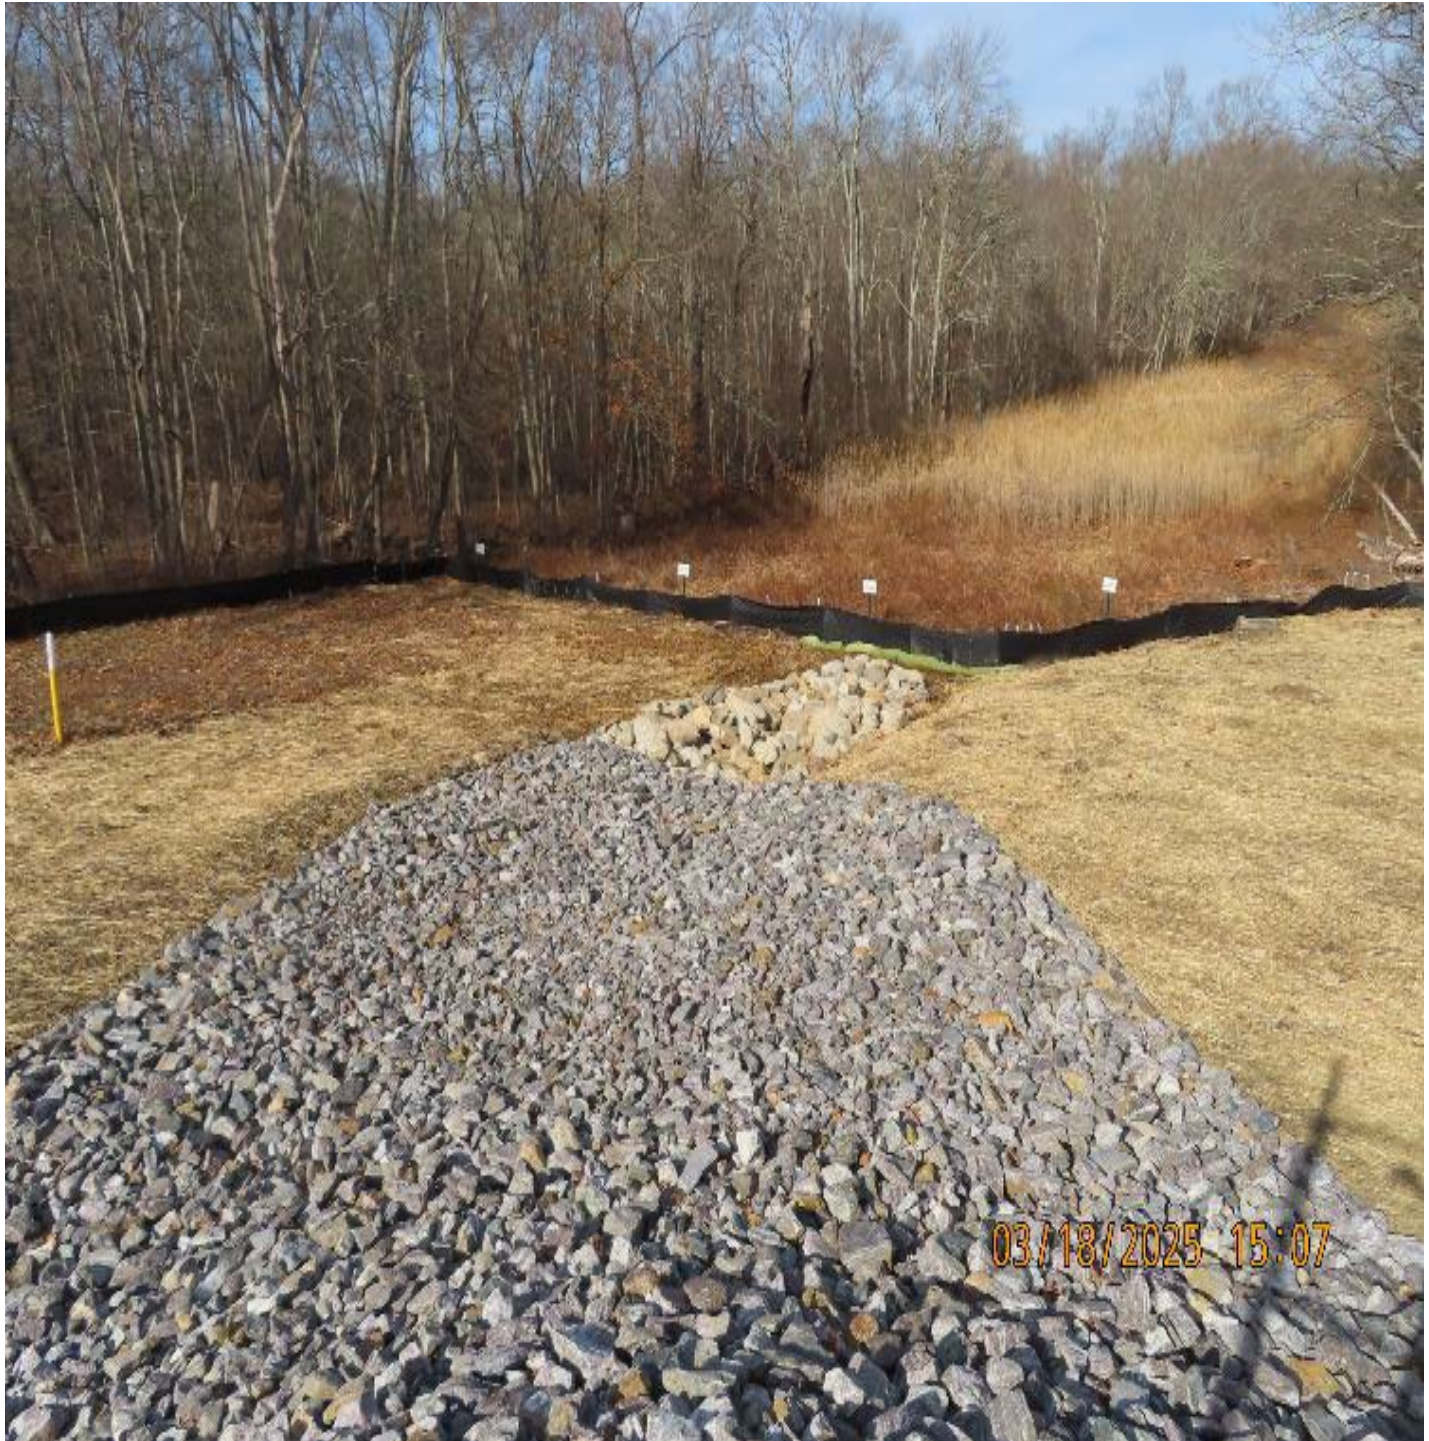
**Photo 6:** View (looking north) of rip-rap and rock armored drainage swale downslope from northwest corner of the new regulator building.
