Re: *Algonquin Gas Transmission, LLC*
E-1 System Regulator Installation Project, Docket No. CP24-21-000
Report No. 36

**E-1 System Regulation
BI-WEEKLY REPORT #36**

Project:	E-1 System Regulation
FERC Docket Number:	CP24-21-000
Report Number:	36
Reporting Period:	March 20 through April 2, 2025

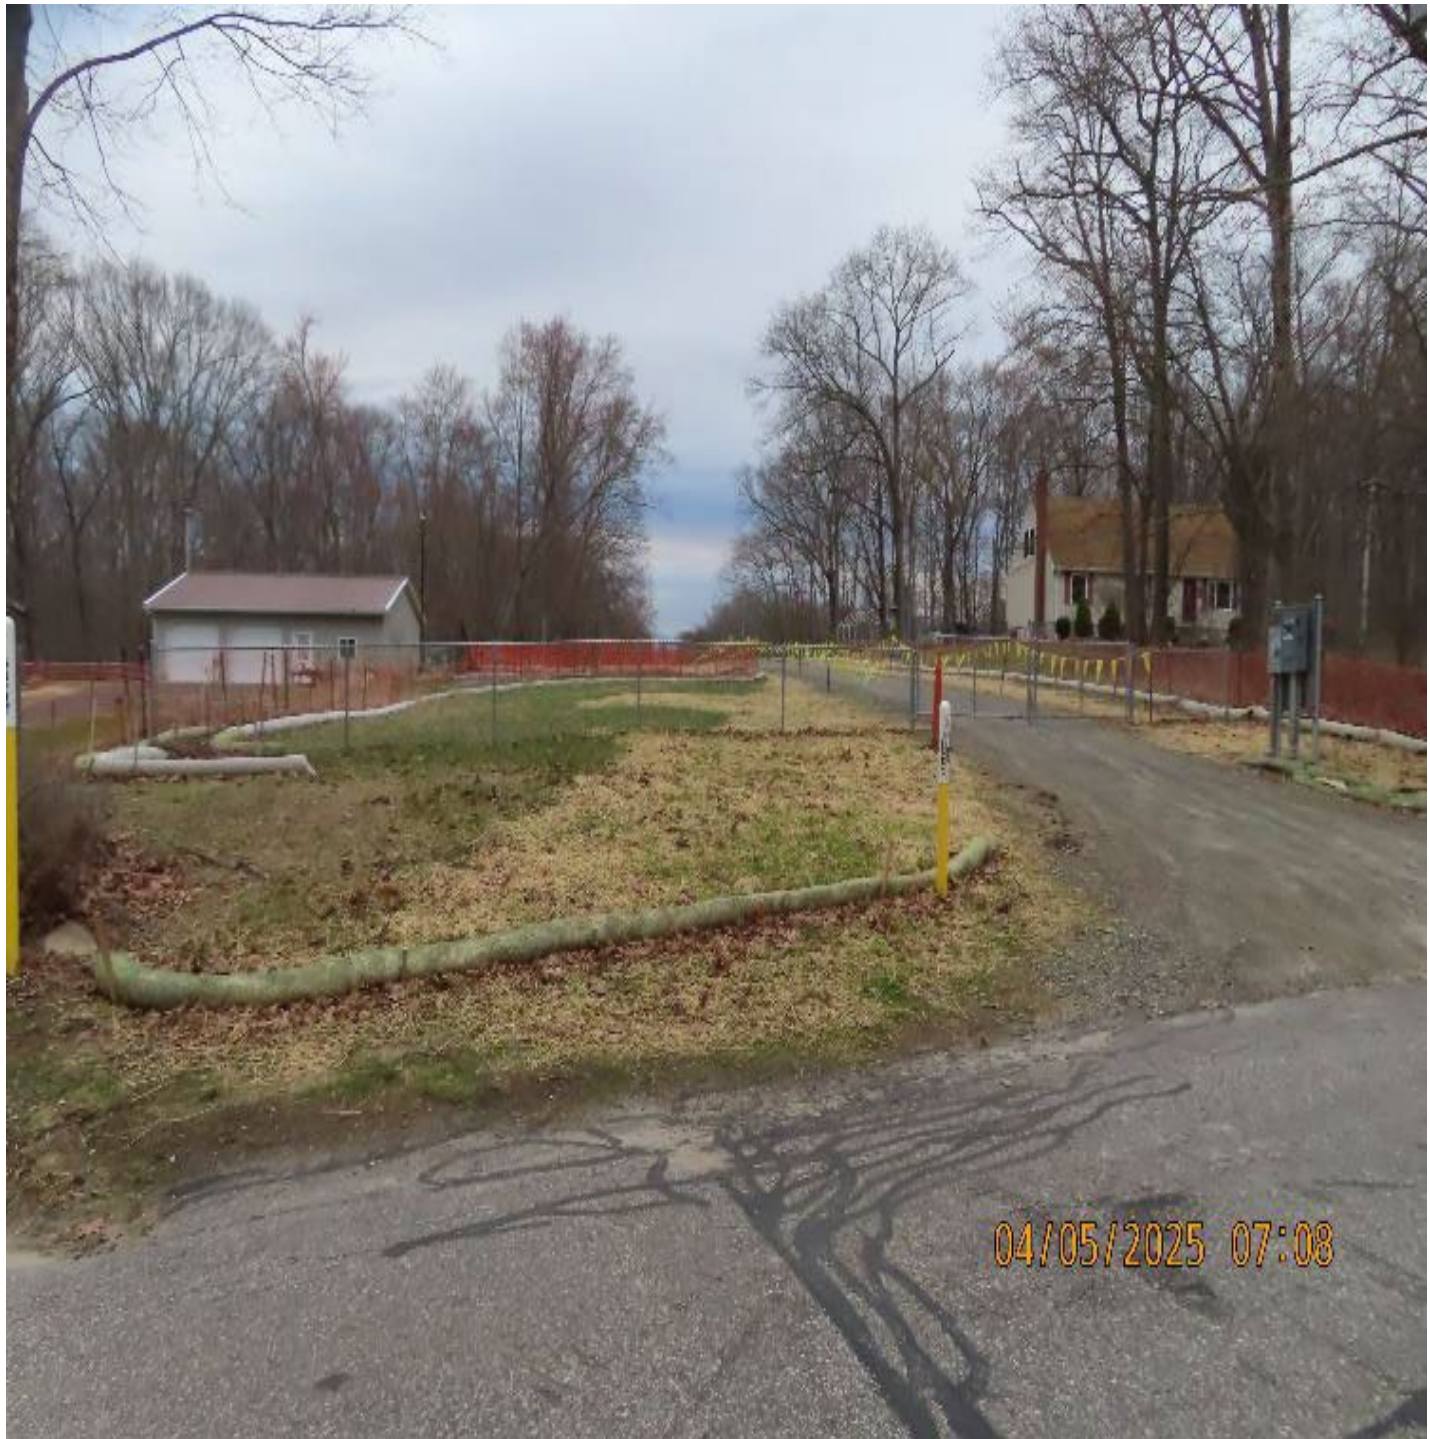
Photo 1: View (looking northeast) of site entrance from Hop River Road.

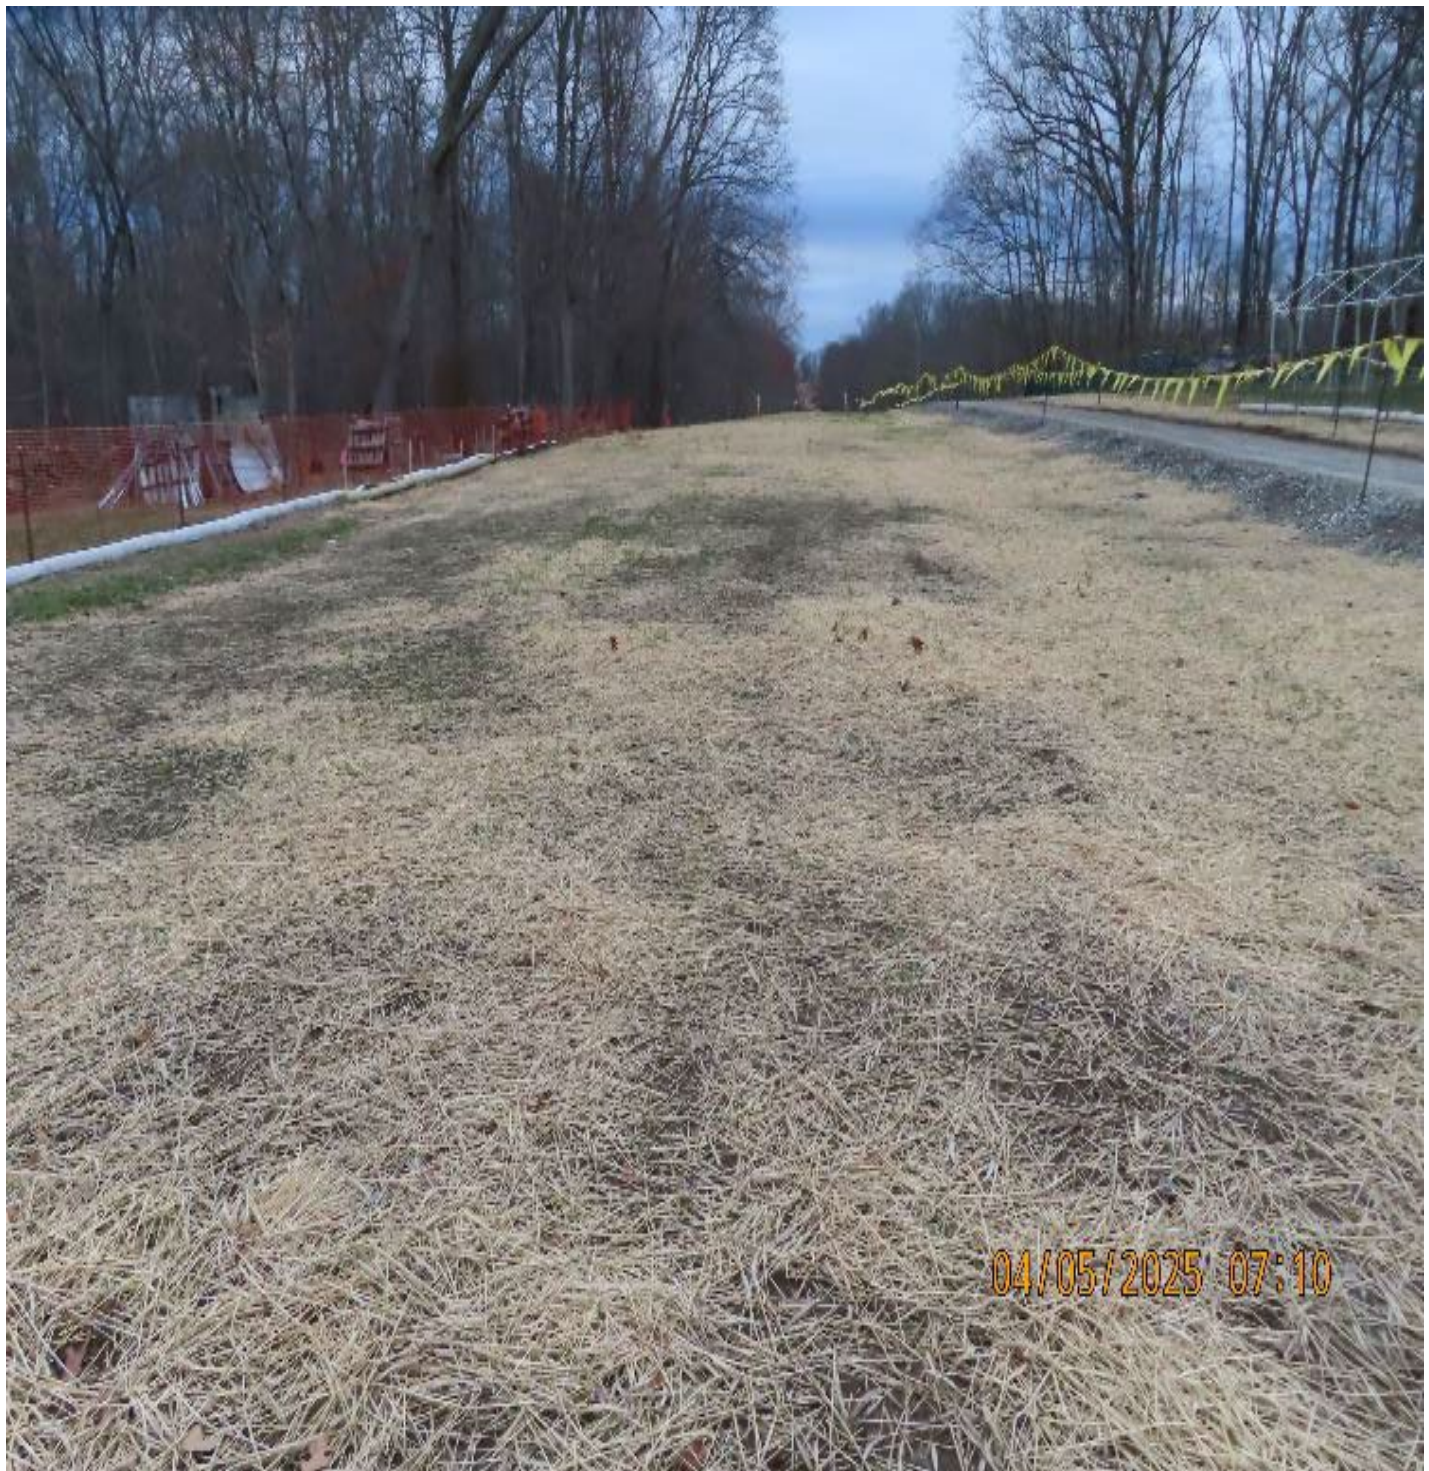
Photo 2: View (looking northeast) of access road and former equipment staging area.

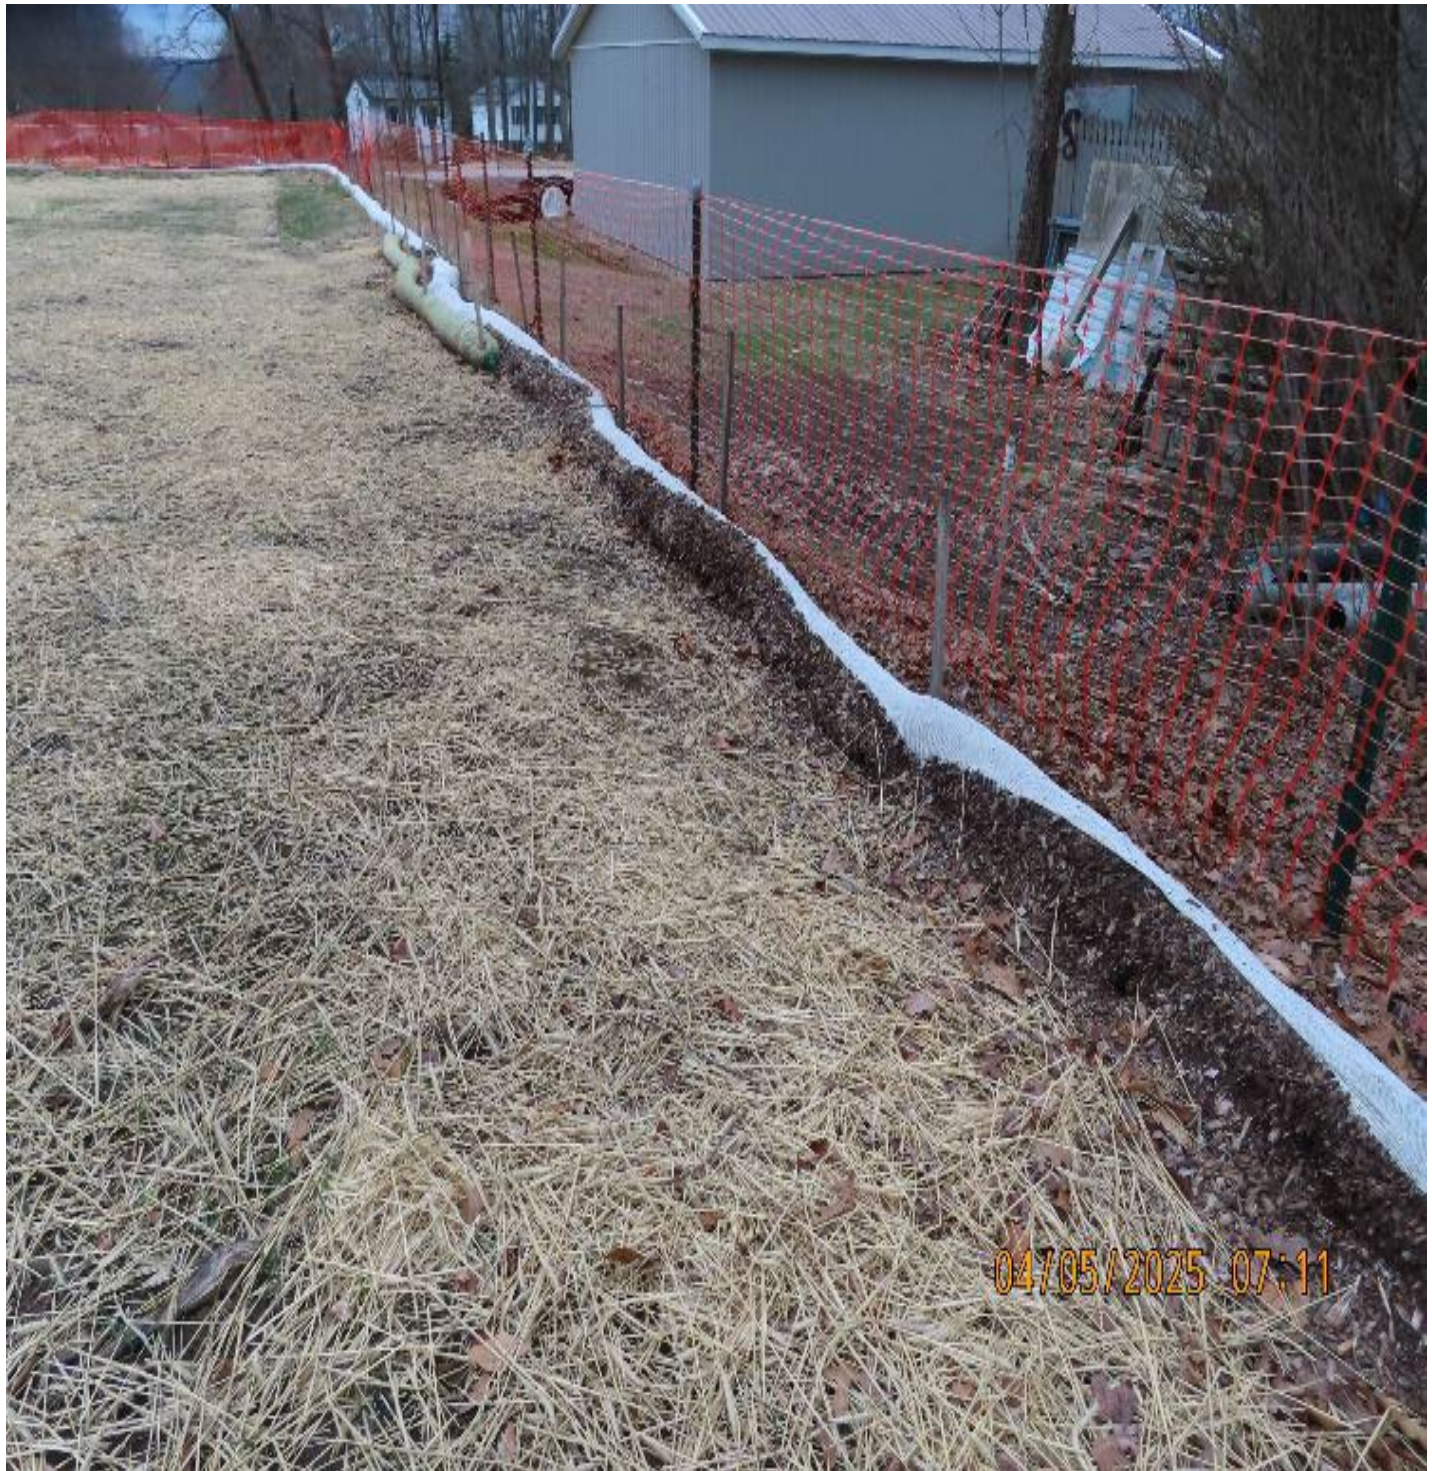
Photo 3: View (looking southwest) of perimeter controls in residential area.

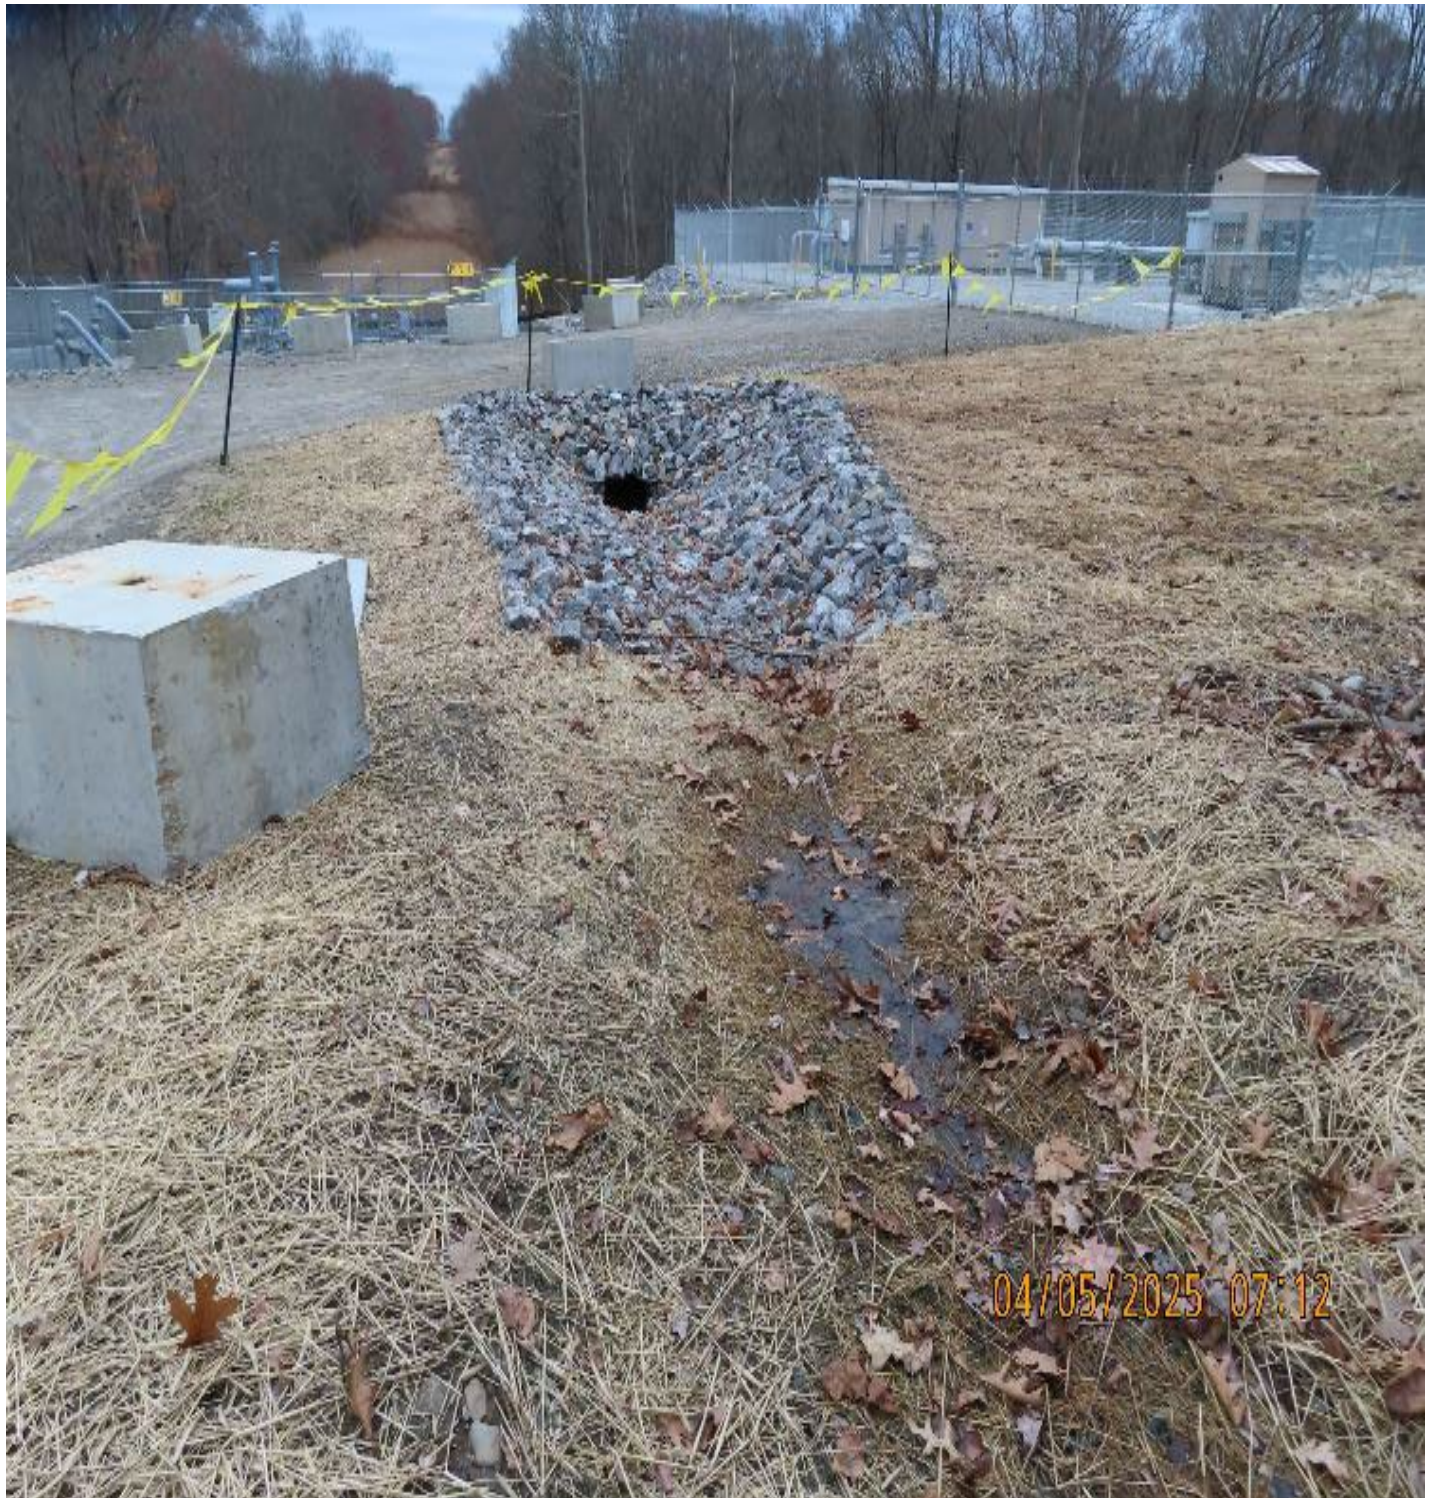
Photo 4: View (looking northeast) of drainage swale and culvert at valve yard entrance.

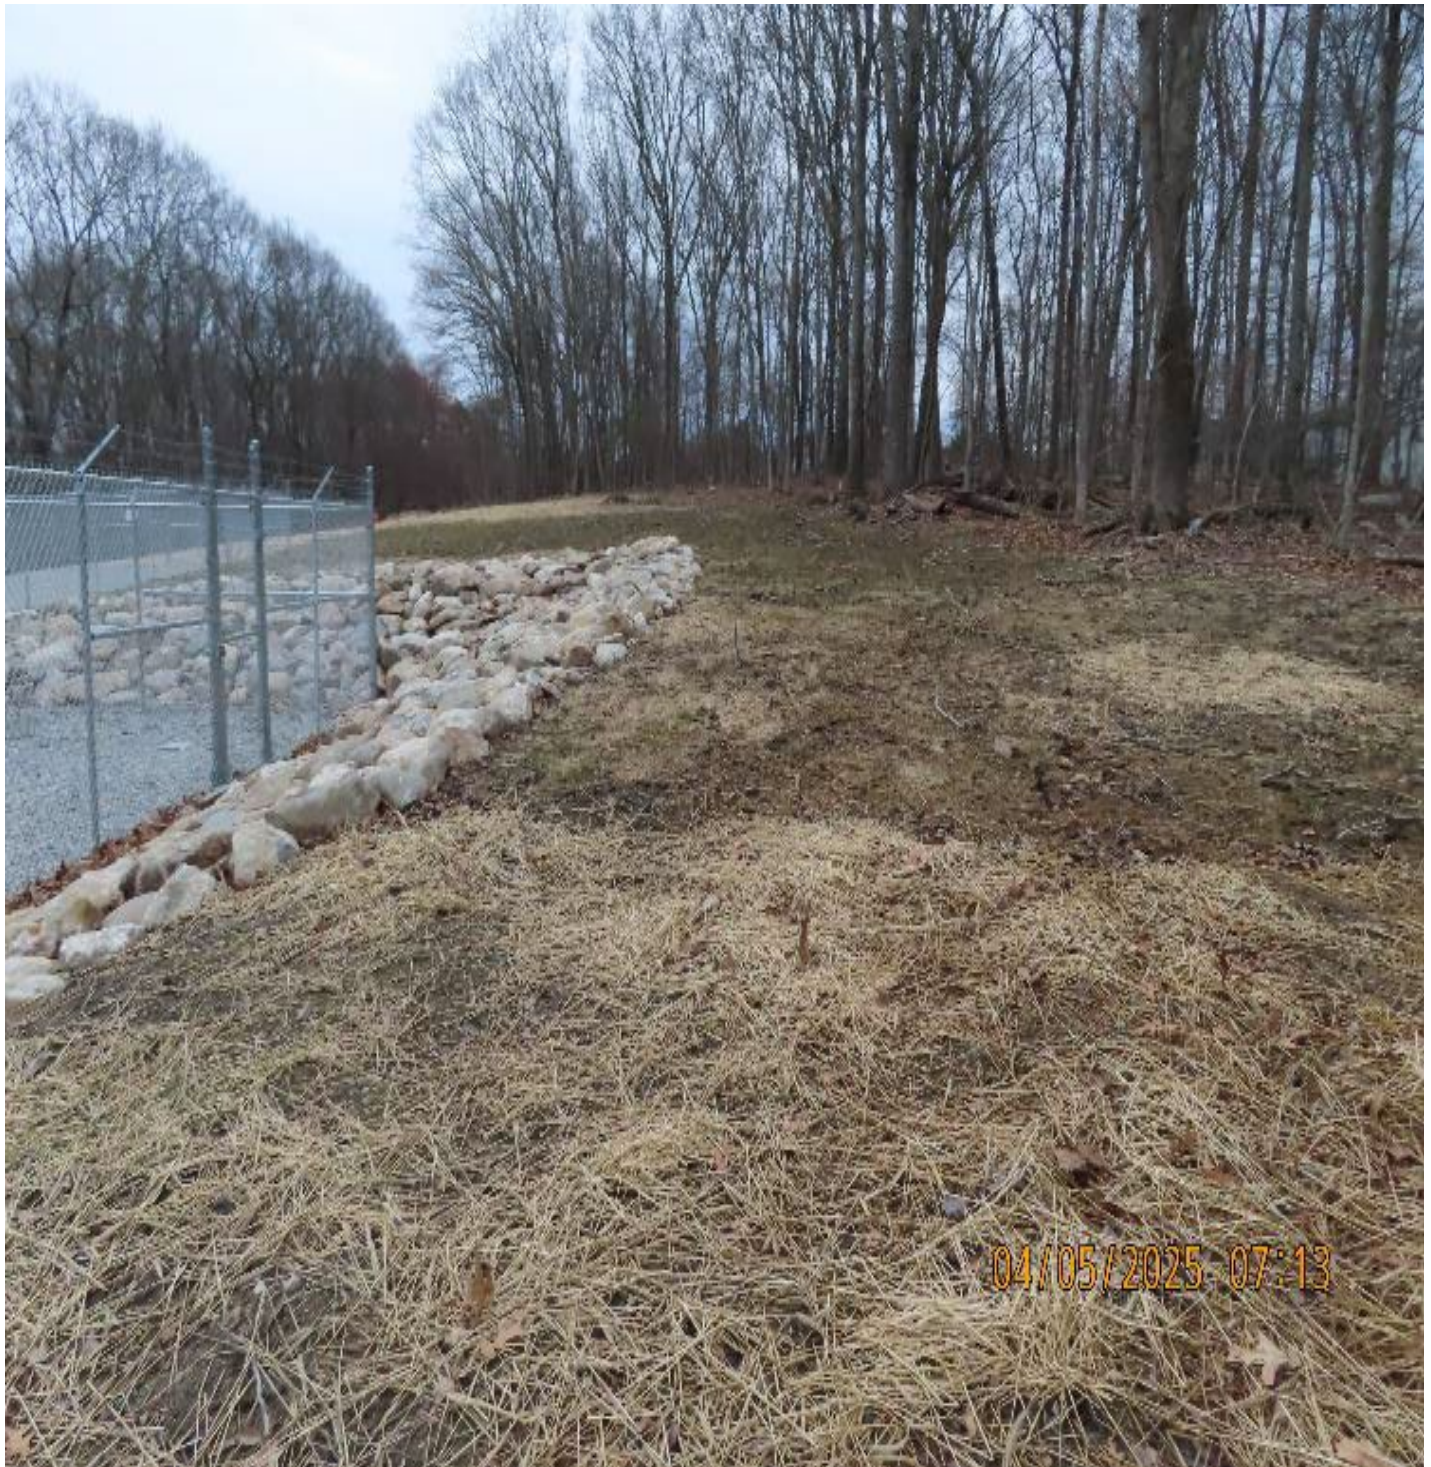
Photo 5: View (looking east) of area south of main worksite.

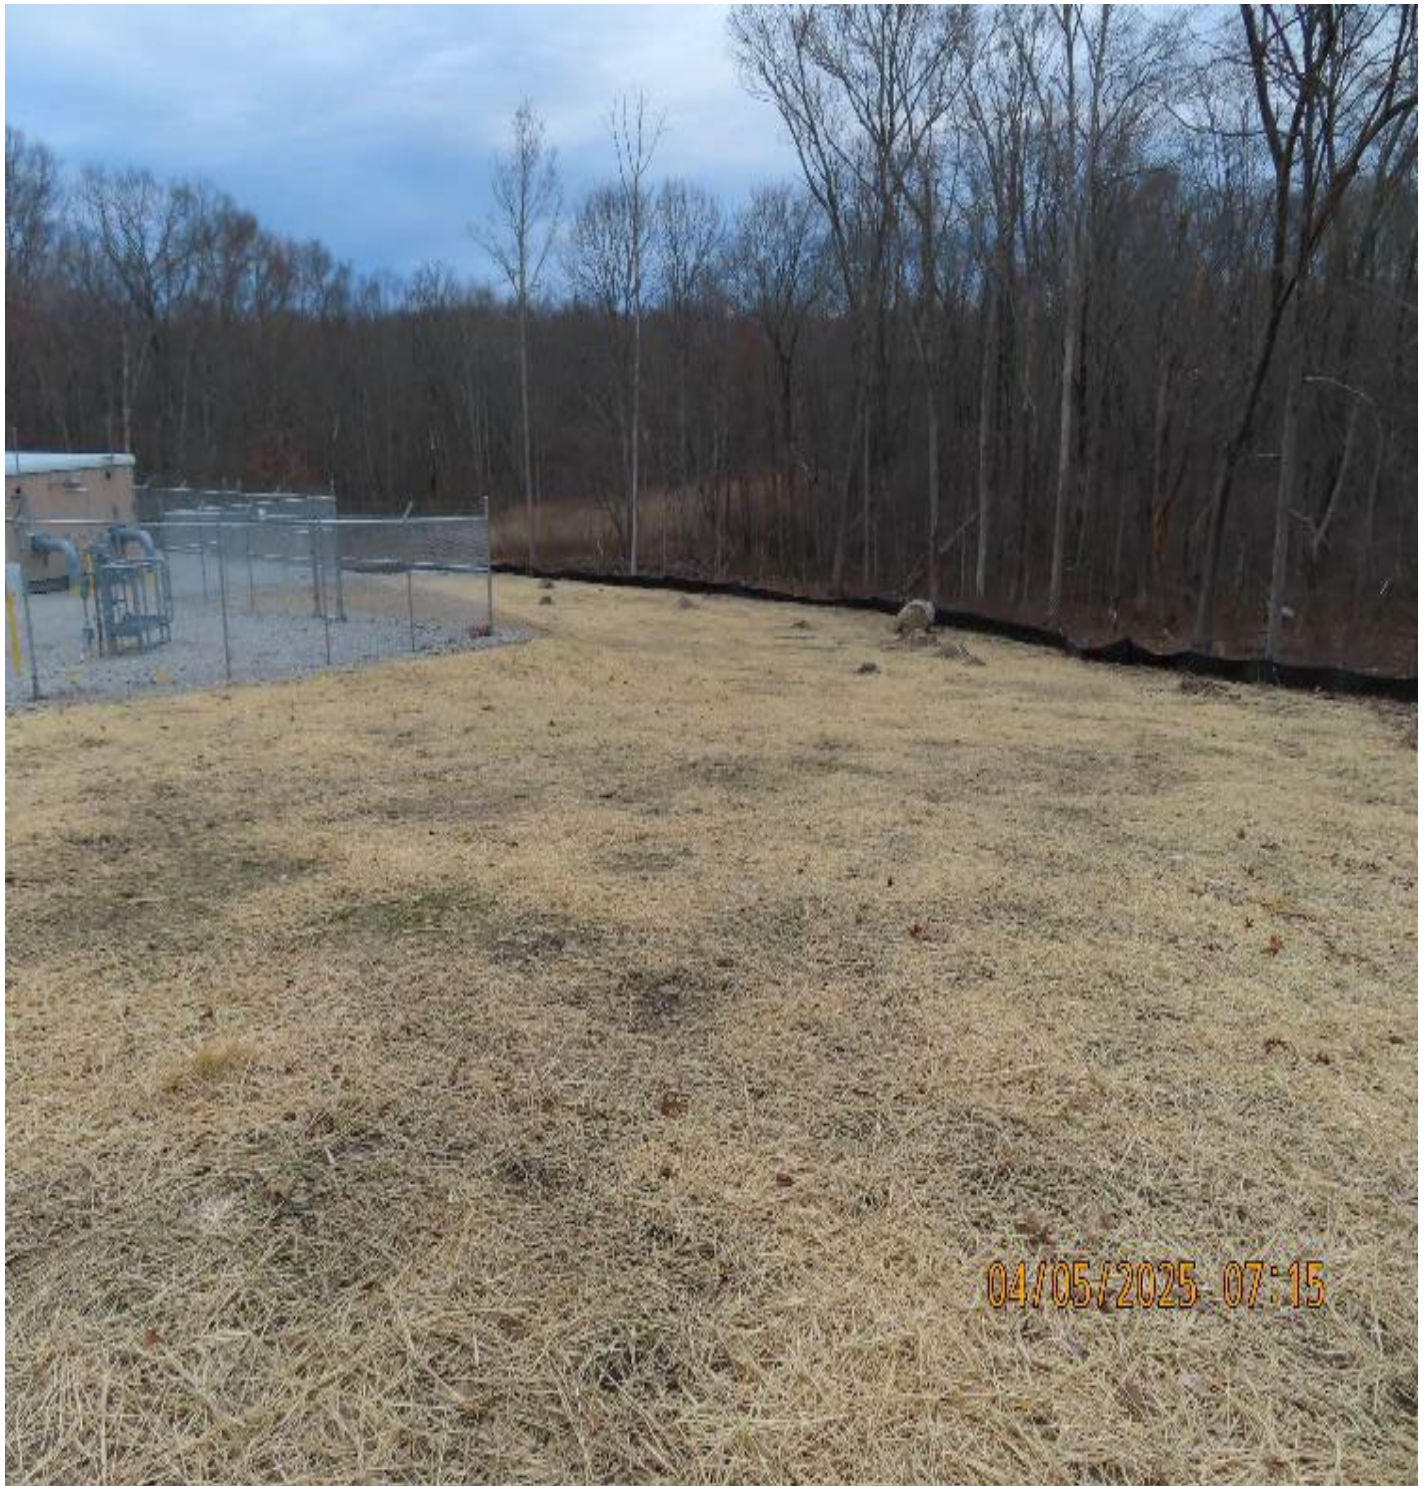
Photo 6: View (looking north) of east workspace boundary.

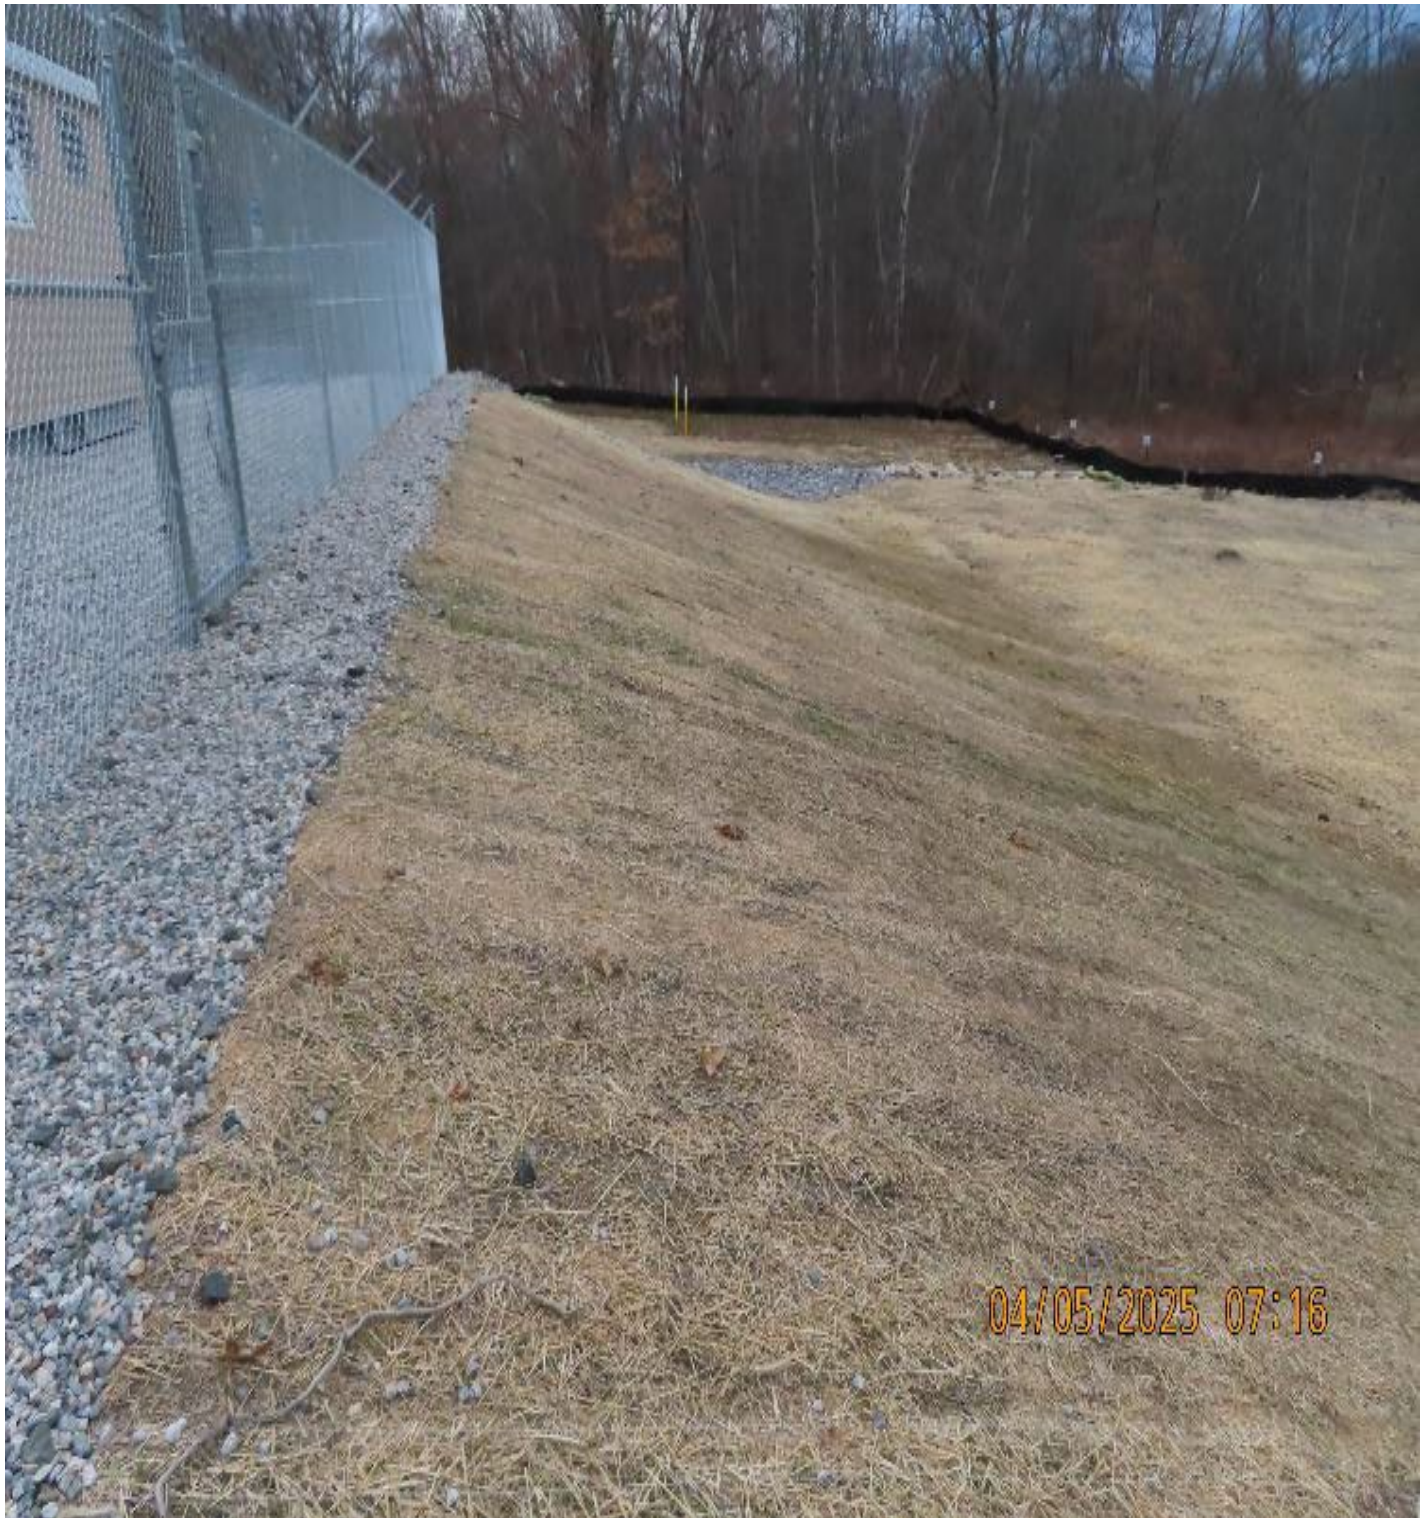
Photo 7: View (looking northwest) along stabilized slope along north side of new regulator building.

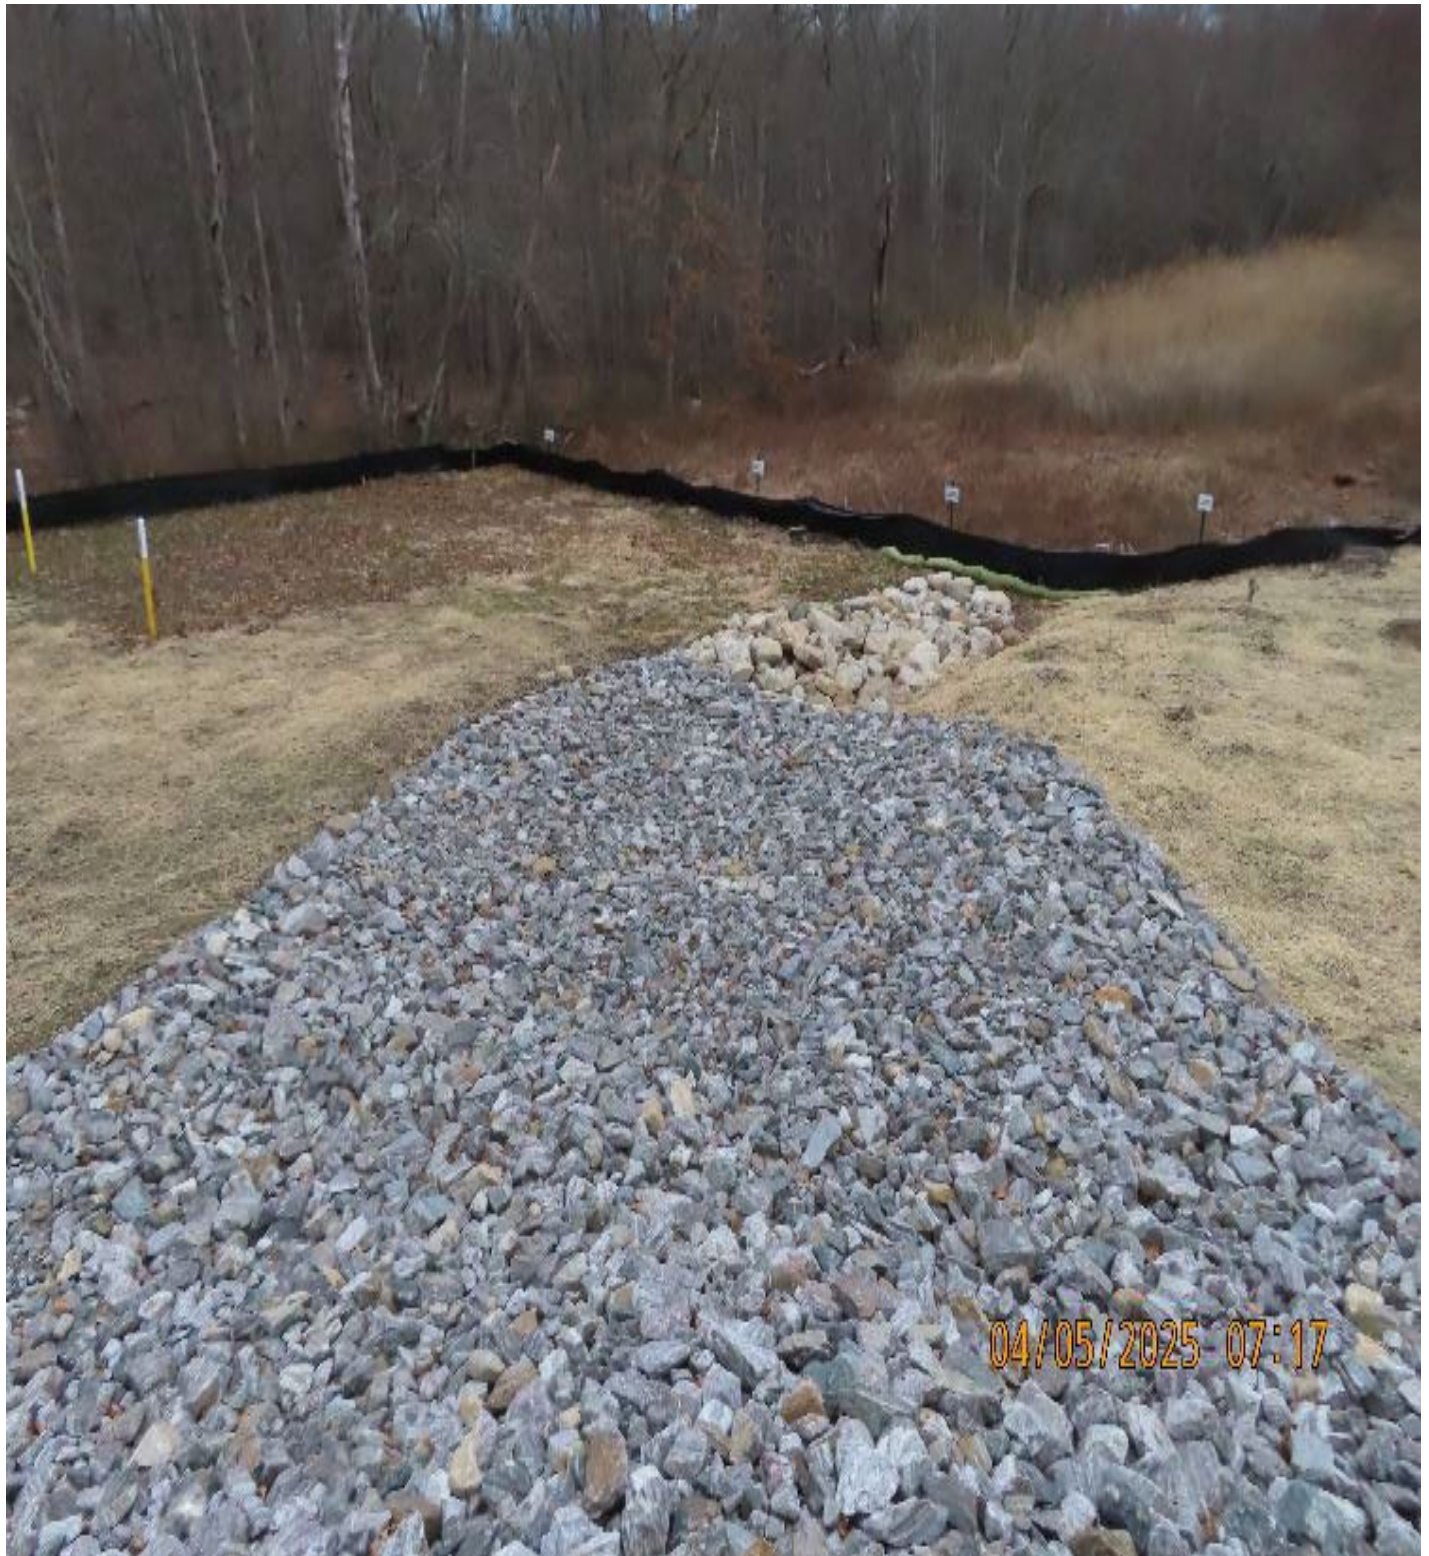
Photo 8: View (looking north) of northwest corner of work site (downslope)
