Re: Algonquin Gas Transmission, LLC

E-1 System Regulator Installation Project, Docket No. CP24-21-000

Report No. 37

E-1 System Regulation BI-WEEKLY REPORT #37

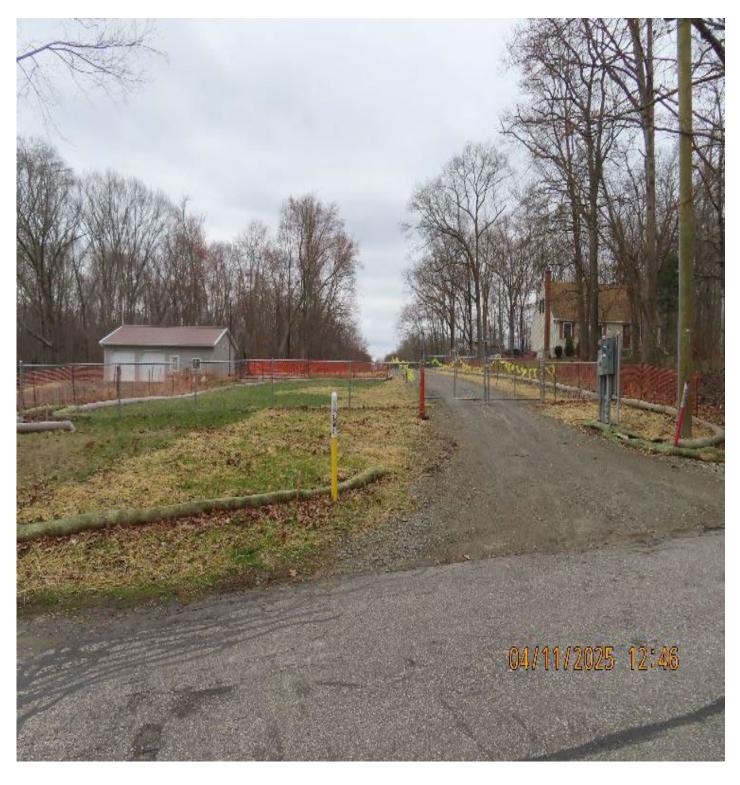
Photo 1: View (looking northeast) of site entrance from Hop River Road.

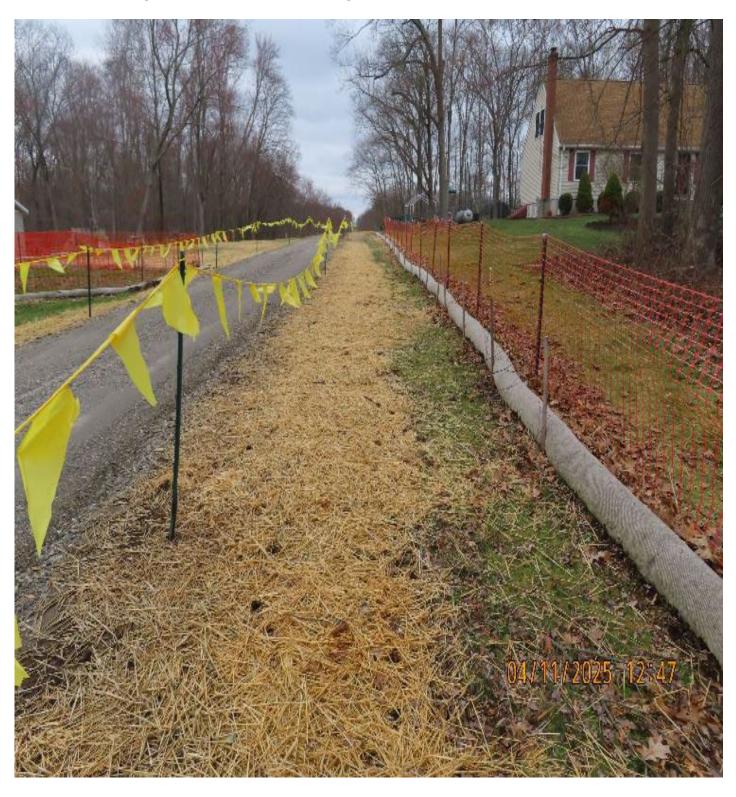
Photo 2: View (looking northeast) of access route through residential area.

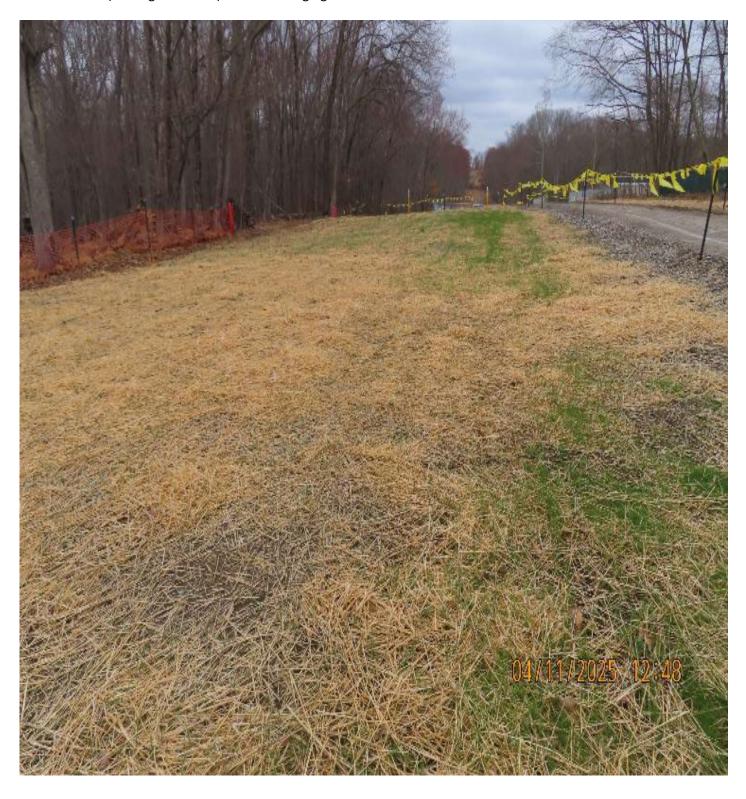
Photo 3: View (looking northeast) of former staging area.

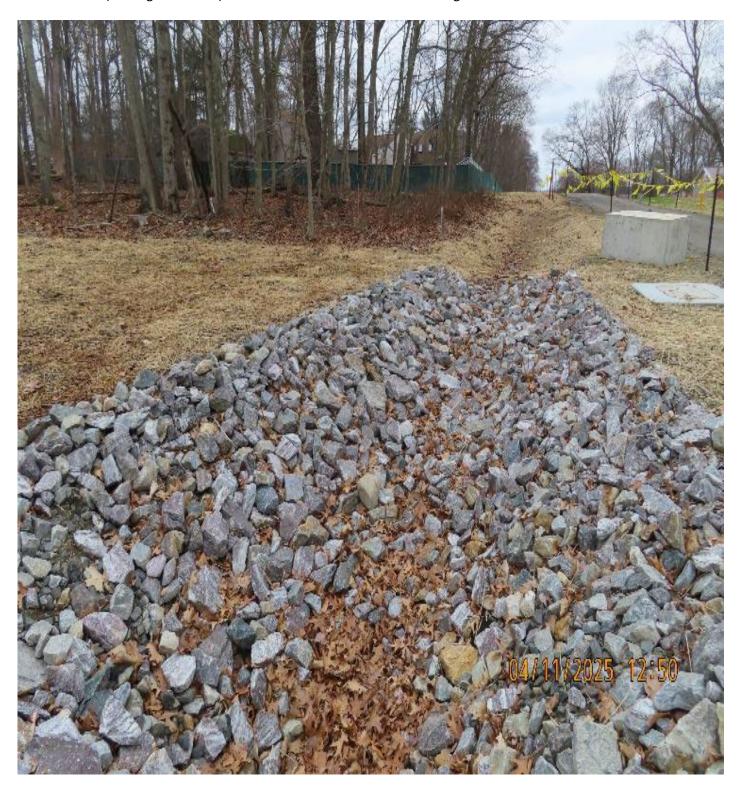
Photo 4: View (looking southwest) of inlet to restored stormwater drainage swale.

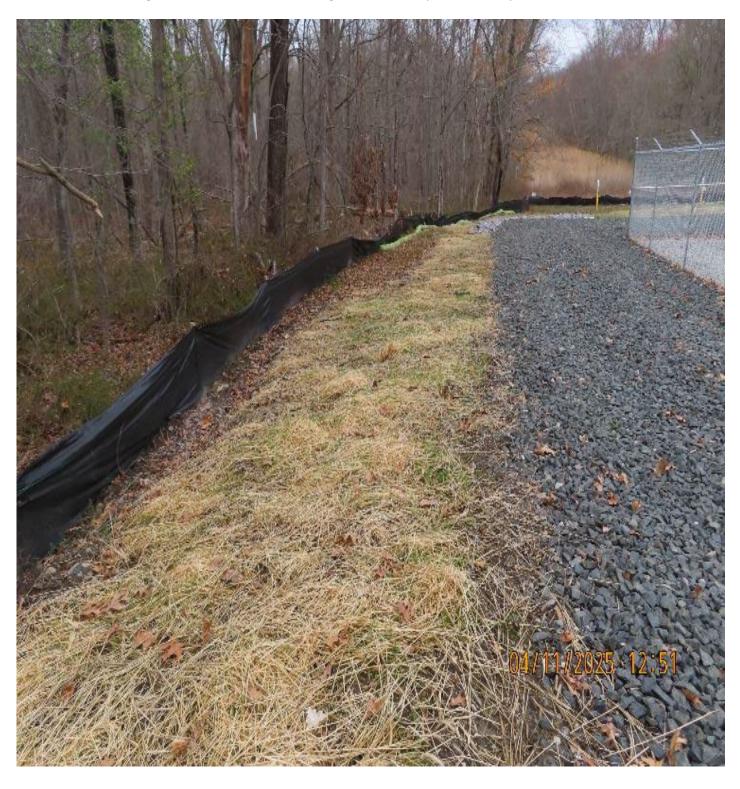
Photo 5: View (looking northeast) of conditions along western workspace boundary.

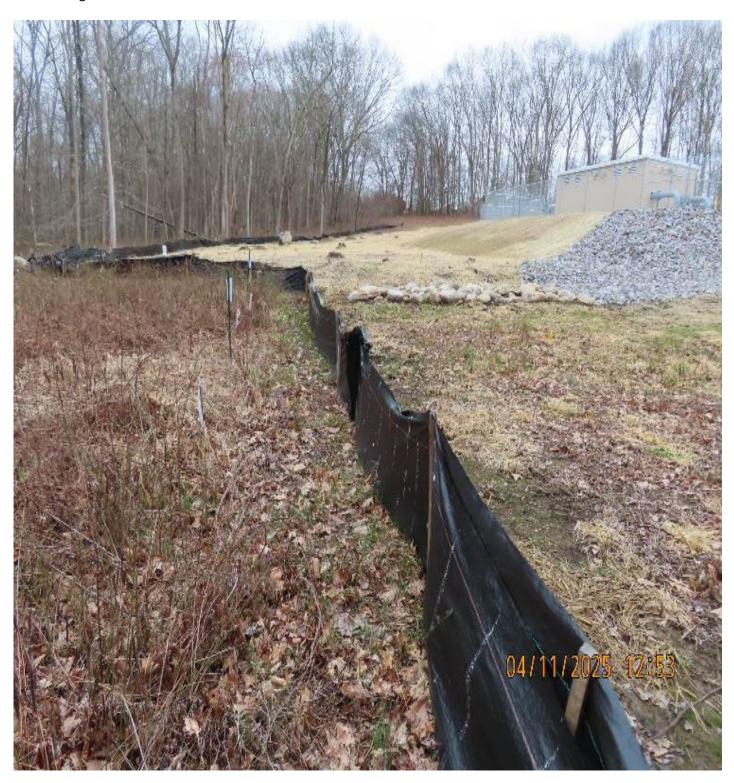
Photo 6: View (looking east) of silt fence along boundary of wetland W-CZ-01 and new regulation building in the background.

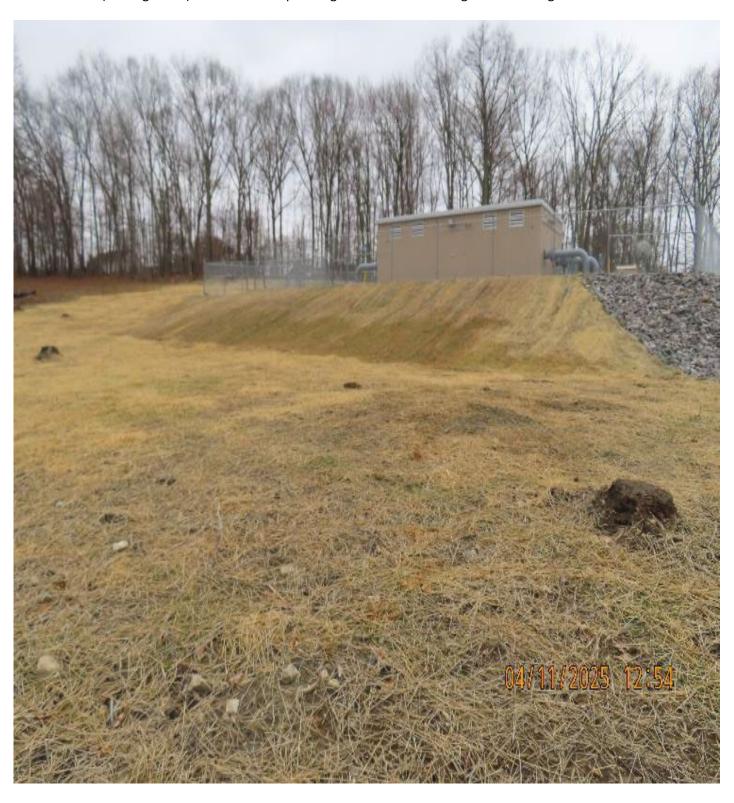
Photo 7: View (looking south) of stabilized slope along north side of new regulator building.

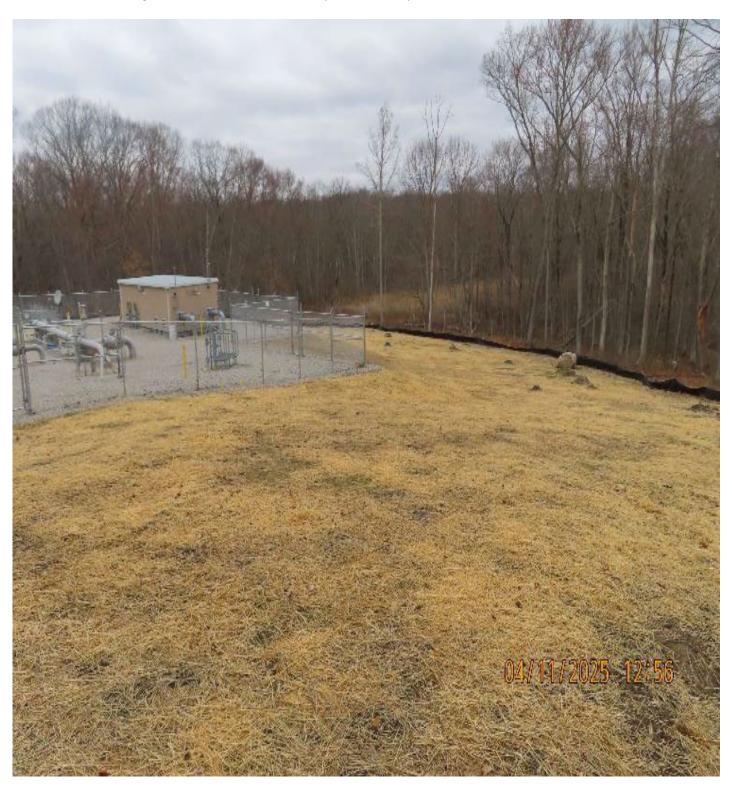
Photo 8: View (looking northwest) of western workspace boundary.
