Re: *Algonquin Gas Transmission, LLC*
E-1 System Regulator Installation Project, Docket No. CP24-21-000
Report No. 38

**E-1 System Regulation
BI-WEEKLY REPORT #38**

Project:	E-1 System Regulation
FERC Docket Number:	CP24-21-000
Report Number:	38
Reporting Period:	April 17 April 30, 2025

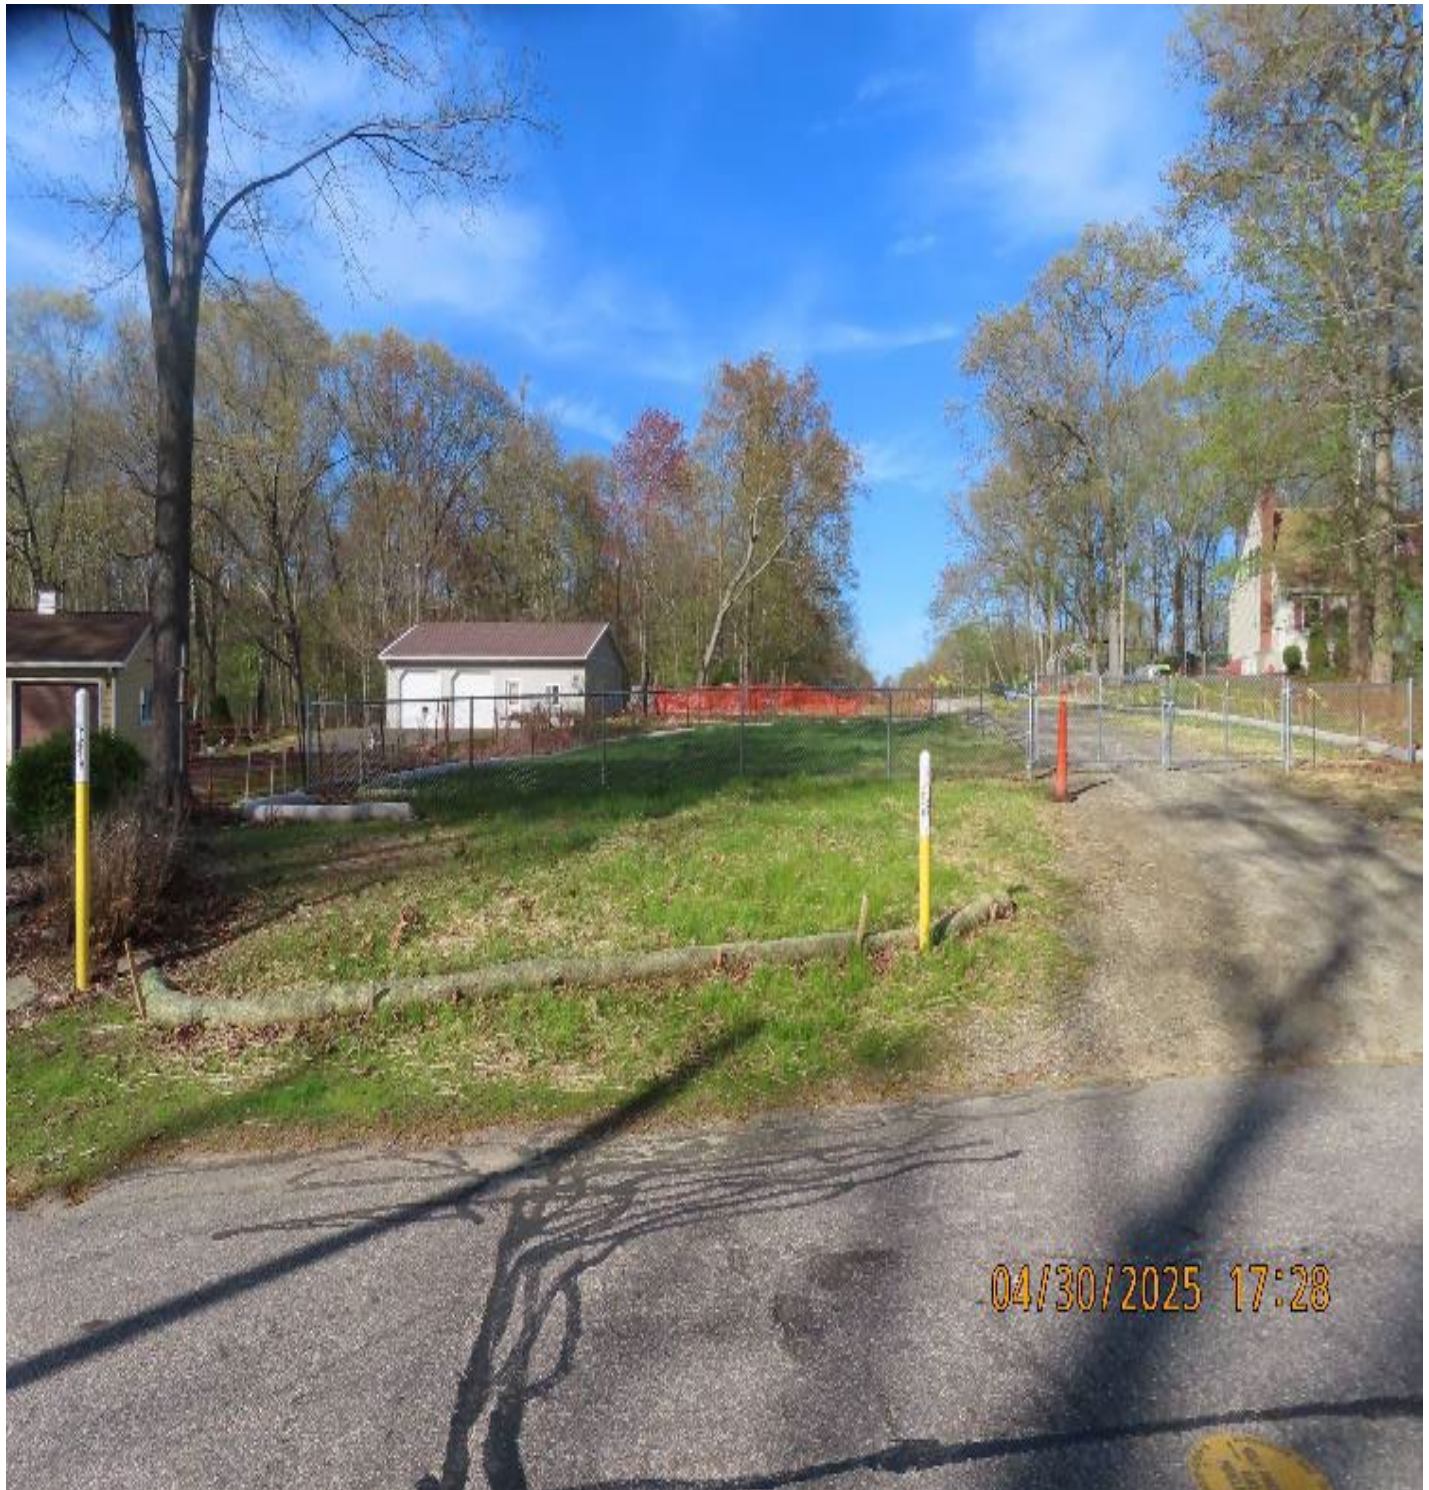
Photo 1: View (looking northeast) of site entrance from Hop River Road where SESC's can be removed soon.

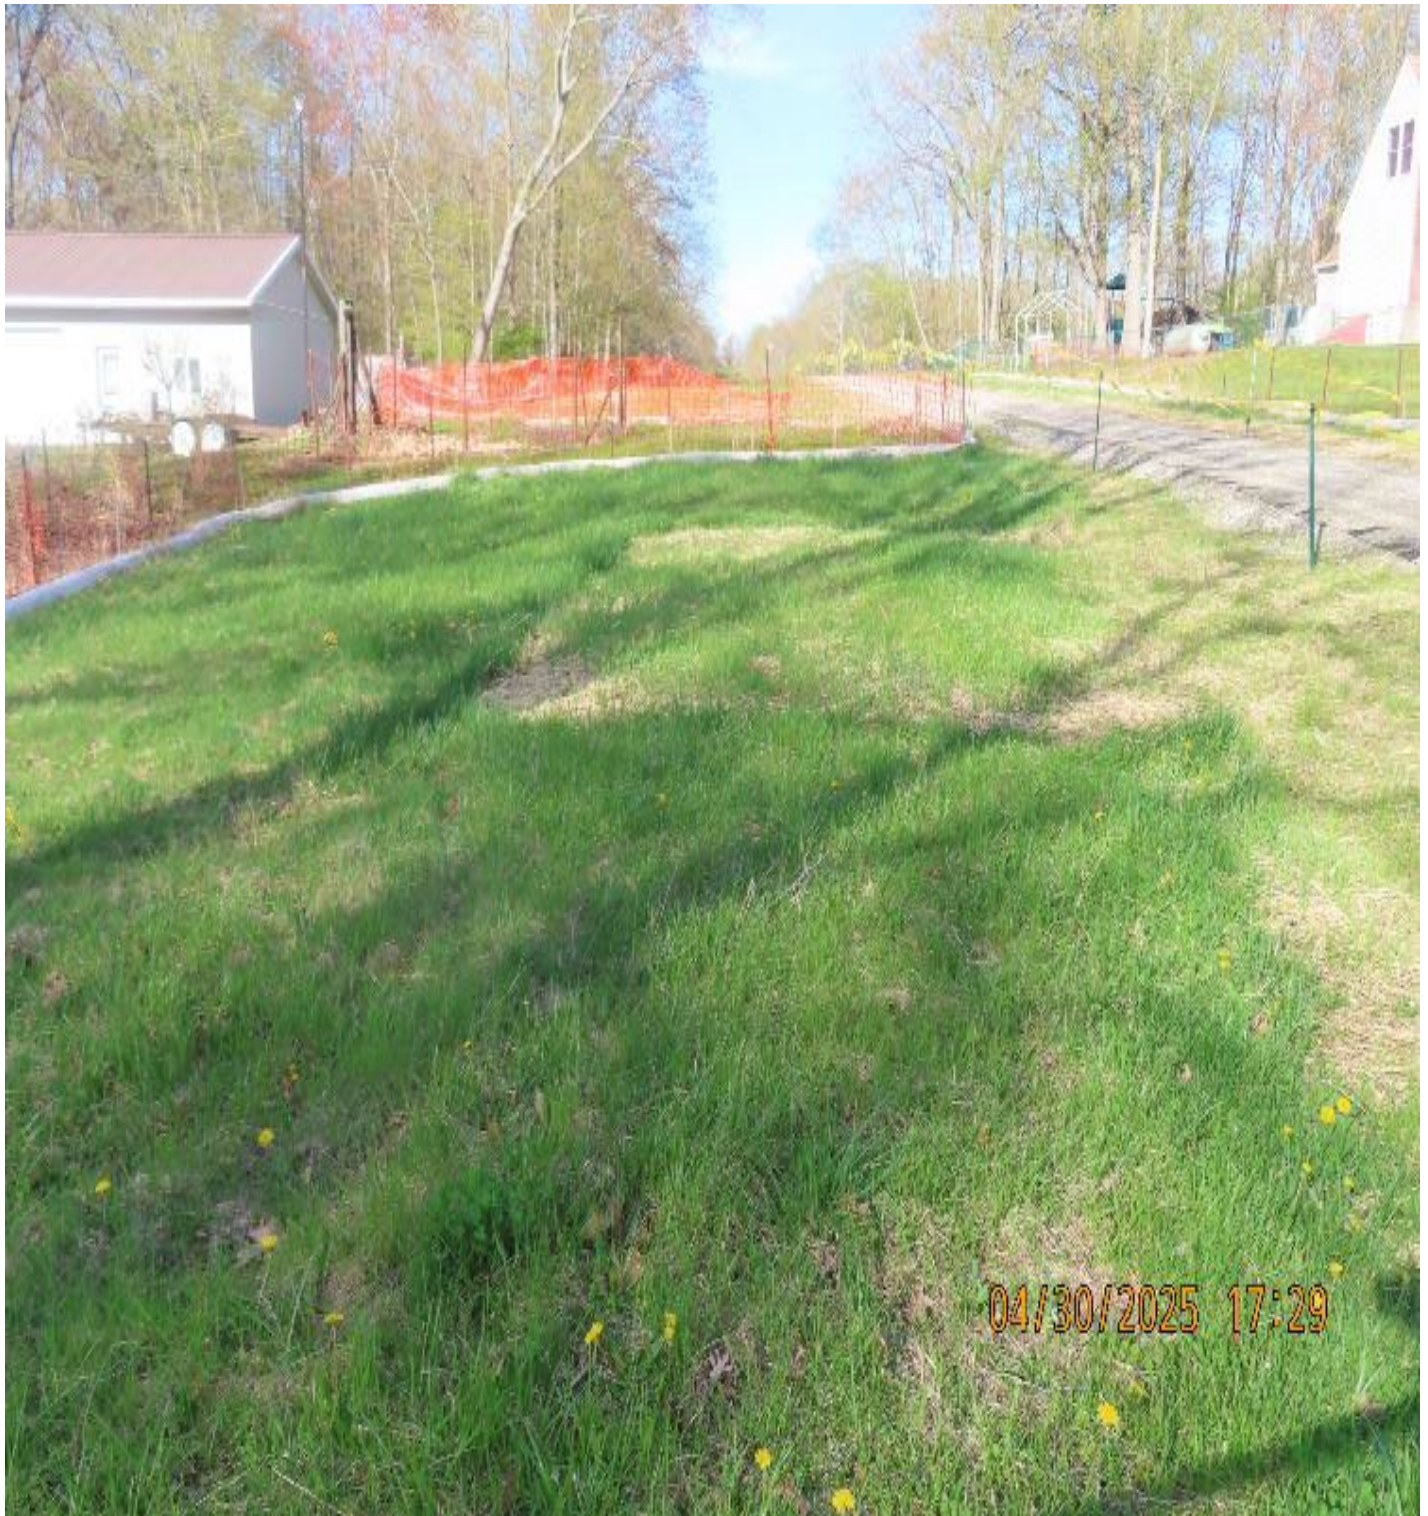
Photo 2: View (looking northeast) of private lawn where security fence and SESCOs can be removed soon.

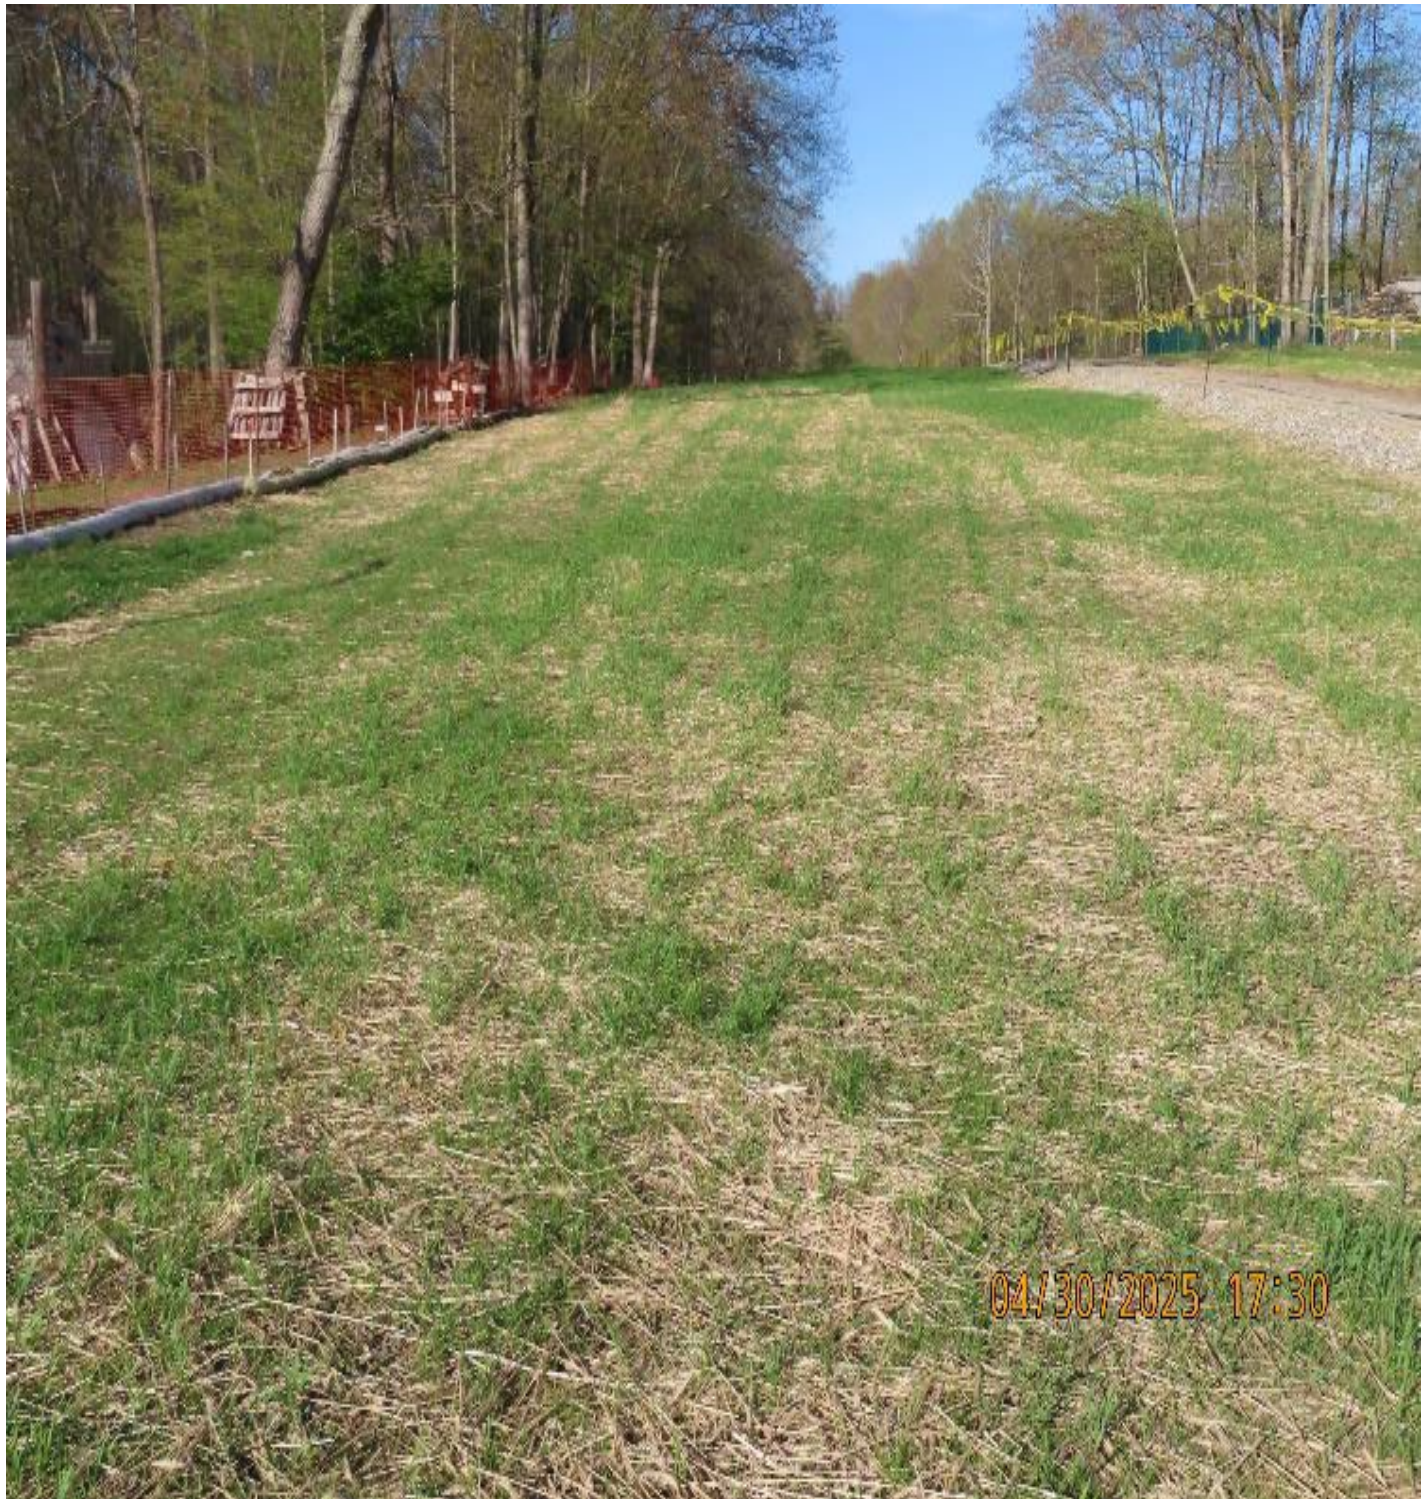
Photo 3: View (looking northeast) of former materials staging area along access road where revegetation is progressing towards full recovery.

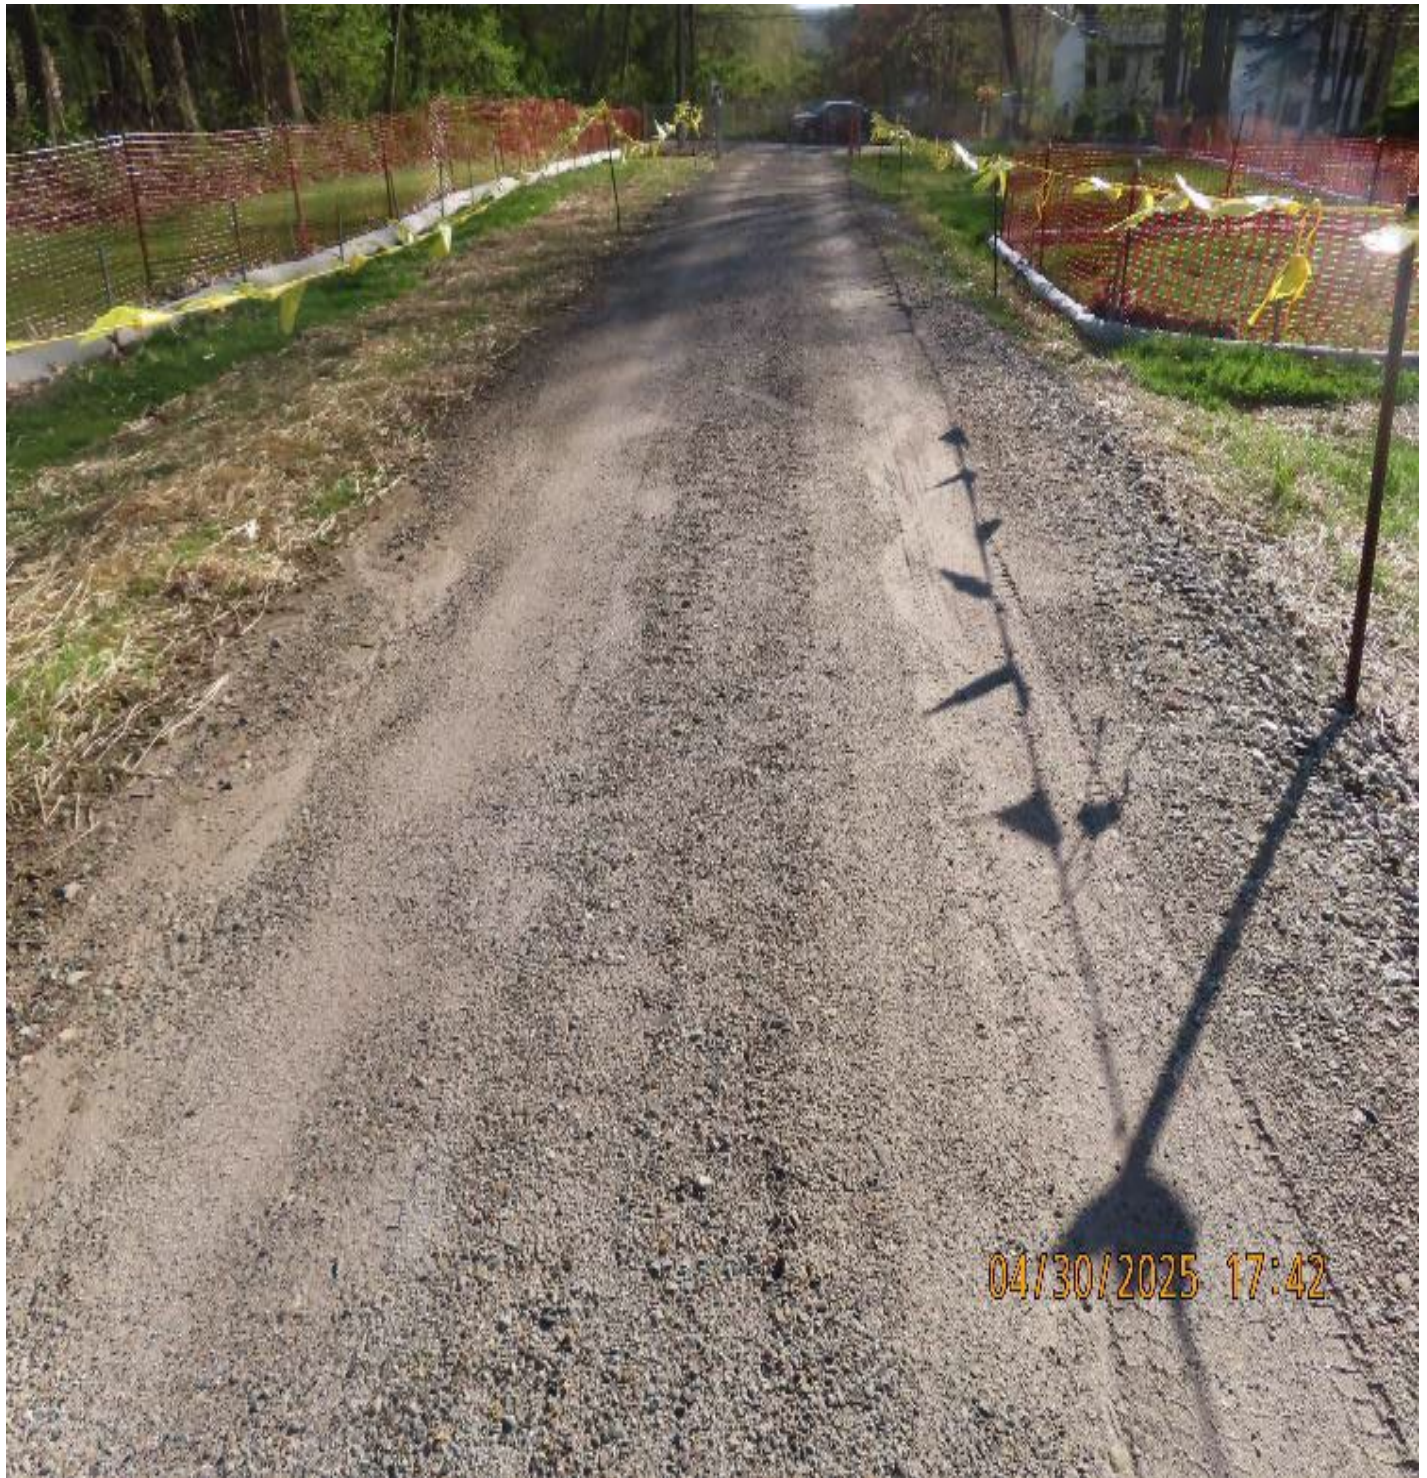
Photo 4: View (looking southwest) along gravel access road where SESC's and security fencing can be removed soon.

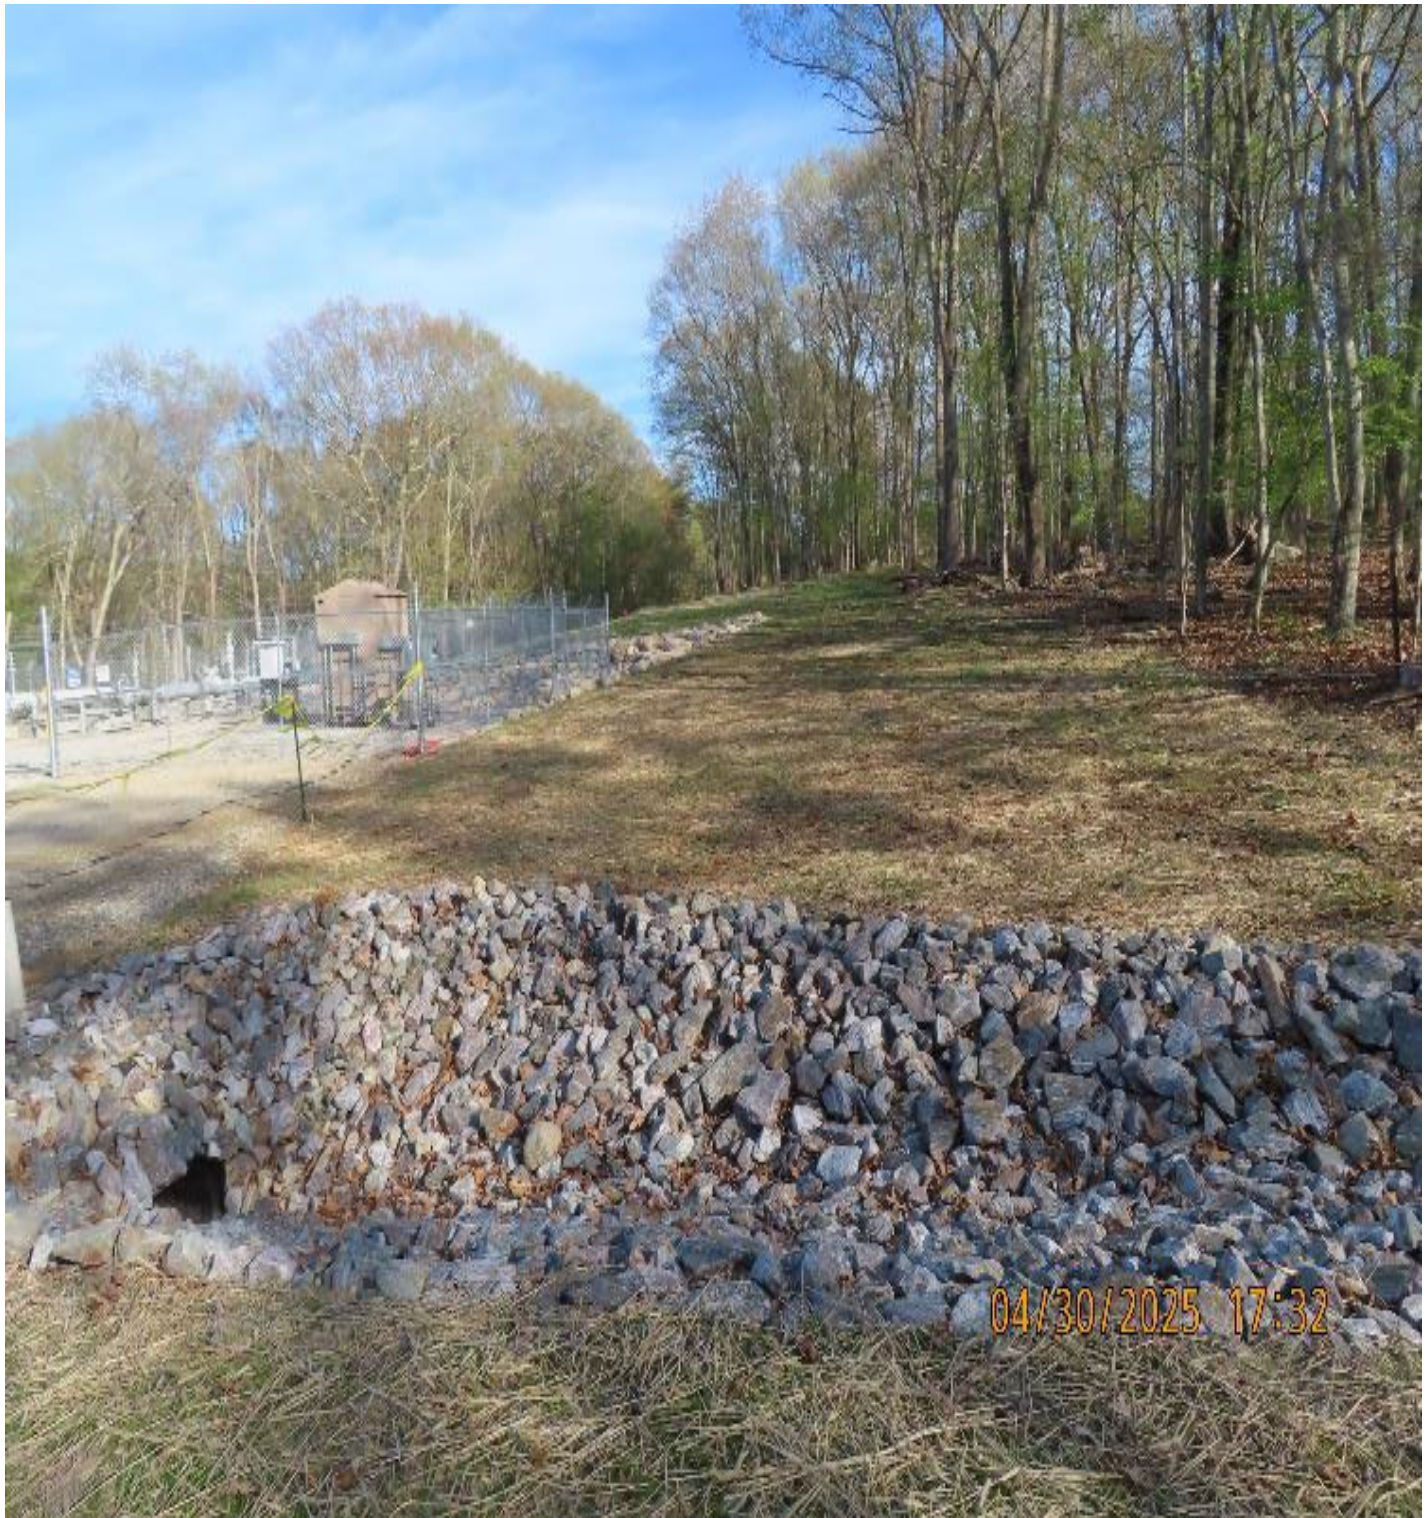
Photo 5: View (looking east) of stabilized drainage swale inlet to stormwater culvert near the valve yard.

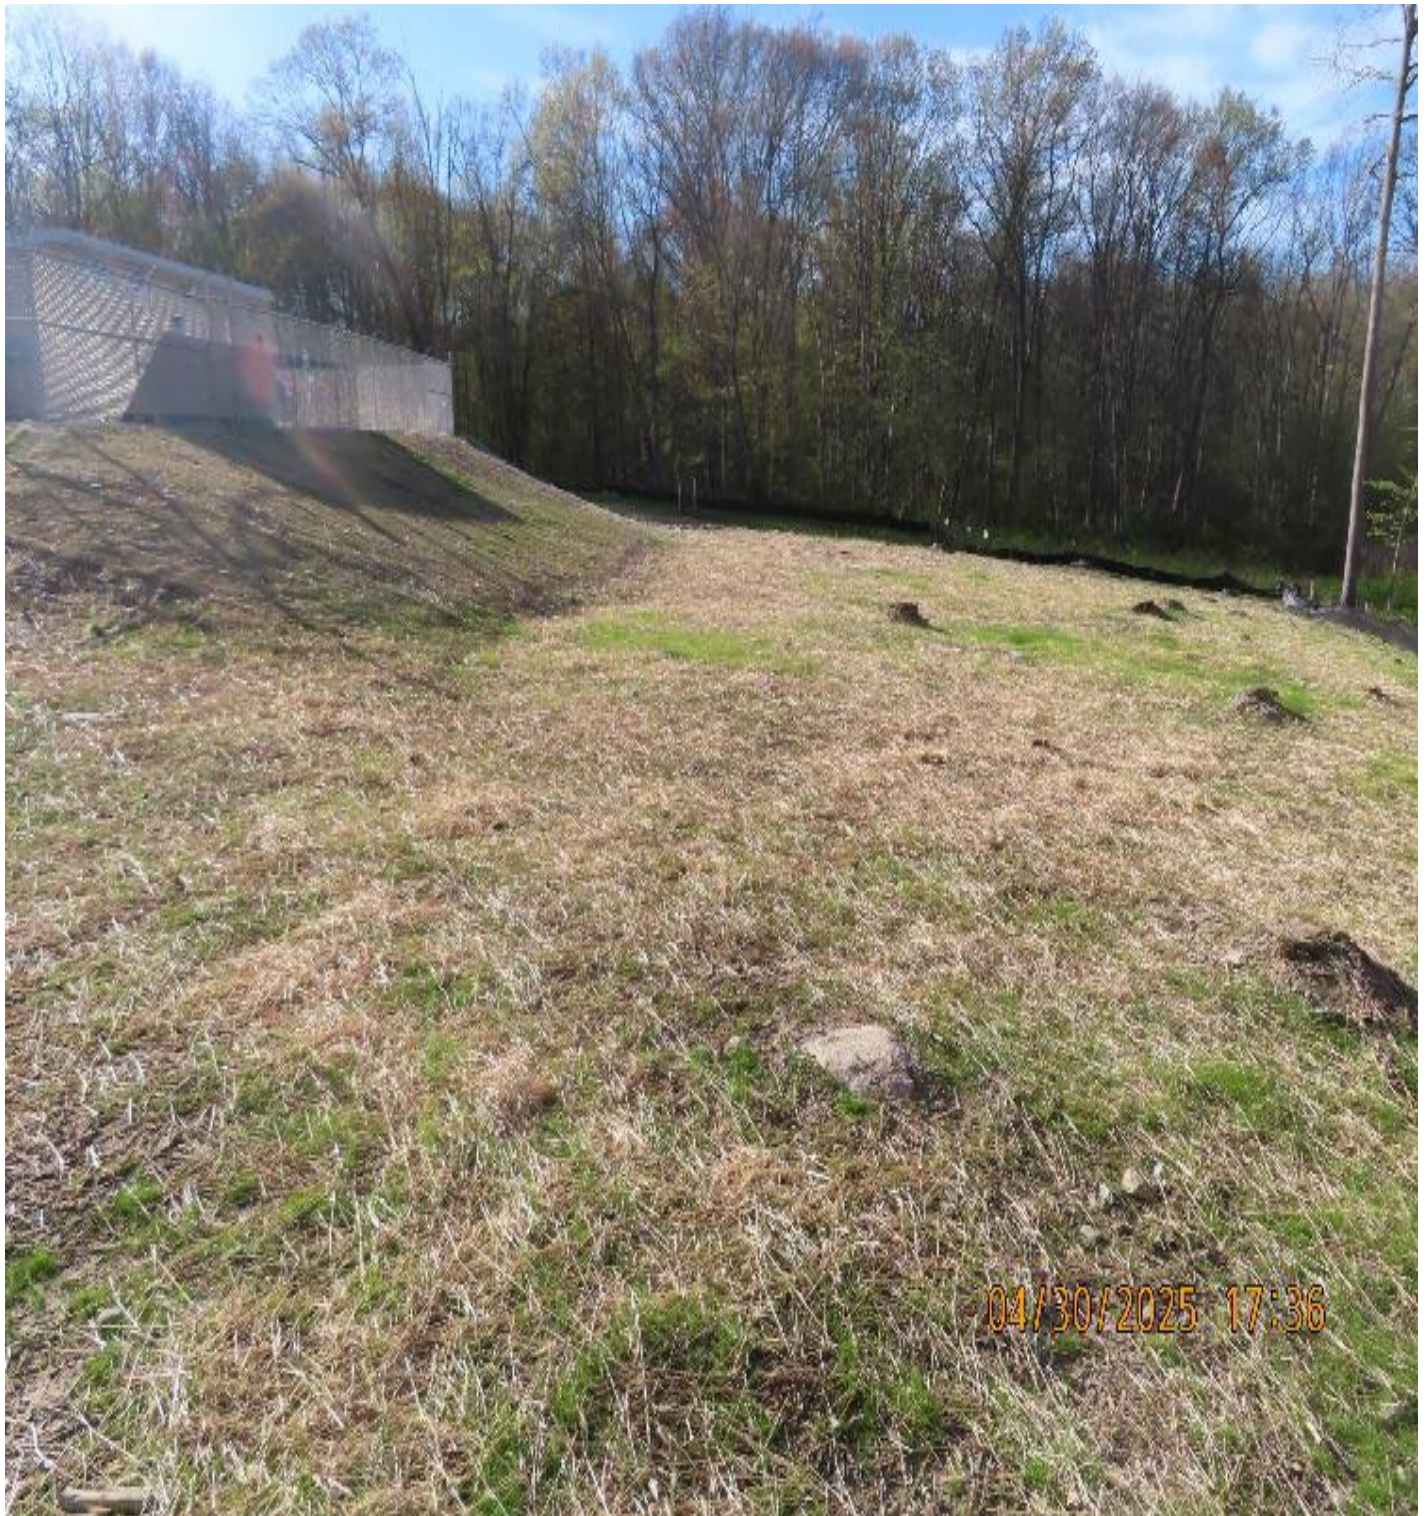
Photo 6: View (looking northwest) of stabilized areas downslope of new regulatory building.

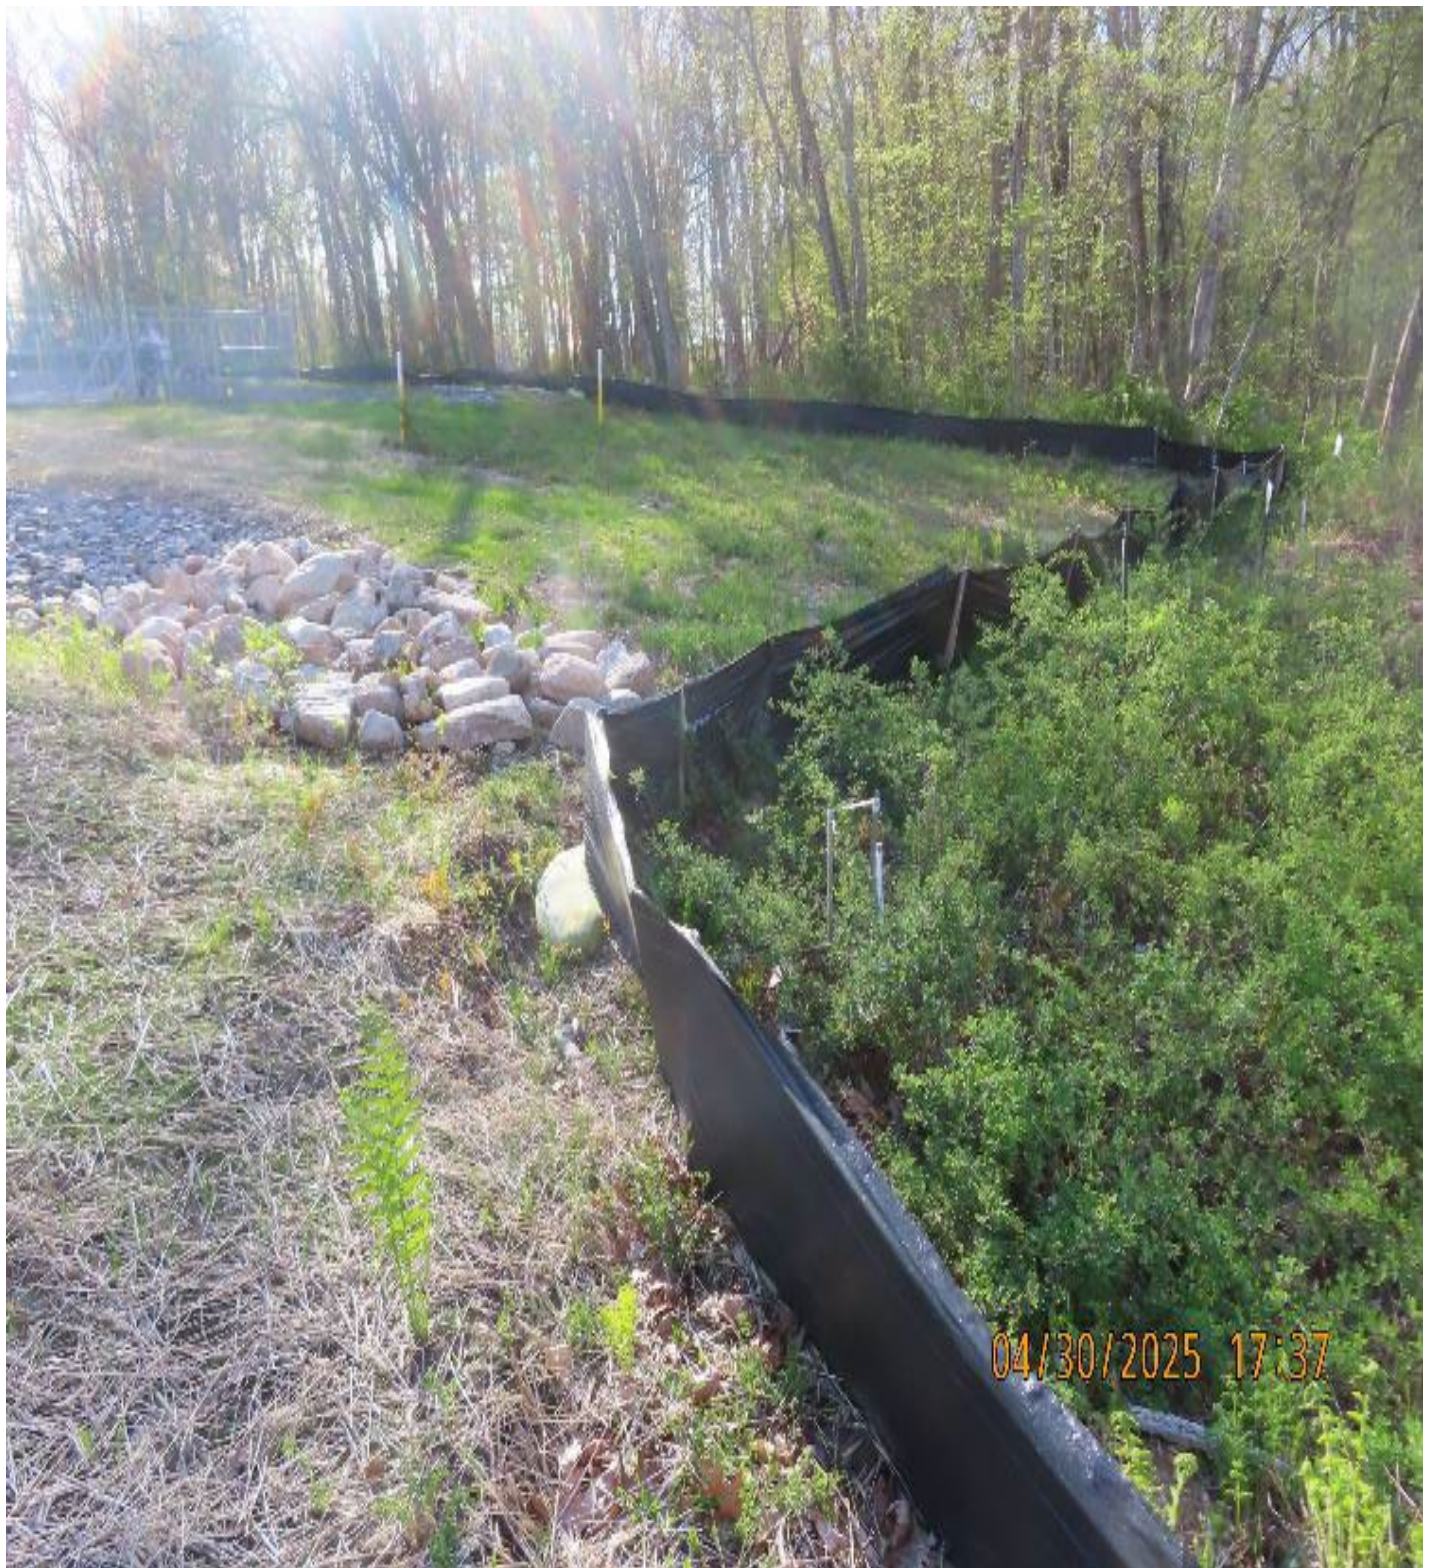
Photo 7: View (looking west) of silt fence and vegetative buffer along boundary with wetland W-CZ-01.

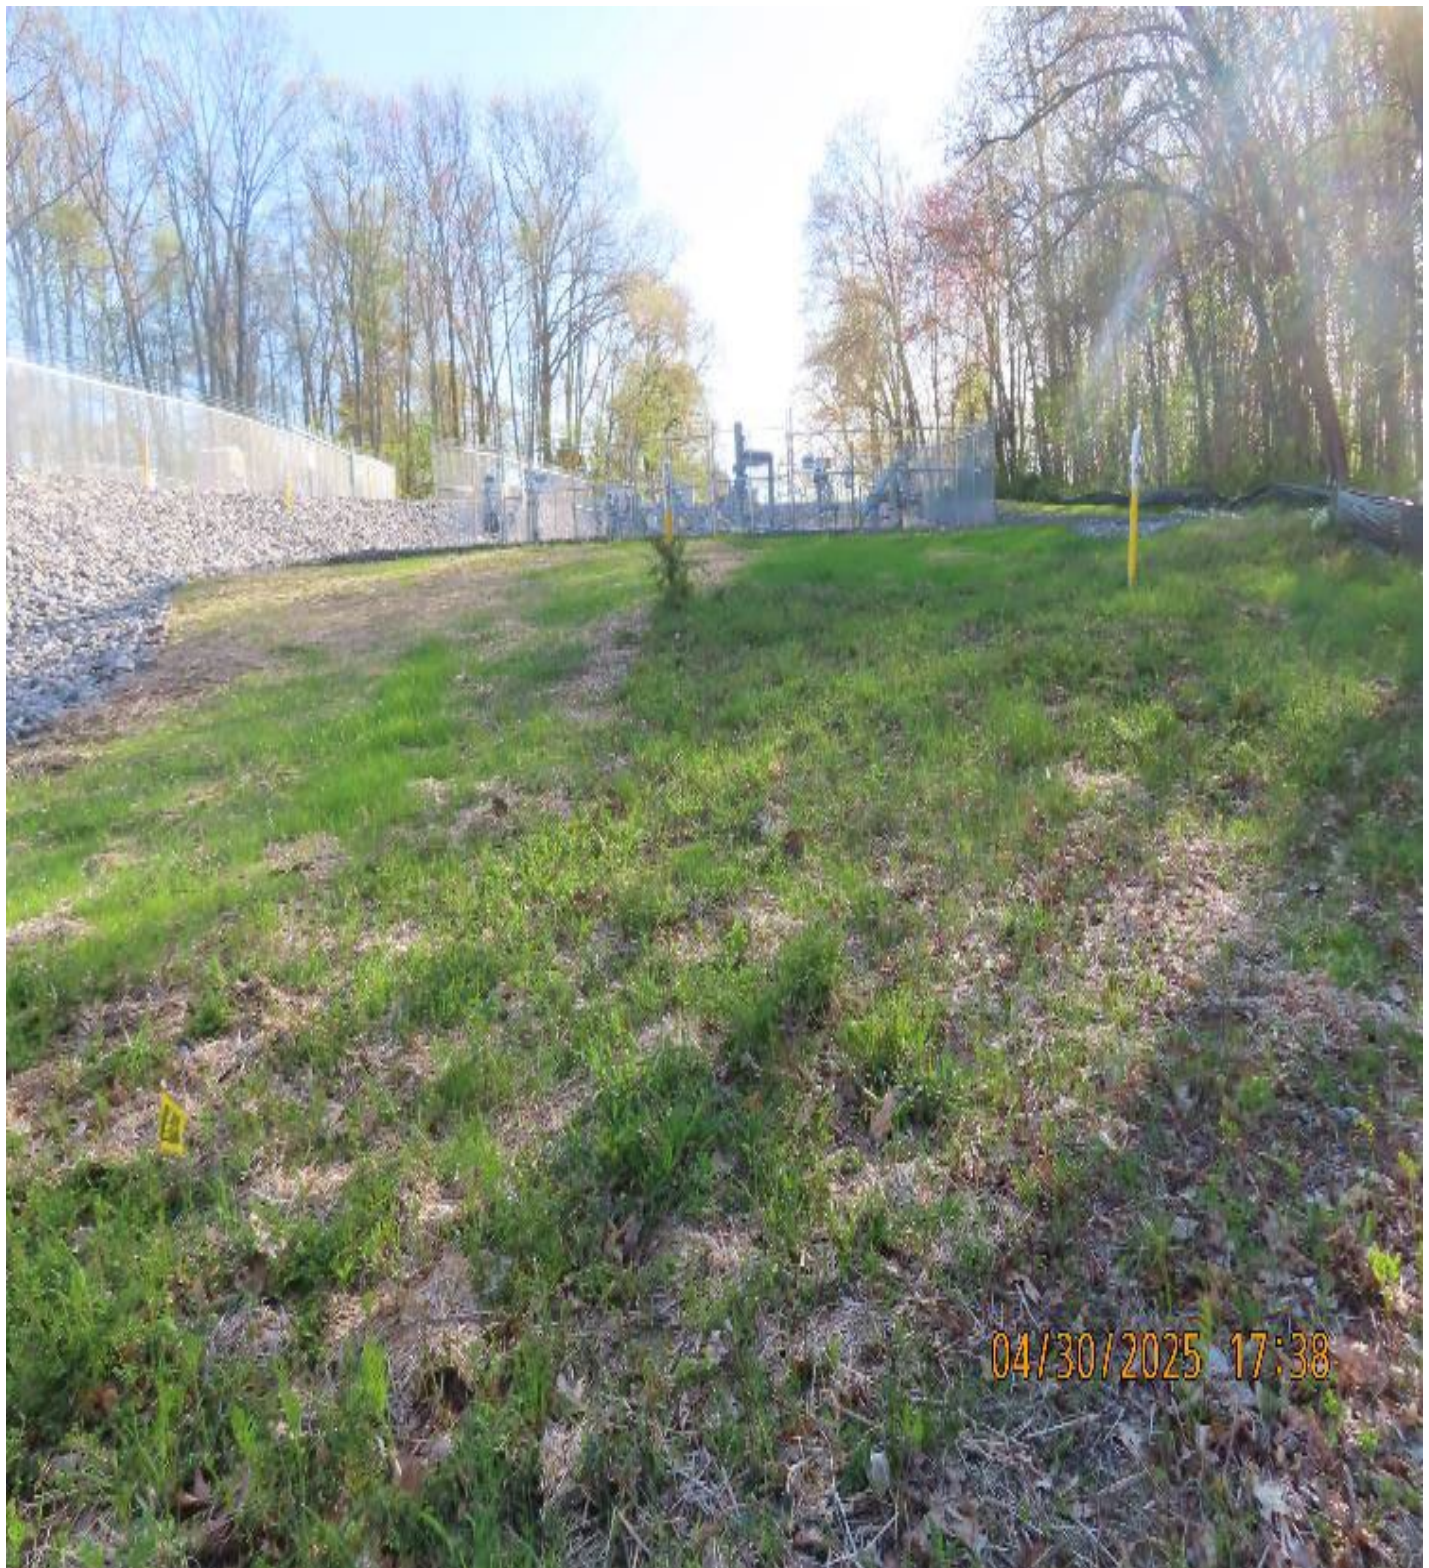
Photo 8: View (looking southwest) of revegetation progress downslope of the valve yard.
